Heiple Wiedower
Architects Planners

LITTLE ROCK POLICE HEADQUARTER'S BUILDING UPPER LEVEL PLAN ABOVE CEILING INVESTIGATION
SCALE: 3/16" = 1'-0"

LITTLE ROCK POLICE HEADQUARTER'S BUILDING LOWER LEVEL PLAN ABOVE CEILING INVESTIGATION
 SCALE: 3/16" = 1'-0"

This report is the second phase of a three phase program to eliminate water and humidity from the interior of the Little Rock Police Building. The first phase was to repair the leaking roof and increase roof insulation and roof reflectivity and that phase is currently underway. This second phase includes repairing interior problems including condensate leaks from ducts and pipes, limiting intrusion of humidity and some basic improvement of air flow as well as clearing the plenum space of obstacles and unused materials. The third phase will involve dealing with the mechanical equipment problems within the building.

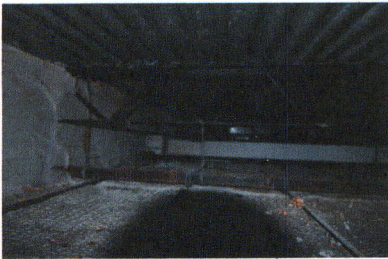
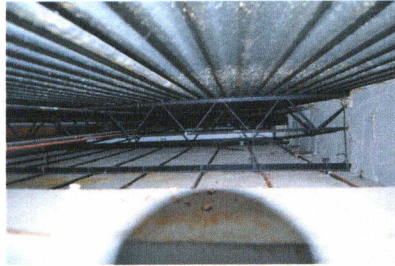
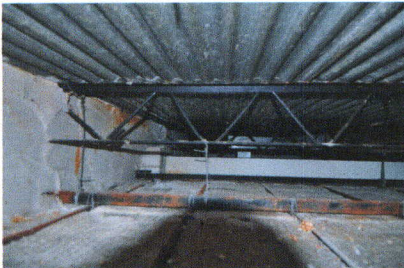
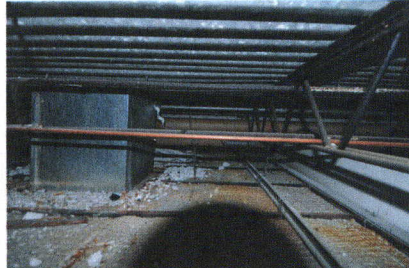
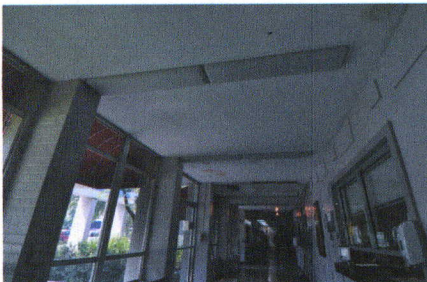
1. Lobby @ Entry and east end
The ceiling in this area is the original plaster. The plaster is stained and damaged by water intrusion. This plaster should be removed and new 2x2 lay in ceiling installed. The damage in this area is primarily from roof leaks. See 5 photos of this areas. Repairs include demo of plaster, replacement with 2x2 lay-in ceiling and 6 new light fixtures.

The cost of this remedy is \$2,800.00.

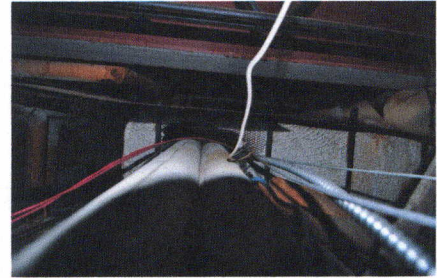
2. Lobby at west end
Mens Restroom Vestibule

This area includes 3 different problem areas these are primarily from water piping and condensate problems. This area has most of the original plaster ceiling intact above the new lay-in ceiling. In order to facilitate future work above the ceiling it is recommended that the plaster be removed. The Men's toilet vestibule leak is caused by an uninsulated pipe and this must be repaired as well as new ceiling and new lights. The 2 other leaks are located in the hall and are both caused by condensate from piping. This area should have plaster ceiling removed as well as insulation and ceiling tiles replaced. There is also an abandoned fan coil unit that should be removed. The removal of abandoned wiring and cabling is included in this area.

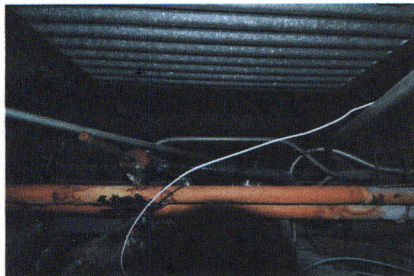
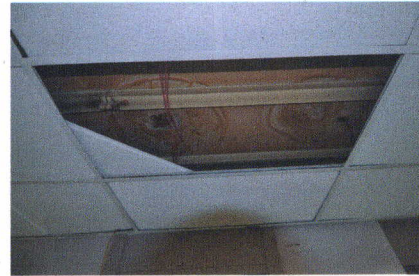
2A. Condensate leak from uninsulated pipe

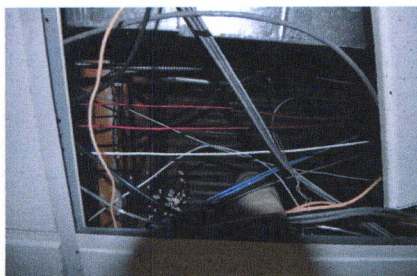
2AA. Condensate leak from uninsulated pipe

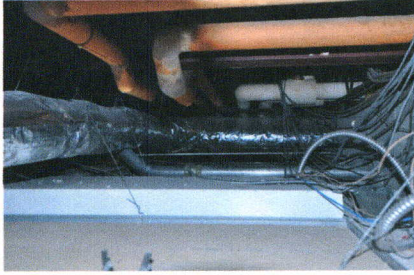
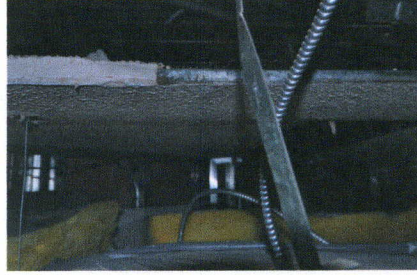
2AAA. Condensate leak from uninsulated pipe

The cost for this remedy is \$2,090.00.

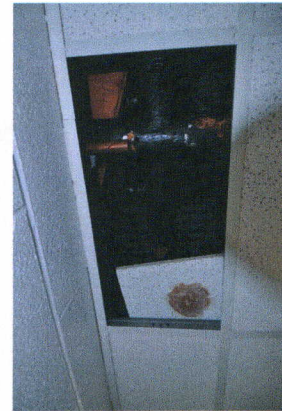
4. Hallway in Administration
There is plaster in this area above the lay-in ceiling that should be removed.
Fiberglass insulation has been laid in this area - has been disturbed this should be replaced to provide insulation coverage
Several roof leaks are the source of most stained tile in this area.
There are also several pipe leaks in rear corridor on 4 pipes running length of building - approximately 300 lf of chilled water pipe insulation should be replaced
Stains on wall should be repainted and approximately 20 ceiling tiles should be replaced

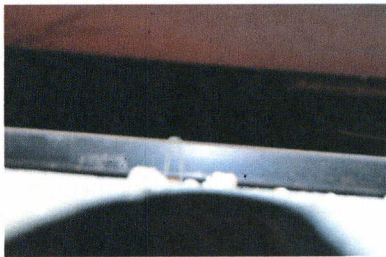
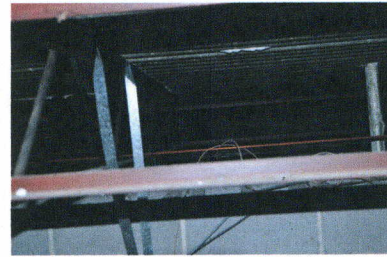
- 4.A At this nearby location there is a pipe leak where approximately 5' of insulation should be replaced

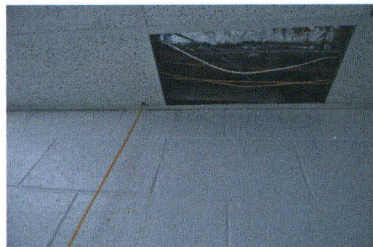
- 4.AA Roof leak

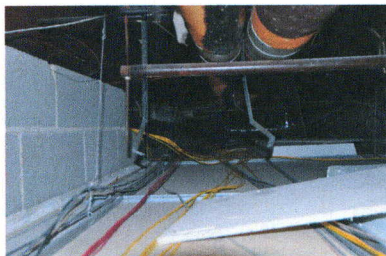
- 4.AAA Condensation leak exists but there is no plaster toward the northeast corner of the building

The cost for this remedy is \$2,600.00.

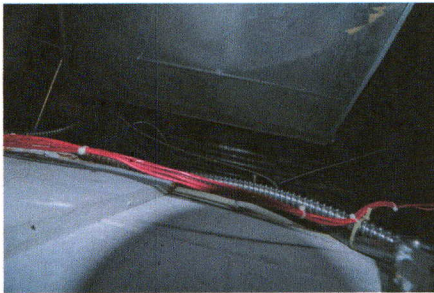
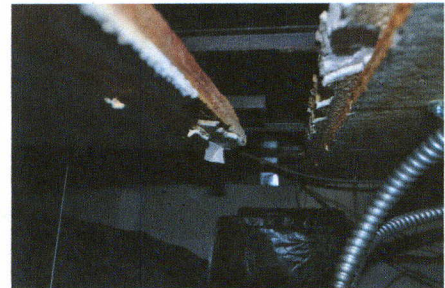
5. Administration Area
Gay's office is the location of a major roof leak, so large that a trash can is placed above the ceiling to catch water
Plaster ceiling remains above lay-in located in the southeast corner of the building in approximately 2500 sf area. This area has fiberglass insulation laying on the lay-in ceiling tiles which should be replaced for proper insulation coverage.

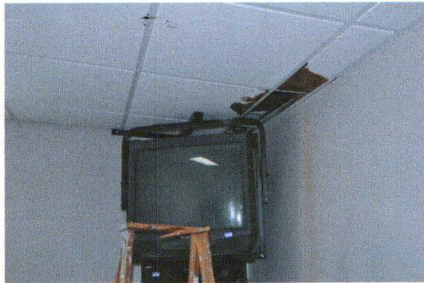
- 5.A Chief Corbin's office
There is a roof leak in this room but also evidence of a condensate leak from uninsulated piping. Reinsulated piping and replace ceiling tiles.

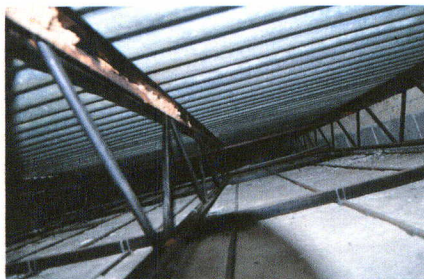
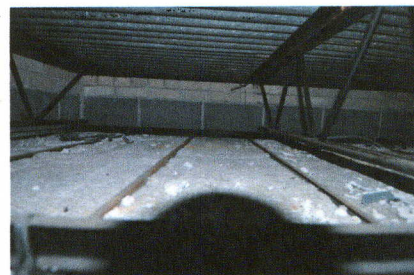
- 5.AA Conference Room
All plaster above ceiling
No leaks or pipe problems

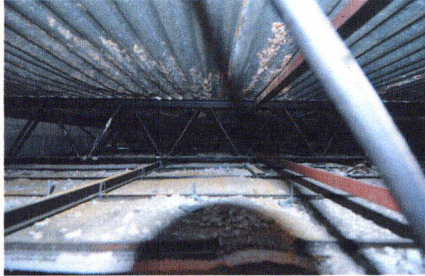
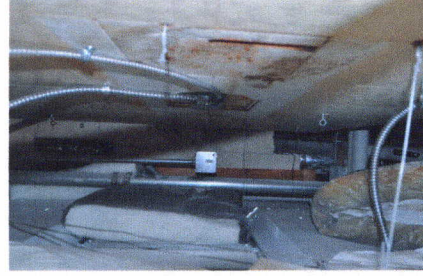
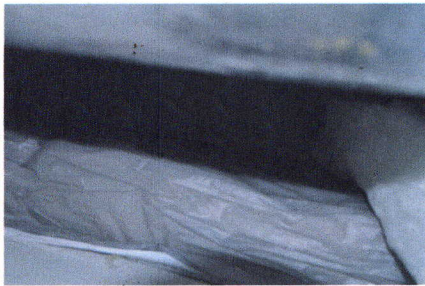
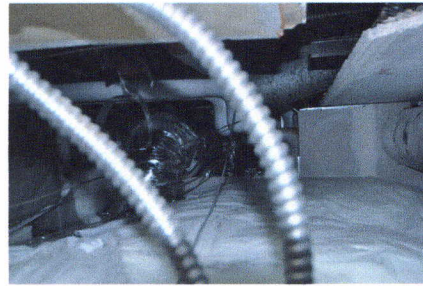
5.AAA Chiefs Office

There is plaster above the lay-in ceiling in this entire area.

Much of the roof deck has water damage and evidence of many roof leaks. No stained ceiling tiles, but much evidence of leaks implies that tiles are replaced regularly. Fiberglass insulation lays on the lay-in ceiling and should be replaced for proper coverage. Abandoned wiring and cable should be removed in this area

Cost of this remedy is \$1,950.00

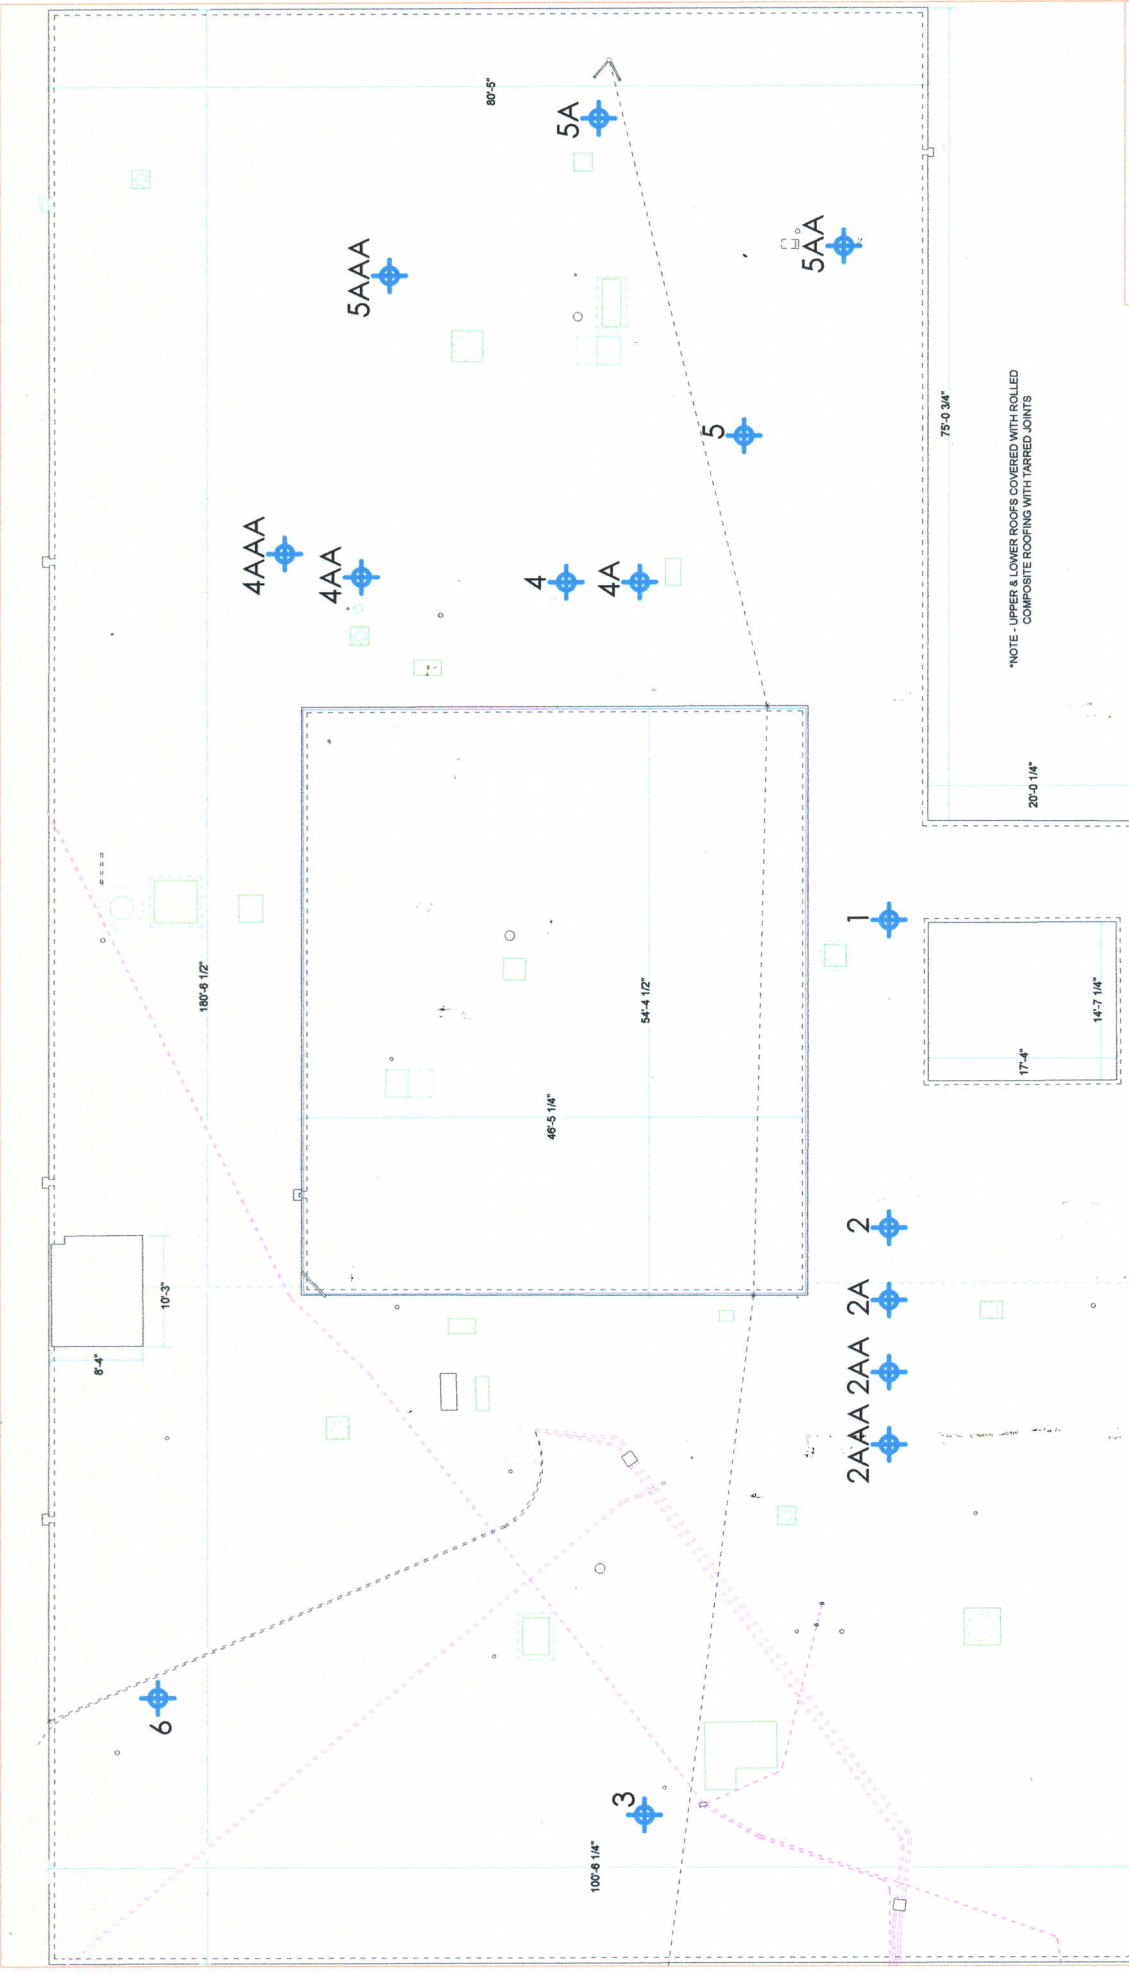
The moisture problems on the upper level are a result of roof leaks and condensation from uninsulated pipes and ducts.

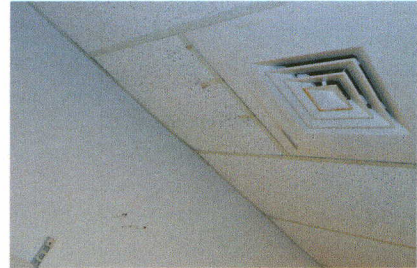
#14. Latent Fingerprints

This area has some humidity problems which are shown by mold growth in ceiling tiles need grilles and on walls that are hit by cold air. Limiting the humidity from crawl space and verification of hvac operation needed.

There are 3 apparent above ceiling leaks in this areas that require replacement of 5 ceiling tiles./ Approximately 6 sf of pipe insulation is required to stop condensate leaks.
Cost for this remedy is \$125.00.

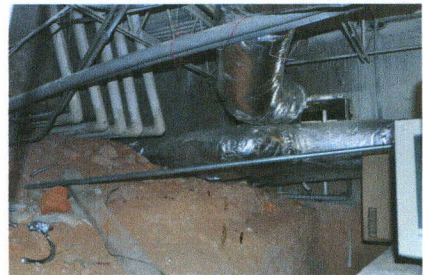
#15. Crawl space

The unfinished crawl space has exposed earth along the south side and water/moisture is free to seep into this entire end of the building. There are also open sumps and hvac condensation present to add to the humidity even in dry weather. This can never be kept dry but openings should be sealed between this area and the adjacent rooms to lower humidity in those areas. Sealing of this wall can be accomplished by adding sheet moisture barrier on walls, sealant on penetrations and gasketing of doors to reduce the mold problem.

Cost to install vapor barrier between crawl space and occupied rooms would be \$3500.00.

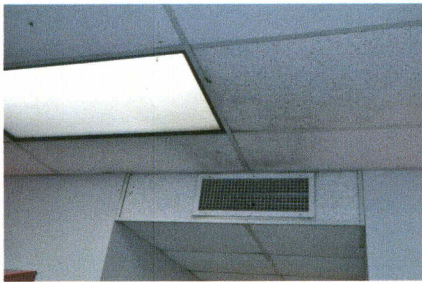
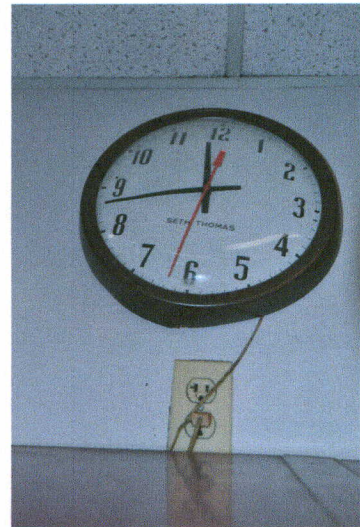
#16. Men's Locker

This locker room has lay-in ceiling which provides a growth area for mold in this high moisture level environment. The humidity from the showers and from the adjacent crawl space meets the air from a malfunctioning hvac system to grow mold around air grilles and penetrating in walls. See photo of grille in Men's Locker and clock receptacle on common wall with the crawl space. This area also has return air problems and this area restriction adds to the problems in this area. Replace 25 ceiling tiles and install transfer grilles in doors. Cost for this remedy is \$575.00.

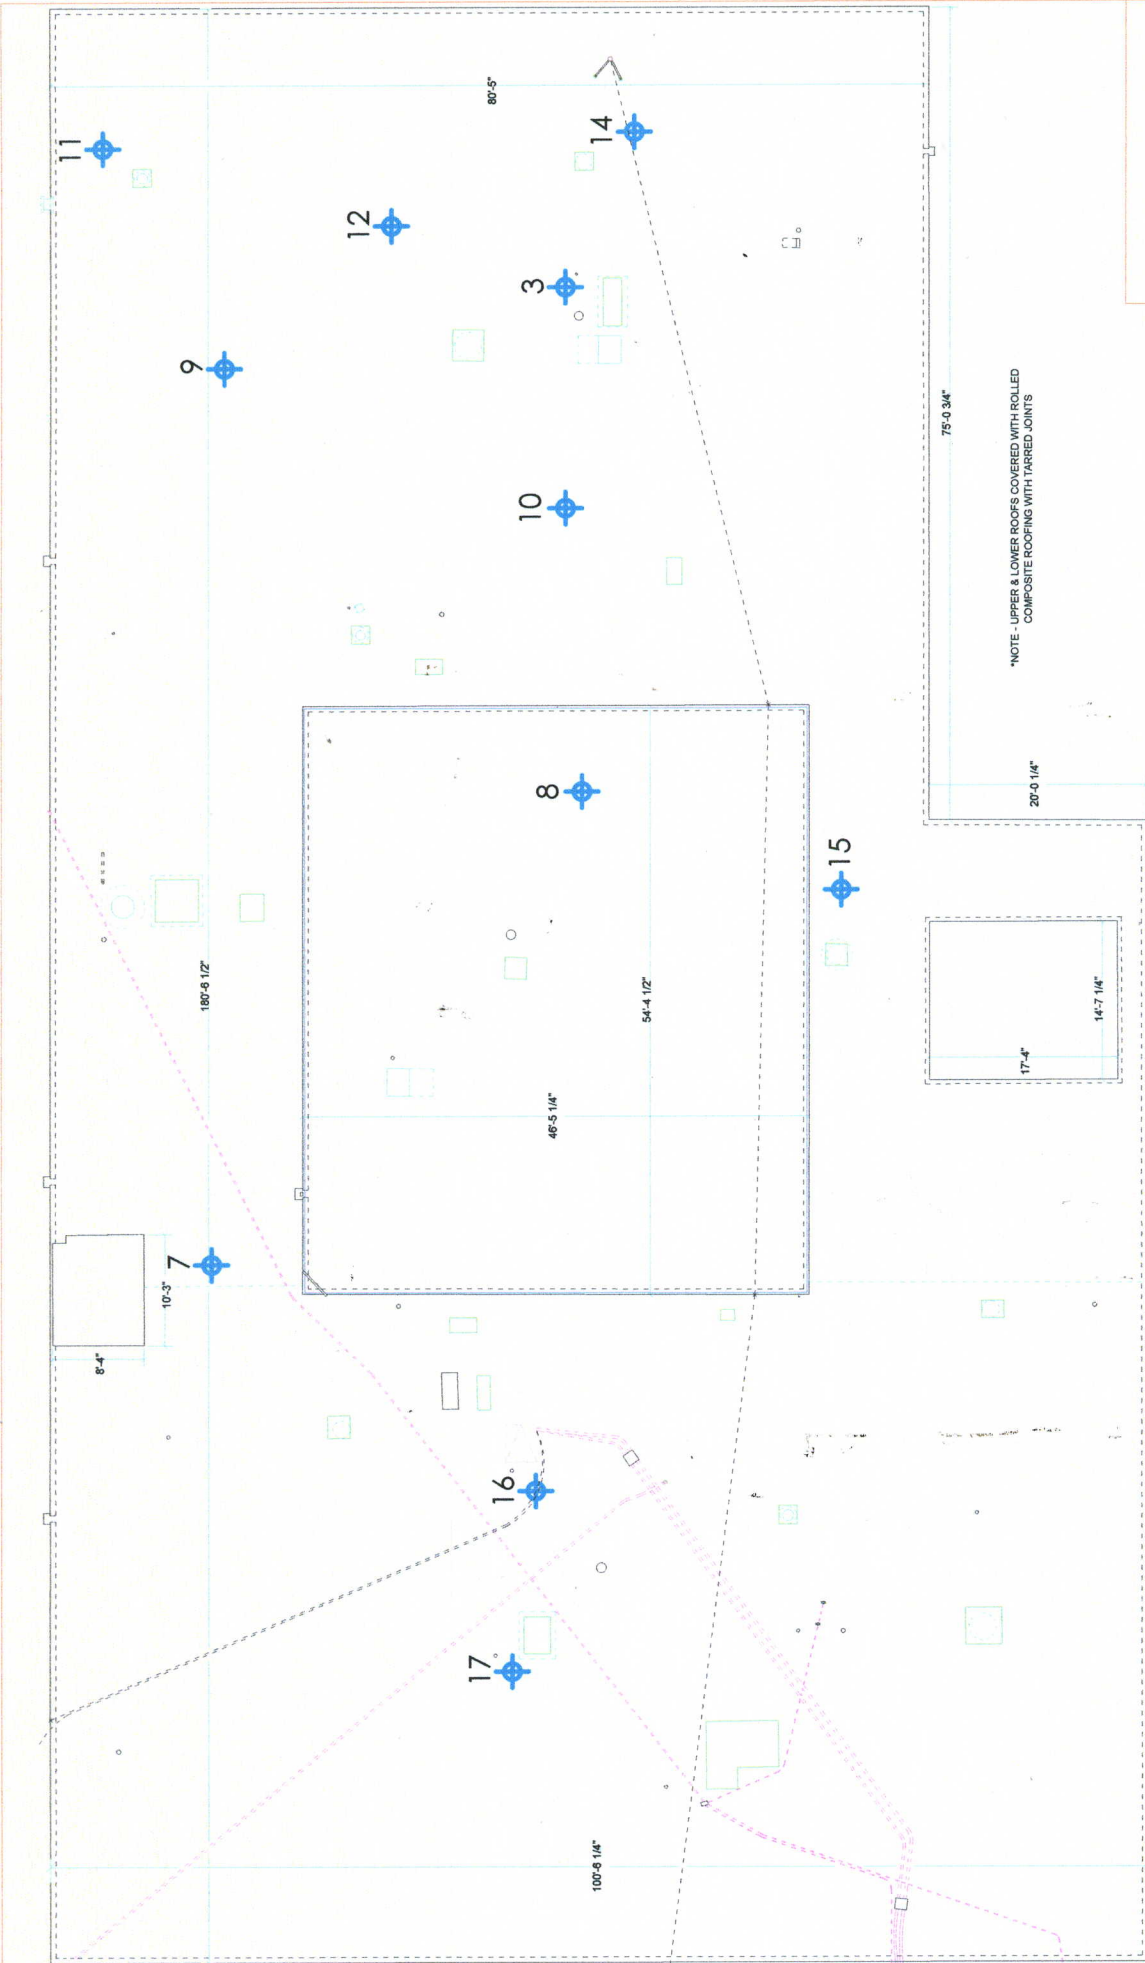
The moisture problems on the lower level are from 2 sources. They are primarily from leaking pipes and ducts and secondly and more importantly from intrusion of humidity in the building combined with mechanical equipment that is not operating properly.
