*METALLURGICAL INVESTIGATION OF A
FRACTURED SECTION OF THE 20" O.D.
PIPELINE AT MILEPOST 314.77 IN THE
CONWAY TO CORSICANA SEGMENT OF
THE PEGASUS CRUDE OIL PIPELINE*

REPORT NO. 64961, REV. 1

Prepared for
ExxonMobil Pipeline Company and the
Pipeline and Hazardous Materials Safety Administration
pursuant to Corrective Action Order CPF 4-2013-5006H

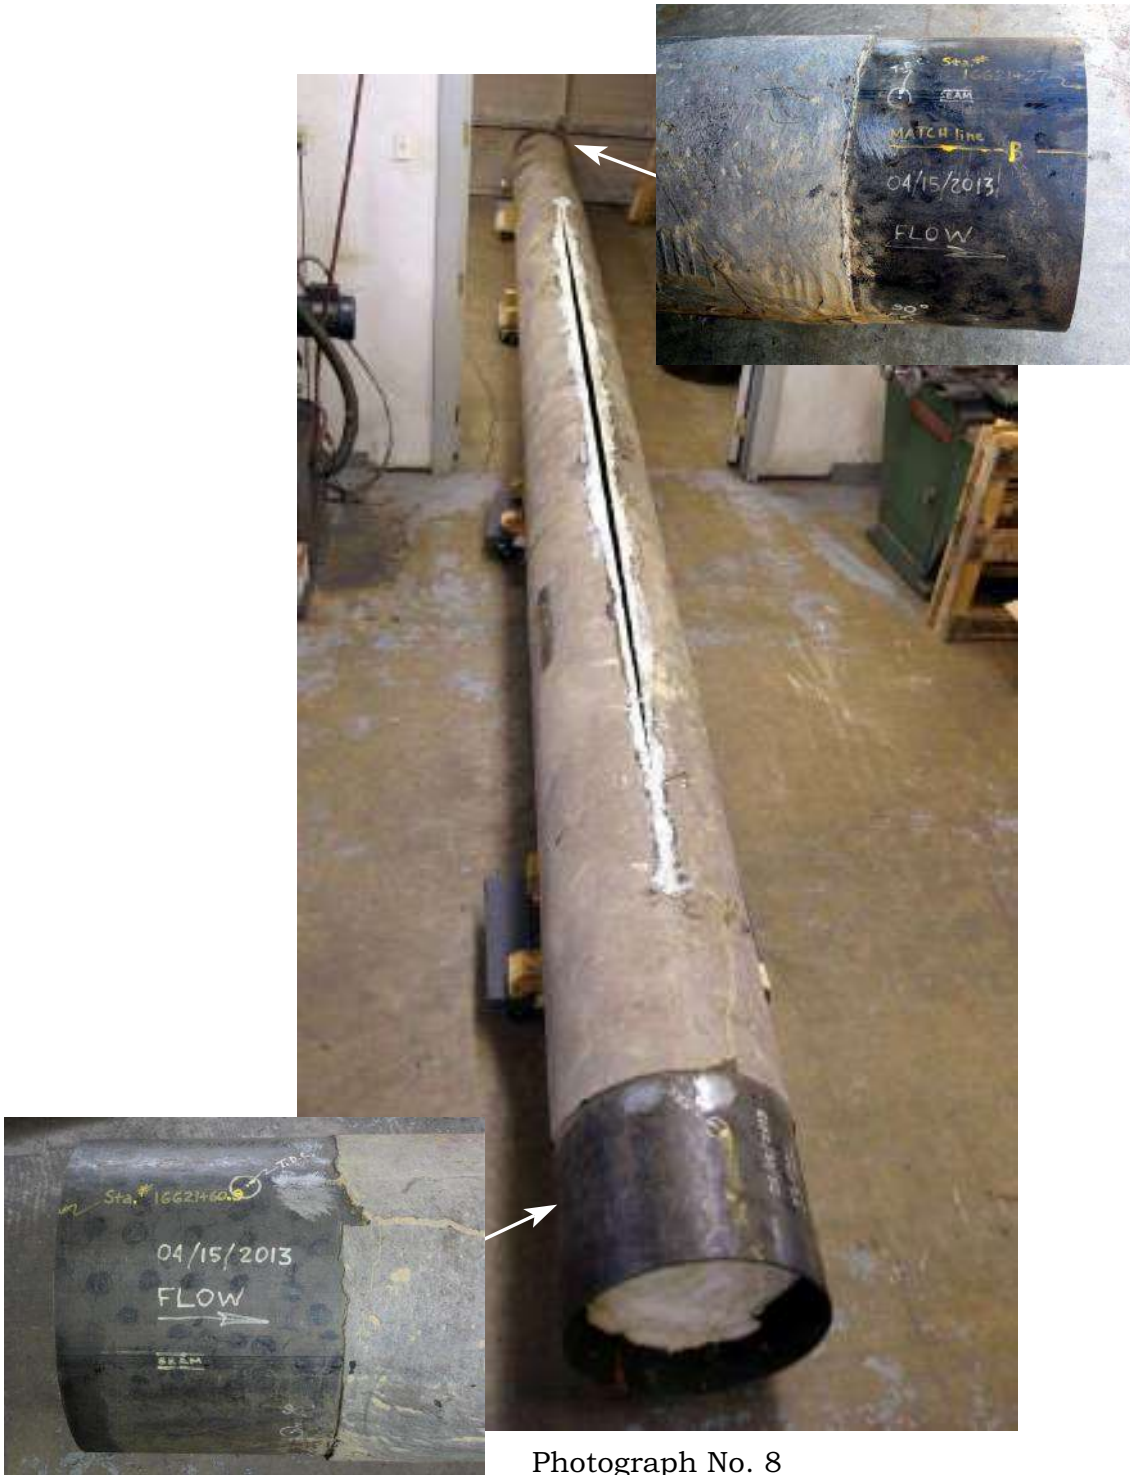
Photograph No. 8

The photograph displays the fractured pipe section following removal of the 2nd wrapping material, revealing the fracture faces coated with grease to protect from post-incident corrosion.

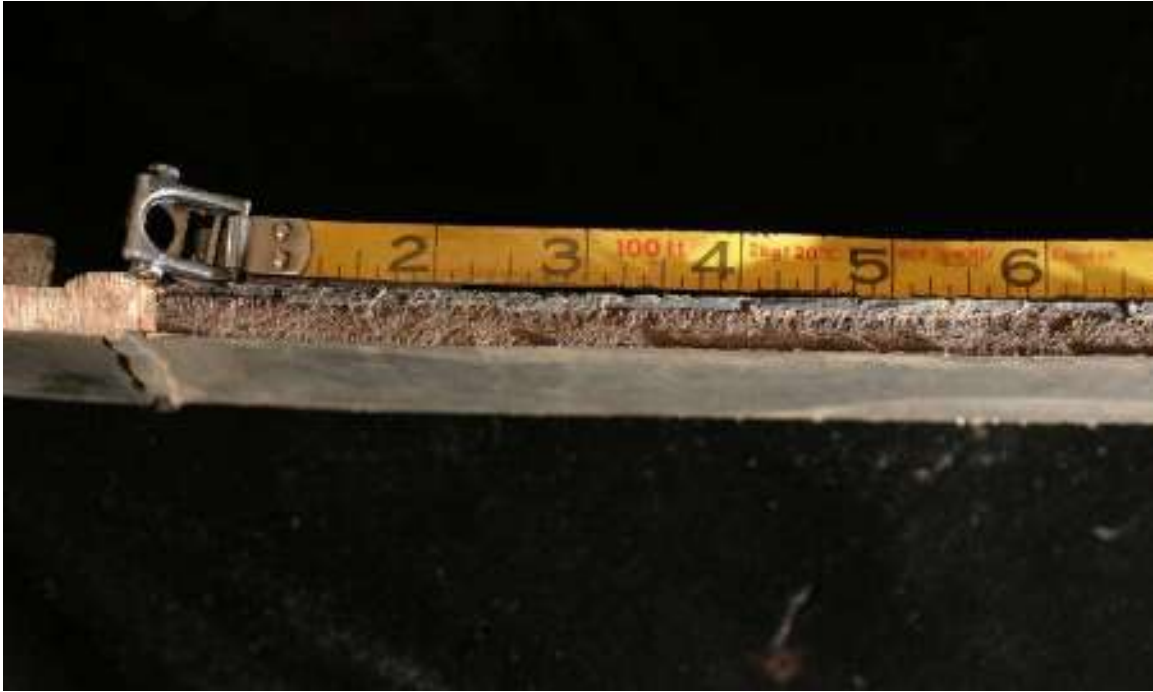
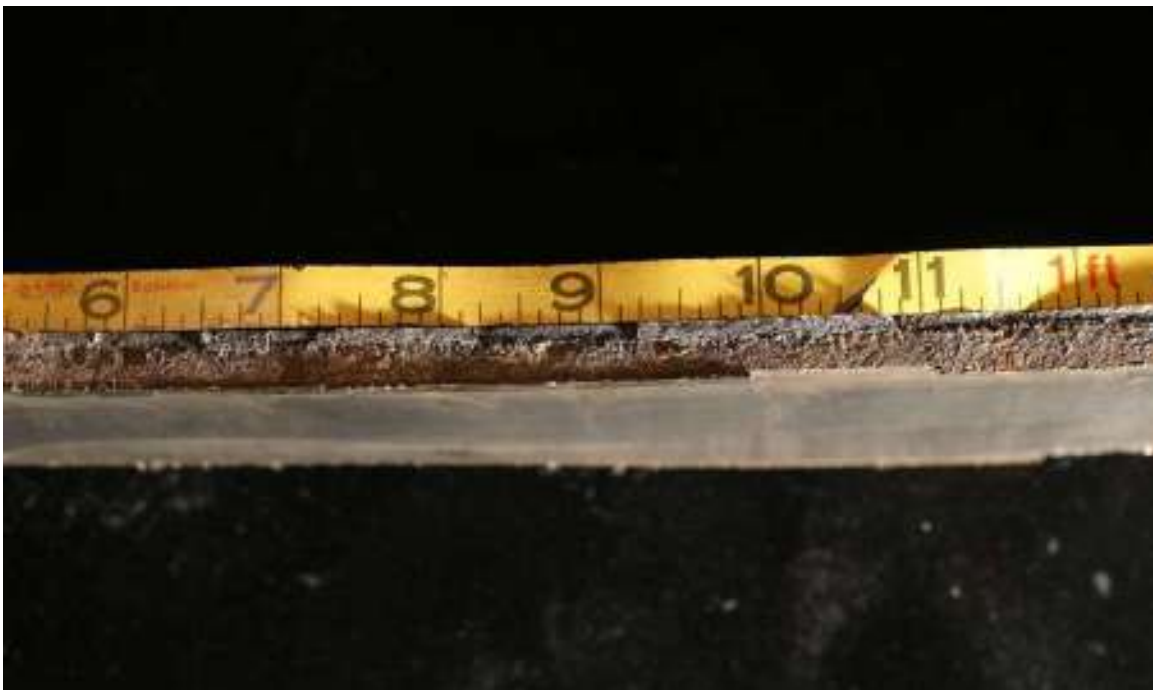
The photographs display evidence of manufacturing imperfection, i.e. the upturned bands near the O.D. in the fracture path of the final fracture.

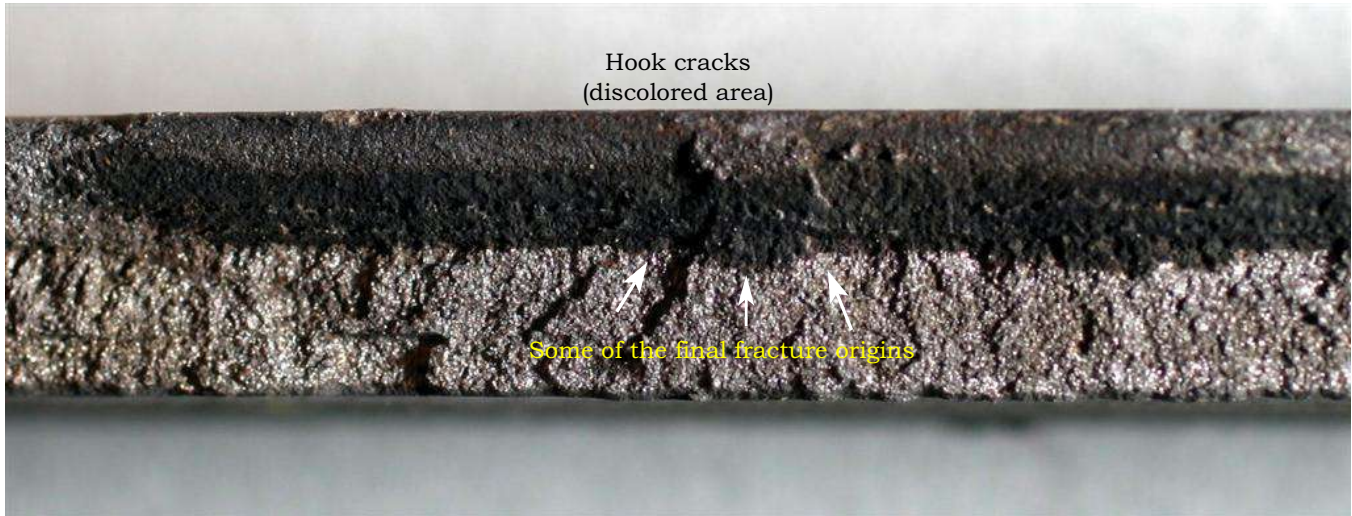
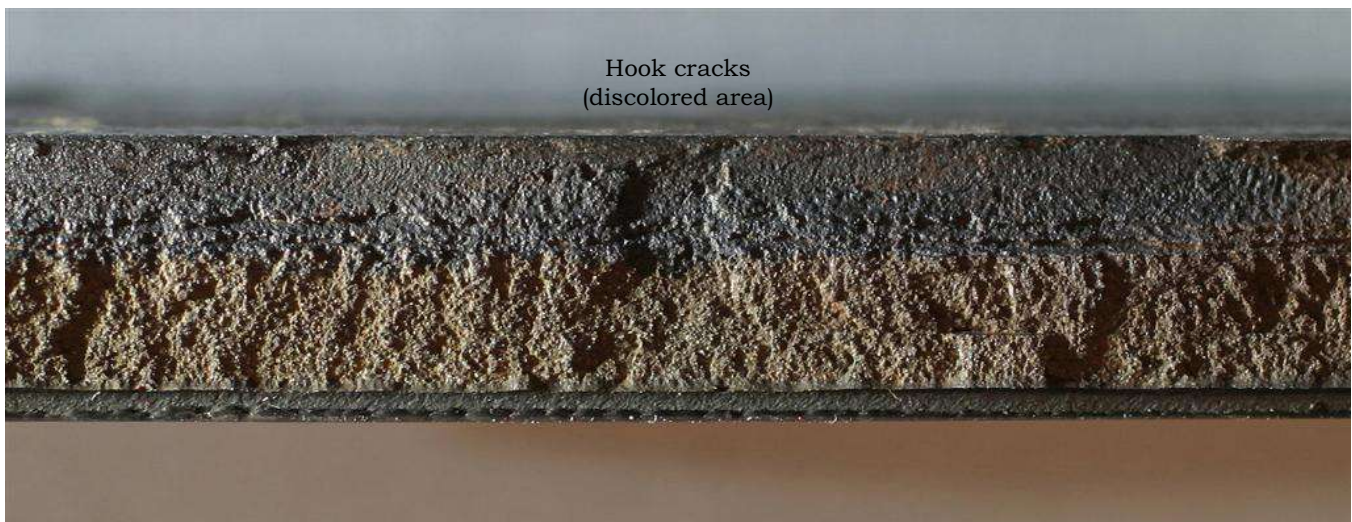
The photographs display the mating fracture faces revealing some of the fracture origin site(s) at a distance of approximately 20' 5-5/16" from the north girth weld, which were later examined at higher magnifications using a Scanning Electron Microscope (SEM) to characterize the fracture morphologies.

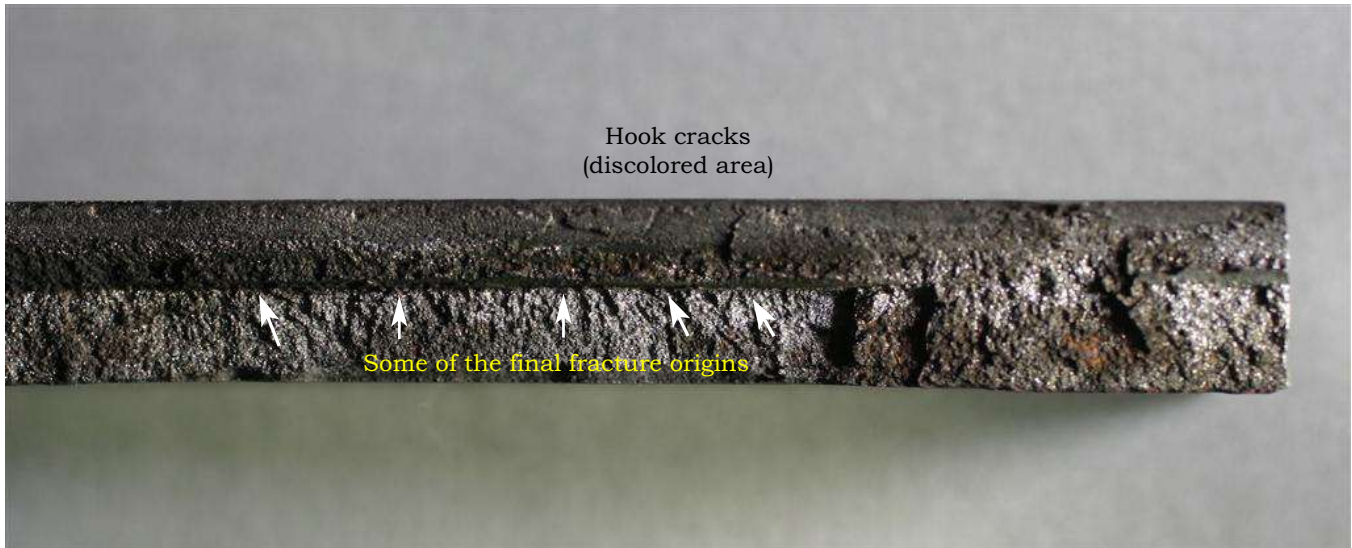
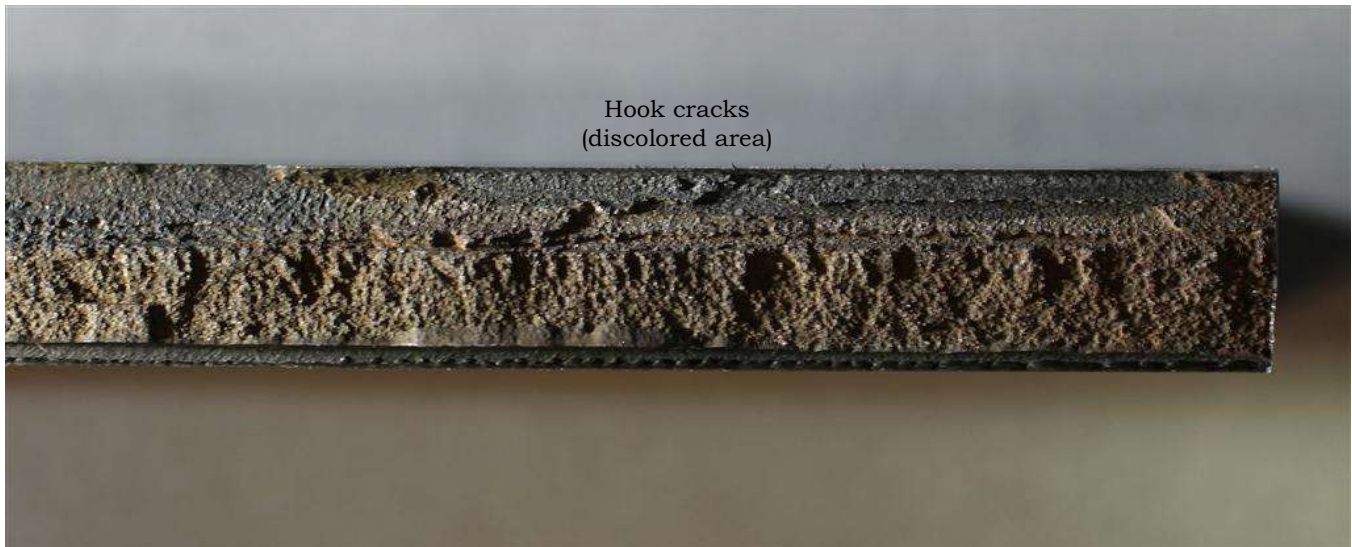
The photographs display the mating fracture faces revealing some of the fracture origin sites at a distance between 20' 5-3/4" and 20' 7-1/2" from the north girth weld, which were later examined at higher magnifications using an SEM to characterize the fracture morphologies.

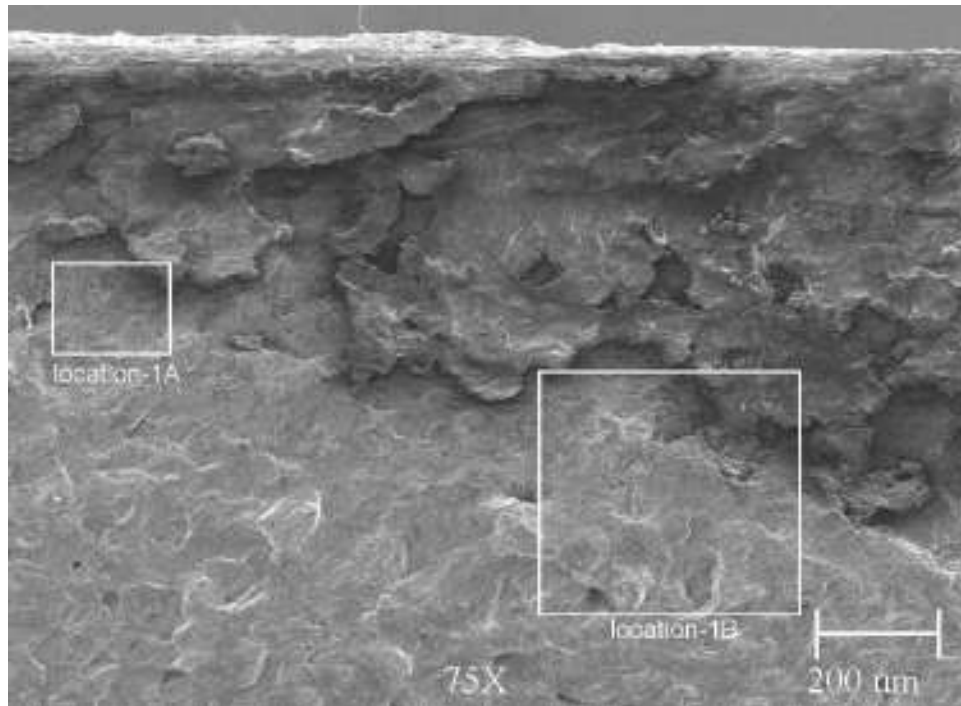
Area-A
Photograph No. 124

The SEM fractograph taken of the Area-A of the hook crack near the O.D. surface, as displayed in Photograph No. 123, displays essentially a nondescript featureless fracture surface. Note the absence of any fracture features, likely due to the metal-to-metal contact from the mating fracture faces of the crack and post-crack oxidation. The fracture locations labeled as Location-1A and Location-1B were examined at higher magnifications to further characterize the fracture morphology.

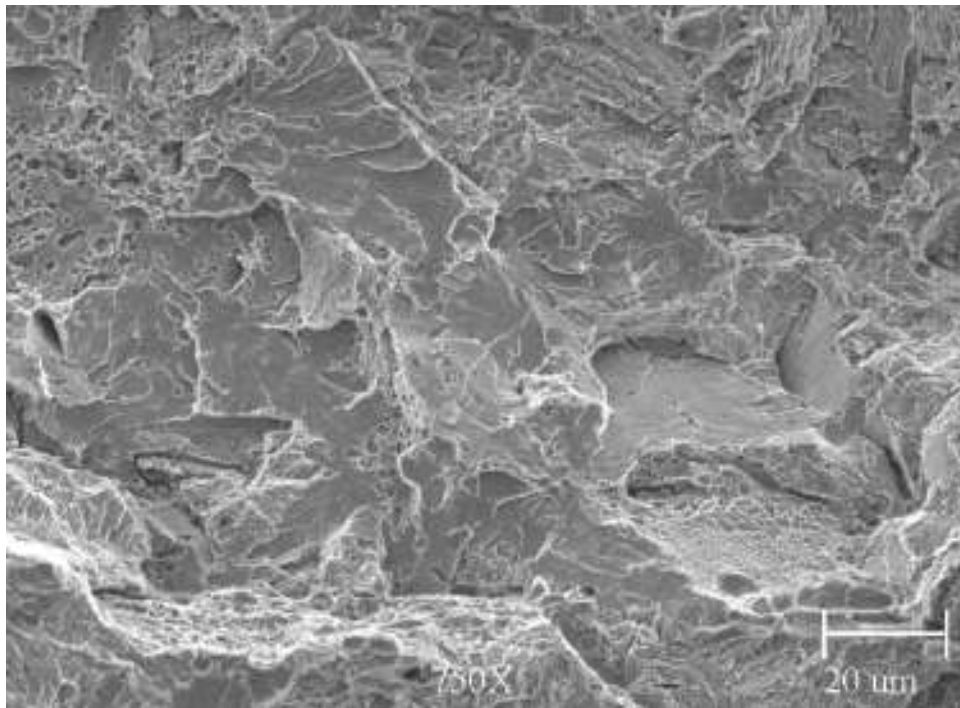
Area-F, Location-6A
Photograph No. 140

The SEM fractograph taken of the Area-F at Location-6A of the final fracture zone confirm the presence of predominantly brittle failure with some isolated areas of ductile failure, as indicated by the presence of cleavage separation and patches of microvoid coalescence, respectively.

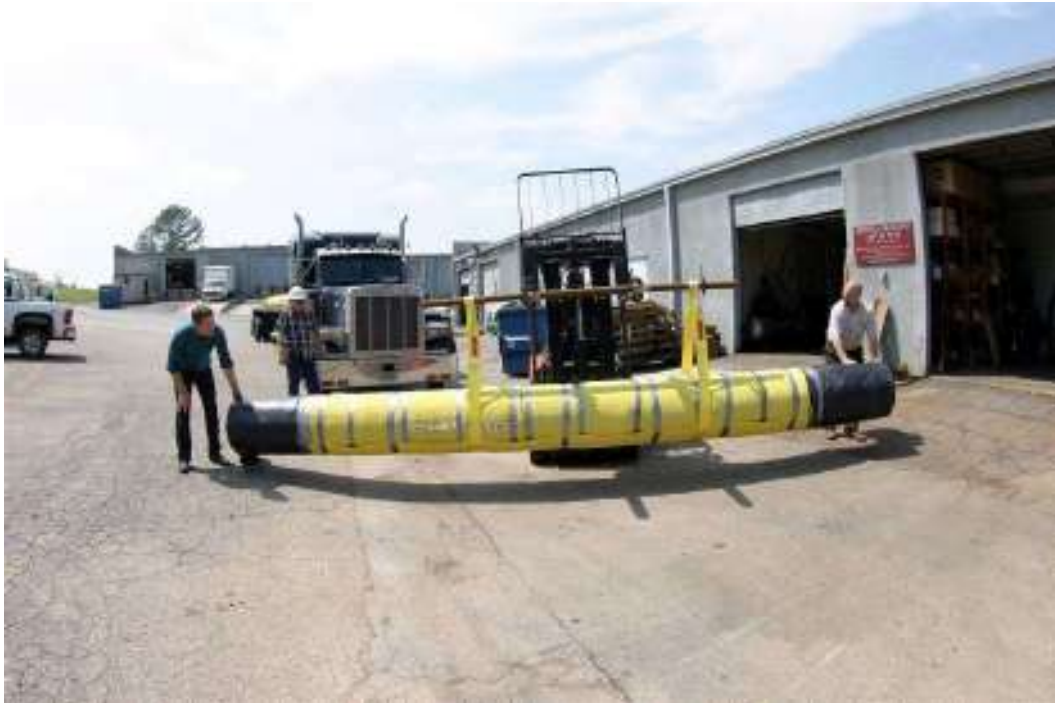
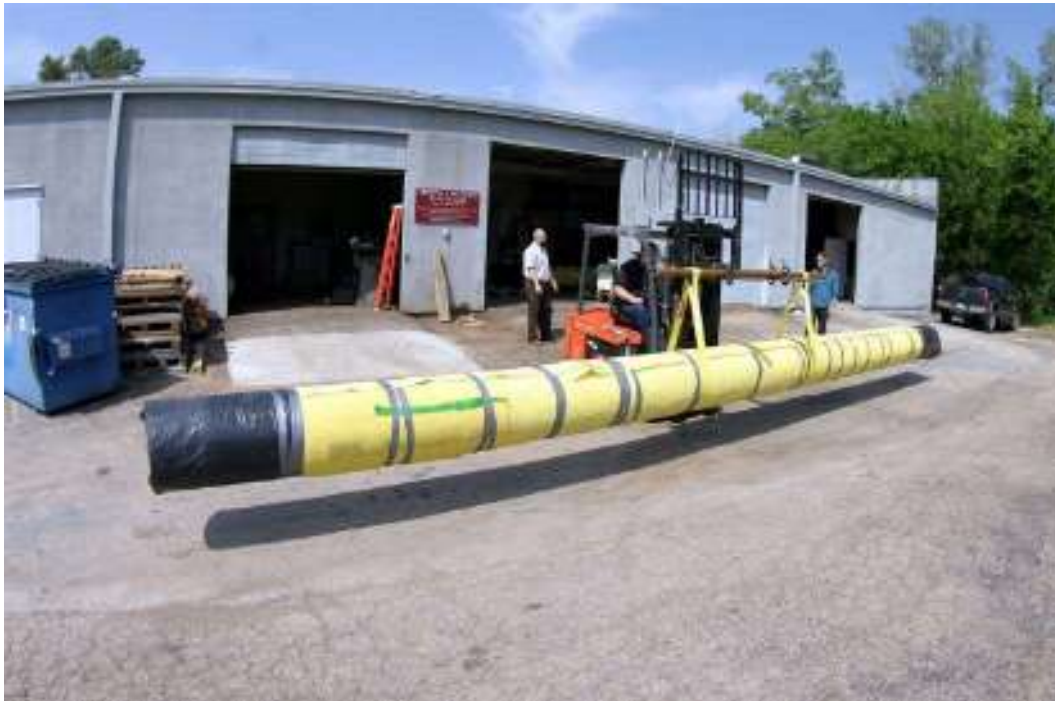
The photographs display two (2) pipe sections during the unloading process. There was no evidence of any transportation related damage to the pipe sections.
