TranScan™ Inspection Report for 20 inch Crude Oil Pipeline

ExxonMobil Pipeline Company

Doniphan to Conway Run Date: 9 August 2010

110004 20B August 2012 Part 1 of 1 Issue 1

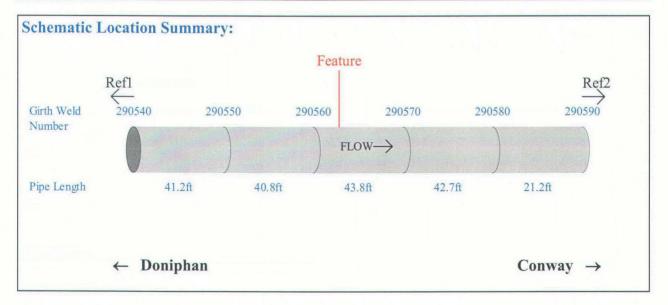
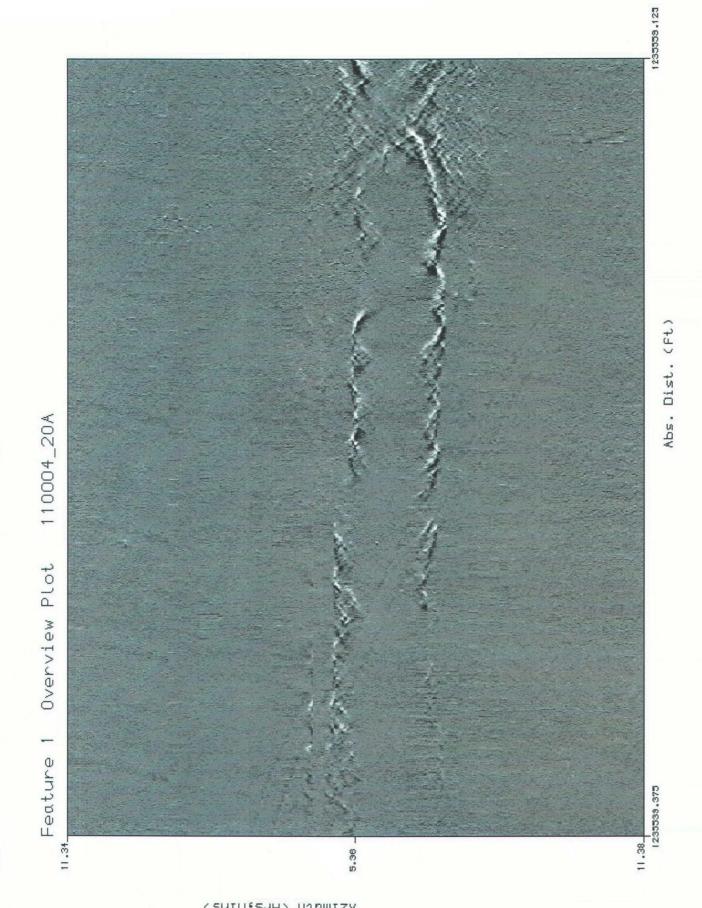
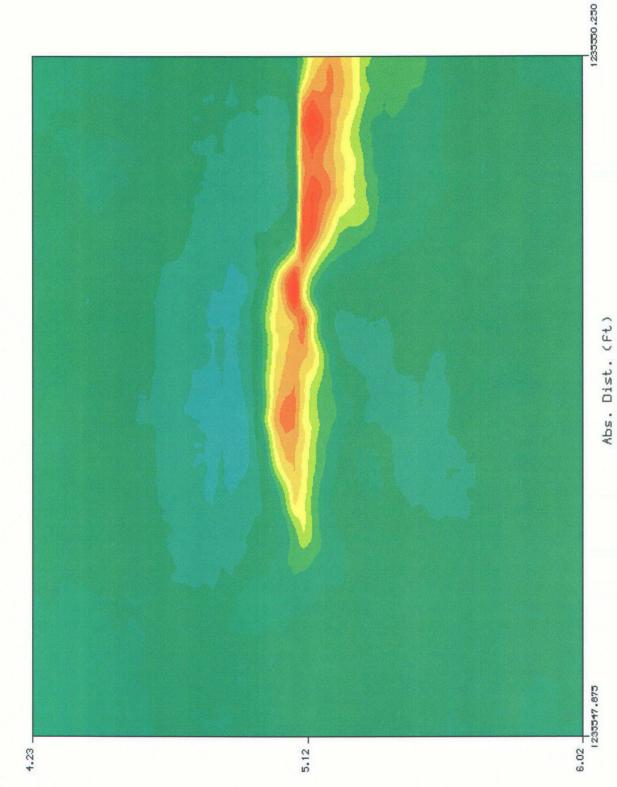
Feature 1 Detail Contour Plot 110004_20A

This metal loss feature has the appearance of corrosion.

The feature is located 12.6 feet downstream from the reference girth weld.

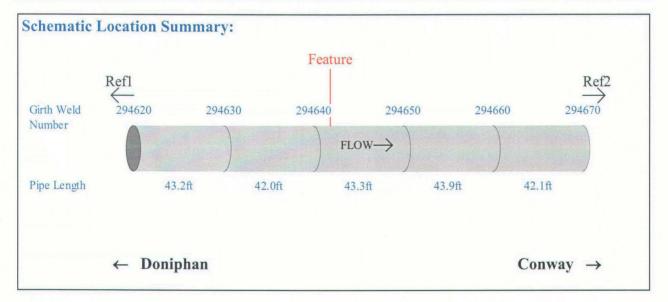
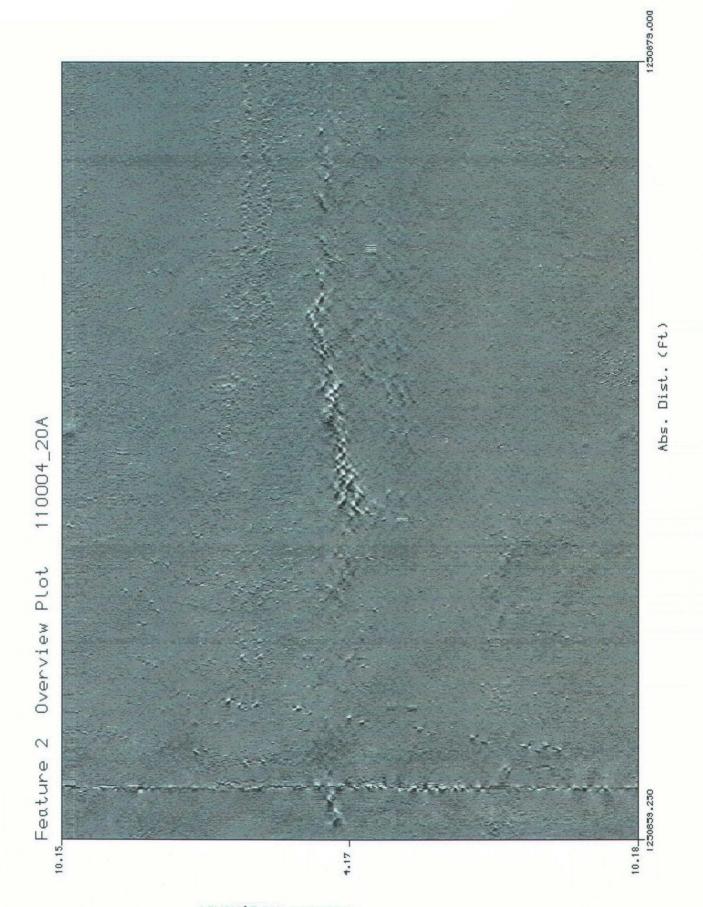
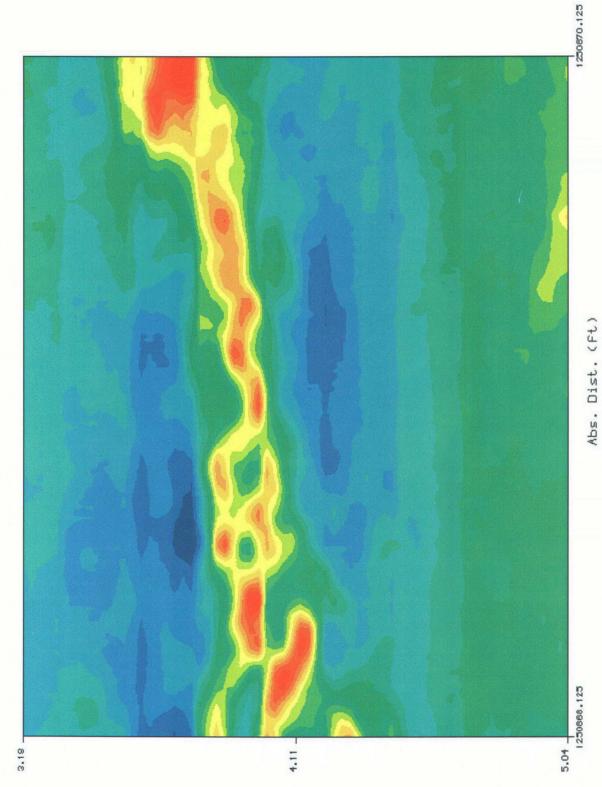
Feature 2 Detail Contour Plot 110004_20A

This metal loss feature has the appearance of corrosion.

The feature is located 8.0 feet downstream from the reference girth weld.

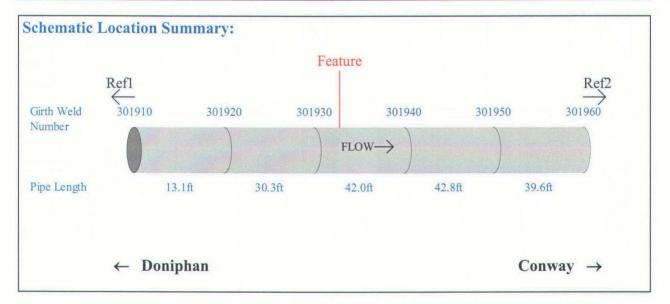
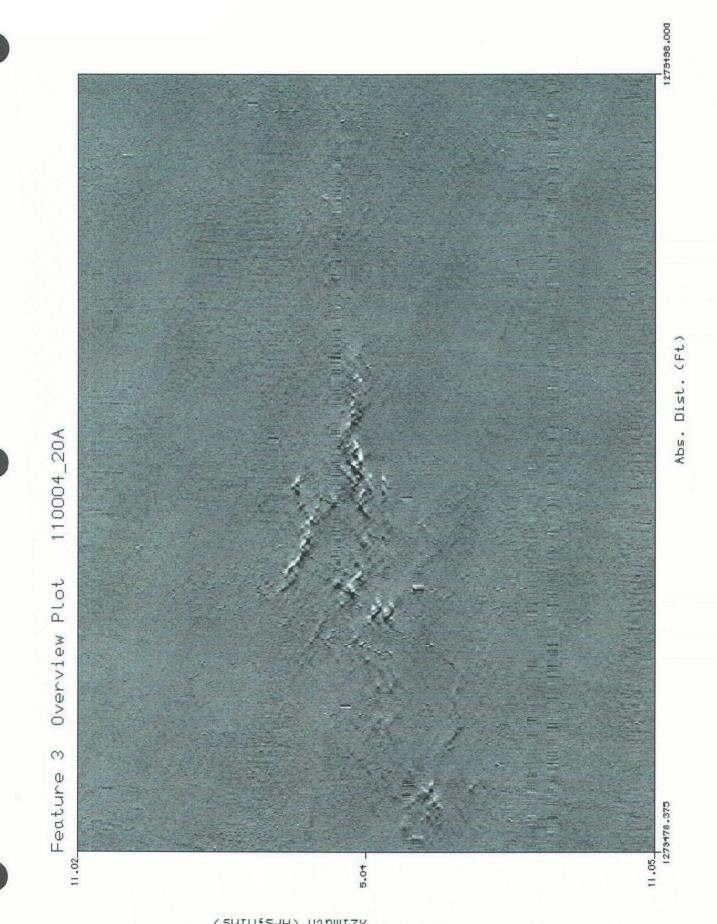
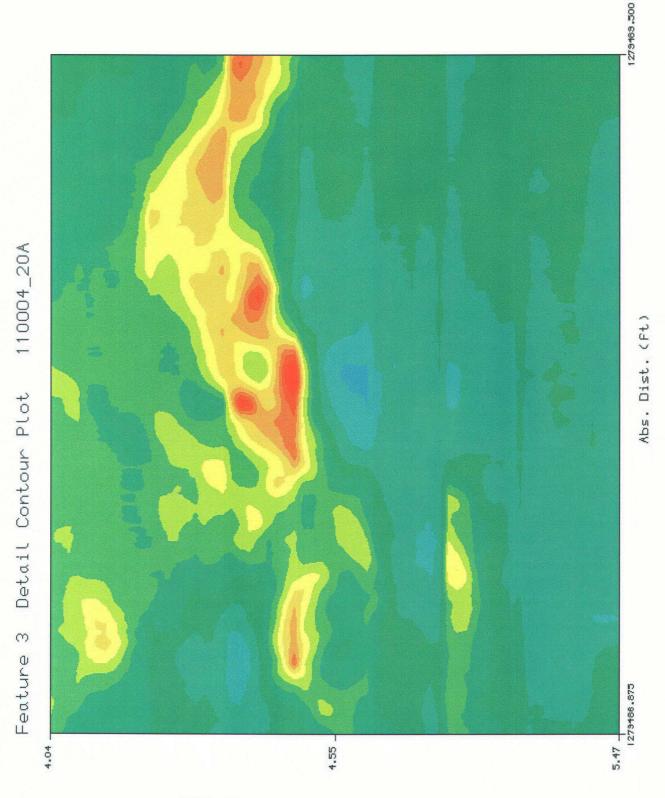
Inspection Sheet Number 3

This metal loss feature has the appearance of corrosion.

The feature is located 12.0 feet downstream from the reference girth weld.

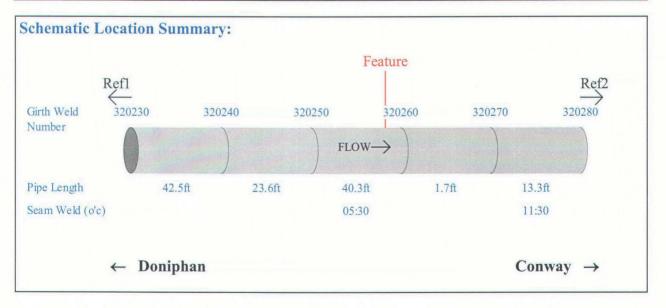
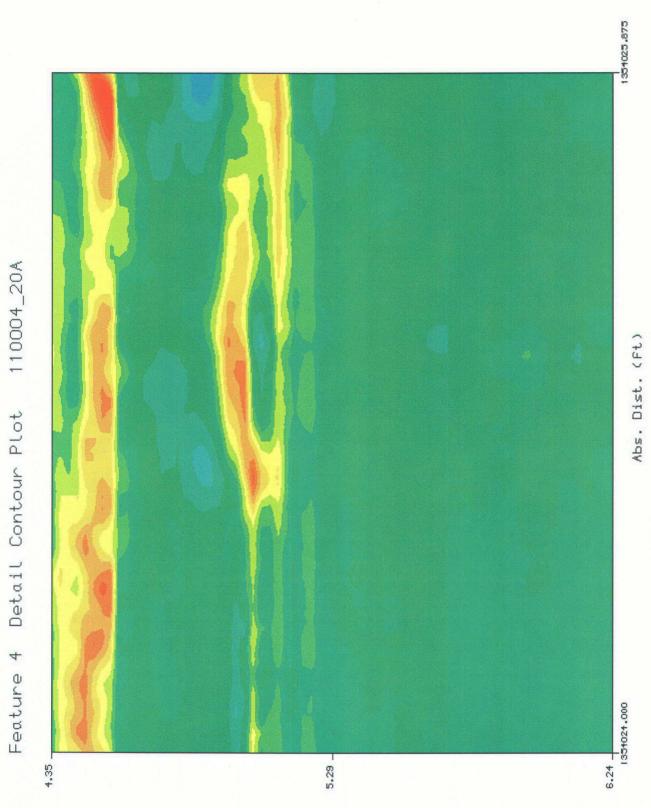
Inspection Sheet Number 4

This metal loss feature has the appearance of corrosion.

The feature is located 33.3 feet downstream from the reference girth weld.

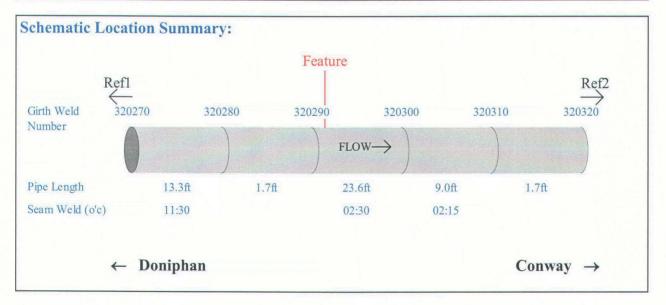
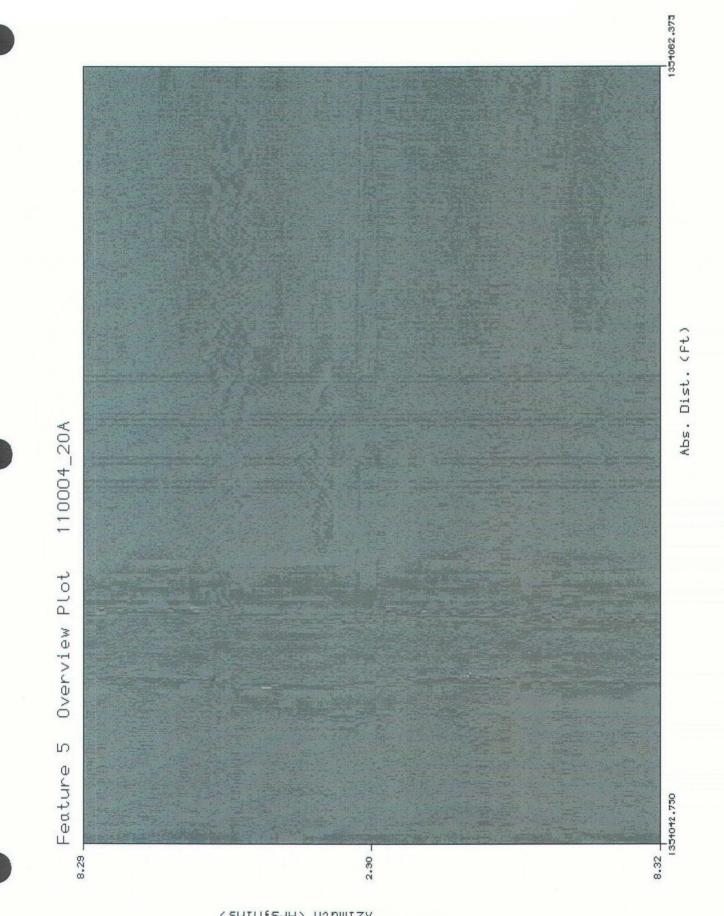
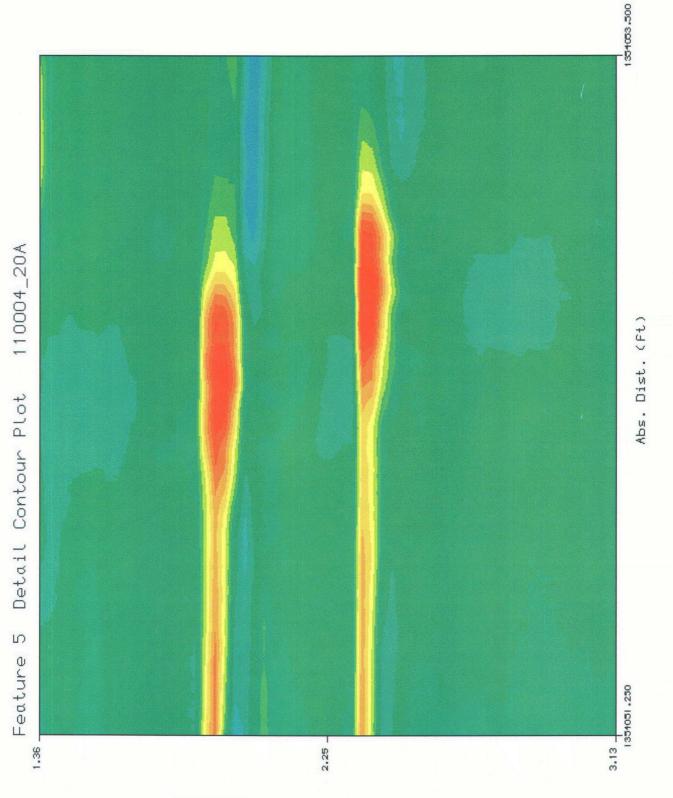
This metal loss feature has the appearance of corrosion.

The feature is located 3.5 feet downstream from the reference girth weld.

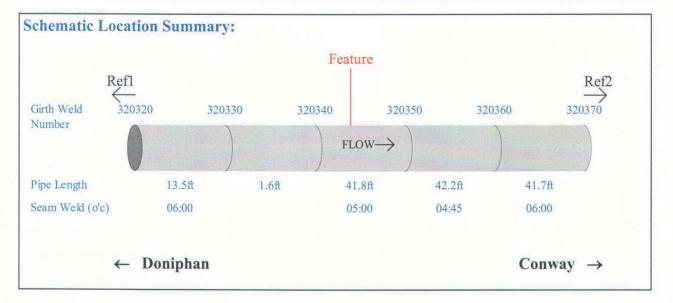
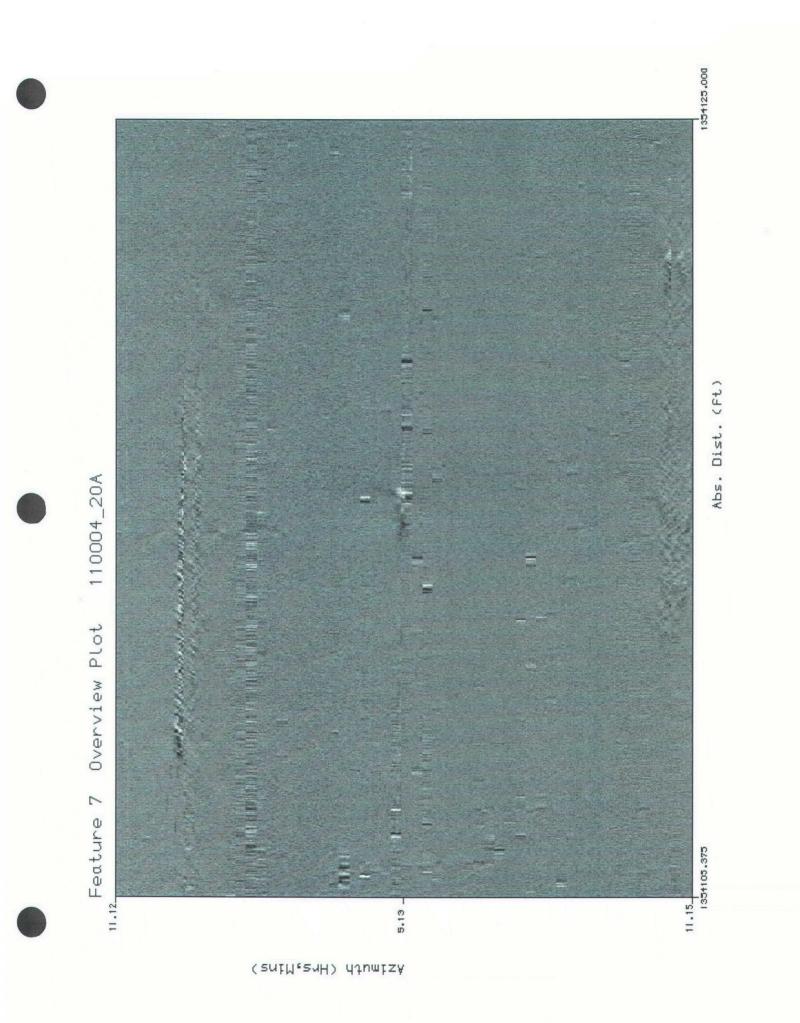
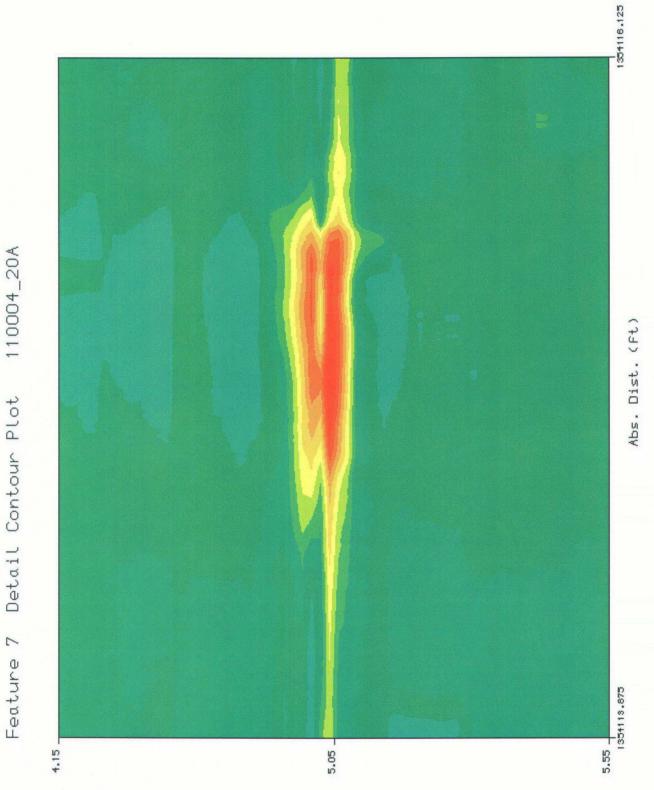
The feature is located 16.7 feet downstream from the reference girth weld.

Feature Description	
Type:	Seam Weld Anomaly
Orientation:	05:00 (o'clock)
Axial length:	11.3 in
Circumferential width:	N/A
Depth:	N/A
Pressure Ratio (ERF):	N/A
Feature Ranking:	N/A
Nominal Pipe wall thickness for spool:	0.375 in
Absolute Distance from Launch:	1354114.9 feet
Commenter

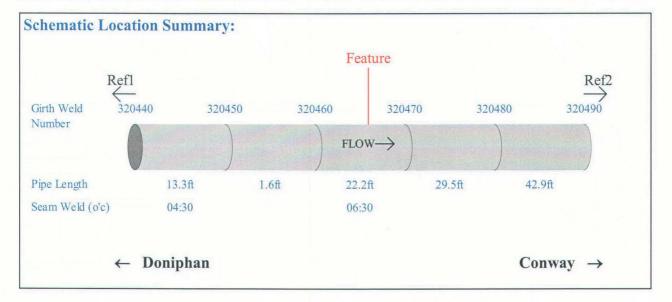
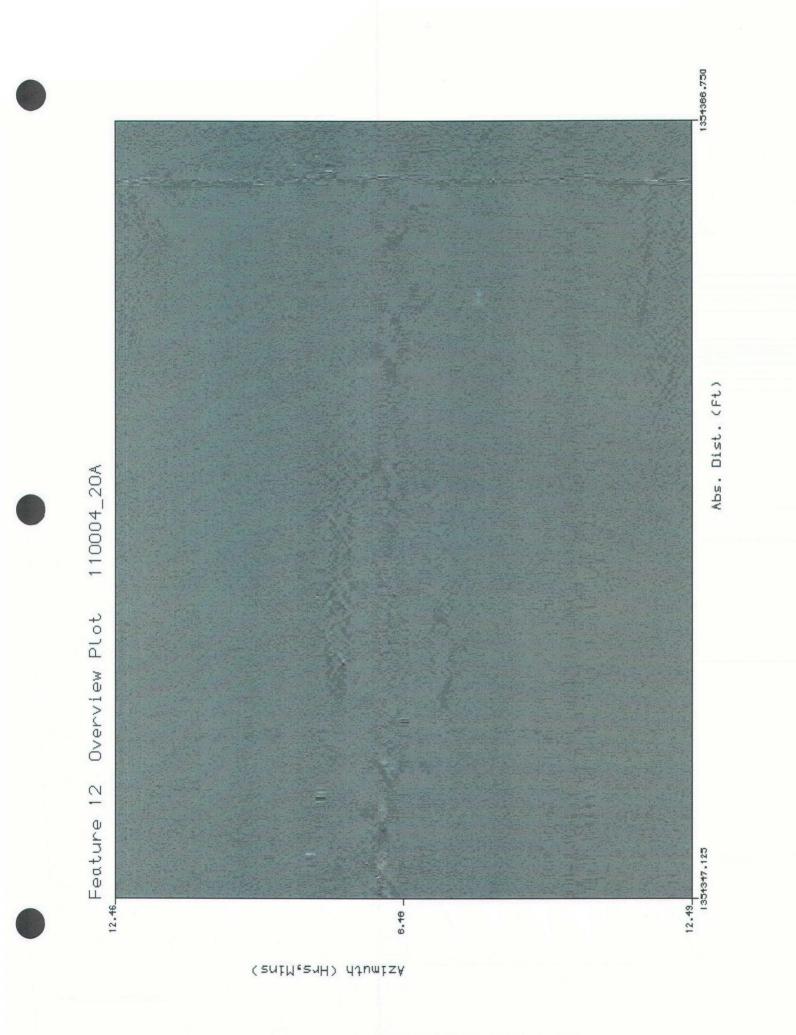
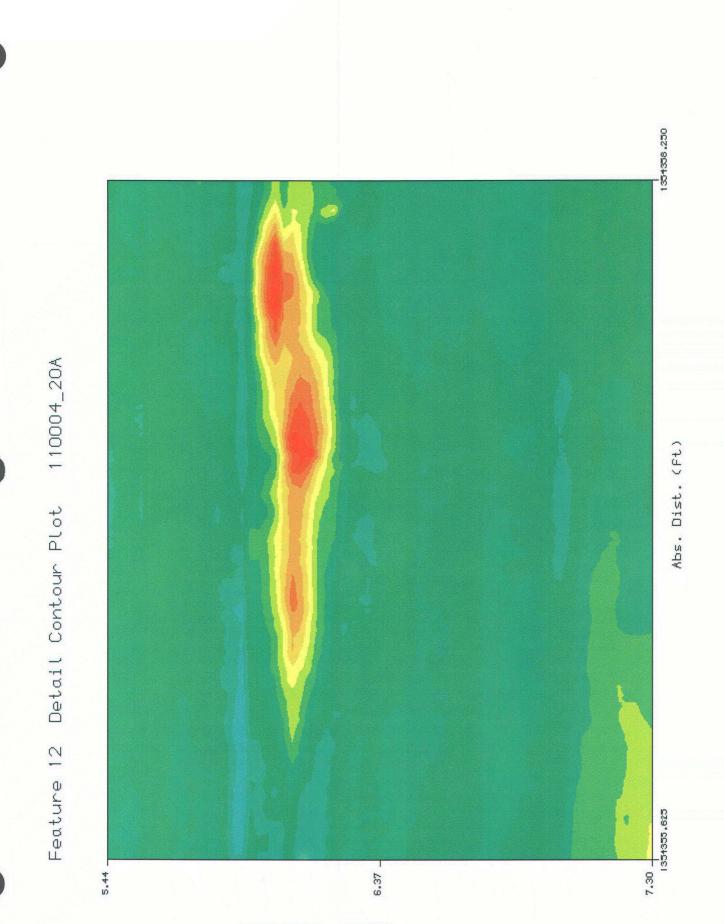
Feature Description	
Type:	External Axial Seam Weld Metal Loss
Orientation:	06:15 (o'clock)
Axial length:	13.7 in
Circumferential width:	1.4 in
Depth - Peak:	12% WT
Pressure Ratio (ERF):	0.911
Feature Selection Rule:	10
Nominal Pipe wall thickness for spool:	0.281 in
Absolute Distance from Launch:	1354356.4 feet
~

This metal loss feature has the appearance of corrosion.

The feature is located 13.2 feet downstream from the reference girth weld.
