ARKANSAS
Department of Environmental Quality

RE: Inspection/Complaint Investigations
AFIN: 04-00175 Permit Tracking No.: 4438-WR-4

On October 22 and 24, 2013, I performed a compliance inspection at Allen's, Inc. spray irrigation sites west of Butler Road in response to several complaints. On November 13, 2013, Jason Bolenbaugh, Water Division Inspection Branch Manager, and I conducted an inspection at Allen's, Inc. spray irrigation sites east of Turkey Road in response to a complaint. The inspections were conducted in accordance with the provisions of the Arkansas Water and Air Pollution Control Act and the regulations promulgated thereunder. The inspections revealed the following violations:

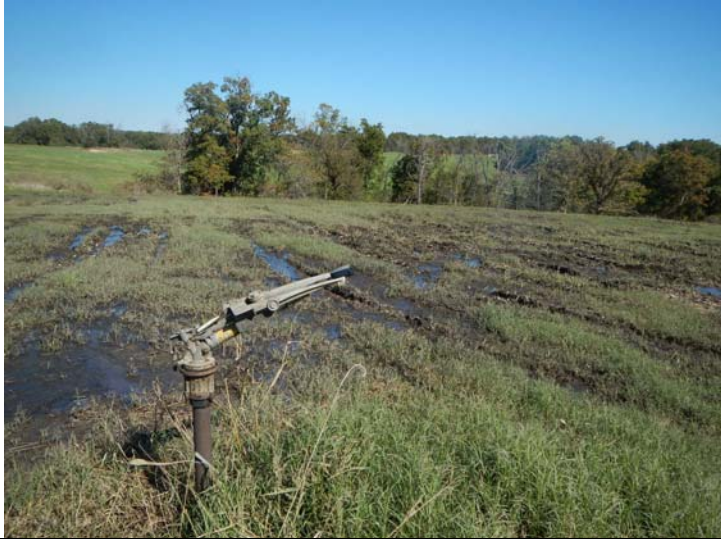
Location:		Allen's, Inc.-Country Plant						
Photographer:		Alison West			Witness:		NA	
Photo #	1	Of	62		Date:	10-22-2013	Time:	12:35 p.m.
Description:		DSCN1405. Irrigation Head 25- Waste was applied in a manner which resulted in pooling. Poor vegetative cover. Run-off towards drainage located in the tree line north of the irrigation head. Dark gray is residuals. Ground is saturated.

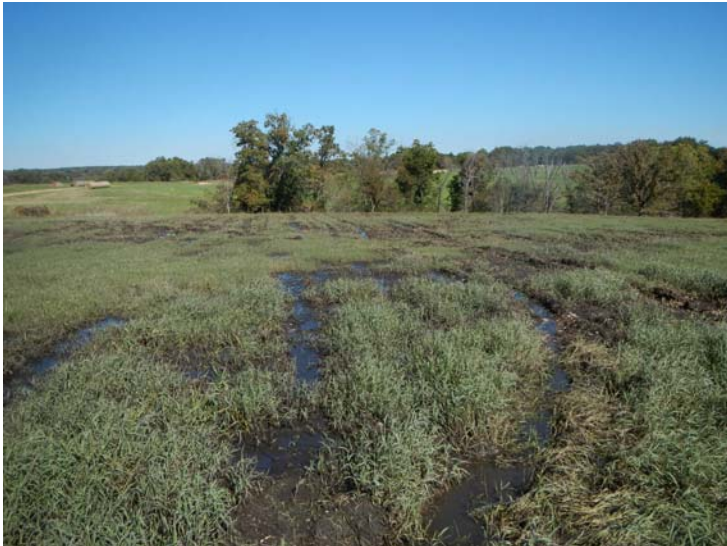
Photographer:		Alison West			Witness:		NA	
Photo #	2	Of	62		Date:	10-22-2013	Time:	12:35 p.m.
Description:		DSCN1406. Irrigation Head 25- Waste was applied in a manner which resulted in pooling. Poor vegetative cover. Run-off towards drainage located in the tree line north of the irrigation head. Dark gray is residuals. Ground is saturated.

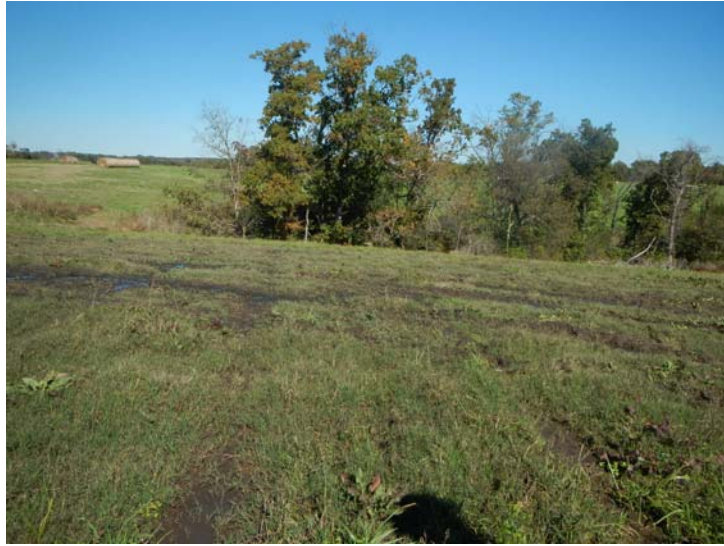
Location:	Allen's, Inc.-Country Plant						
Photographer:	Alison West				Witness:	NA	
Photo #	3	Of	62		Date:	10-22-2013	Time: 12:34 p.m.
Description:	DSCN1402. Irrigation Head 25- Run-off towards drainage located in the tree line north of the irrigation head.

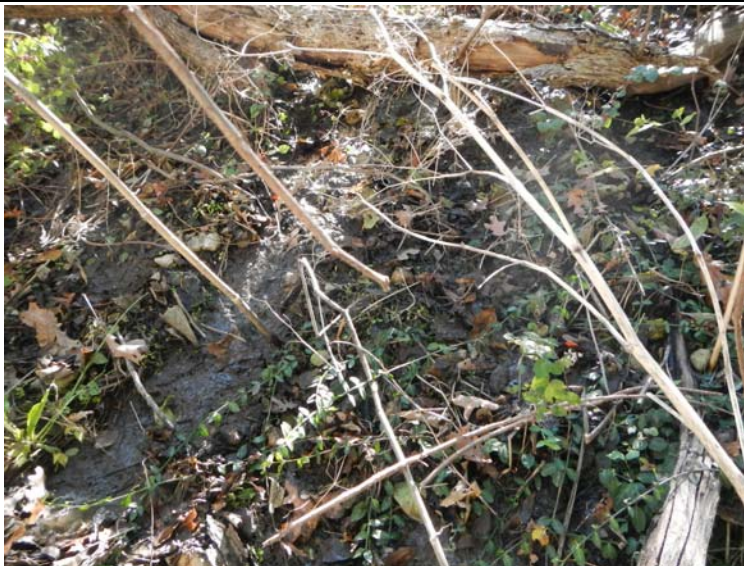
Description:	DSCN1386. Flow path of waste from Irrigation Head 25 towards the drainage. . Drainage is below. Drainage behind photographer.						
---------------------	---	--	--	--	--	--	--

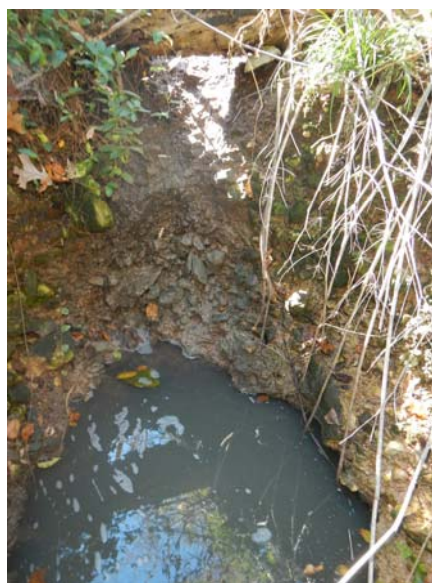
Description:	DSCN1407. Hay Barn Hollow Sample Site. Visibly turbid, discolored water in the drainage.						
---------------------	--	--	--	--	--	--	--

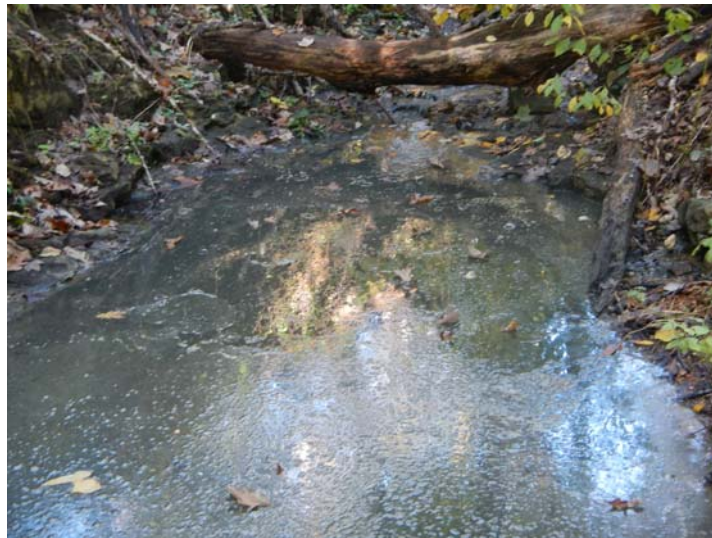
Location:	Allen's, Inc.-Country Plant						
Photographer:	Alison West				Witness:	NA	
Photo #	7	Of	62		Date:	10-22-2013	Time: 12:00 p.m.

Description: DSCN1356. Photographs 7–10 show the stream conditions progressing downstream of the Unnamed Tributary of the Illinois River east of Irrigation Head 25, etc to the drainage north of Irrigation Heads 57-53). The Unnamed Tributary of the Illinois River is visibly turbid, discolored, and foamy.

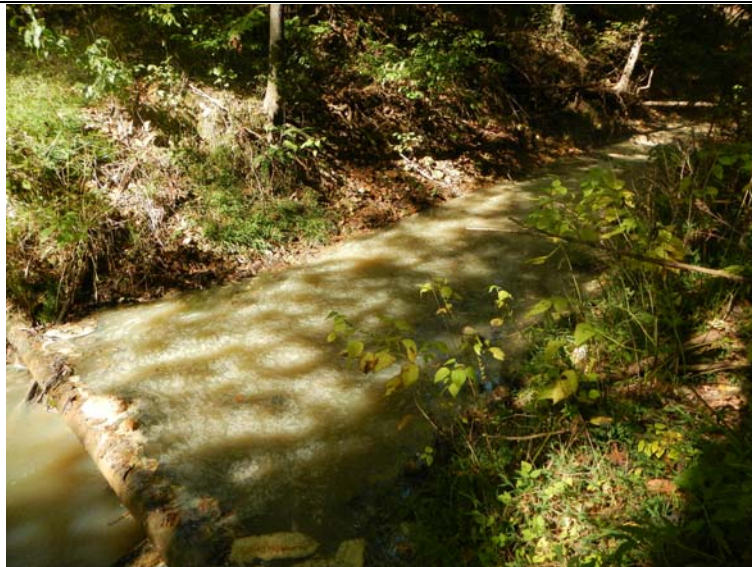
Photographer:	Alison West				Witness:	NA	
Photo #	8	Of	62		Date:	10-22-2013	Time: 11:56 a.m.

Description: DSCN1348. The Unnamed Tributary of the Illinois River is visibly turbid, discolored, and foamy.

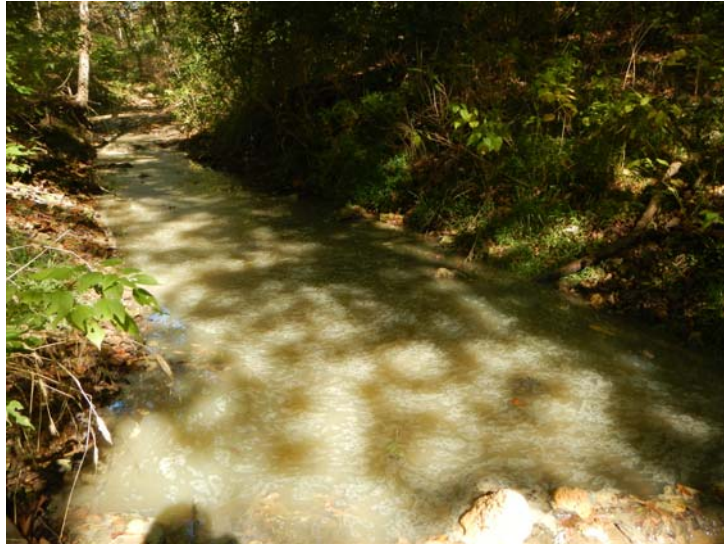
Location:	Allen's, Inc.-Country Plant						
Photographer:	Alison West				Witness:	NA	
Photo #	9	Of	62		Date:	10-22-2013	Time: 11:55 a.m.
Description:	DSCN1347. The Unnamed Tributary of the Illinois River is visibly turbid, discolored, and foamy.

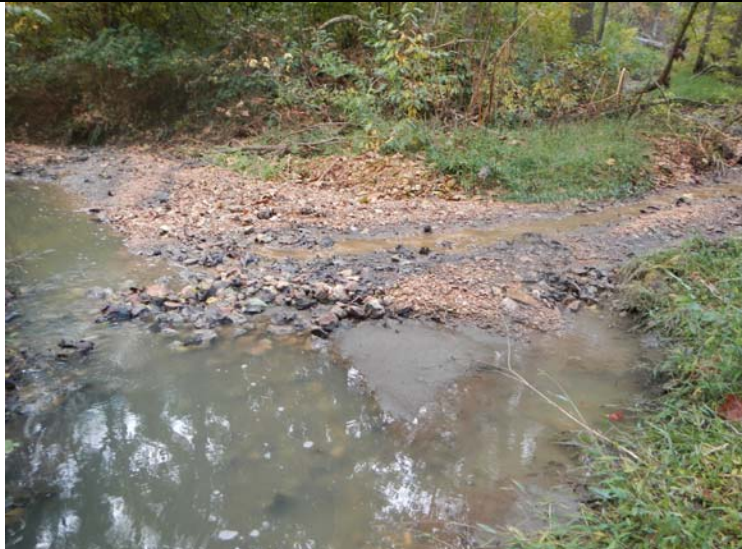
Photographer:	Alison West				Witness:	NA	
Photo #	10	Of	62		Date:	10-22-2013	Time: 10:55 a.m.
Description:	DSCN1308. Looking down the Unnamed Tributary of the Illinois River. The drainage to the right of the picture is a branch north of Irrigation Heads 57-53. Sludge deposits in point bar. Discolored sludge on gravel substrate. The Unnamed Tributary of the Illinois River is visibly turbid, discolored, and foamy.

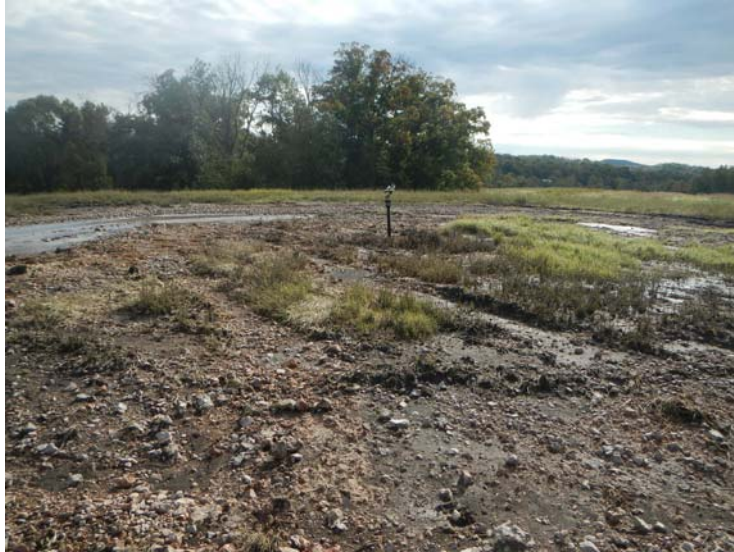
Location:	Allen's, Inc.-Country Plant						
Photographer:	Alison West			Witness:	Jeff Tyler		
Photo #	11	Of	62	Date:	10-22-2013	Time:	10:40 a.m.
Description:	DSCN1279. Irrigation Head 53. Waste was applied in a manner which resulted in pooling. Poor vegetative cover. Run-off towards drainage located in the tree line north of the irrigation head. Dark gray is residuals.

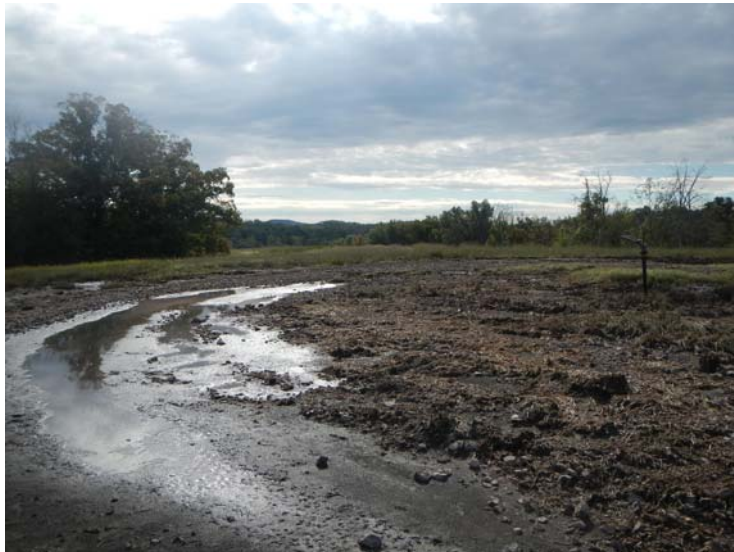
Photographer:	Alison West			Witness:	Jeff Tyler		
Photo #	12	Of	62	Date:	10-22-2013	Time:	10:40 a.m.
Description:	DSCN1280. Irrigation Head 53. Waste was applied in a manner which resulted in pooling. Poor vegetative cover. Dark gray is residuals. Ground is saturated.

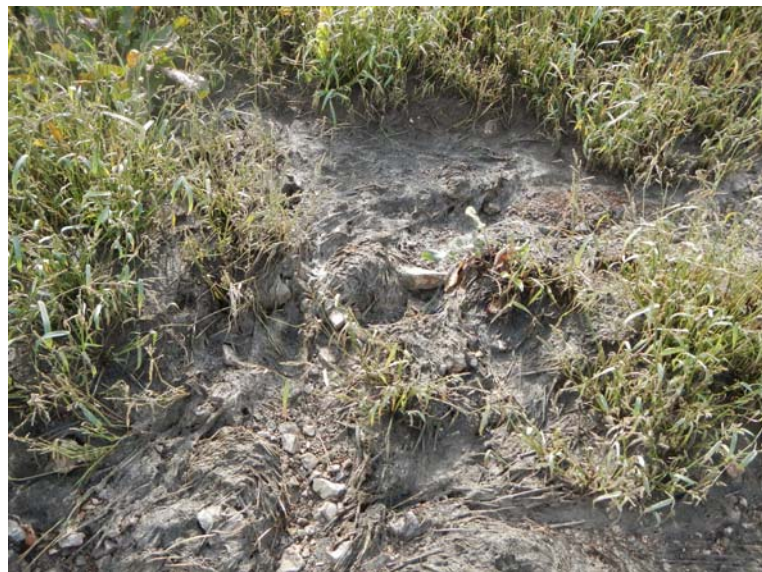
Description:	DSCN1283. Close-up of residuals north of Irrigation Head 53.						
---------------------	--	--	--	--	--	--	--

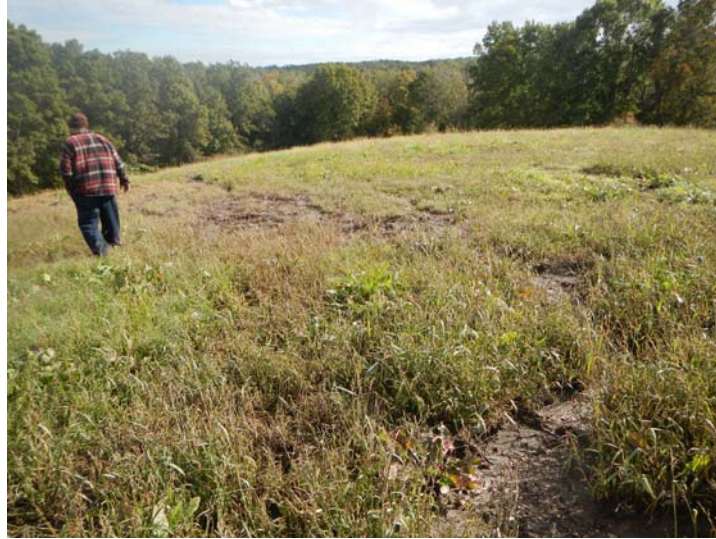
Location:	Allen's, Inc.-Country Plant						
Photographer:	Alison West				Witness:	Jeff Tyler	
Photo #	15	Of	62		Date:	10-22-2013	Time: 10:43 a.m.
Description:	DSCN1284. Flow path of waste north of Irrigation Head 53.

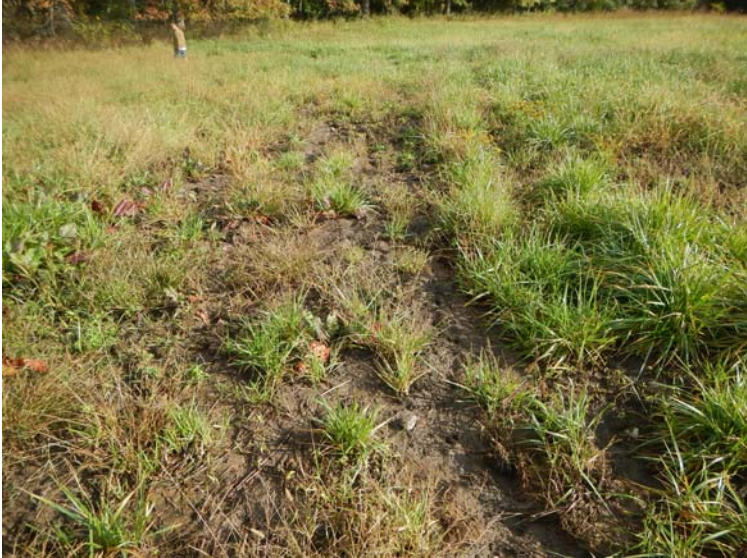
Location:	Allen's, Inc.-Country Plant						
Photographer:	Alison West				Witness:	Jeff Tyler	
Photo #	19	Of	62		Date:	10-22-2013	Time: 10:44 a.m.
Description:	DSCN1289. Flow path of waste north of Irrigation Head 53. Drainage is located in the tree line north of the irrigation head.

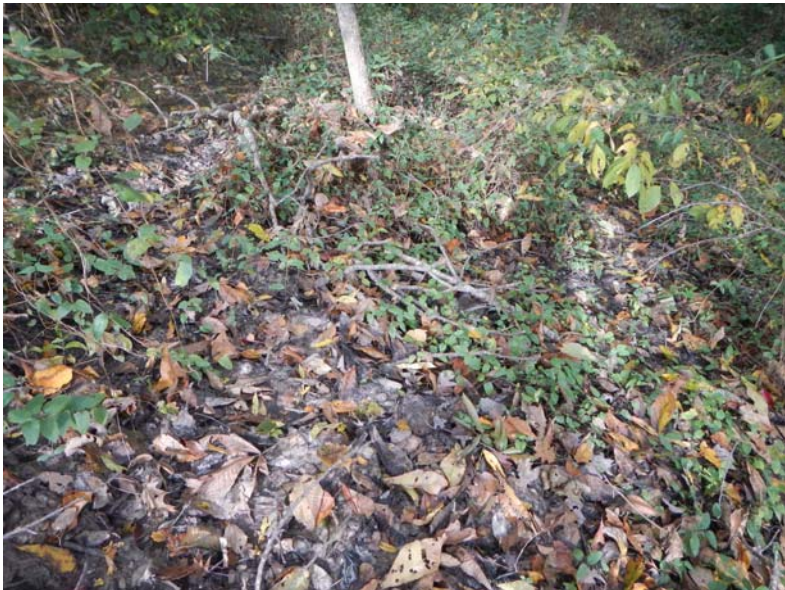
Photographer:	Alison West				Witness:	NA	
Photo #	20	Of	62		Date:	10-22-2013	Time: 10:48 a.m.
Description:	DSCN1292. Flow path of waste north of Irrigation Head 53 towards the drainage.

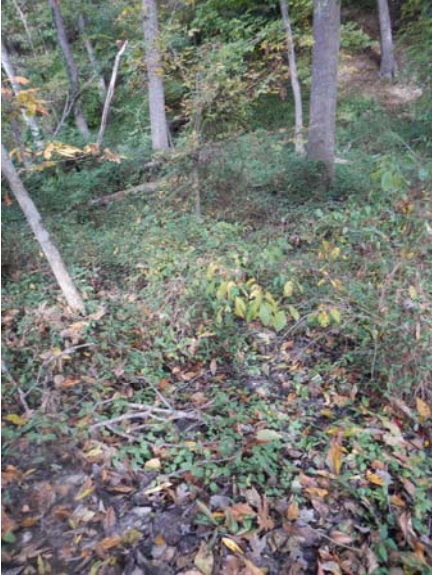
Location:	Allen's, Inc.-Country Plant						
Photographer:	Alison West				Witness:	NA	
Photo #	21	Of	62		Date:	10-22-2013	Time: 10:48 a.m.
Description:	DSCN1293. Flow path of waste north of Irrigation Head 53 towards the drainage.

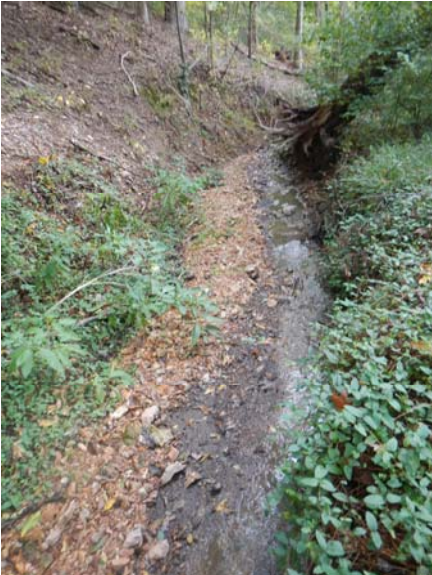
Photographer:	Alison West				Witness:	NA	
Photo #	22	Of	62		Date:	10-22-2013	Time: 10:48 a.m.
Description:	DSCN1295. Photographs 22-26 show the stream conditions progressing downstream to the Unnamed Tributary of the Illinois River from Irrigation Head 53. Sludge coating gravel in drainage north of Irrigation Head 53.

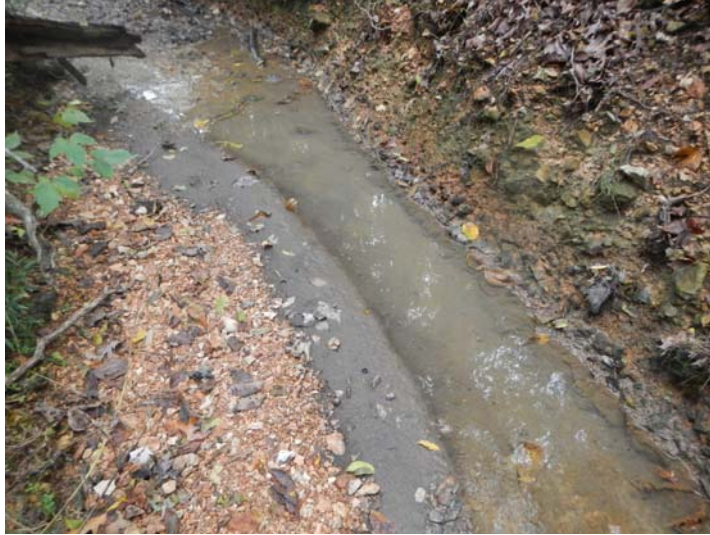
Location:	Allen's, Inc.-Country Plant						
Photographer:	Alison West				Witness:	NA	
Photo #	23	Of	62		Date:	10-22-2013	Time: 10:51 a.m.
Description:	DSCN1299. Sludge coating gravel in drainage. The drainage is visibly turbid and discolored.

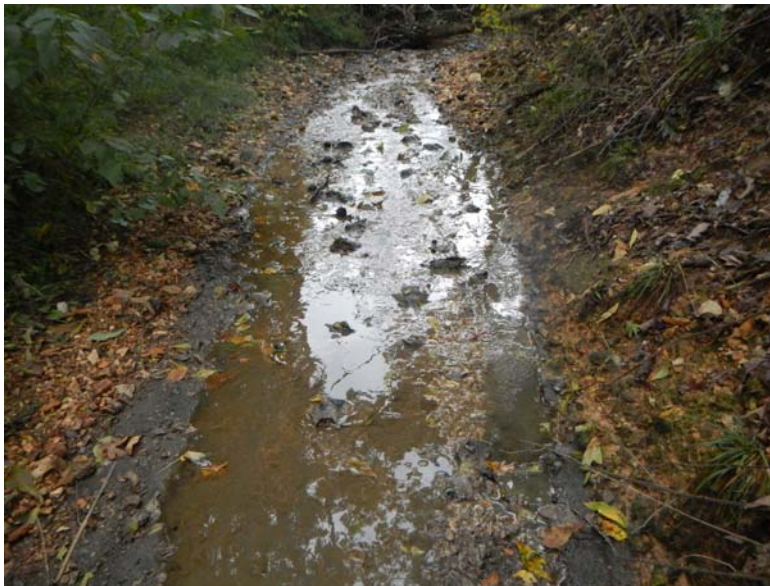
Photographer:	Alison West				Witness:	NA	
Photo #	24	Of	62		Date:	10-22-2013	Time: 10:51 a.m.
Description:	DSCN1300. Sludge coating gravel substrate.

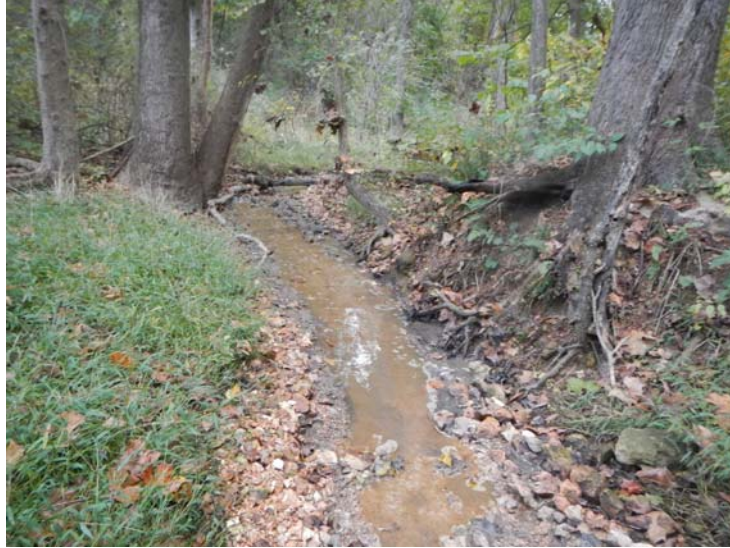
Location:	Allen's, Inc.-Country Plant						
Photographer:	Alison West				Witness:	NA	
Photo #	25	Of	62		Date:	10-22-2013	Time: 10:54 a.m.
Description:	DSCN1303. Sludge coating gravel substrate.

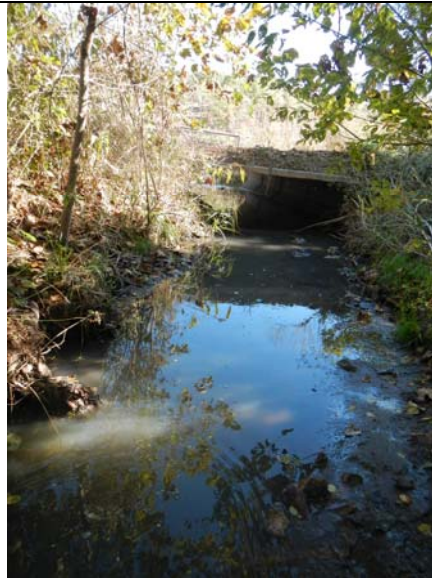
Photographer:	Alison West				Witness:	NA	
Photo #	28	Of	62		Date:	10-22-2013	Time: 14:52 p.m.

Description: DSCN1408. **Photographs 28-35 show the stream conditions progressing downstream to the Unnamed Tributary of the Illinois River.** East Sample Site #2. The Unnamed Tributary of the Illinois River is visibly turbid and discolored.

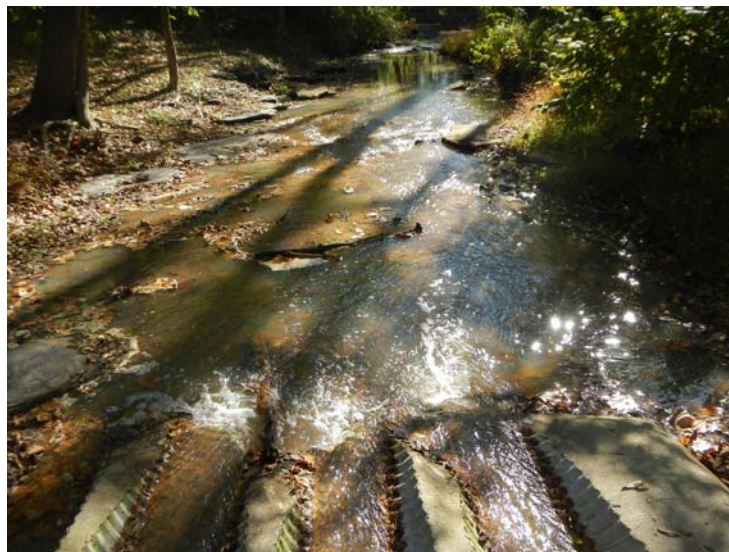
Description:	DSCN1413. Rust colored algae in Unnamed Tributary to the Illinois river at 16614 Butler Road in Siloam Springs, AR.							
---------------------	---	--	--	--	--	--	--	--

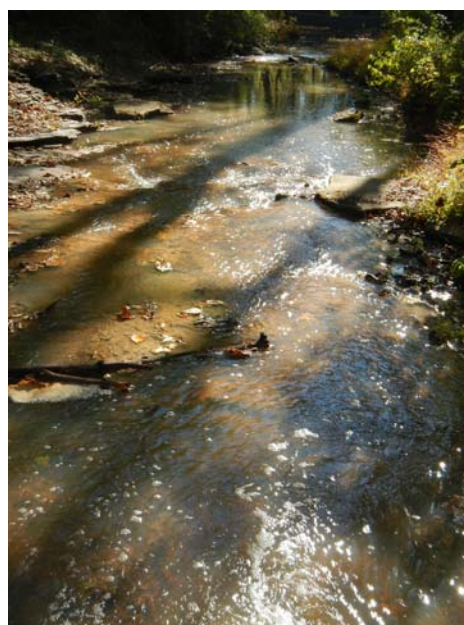
Description:	DSCN1414. Rust colored algae in Unnamed Tributary to the Illinois river downstream of bridge crossing at 16614 Butler Road in Siloam Springs, AR.							
---------------------	---	--	--	--	--	--	--	--

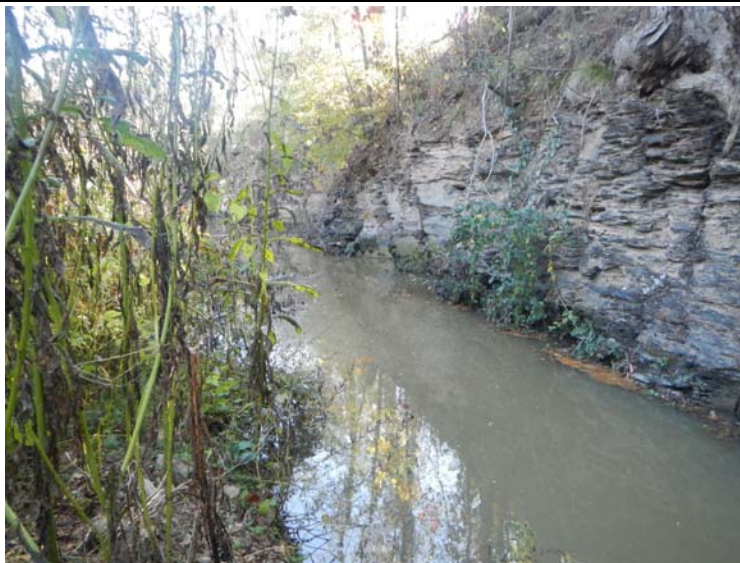
Location:	Allen's, Inc.-Country Plant						
Photographer:	Alison West				Witness:	NA	
Photo #	35	Of	62		Date:	10-22-2013	Time: 15:59 p.m.
Description:	DSCN1420. The Unnamed Tributary of the Illinois River is visibly turbid and discolored south of 16614 Butler Road. Based on Google Earth Imagery, the Illinois River is approximately 700 feet from this location.

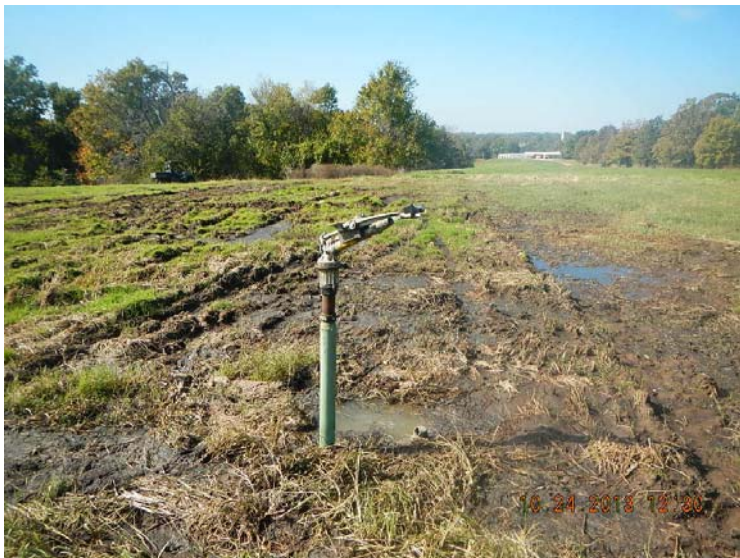
Photographer:	Alison West				Witness:	NA	
Photo #	37	Of	62		Date:	10-24-2013	Time: 12:30 p.m.
Description:	DSCN1472. Irrigation Head 1-Waste was applied in a manner which resulted in pooling. Poor vegetative cover. Run-off towards drainage located in the tree line west of the irrigation head. Ground is saturated.

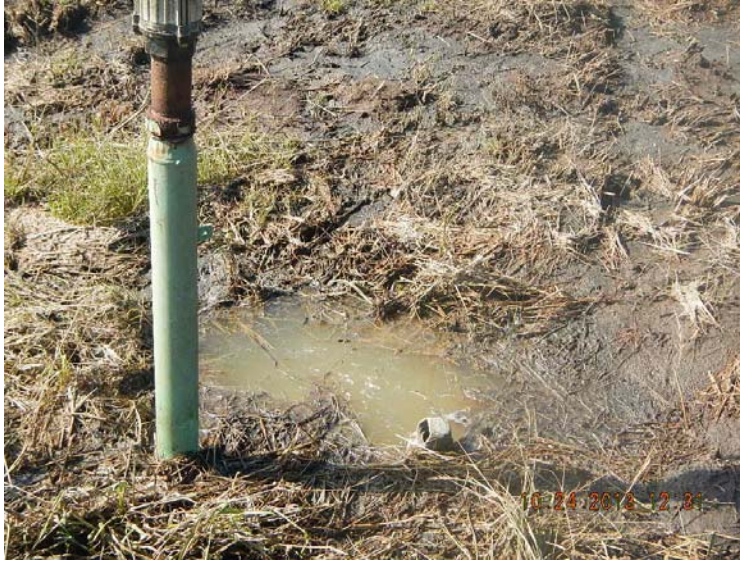
Location:	Allen's, Inc.-Country Plant						
Photographer:	Alison West				Witness:	NA	
Photo #	38	Of	62		Date:	10-24-2013	Time: 12:31 p.m.
Description:	DSCN1473. Irrigation Head 1- Waste was applied in a manner which resulted in pooling. Poor vegetative cover.

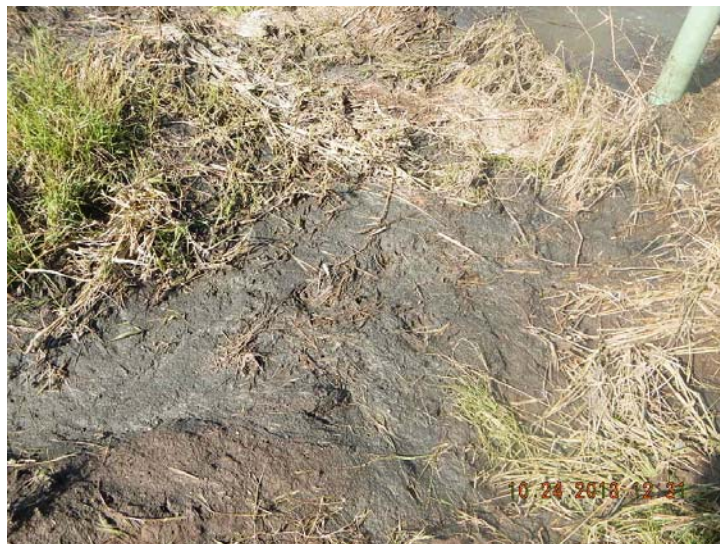
Photographer:	Alison West				Witness:	NA	
Photo #	39	Of	62		Date:	10-24-2013	Time: 12:31 p.m.
Description:	DSCN1475. Irrigation Head 1-Poor vegetative cover. Dark gray is residuals.

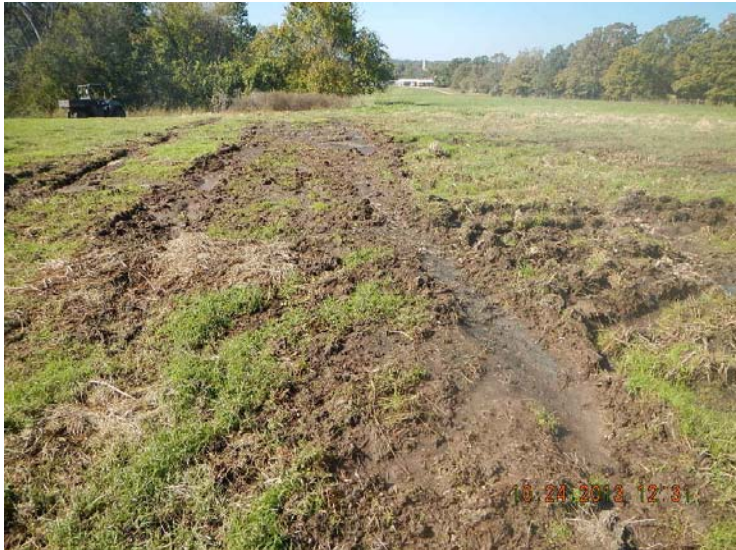
Location:	Allen's, Inc.-Country Plant						
Photographer:	Alison West				Witness:	NA	
Photo #	40	Of	62		Date:	10-24-2013	Time: 12:31 p.m.
Description:	DSCN1476. Irrigation Head 1- Run-off towards drainage located in the tree line west of the irrigation head. Poor vegetative cover.

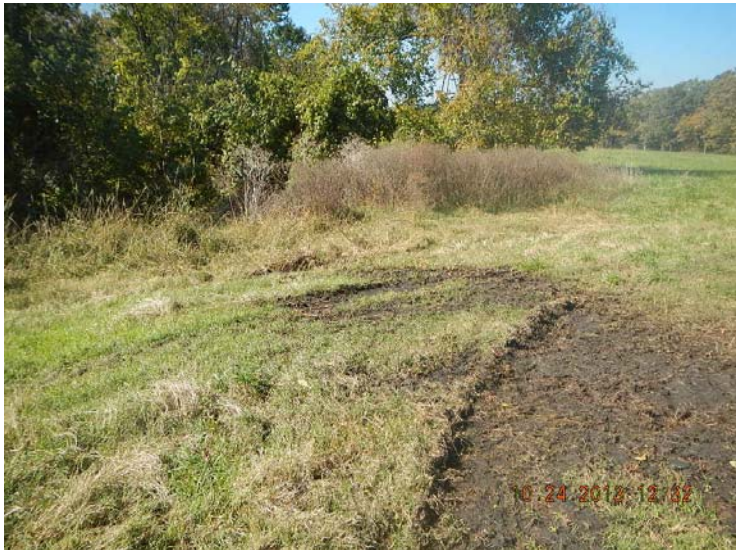
Photographer:	Alison West				Witness:	NA	
Photo #	41	Of	62		Date:	10-24-2013	Time: 12:32 p.m.
Description:	DSCN1478. Irrigation Head 1- Run-off towards drainage located in the tree line west of the irrigation head.

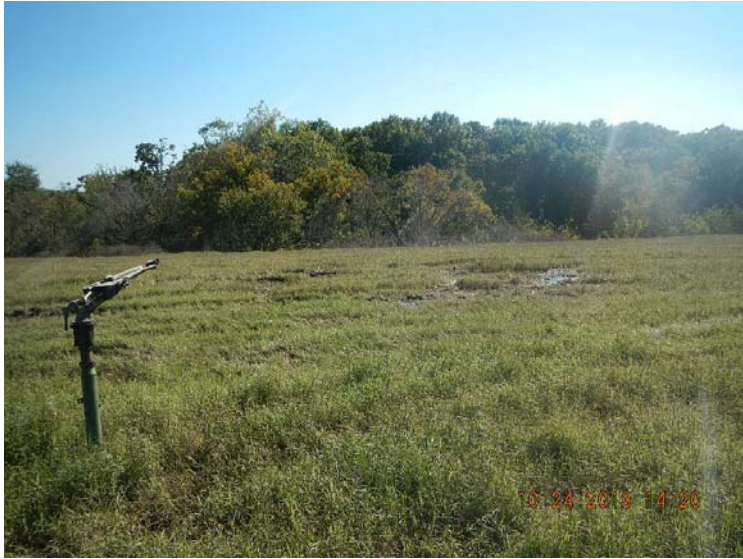
Location:	Allen's, Inc.-Country Plant						
Photographer:	Alison West				Witness:	NA	
Photo #	42	Of	62		Date:	10-24-2013	Time: 2:20 p.m.
Description:	DSCN1596. Irrigation Head 47.

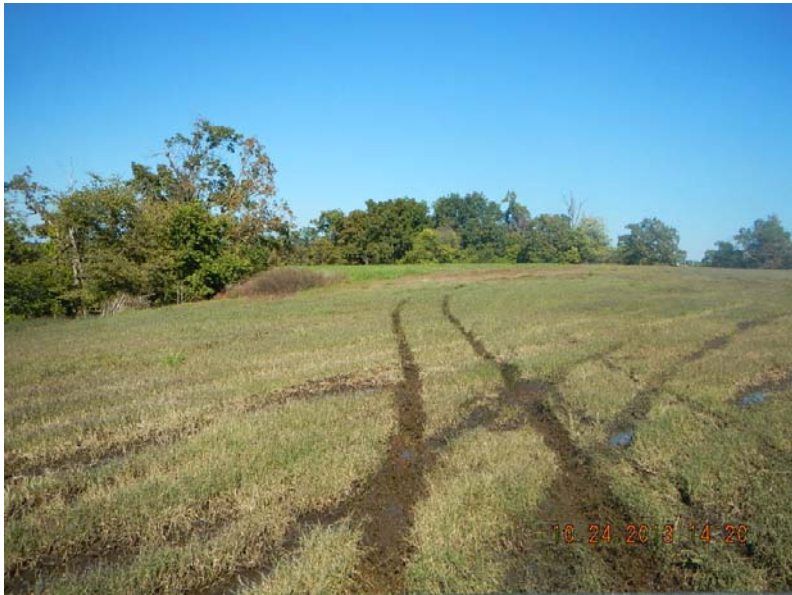
Photographer:	Alison West				Witness:	NA	
Photo #	43	Of	62		Date:	10-24-2013	Time: 2:20 p.m.
Description:	DSCN1599. Irrigation Head 47-Ground is wet near tree line.

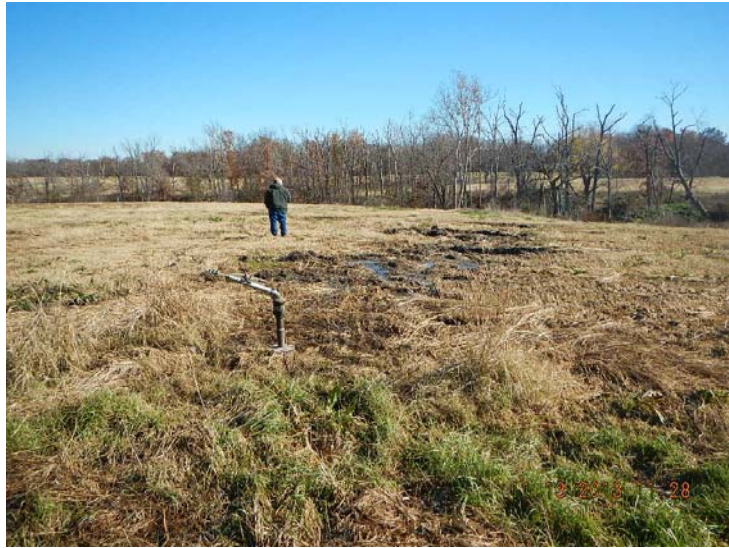
Location:	Allen's, Inc.-Country Plant						
Photographer:	Alison West				Witness:	NA	
Photo #	44	Of	62		Date:	11-13-2013	Time: 10:28 a.m.
Description:	DSCN1677. Irrigation Head C5 at Turkey Ridge. Run-off towards drainage located in the tree line east of the irrigation head.

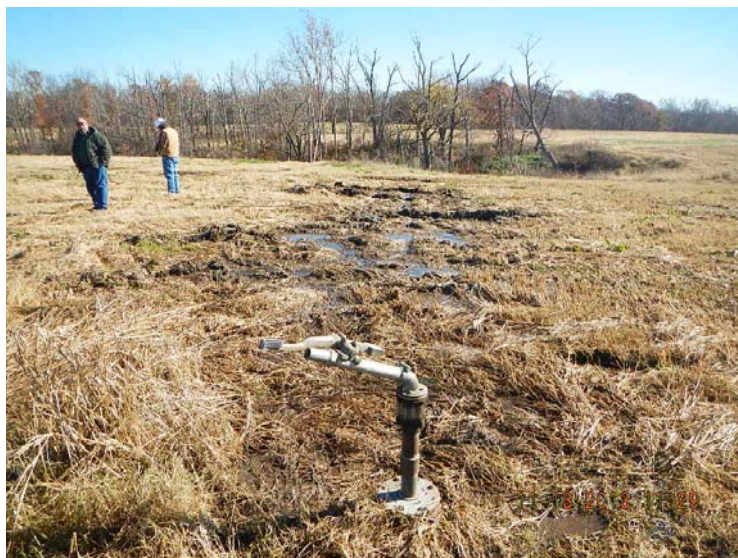
Photographer:	Alison West				Witness:	NA	
Photo #	45	Of	62		Date:	11-13-2013	Time: 10:29 a.m.
Description:	DSCN1679. Irrigation Head C5 at Turkey Ridge. Run-off towards drainage located in the tree line east of the irrigation head. Ground is wet.

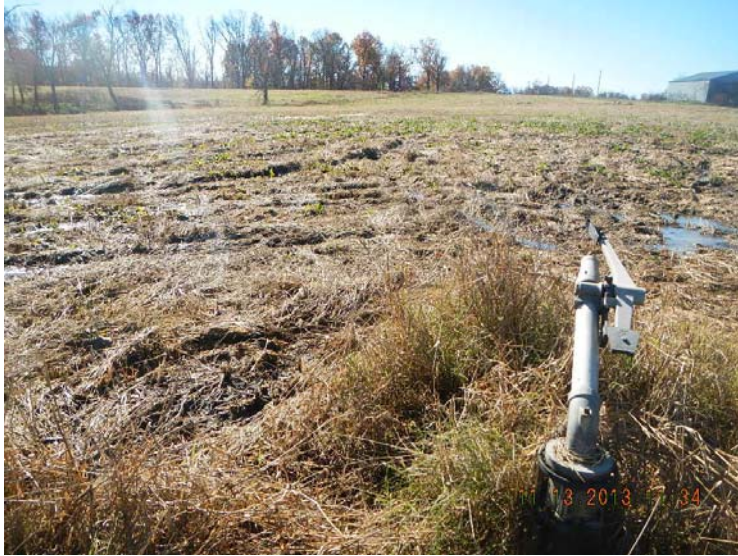
Location:	Allen's, Inc.-Country Plant						
Photographer:	Alison West			Witness:	Jason Bolenbaugh		
Photo #	48	Of	62	Date:	11-13-2013	Time:	10:34 a.m.
Description:	DSCN1684. Irrigation Head C9 at Turkey Ridge. Waste was applied in a manner which resulted in pooling. Ground is saturated.

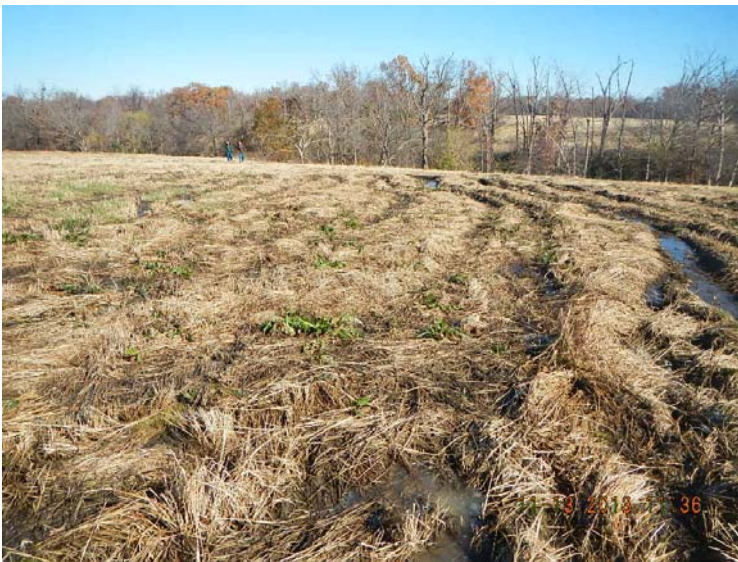
Photographer:	Alison West			Witness:	Jason Bolenbaugh		
Photo #	49	Of	62	Date:	11-13-2013	Time:	10:36 a.m.
Description:	DSCN1685. Irrigation Head C9 at Turkey Ridge. Run-off towards drainage located in the tree line east of the irrigation head.

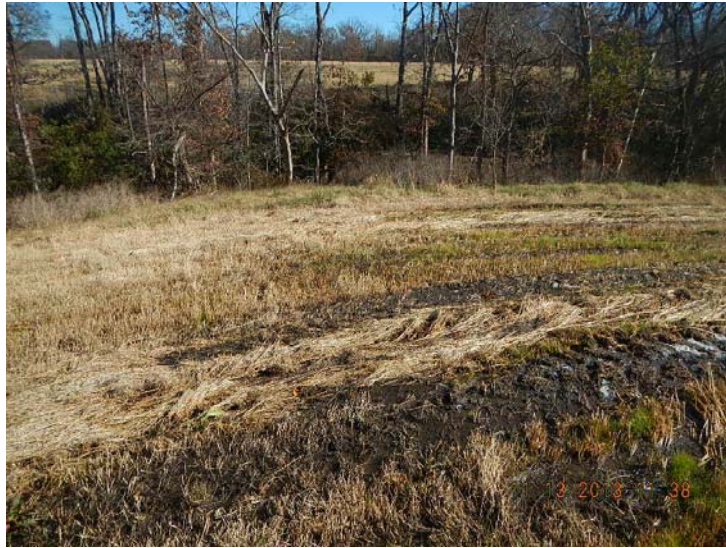
Location:	Allen's, Inc.-Country Plant						
Photographer:	Alison West				Witness:	Jason Bolenbaugh	
Photo #	52	Of	62		Date:	11-13-2013	Time: 11:38 a.m.
Description:	DSCN1688. Irrigation Head C9 at Turkey Ridge. Run-off towards drainage located in the tree line east of the irrigation head.

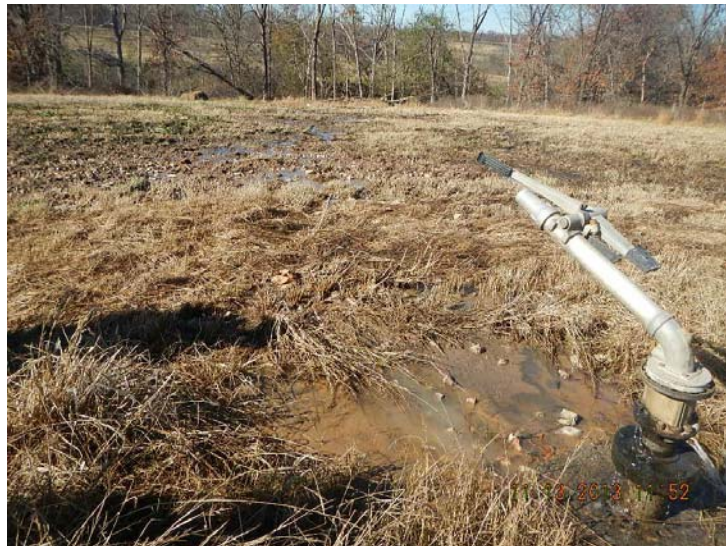
Photographer:	Alison West				Witness:	Jason Bolenbaugh	
Photo #	53	Of	62		Date:	11-13-2013	Time: 10:52 a.m.
Description:	DSCN1699. Irrigation Head A14 at Turkey Ridge. Irrigation head is leaking. Run-off towards drainage located in the tree line west of the irrigation head. Waste was applied in a manner which resulted in pooling. Poor vegetative cover.

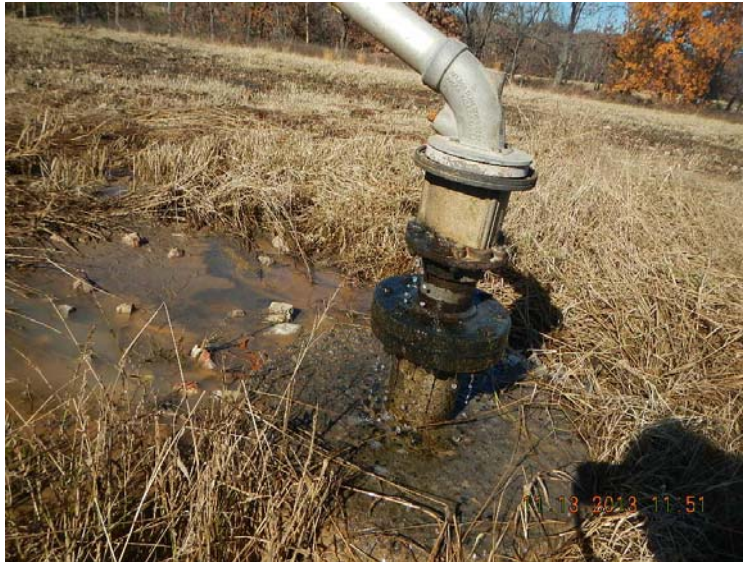
Description: DSCN1698. Irrigation Head A14 at Turkey Ridge. Irrigation head is leaking. Waste was applied in a manner which resulted in pooling.

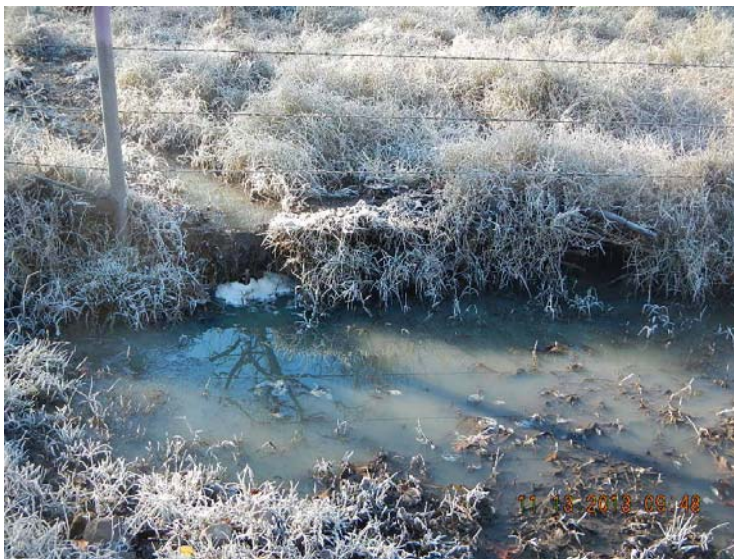
Location:	Allen's, Inc.-Country Plant						
Photographer:	Alison West				Witness:	Jason Bolenbaugh	
Photo #	58	Of	62		Date:	11-13-2013	Time: 8:48 a.m.
Description:	DSCN1642. Drainage is visibly turbid on Paul Young's property. Same area as Photograph 57.

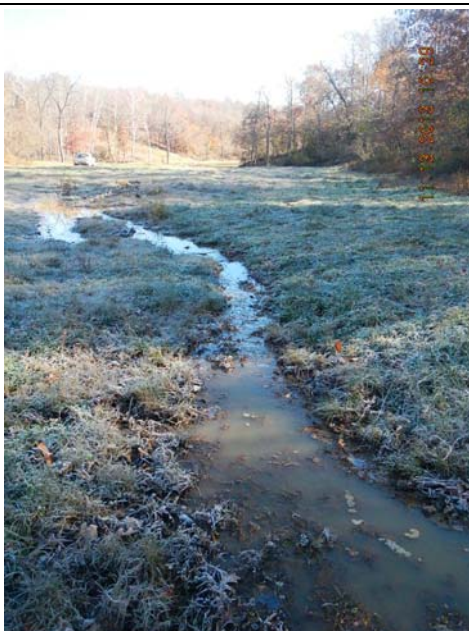
Photographer:	Alison West				Witness:	Jason Bolenbaugh	
Photo #	59	Of	62		Date:	11-13-2013	Time: 9:29 a.m.
Description:	DSCN1648. Drainage flows through a swath north of Allen's, Inc. near C13 at Turkey Ridge. Drainage is visibly turbid.

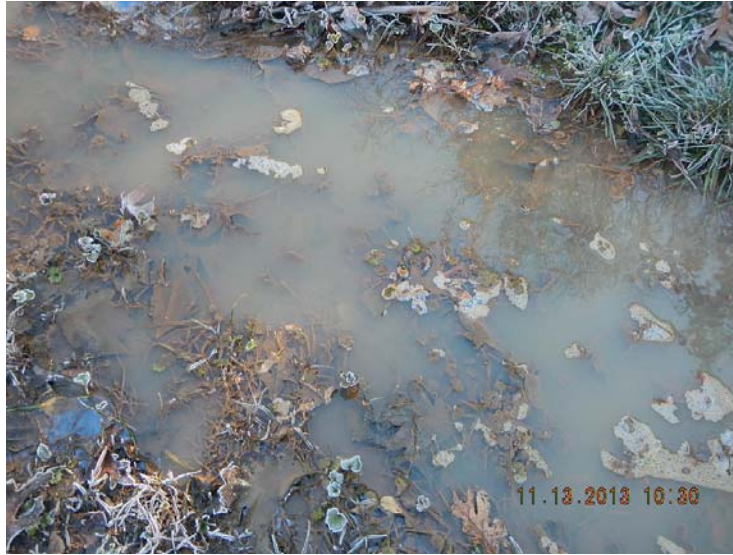
Location:	Allen's, Inc.-Country Plant						
Photographer:	Alison West			Witness:	Jason Bolenbaugh		
Photo #	60	Of	62	Date:	11-13-2013	Time:	9:30 a.m.
Description:	DSCN1649. Same area as DSCN1648. Close-up of drainage. Water is visibly turbid.
