Bridge Investigation Report

May 5, 2015

Investigation Overview

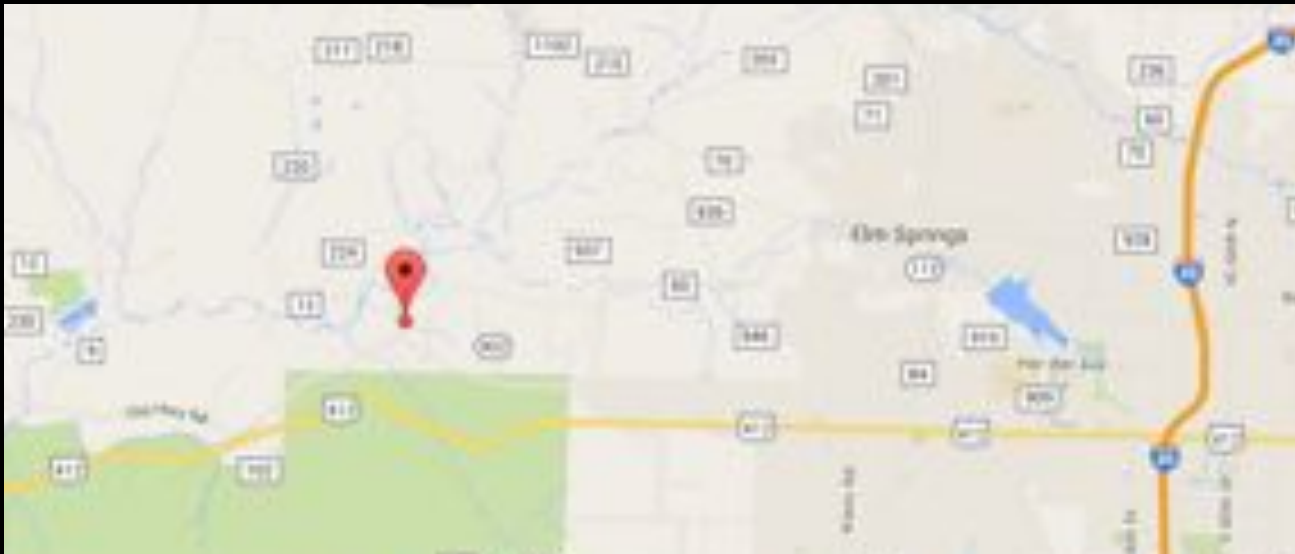
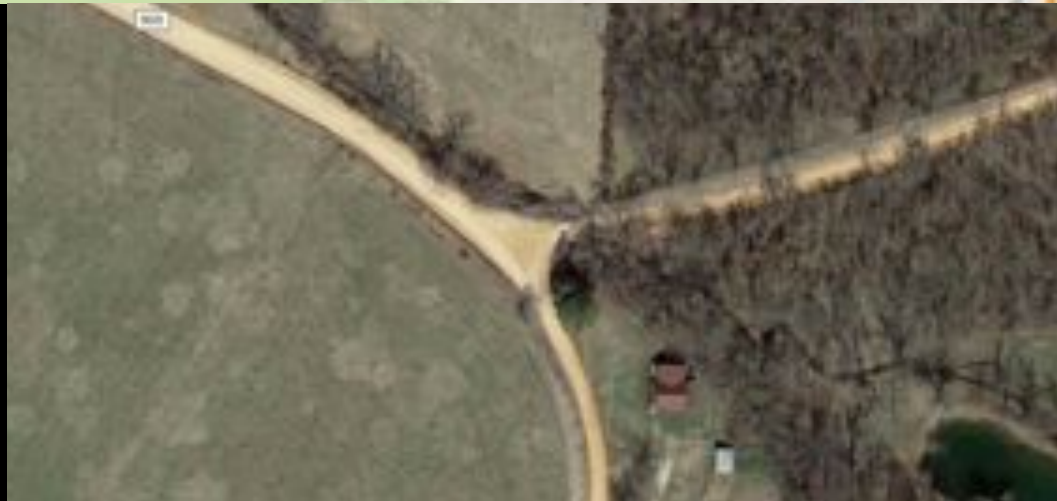
- During the investigation, we learned of deficiencies with a box culvert north of Highway 412, west of Elm Springs, on Osage Creek Road.
- We were told it should be “condemned immediately” because concrete and water erosion had caused part of the road to cave in.
- We heard this from two witnesses; one showed us photos on his phone.
- They said they had been complaining for months, without success. Prior temporary fixes to the bridge had been unsuccessful.

- We promptly notified the County Judge's office the day we learned of the problem.
- The bridge was replaced the following day, on Thursday, April 30.

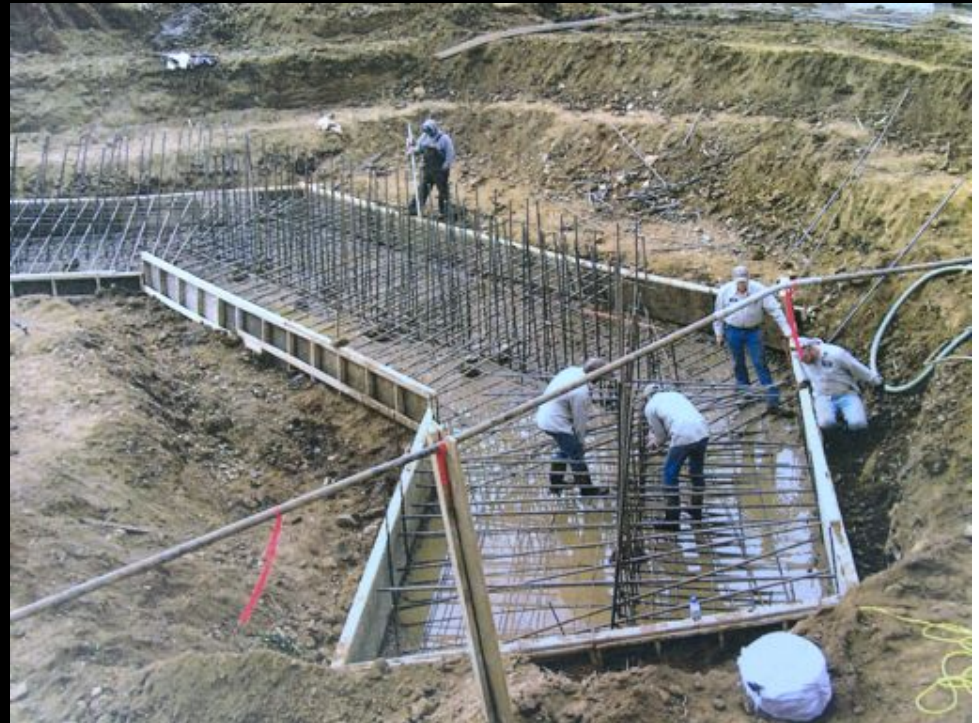
Stonewall east abutment

- Crews fought water and mud while digging footings. In one instance at Stonewall, they encountered a spring near a footing on the west side.
- They used pumps, but we received several reports of concrete being poured on top of mud and water.

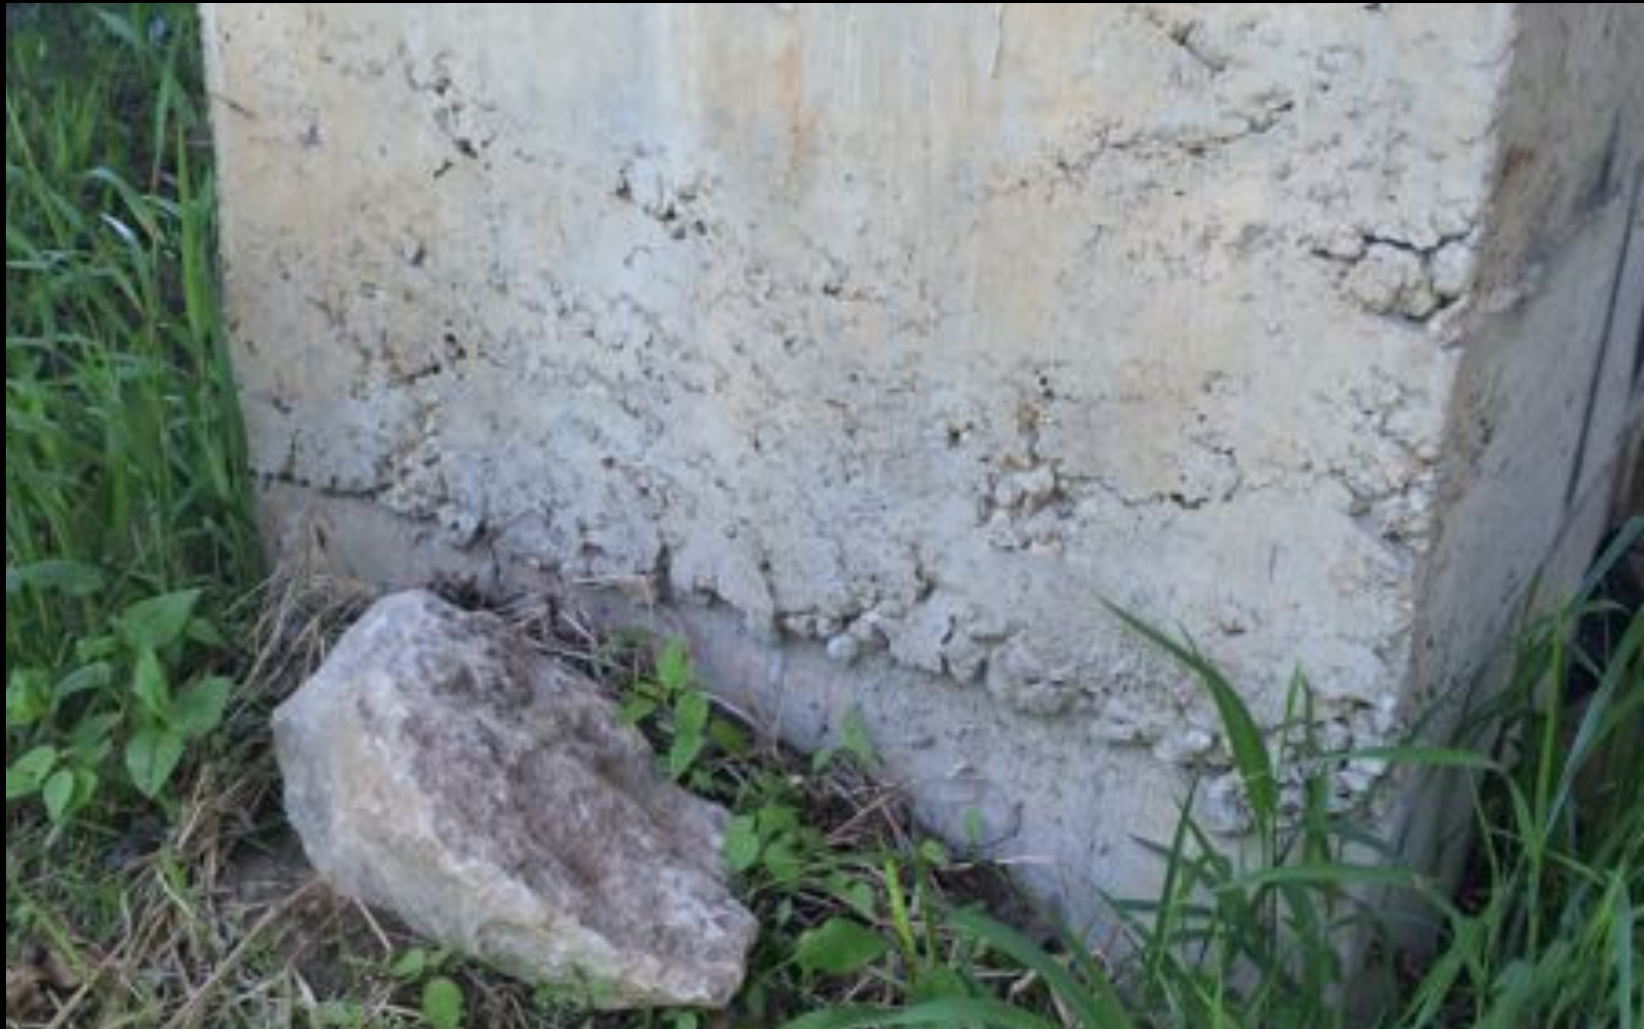
Honeycombing at base of pier

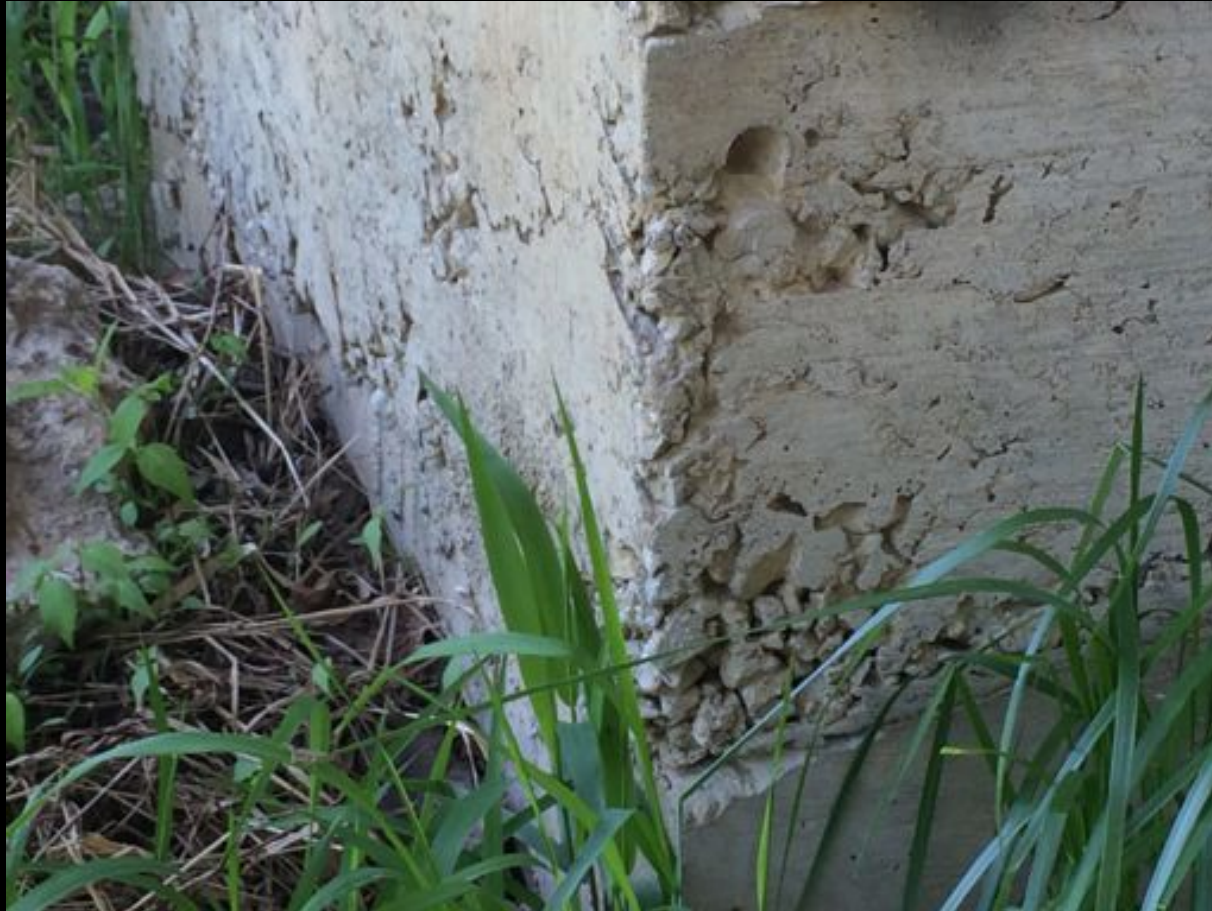
Honeycombing at base of pier

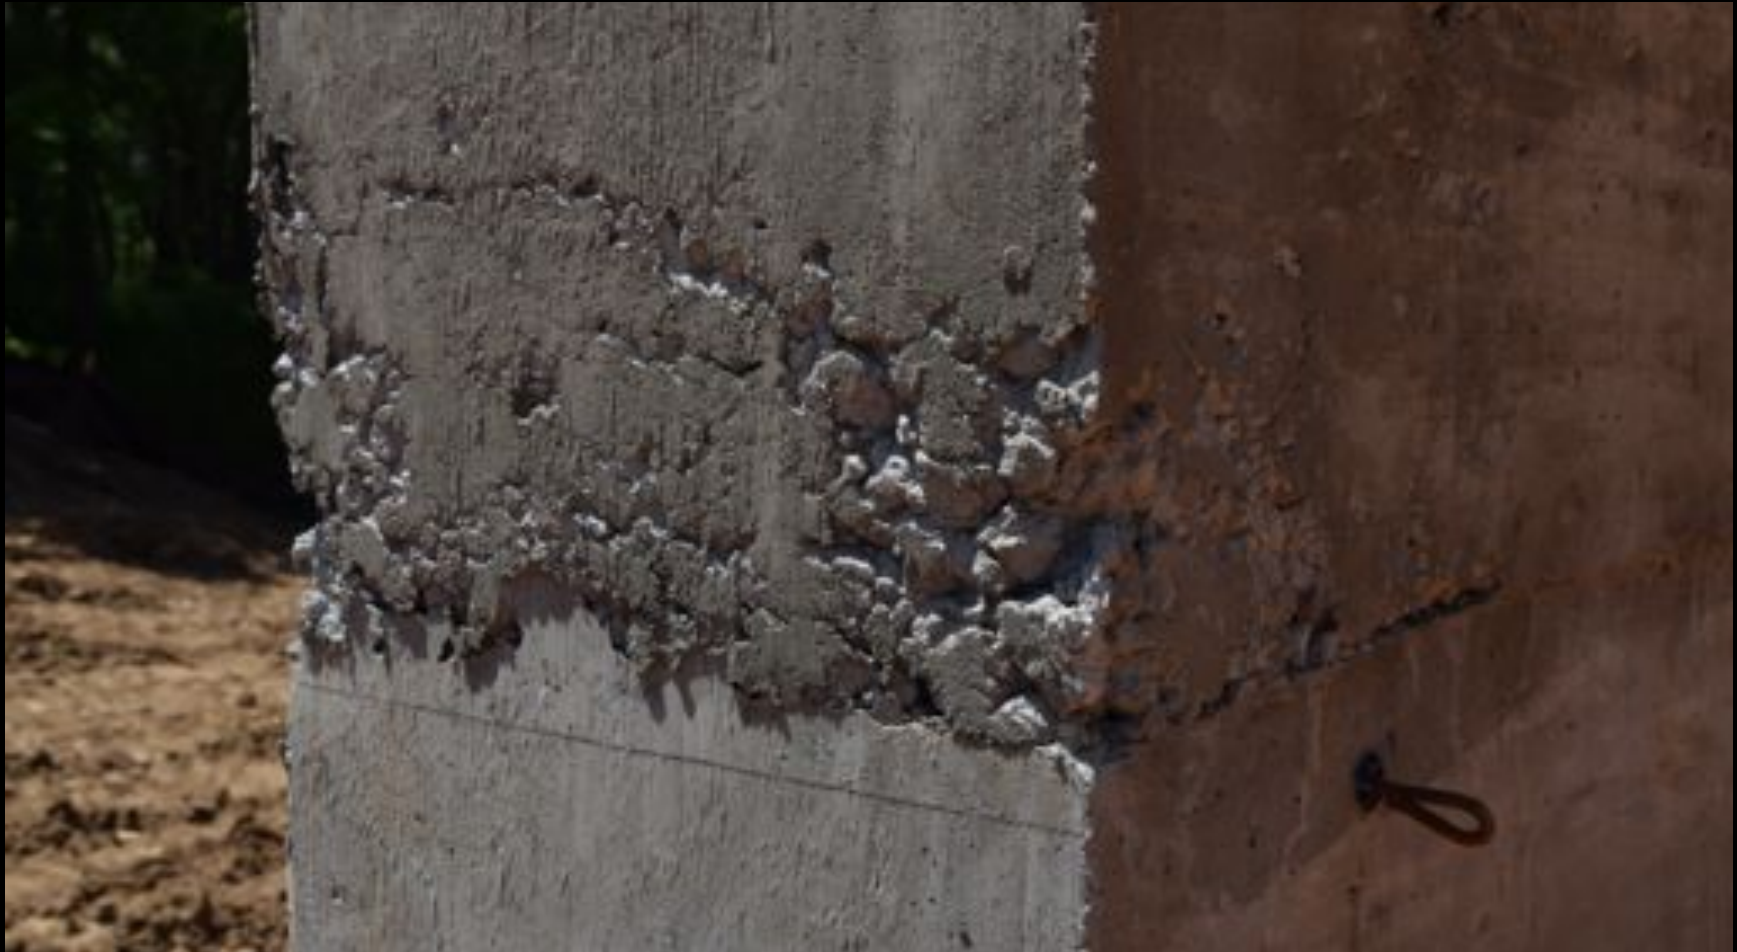
Honeycombing in abutments

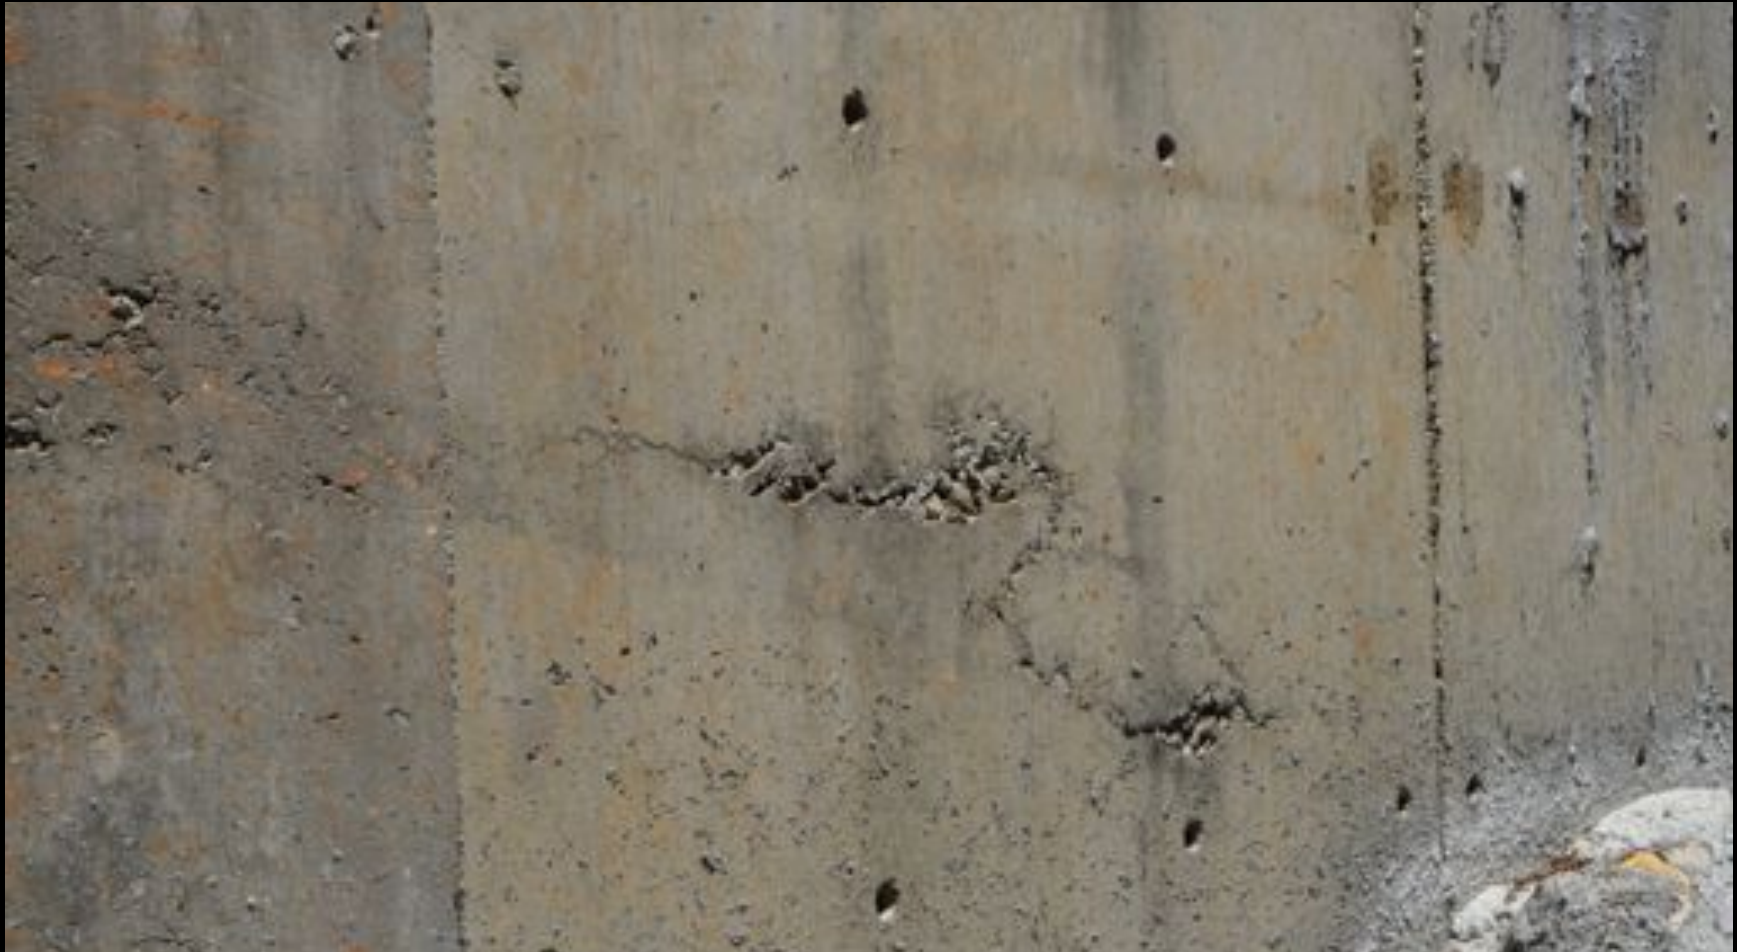
- Honeycombing due to lack of vibration (required by AHTD standards)
- From American Concrete Institute (ACI):
Honeycomb = “voids left in concrete between coarse aggregates due to inadequate consolidation.”
- Honeycombing will accelerate deterioration of the concrete due to freeze-thaw because moisture can easily work its way into the honeycomb areas.

Honeycombing

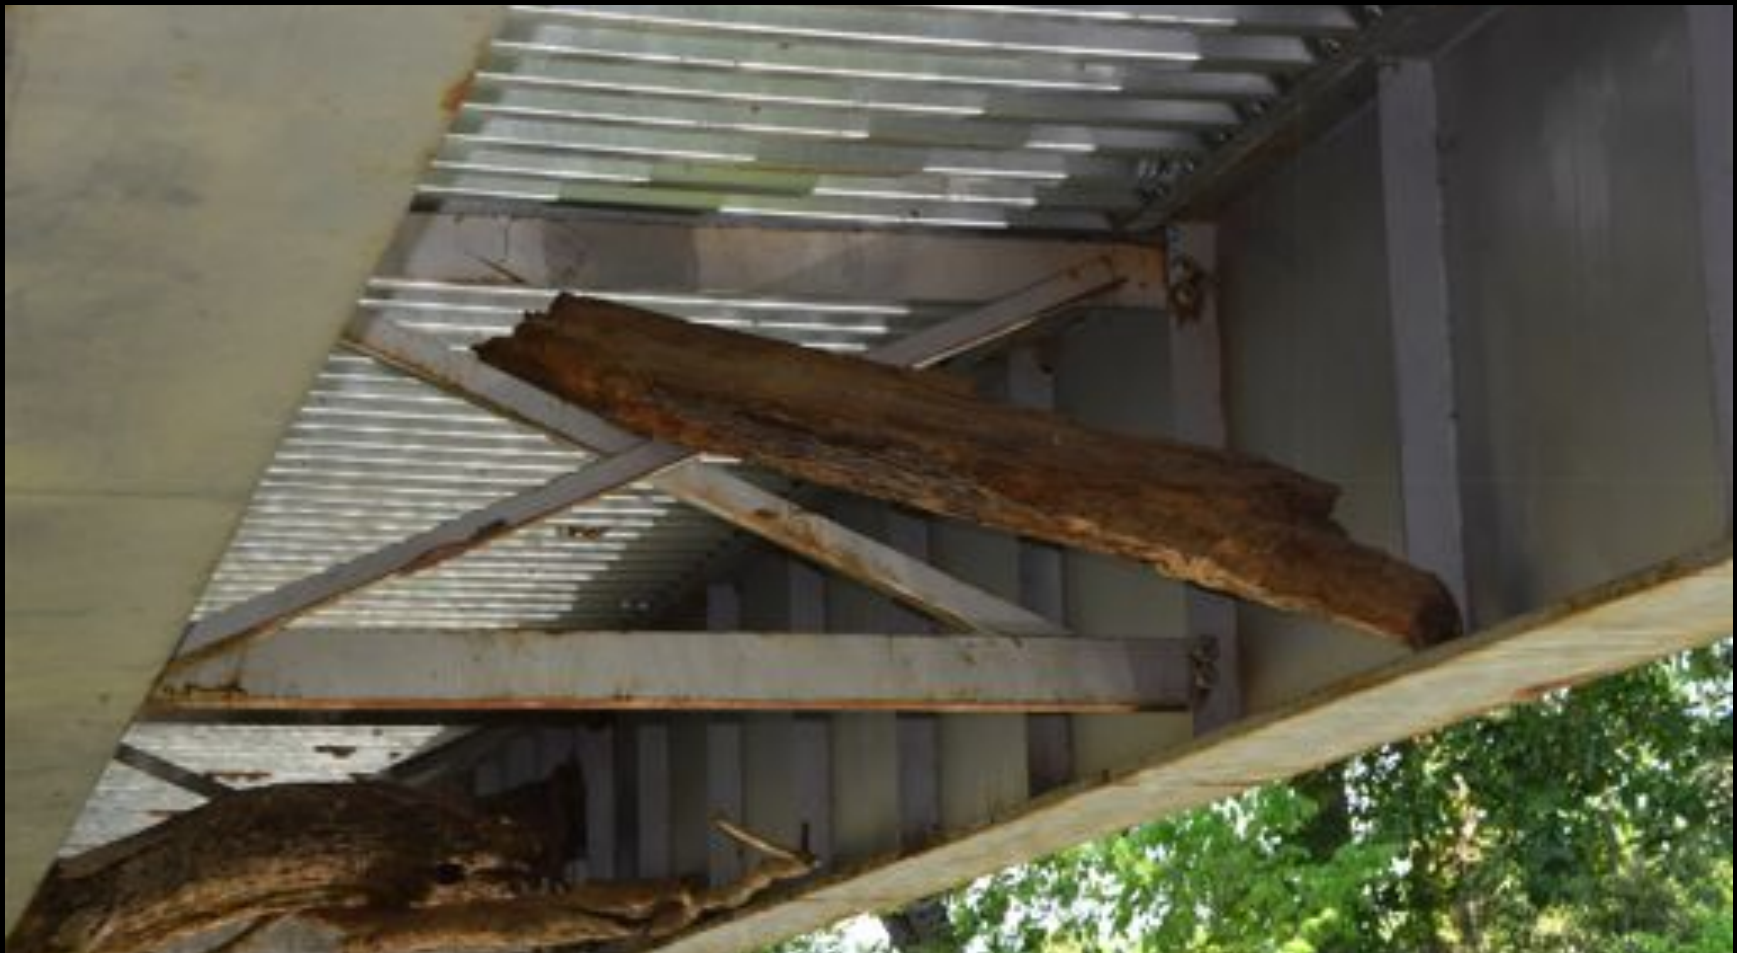
Logs in steel beams under 62 bridge

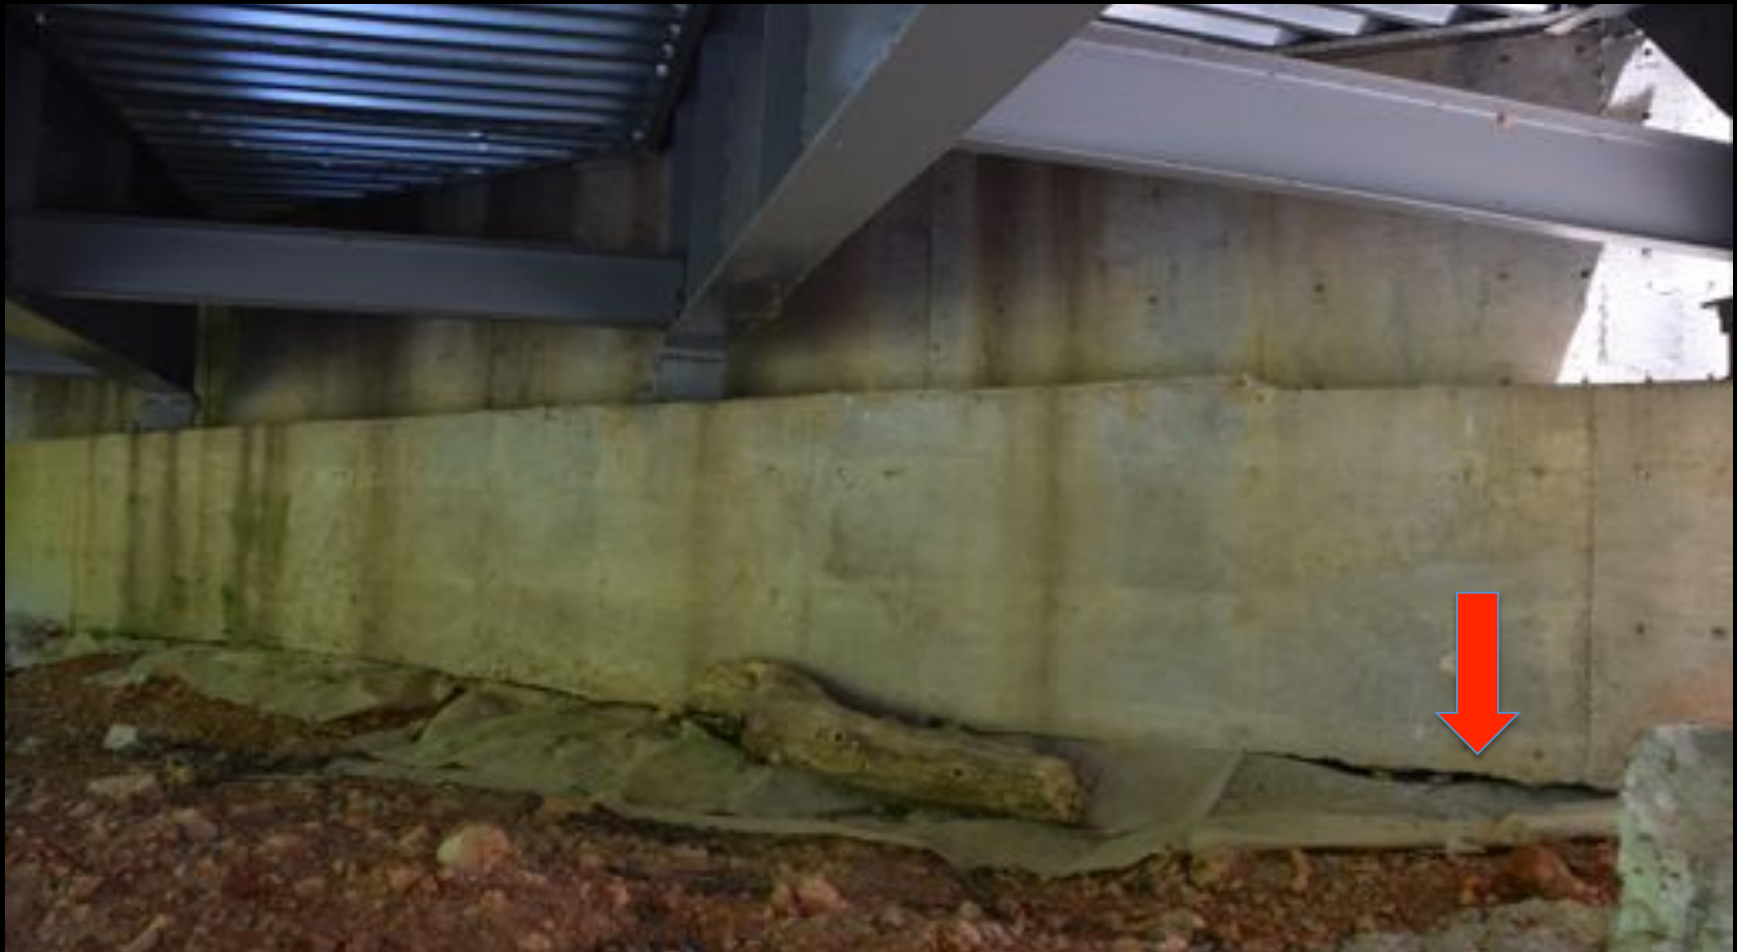
Water getting under footing?

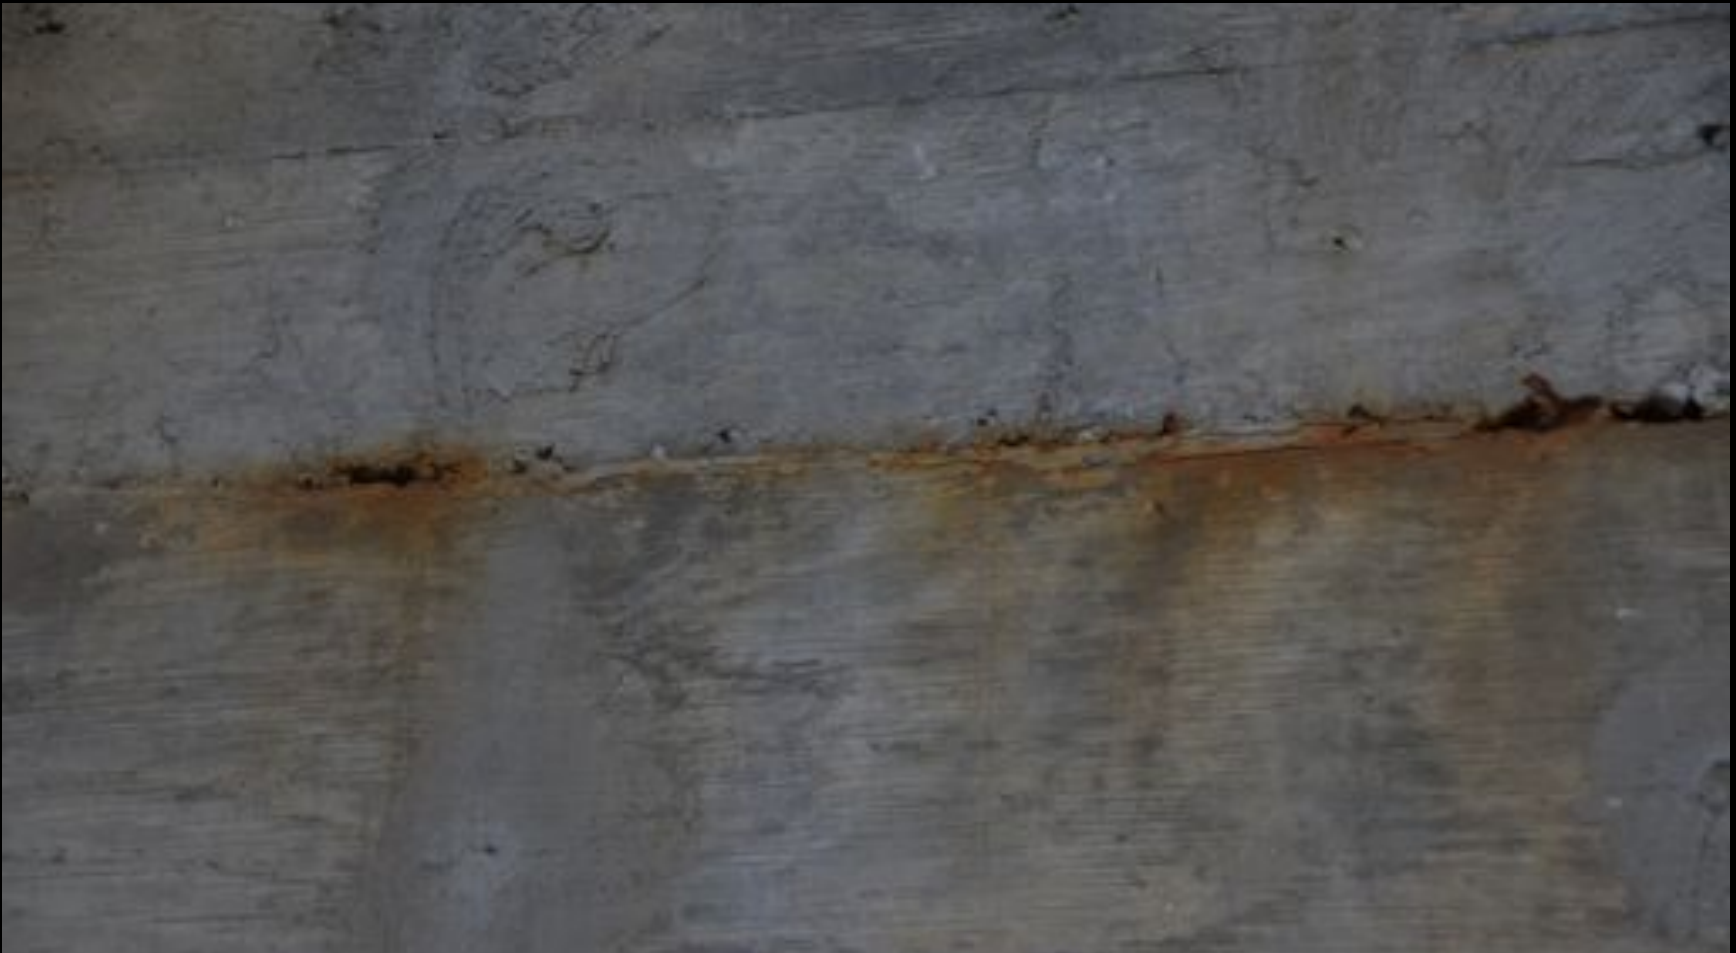
Seam in north abutment wall

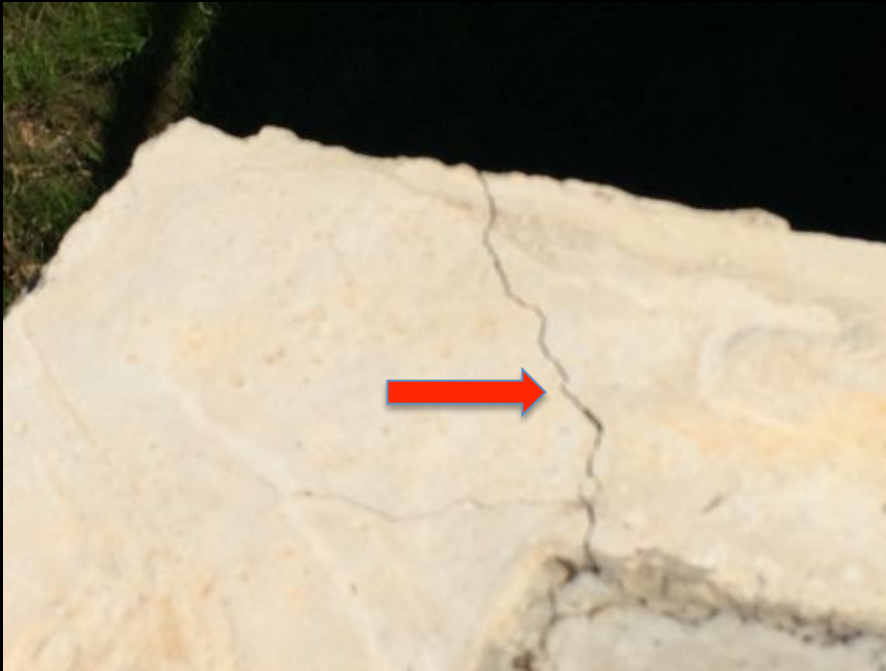
southwest abutment

- Cracks are visible at Harvey Dowell

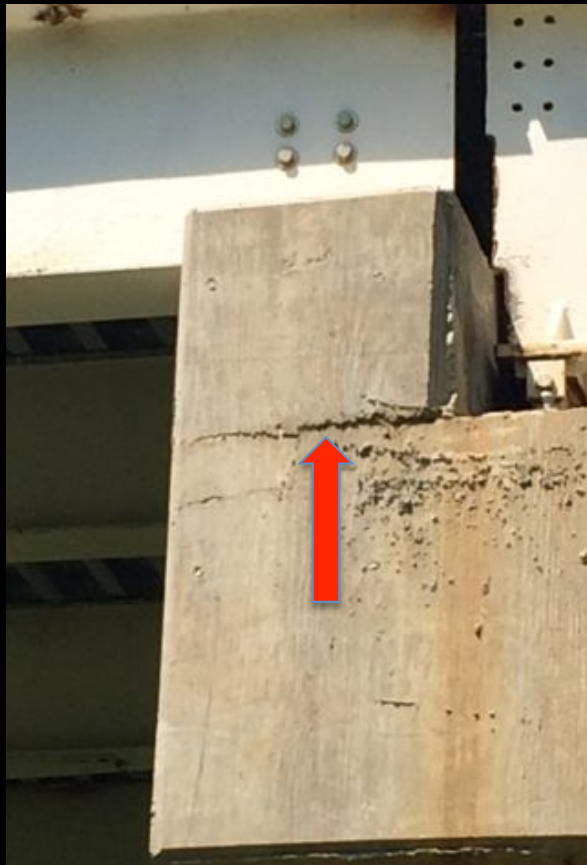
cap of pier

- Cracks are visible at Harvey Dowell

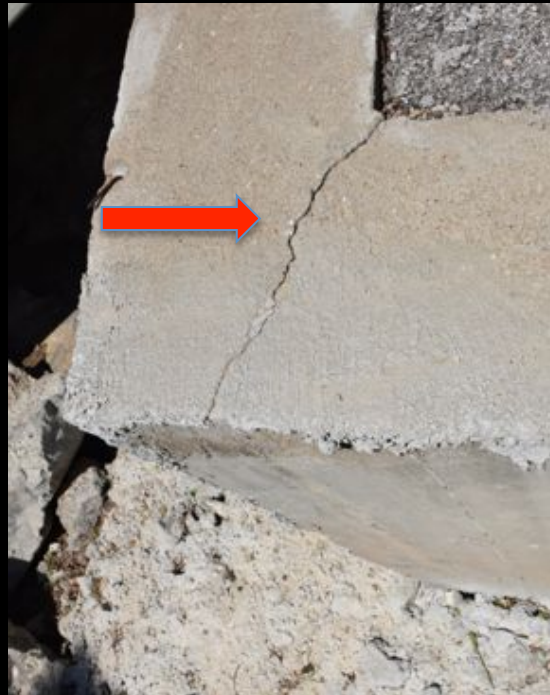
abutment

- Cracks are visible at 62 Bridge

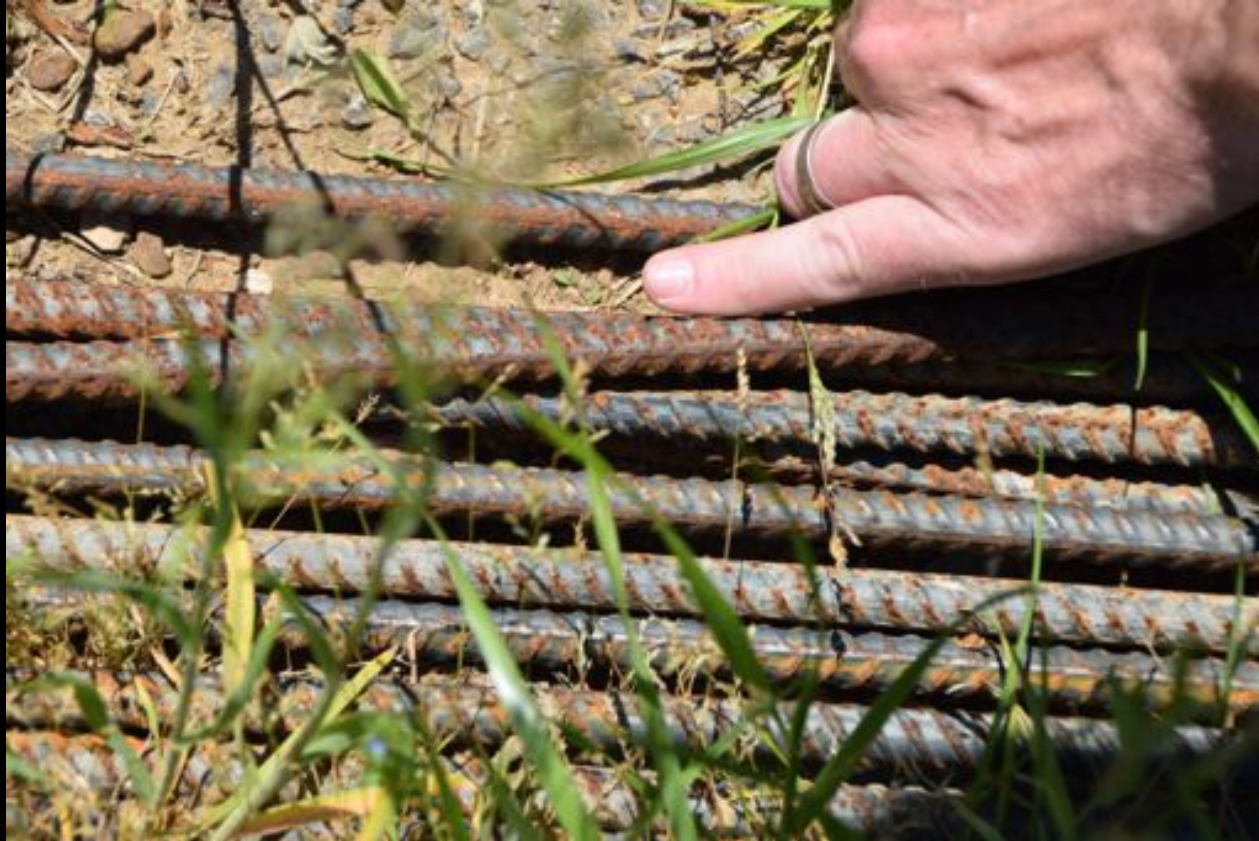
- From AHTD standards: “Steel reinforcement shall be protected from damage. When placed in the work, it shall be free from dirt, detrimental rust or scale, paint, oil, or other foreign substance.”
- “Steel reinforcement shall be stored above the ground on skids, platforms, or other supports.”

Rebar left at Stonewall site

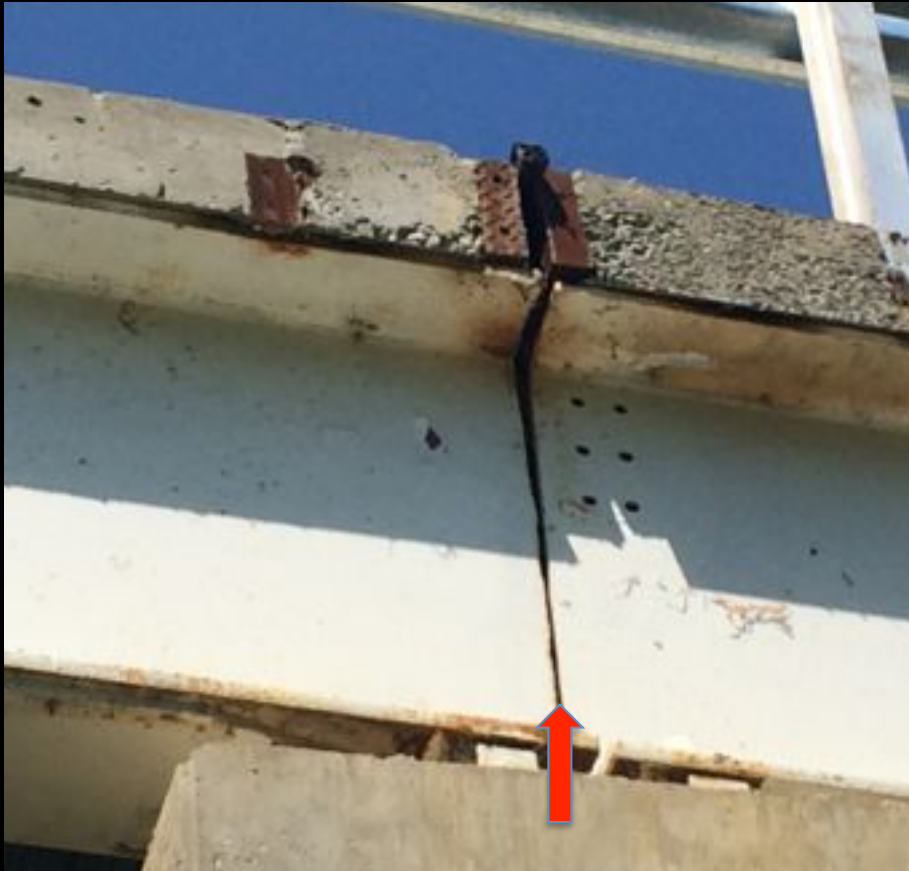
Intermediate joint

- Plans call for steel-to-concrete spacing of $1\frac{3}{4}"$ at joint abutments.

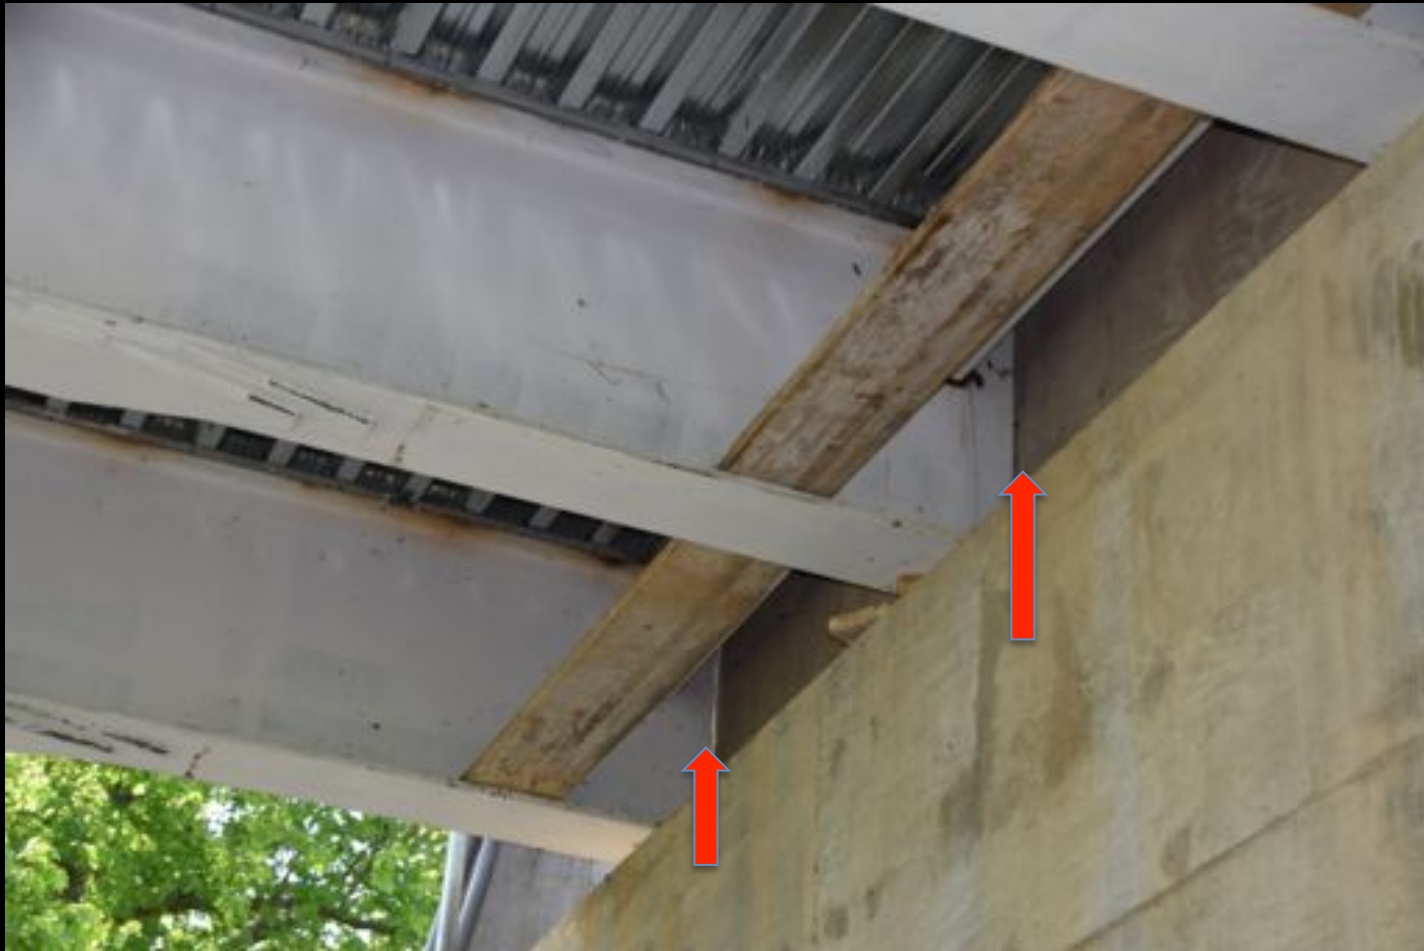
Beam resting on north abutment wall

- Addressed in AHTD report in Dec. 2013 and repair made, but problem still appears today.

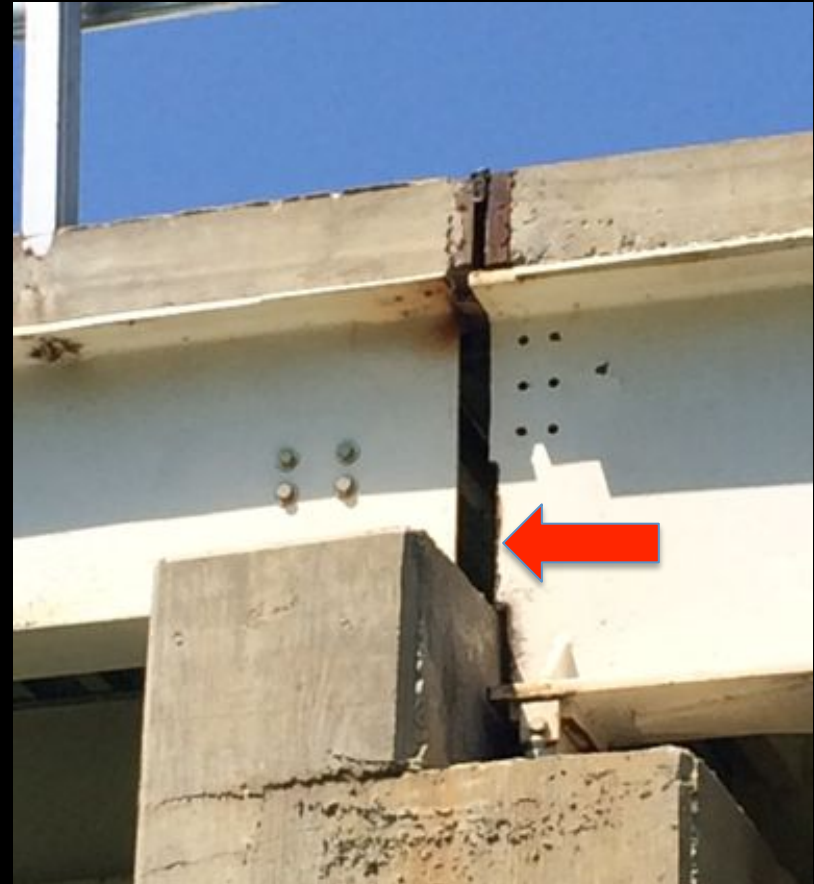
- Beam did not fit, so it was modified with a torch.

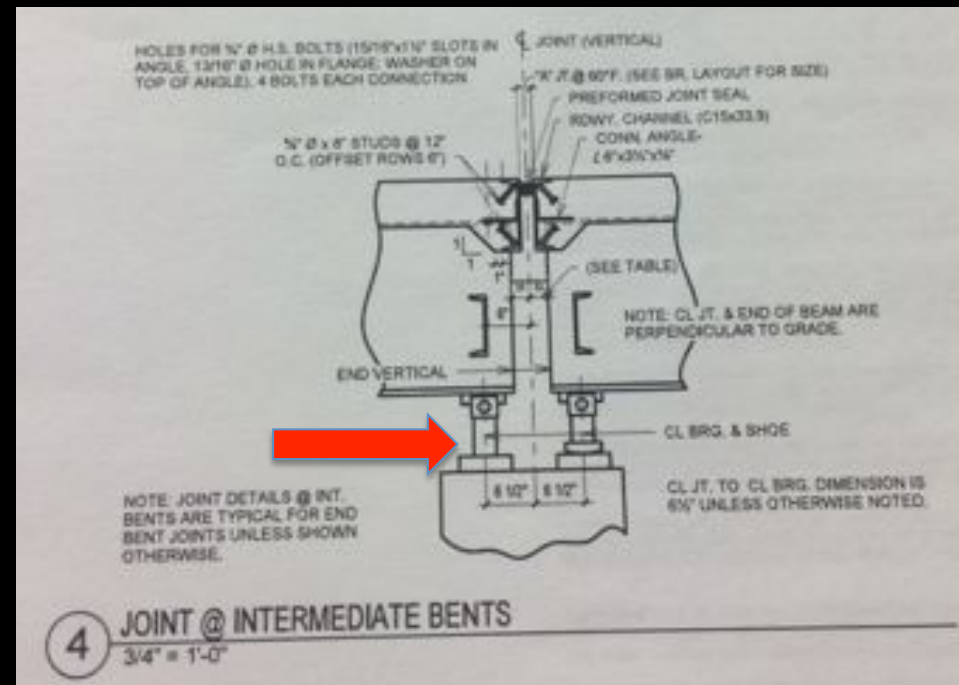
- Sleeves were not used.
- Crews attempted to drill holes in piers/abutments after the fact to affix bolts.
- Sometimes, crews encountered steel/rebar, making drilling difficult or impossible.
- Reports that two or three bolts left out. Other reports that two or three bolts were not attached to full depth.
- Loose bolts visible underneath structure.

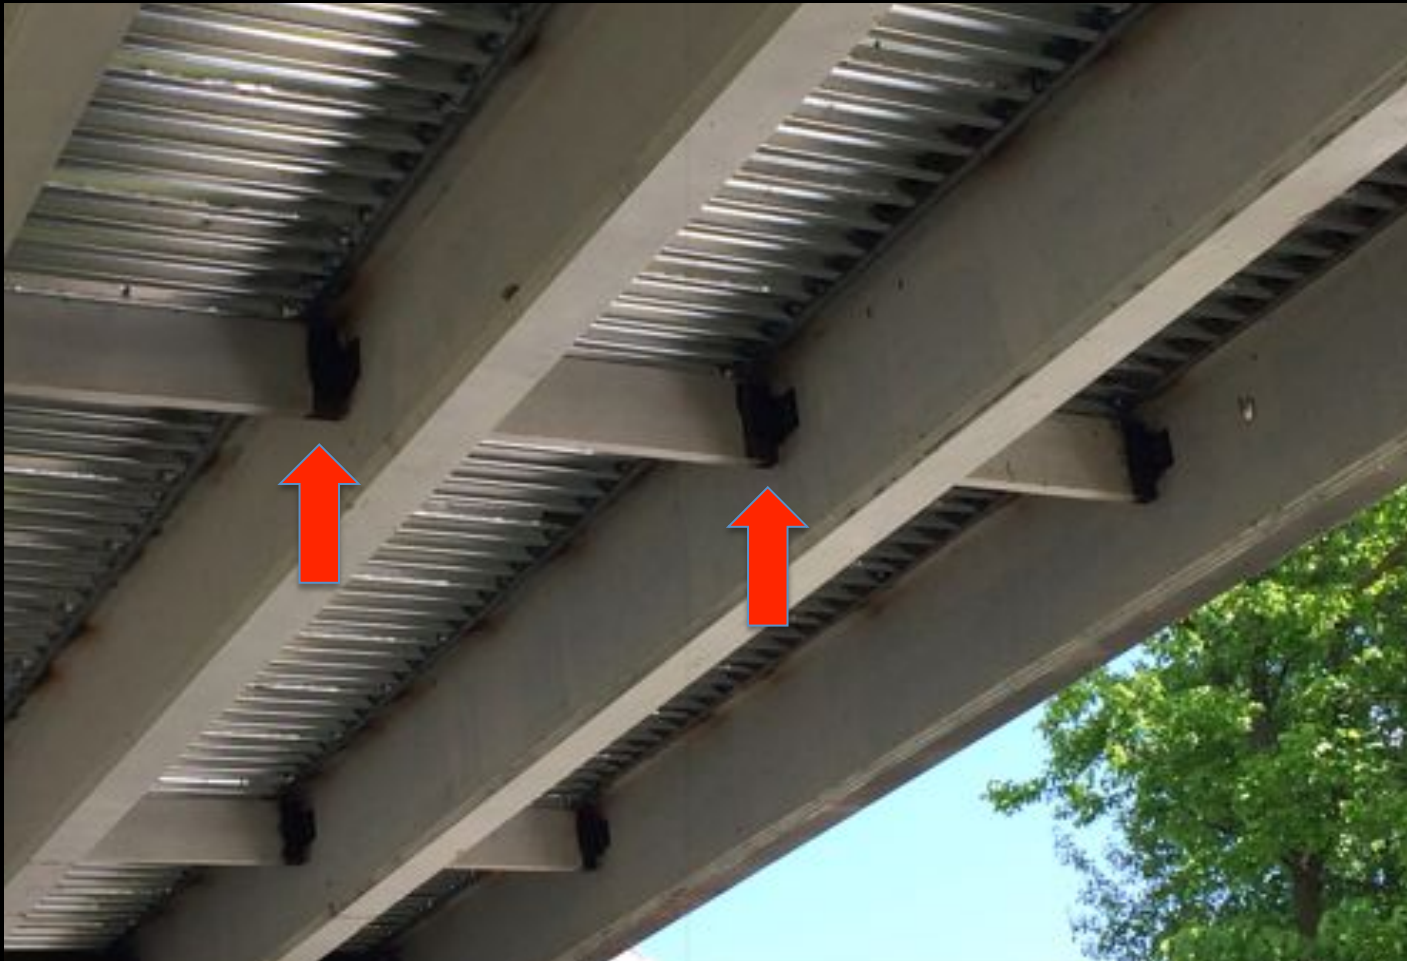
Harvey Dowell

Incomplete Painting

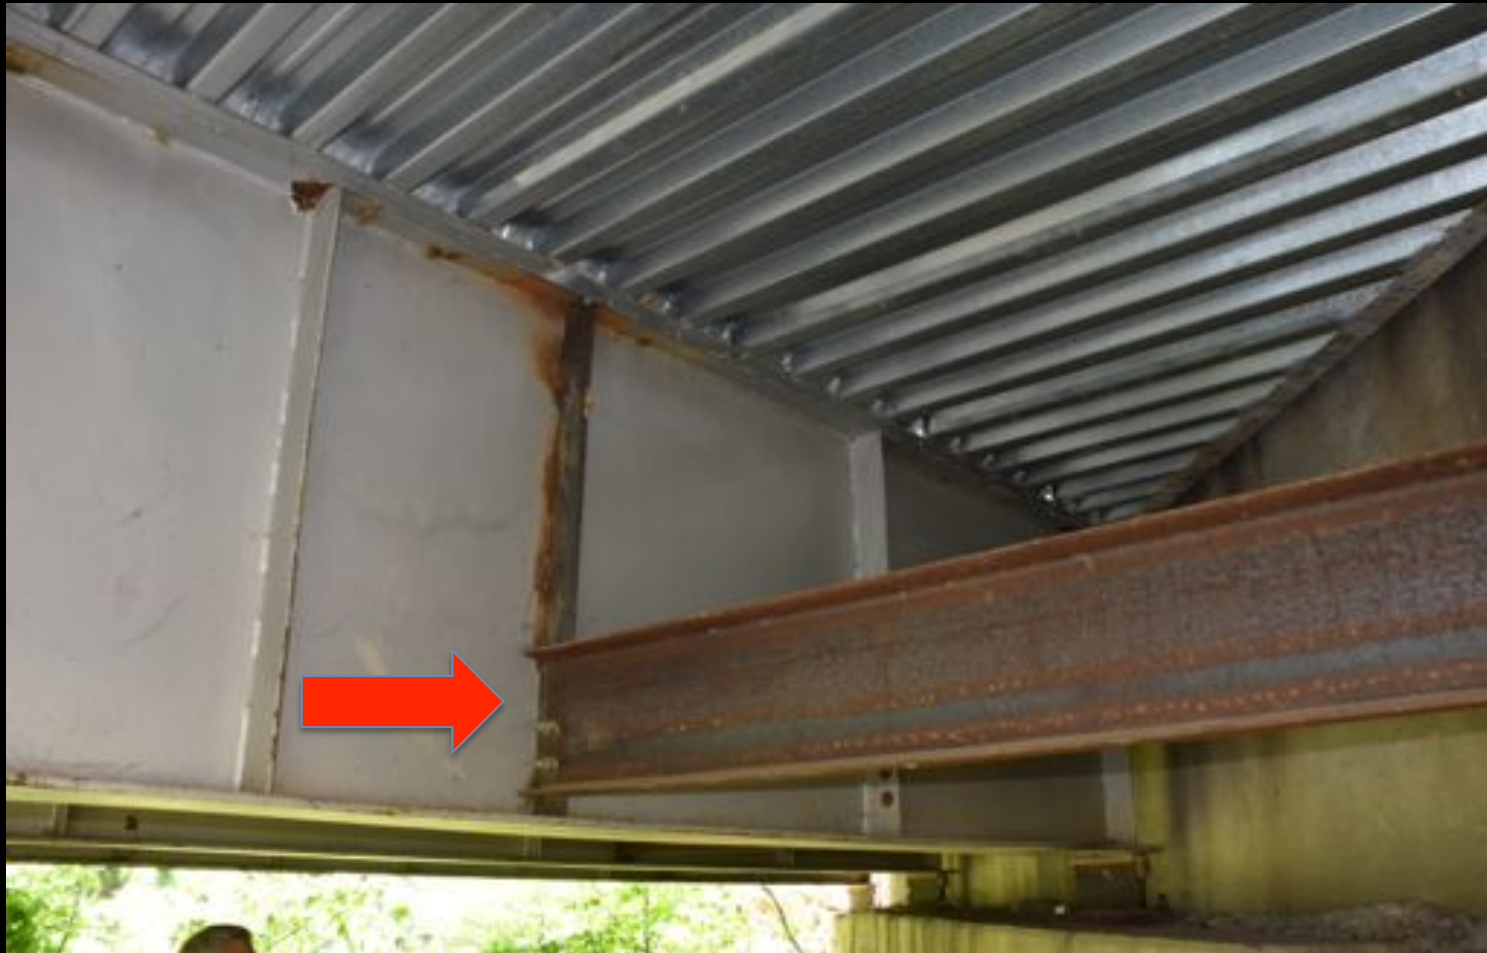
62 Bridge

Incomplete Painting
