Bridge Investigation Report

May 5, 2015

Investigation Overview

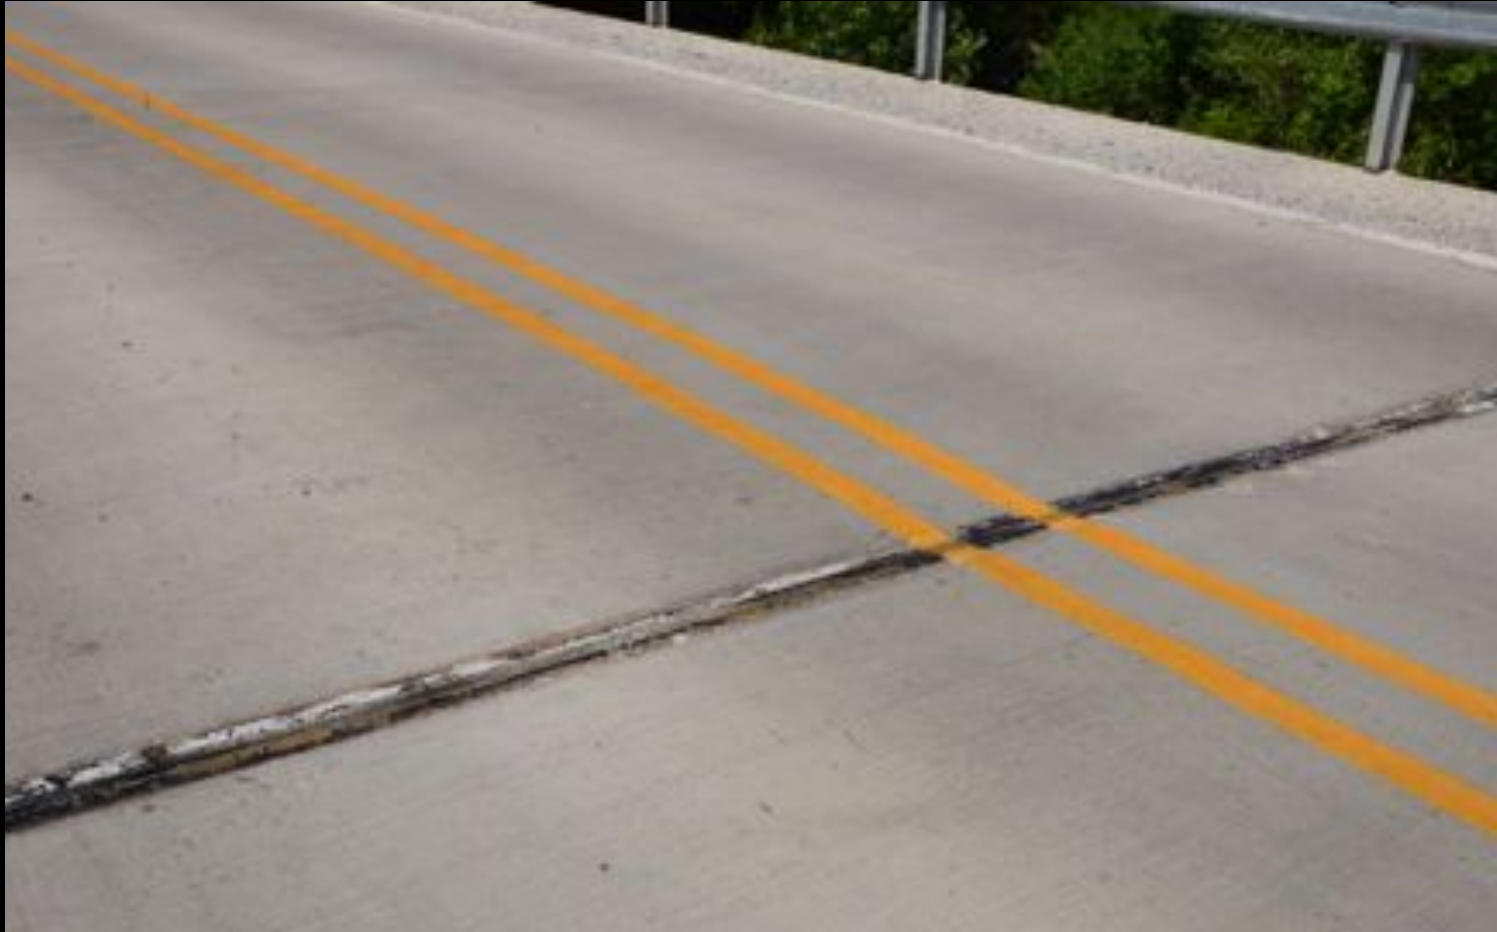
No Tine Finish

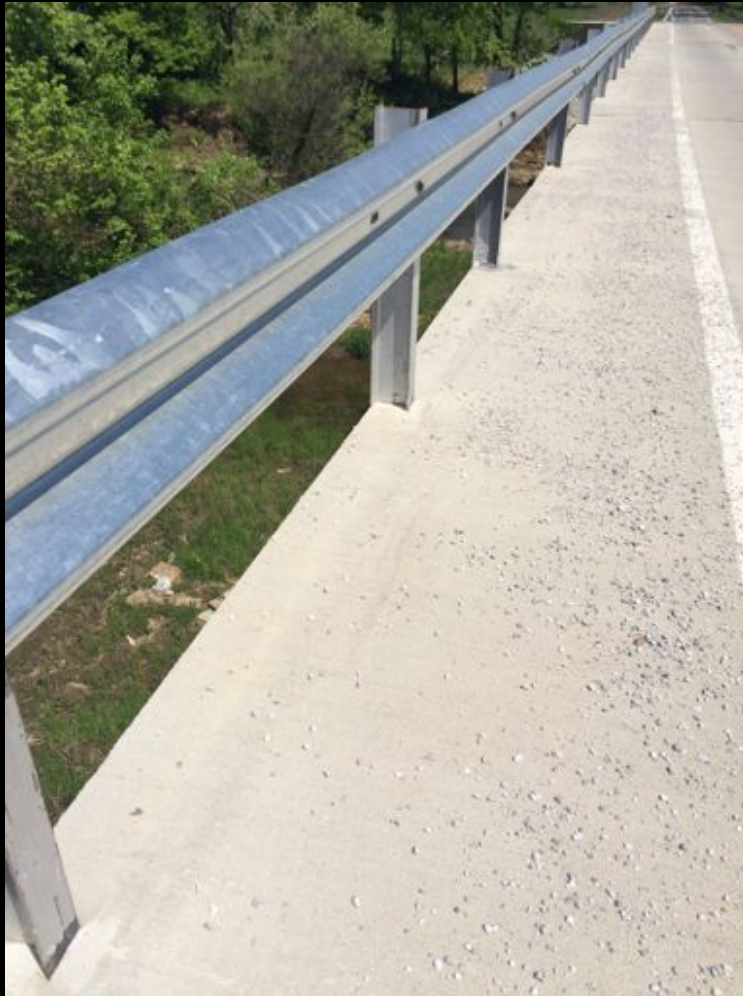
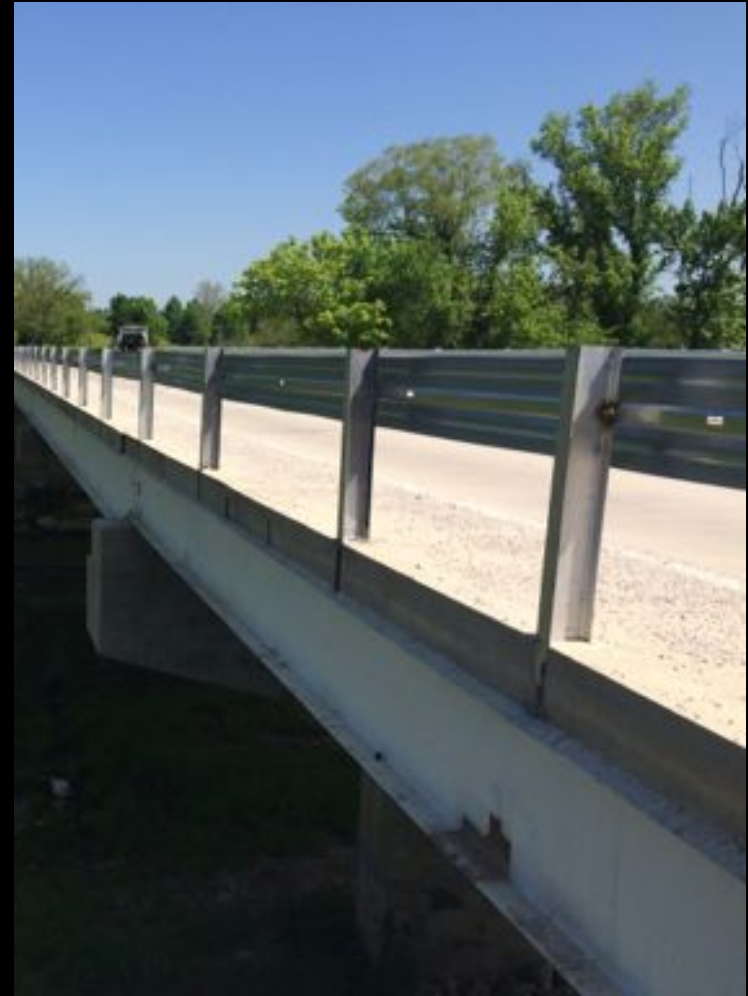
Harvey Dowell Curb/Guard Rail

- Plans call for curbed concrete wall at road deck edge.
- No curb installed, so nothing at road edge.
- Used guard rail instead.
- Plan deviation is visible to anyone.
- Did not think they had ability (e.g., forms) to do per plan.

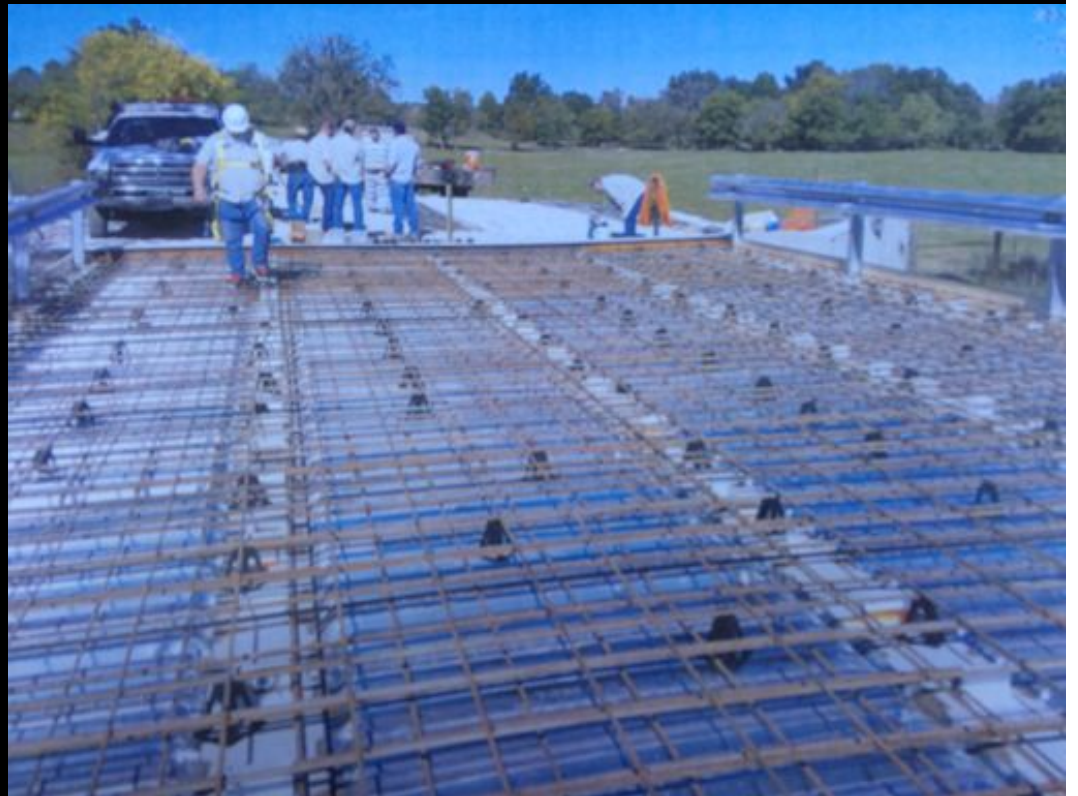
Harvey Dowell

- Reports that rebar spacing on roadway deck farther apart than plan spacing.
- 12" centers versus 9" centers.

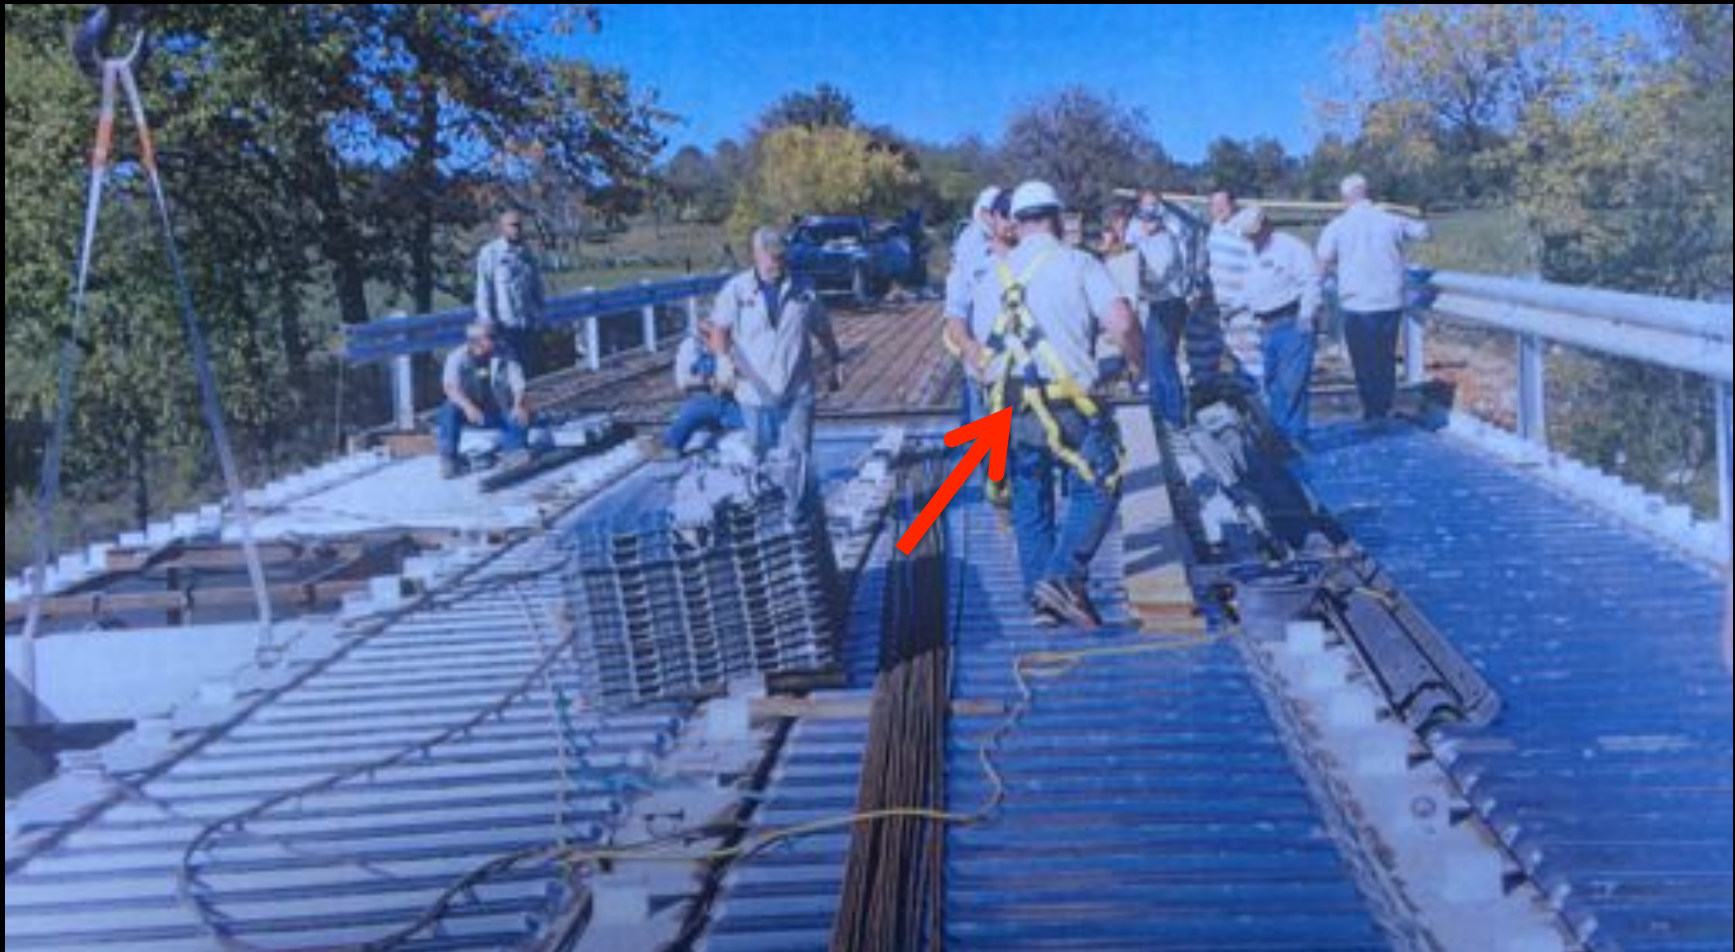
One worker wearing fall protection at Harvey Dowell
