Arkansas Natural Resources Commission

June 14, 2017

RE: INSPECTION: PERMIT 330 -- LAKE FAYETTEVILLE – WASHINGTON CO.

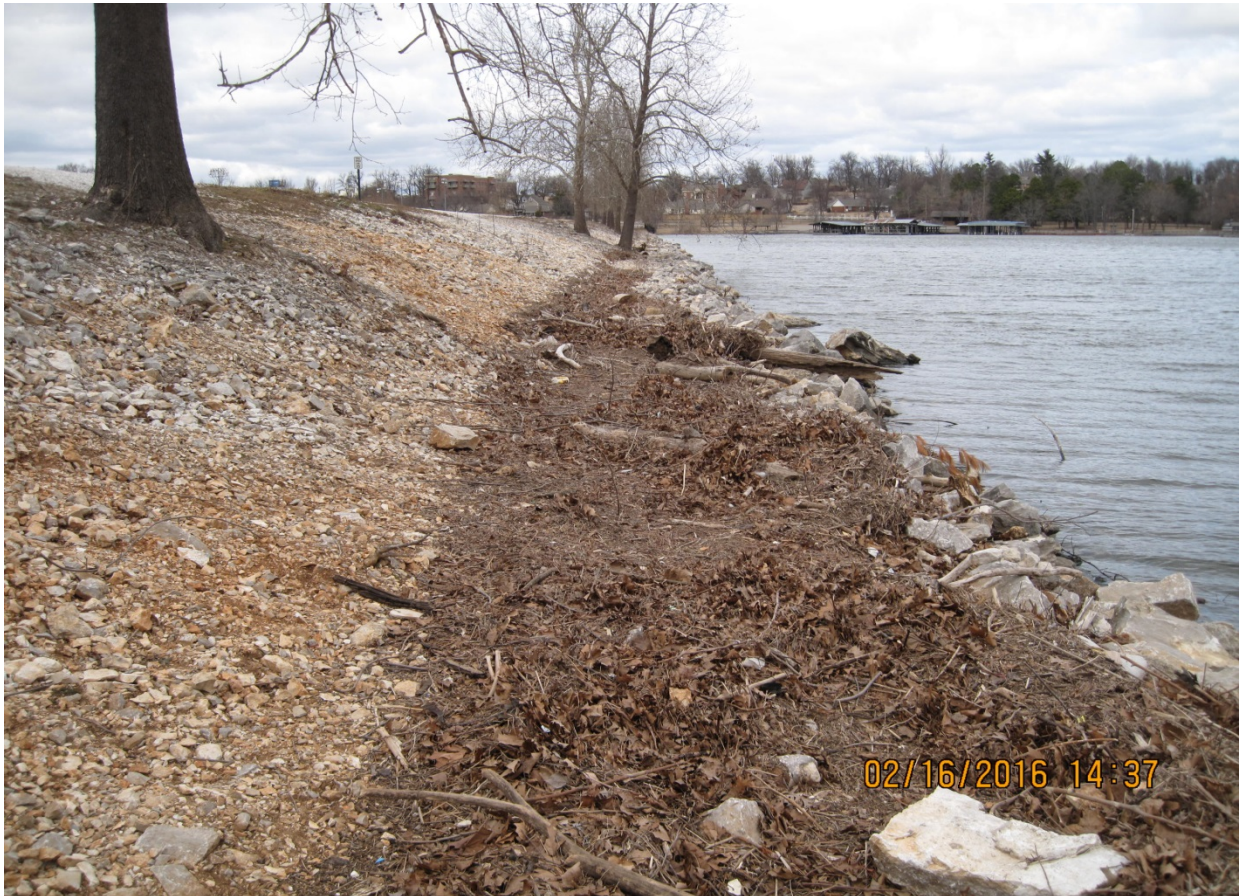
Figure 1 Upstream slope

The upstream slope is likely in better condition to resist erosion at normal pool levels after the recent rearranging of the riprap. But the rains just prior to my visit demonstrated the ease with which a reasonably common event can bring the pool up and into an unprotected area. I believe that additional protection, for at least a portion of the slope, would prove beneficial. Figure one shows this area and the debris deposited from the high water. Creating a uniform grade would also allow for an easy visual check of the condition of the slope.

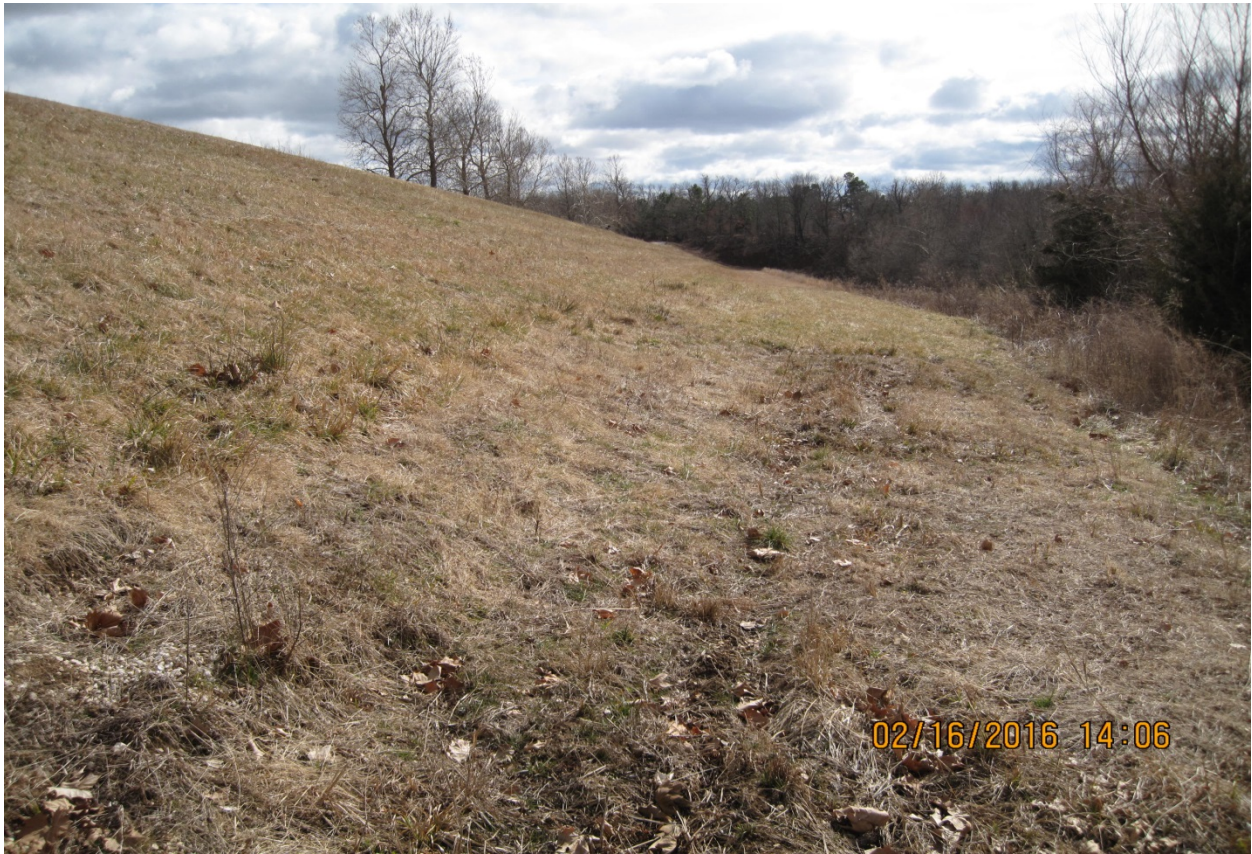
Figure 2 Downstream face

A few small ruts were present on the downstream face/toe area where maintenance efforts encountered saturated areas. Please repair these and any future occurrences as they occur.

The seepage on the dam was consistent with past observations. Your efforts to manage it with filters and drains appears to be effective, but please remain vigilant for changes to volume and characteristics such as turbidity.

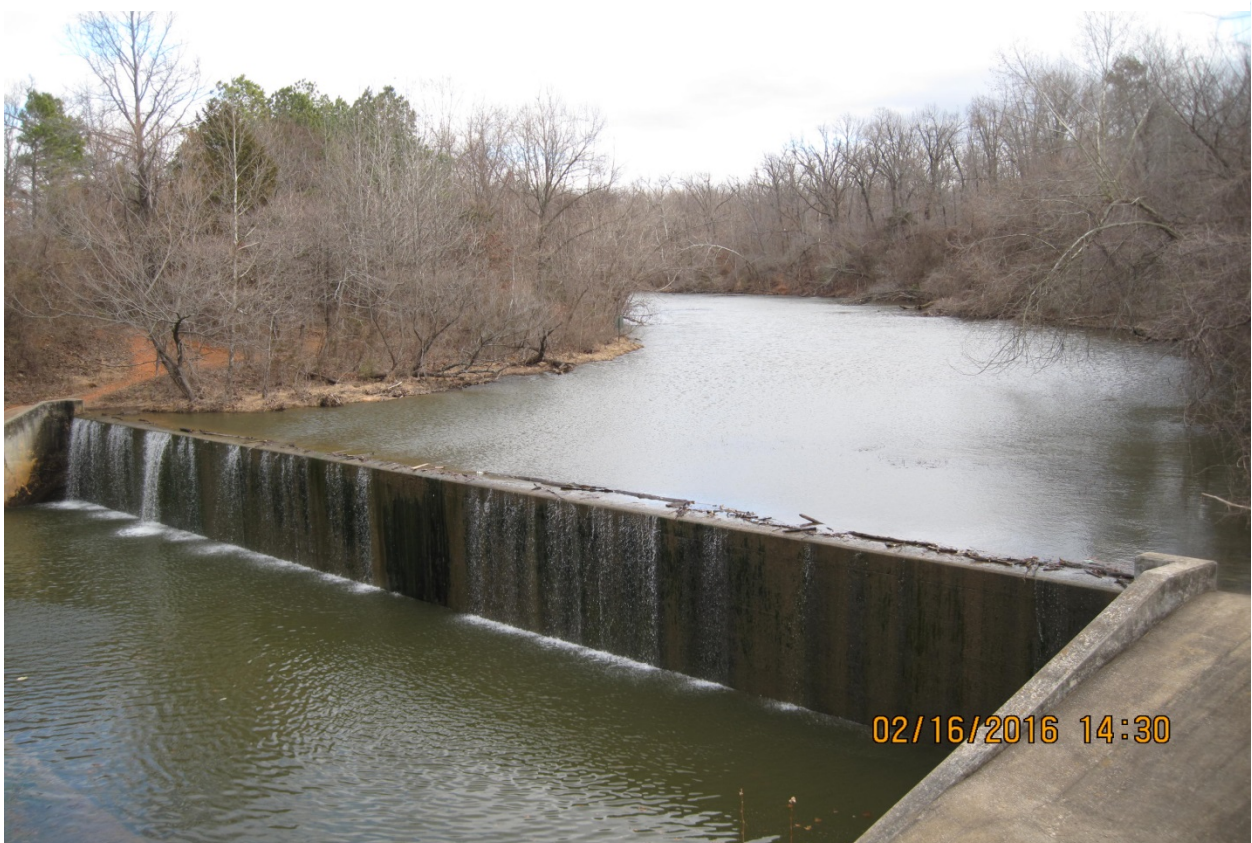
Figure 3 Spillway crest

The spillway did not appear to have any deficiencies.
