# Arkansas Natural Resources Commission

April 20, 2017

## **RE: INSPECTION: PERMIT 330 -- LAKE FAYETTEVILLE – WASHINGTON CO.**

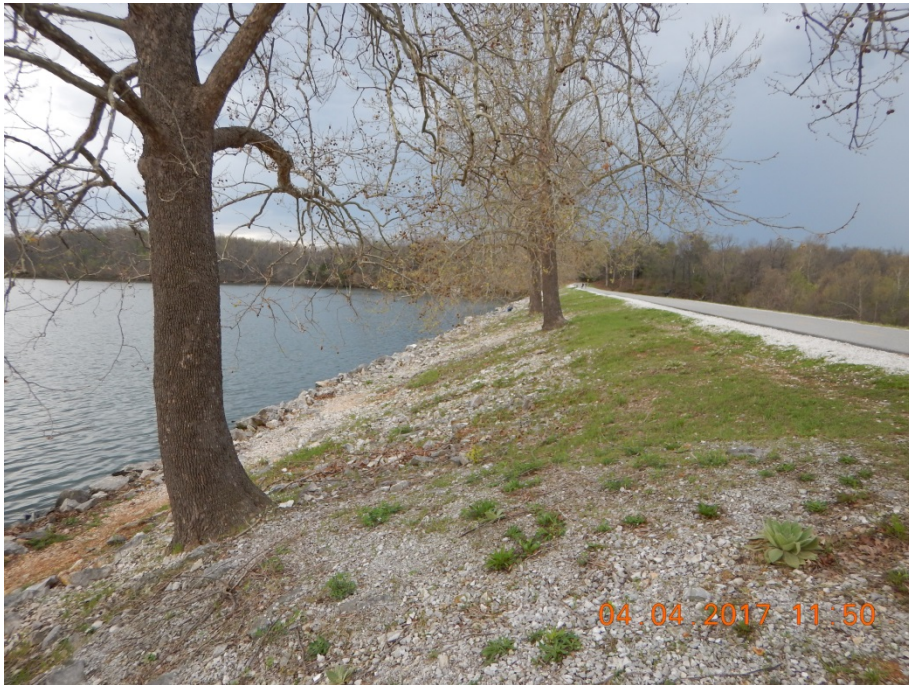
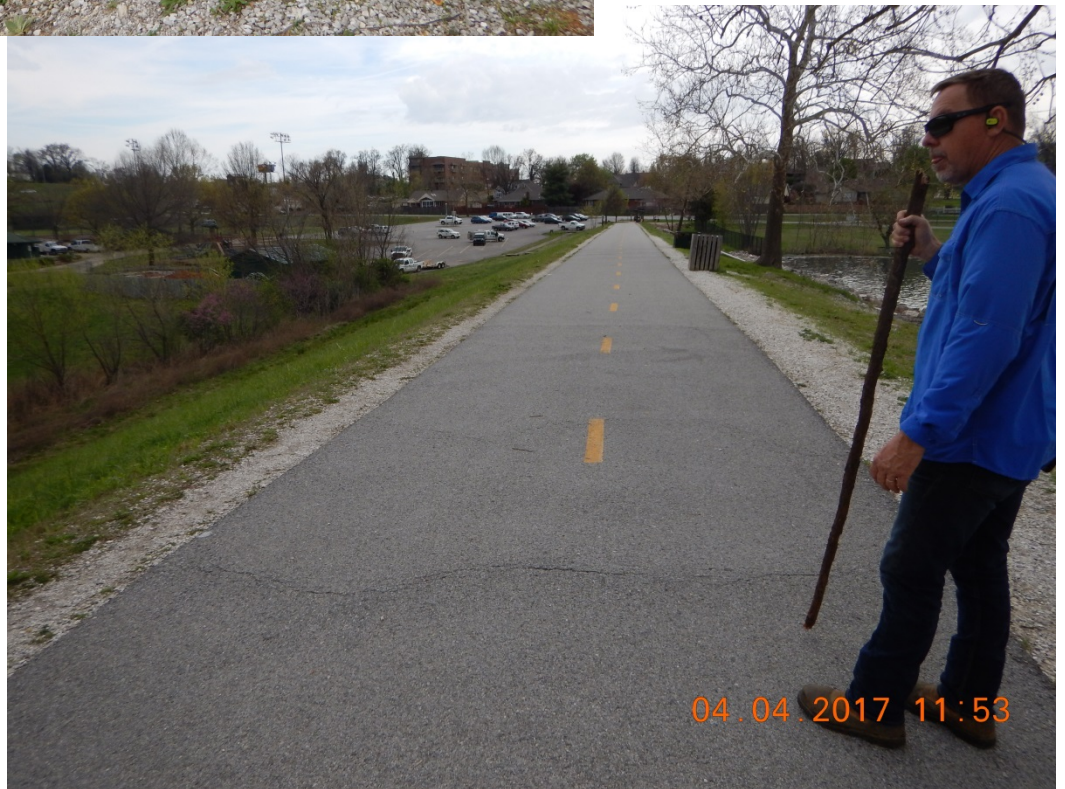
The upstream slope of the dam and the crest appeared to be in good condition overall. There are large trees growing on the upstream slope, and their root systems are causing small depressions and small cracks to form on the crest of the dam (**Figure 1 & 2**). The rip-rap added along the shoreline appears to be holding its position, but the rip-rap line could be brought further up the slope to help prevent erosion when the lake is higher (**Figure 3**).

Figures 1 & 2. Large trees growing on upstream slope. Cracks forming on crest of dam caused by root systems of large trees.

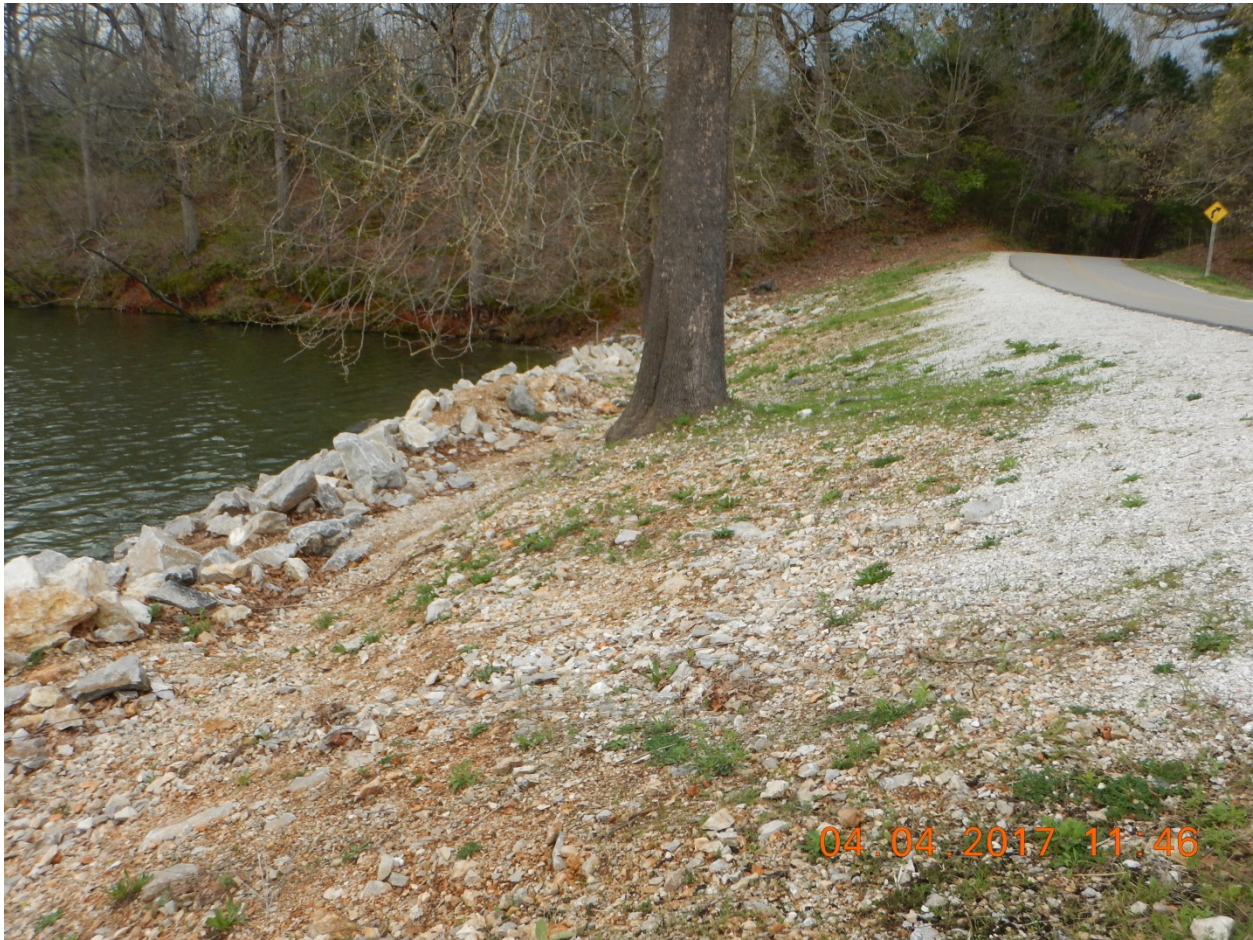
Figure 3. Signs of erosion on the lower portion of the upstream slope above the rip-rap line.

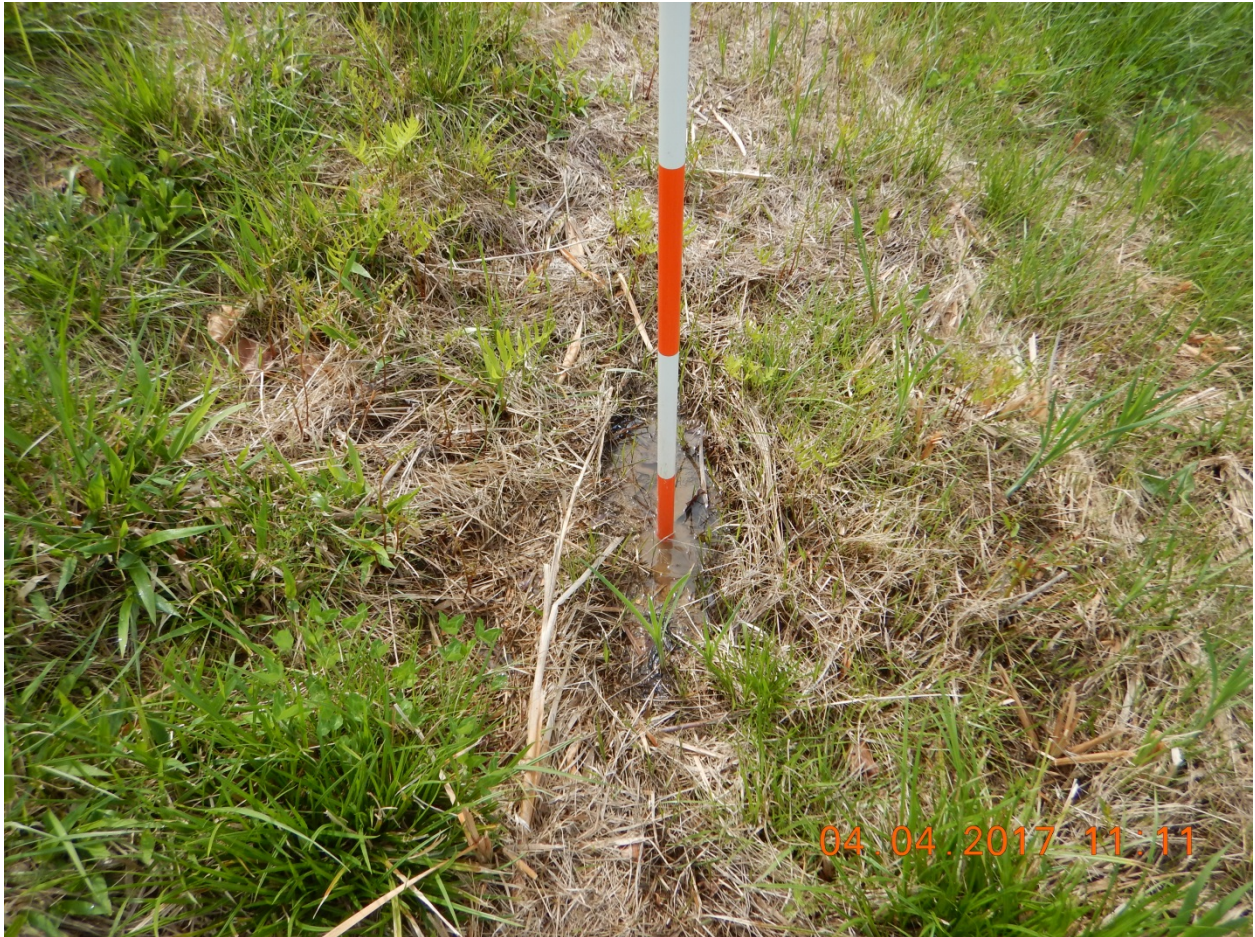
The downstream slope of the dam and the toe of the dam appeared to be in good condition overall, but the embankment was saturated in some areas with some seepage (**Figure 4**). The seepage blanket installed on the right half of the downstream slope appears to be functioning well. Please continue to monitor the downstream slope of the dam for signs of increased/muddy seepage, and continue to regularly mow and burn the brush from the slopes of the dam. A few small ruts were present on the downstream face/toe area where maintenance efforts encountered saturated areas (**Figure 5**). Please repair these and any future occurrences as they occur.

Figure 4. Seepage on downstream slope of dam.

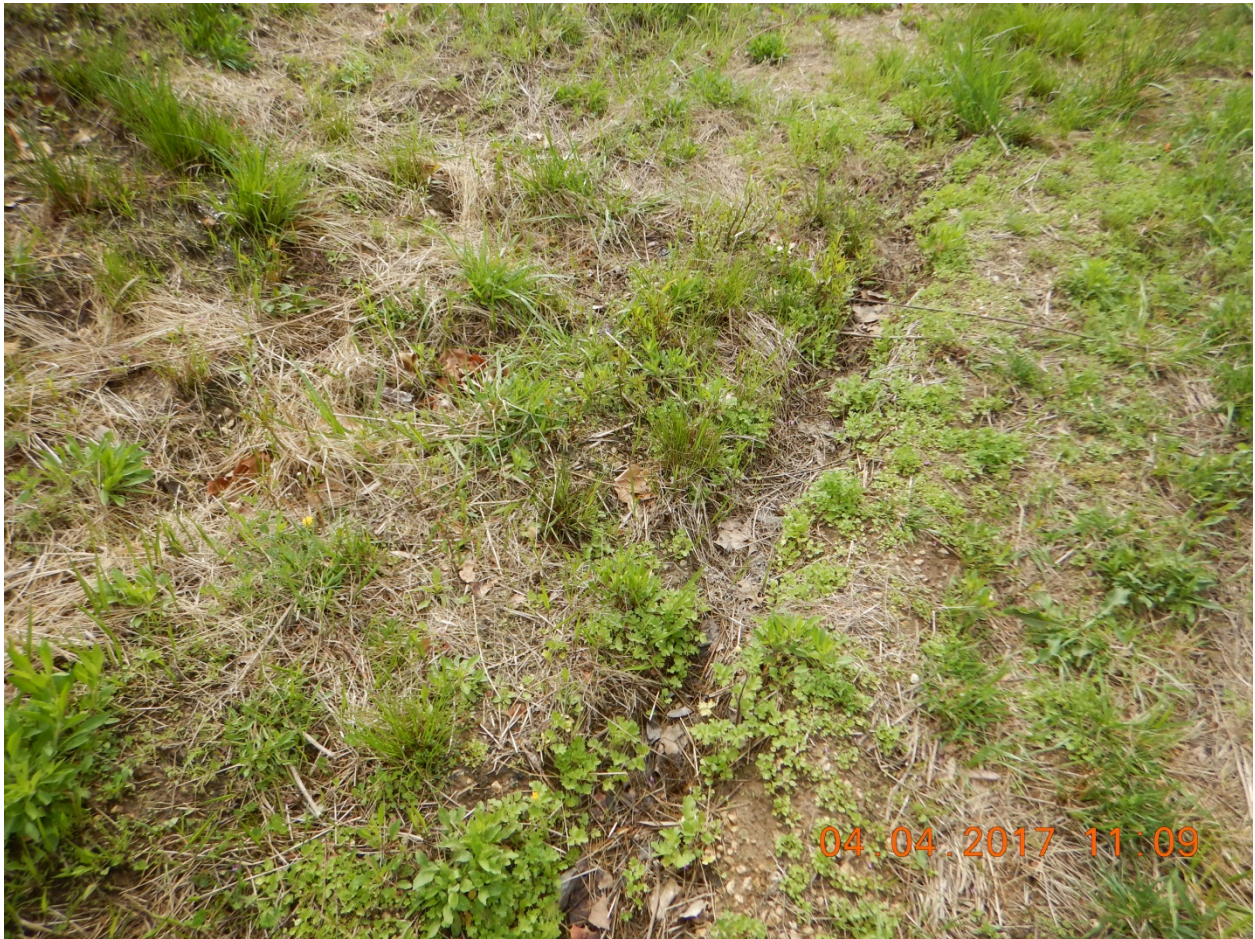
Figure 5. Ruts on downstream slope of dam.
