Regular Inspection Report

Location: 33-I0075-01.29

3 Span Bridge

Inspection Date: July 19, 2018

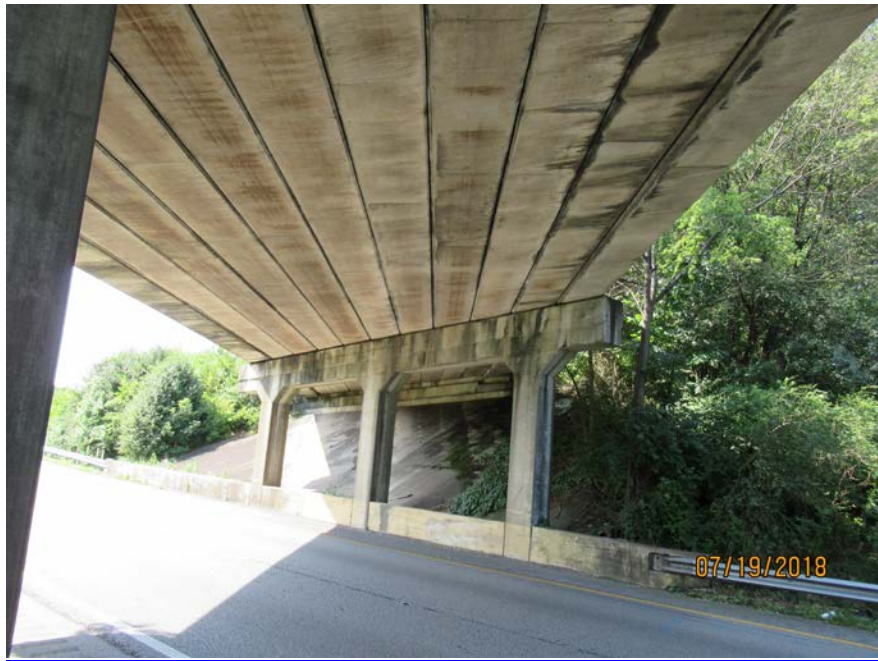
SUPER/SUB STRUCTURE - BENT

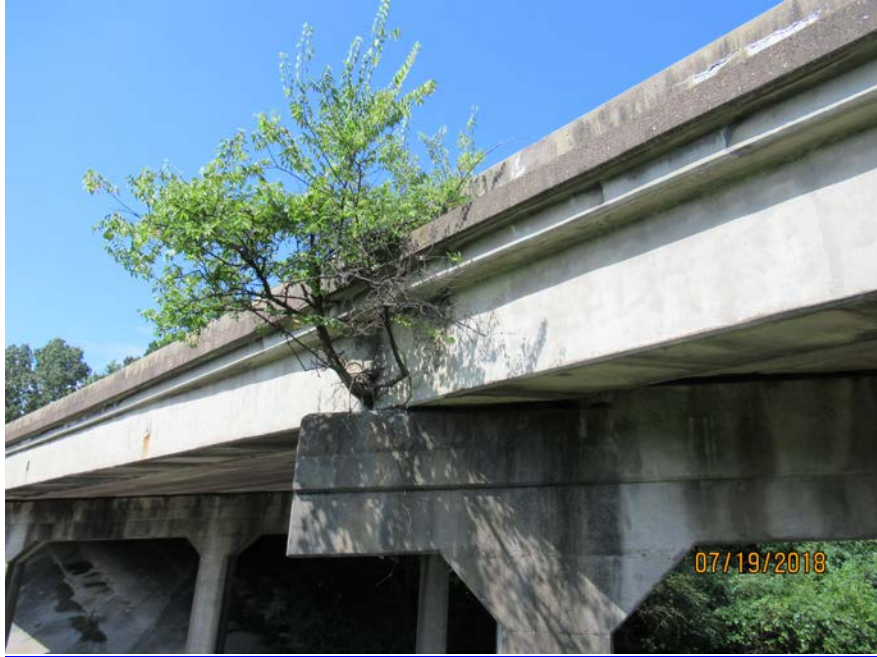
GENERAL COMMENTS:
 TREES GROWING ON TOP OF BENT CAPS IS INCREASING THE SIZE OF CONCRETE CRACKS.

VEGETATION - BENT 2 - RIGHT

| Caps | FAIR | <i>HL CRACKS, DELAMS, MINOR SPALLS. Span 2 - Right Cap - Tree Growing from Cap.</i> |

| No. | RECOMMENDATIONS | REPAIR DATE | REPAIRED BY |
|---|--|---|---|
| 2. | Remove Tree Growing On Bent Cap - Bent 2 - Right Side. | | |

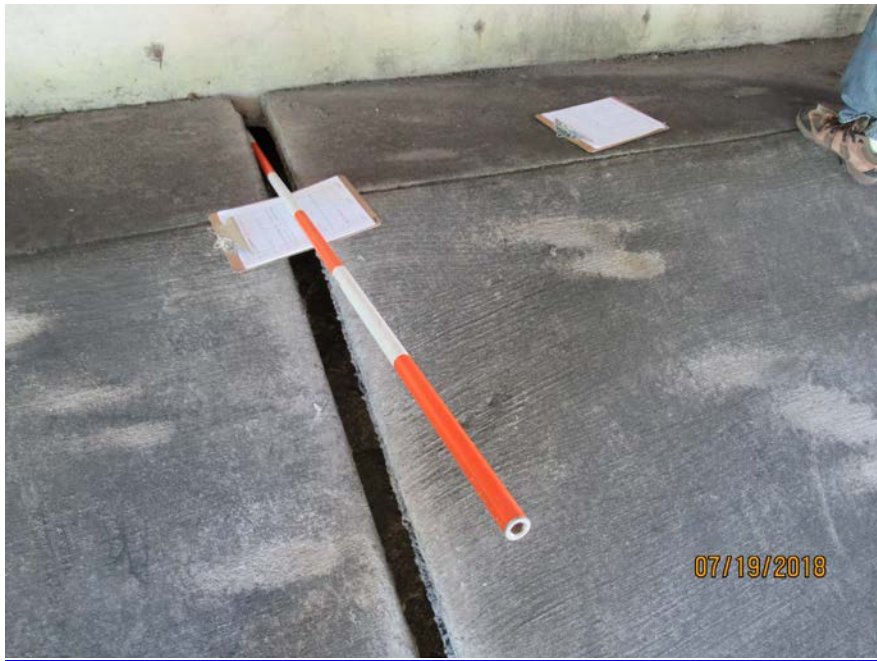
UNDERCUTTING - 8' ROD TO RESISTANCE - ABUTMENT 2

| | Rating | Comments |
|---|---|---|
| Embankment | G-F | <i>Abutment 2 - Undercutting.</i> |

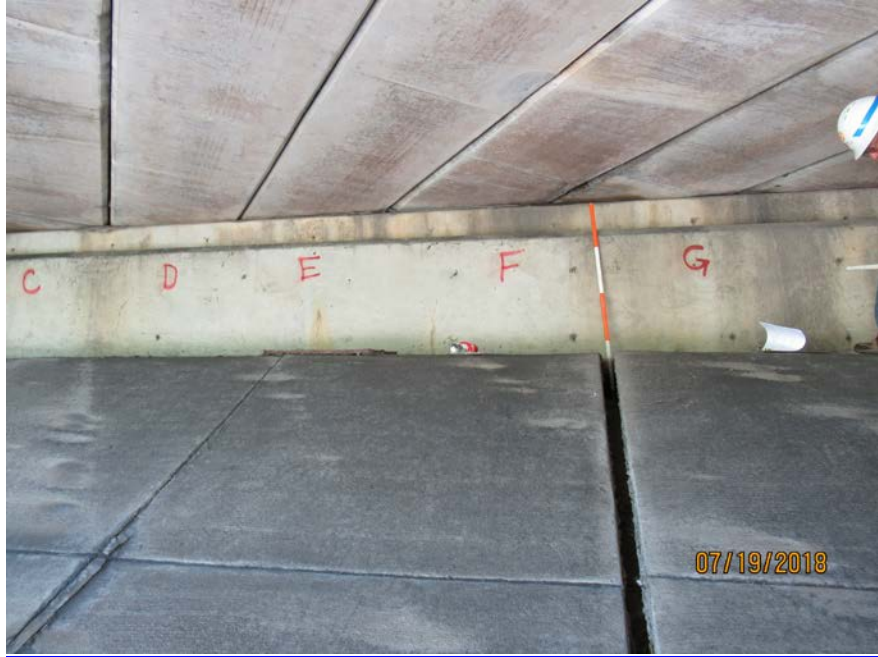
UNDERCUTTING - 4' ROD - TO RESISTANCE – ABUTMENT 2
