Fracture Investigation Memphis, Tennessee

**FINAL REPORT** October 7, 2021 WJE No. 2021.3178.1

The 3.3-mile long I-40 Hernando deSoto Bridge crossing the Mississippi River was closed May 11, 2021 after inspectors performing a routine inspection identified a partial fracture in a tension member that supports one of two tied-arch truss spans. The fracture occurred at a welded plate transition in the upstream (north), box-shaped tension tie member (Figure 1). The six-lane bridge was subsequently closed to traffic.

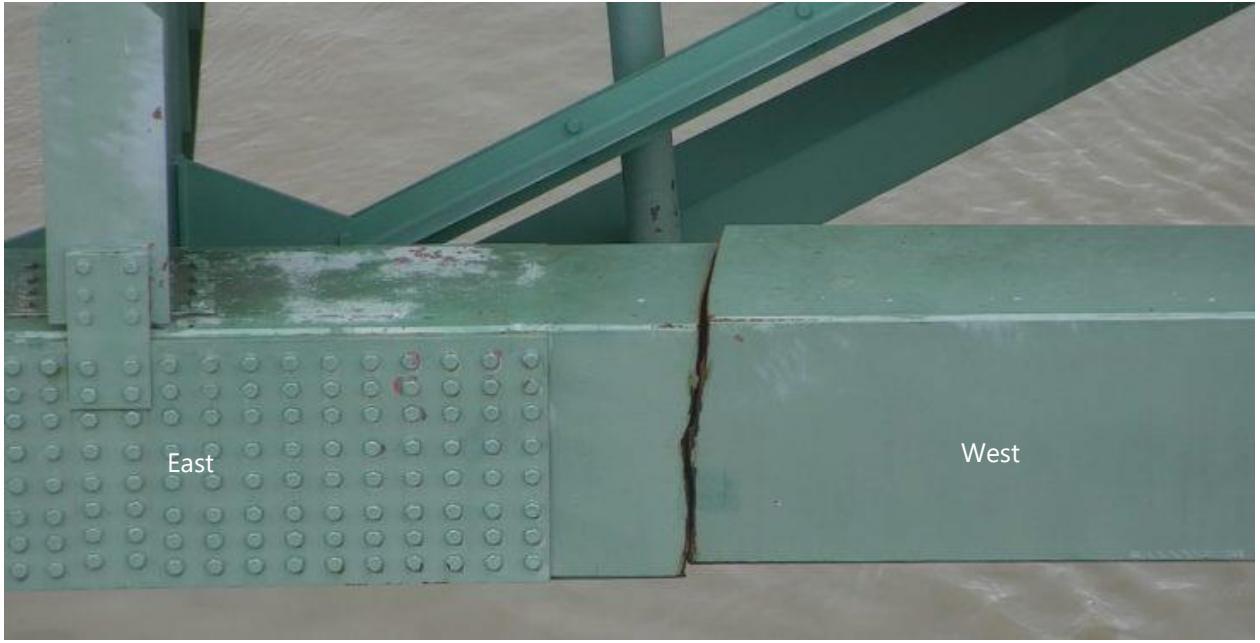
Figure 1. Annotated photo of partial tie girder fracture identified in May 2021 (photo courtesy of TDOT).

On May 11, 2021, while performing an inspection of the bridge hanger cables, bridge inspectors from Michael Baker International (MBI) observed a partial fracture of the tie girder just west of T22 at the welded splice in the north tie of Span B (NB222W). Figure 7 show views of the tie fracture. The bridge was subsequently closed to traffic.

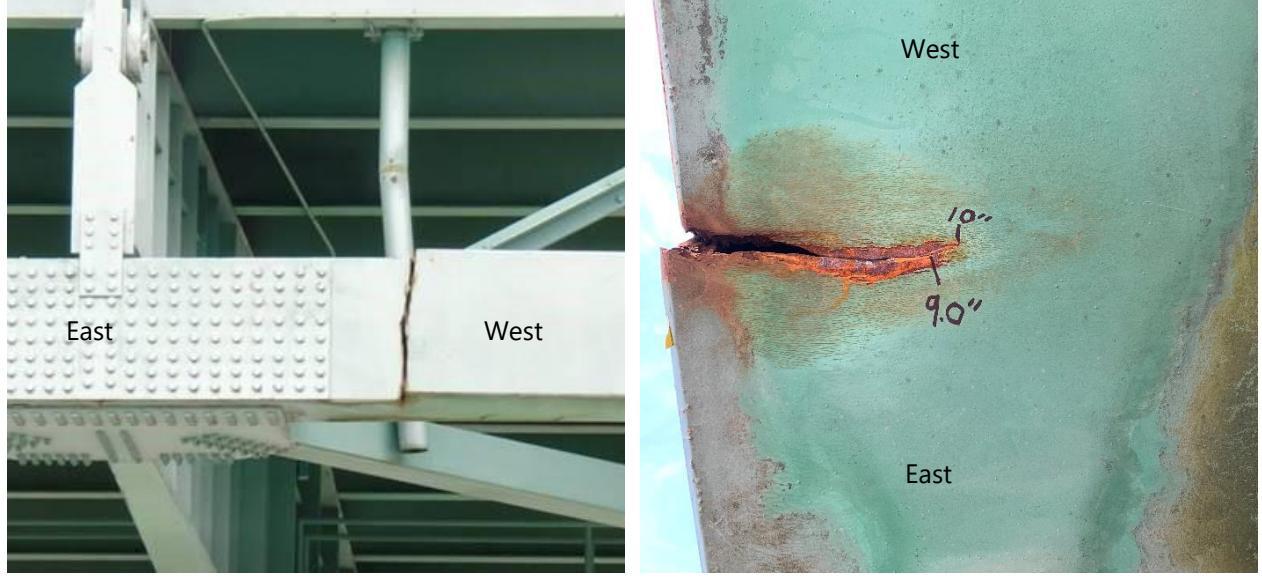
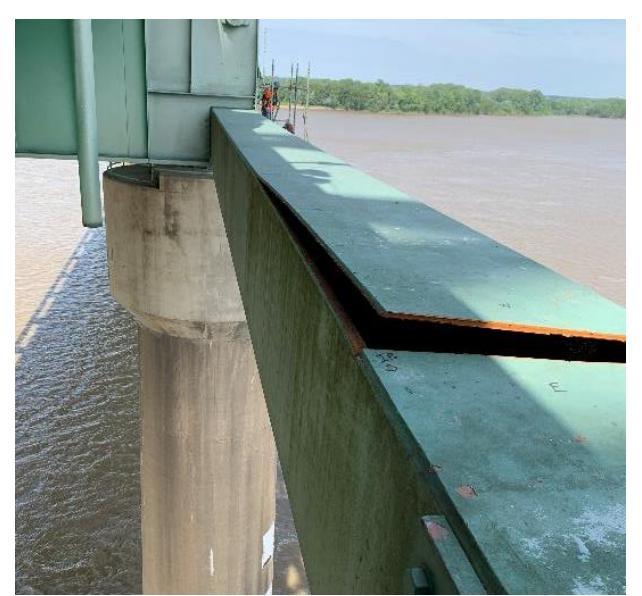
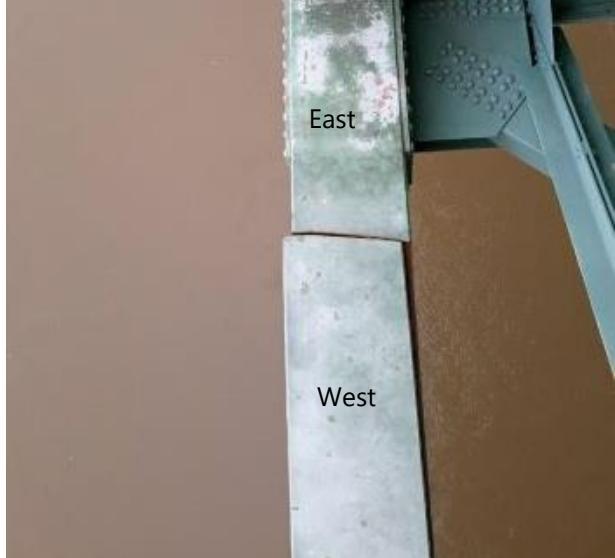
a. Fractured outboard tie plate (photo courtesy of TDOT). b. Partially fractured bottom cover plate. Figure 7. Annotated photos of partial tie girder fracture identified in May 2021.

c. Cracked longitudinal fillet weld connecting top plate to d. Fractured top cover plate (photo courtesy of TDOT). inboard side plate (view looking west). Figure 7 cont. Partial tie girder fracture identified in May 2021.

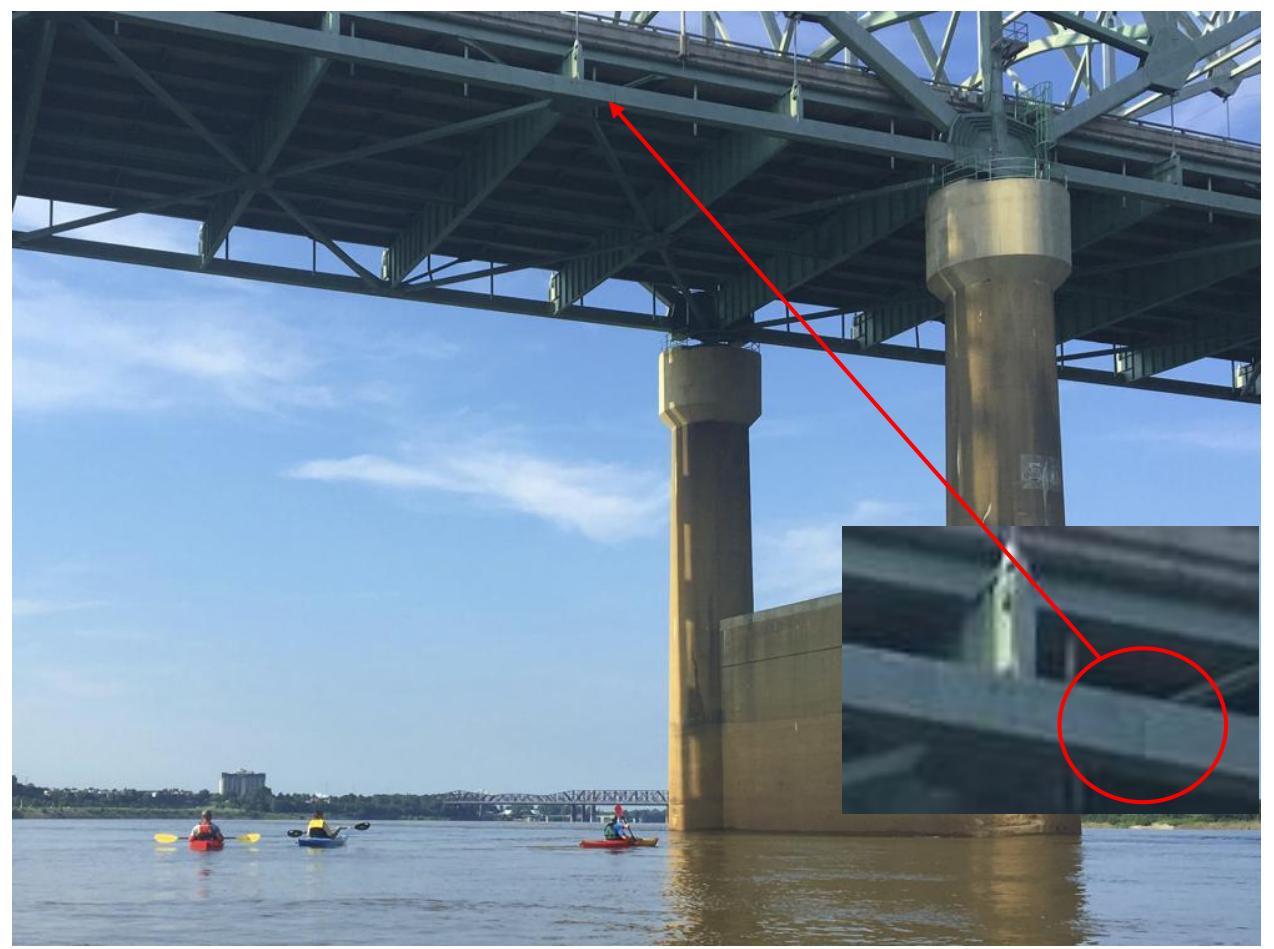
A photo taken by a kayaker in 2016 appears to show a crack-like indication from afar (Figure 9) at this same location.

Figure 9. 2016 crack-like indication in tie girder (photo from Barry W. Moore via AP).

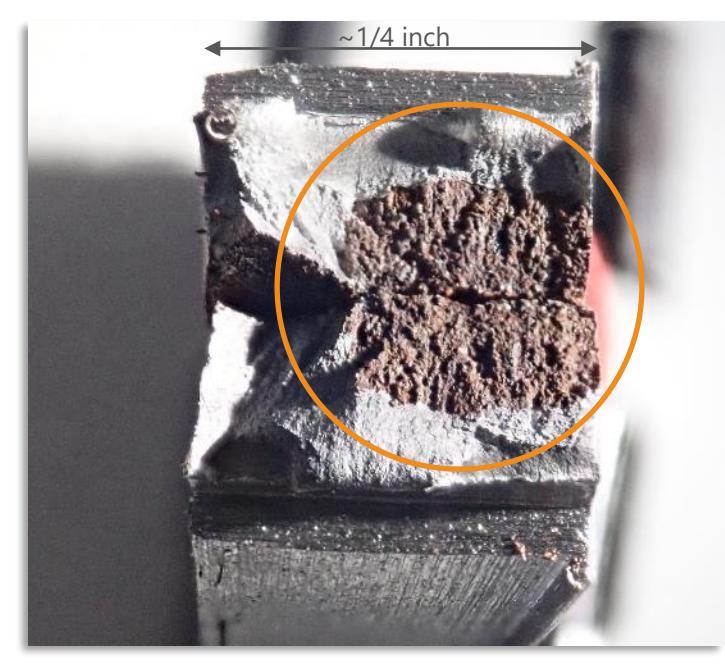
In 1982, an ultrasonic testing (UT) program was undertaken by TDOT to examine groove welds in the bridge. The reason for the inspection is not known nor is the scope of the project. Inspection records provided by HNTB show that a non-rejectable defect was found in the NB222W weld and recorded in the UT examination record (Figure 10). The defect was located 23 inches from the bottom of the side plate and 1 3/4 inches from the weld centerline. The one-inch long defect was characterized as slag.

After removal of the fractured pieces from the bridge, WJE was able to also identify this same defect using phased array ultrasonic test methods (PAUT). Subsequent sectioning of that location identified a shallow interior surface-breaking crack. The crack surface was opened as shown in Figure 11, revealing a 3/32-inch deep by 5/32-inch long crack.

Figure 11. 1982-identified defect (circled) after crack surfaces revealed.

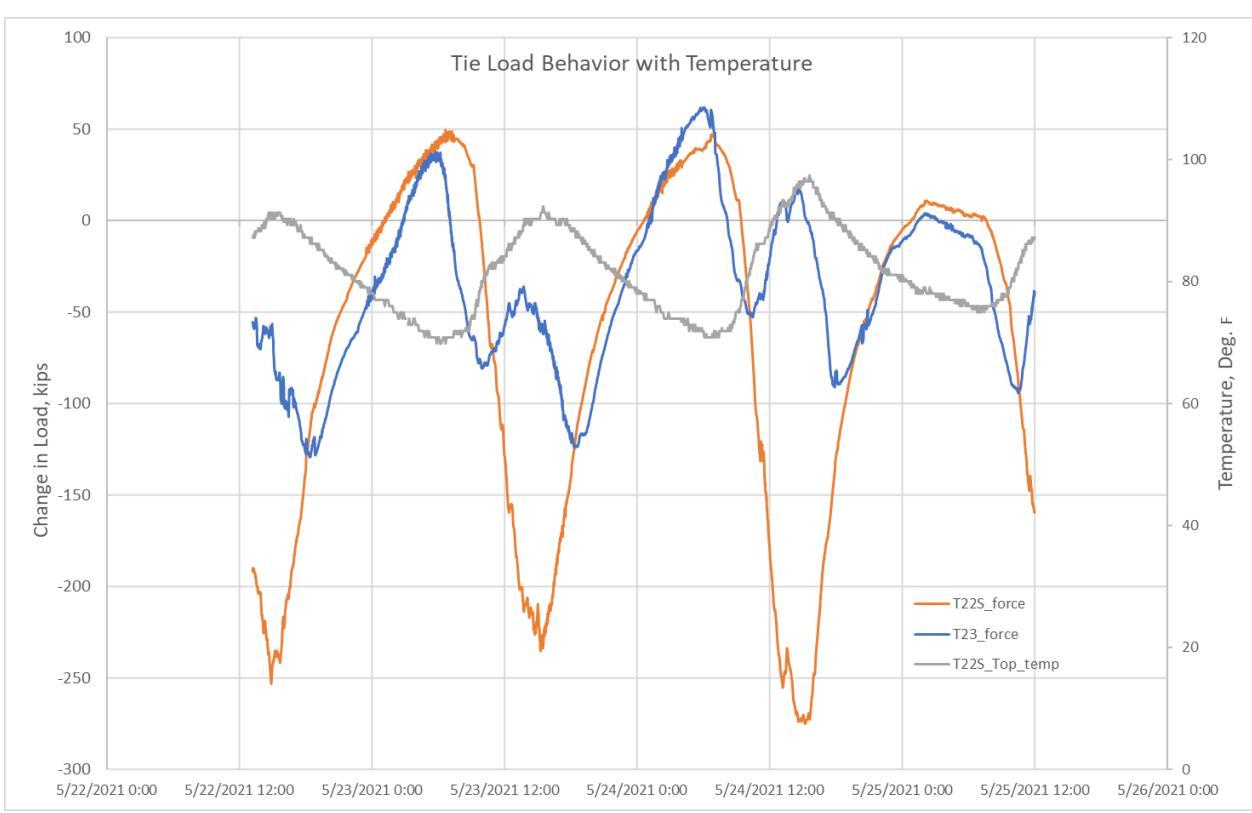
As part of the repair operations, WJE was engaged to install instrumentation on the bridge to monitor the structure's behavior. Strain gages were installed on the upstream (north) and downstream (south) tie girders to monitor changes in load. Prior to installation of the permanent tie girders repairs, data were collected, a portion of which is presented in Figure 12.

Figure 12. Change in load of north (blue) and south (orange) tie girders with changes in temperature (grey).

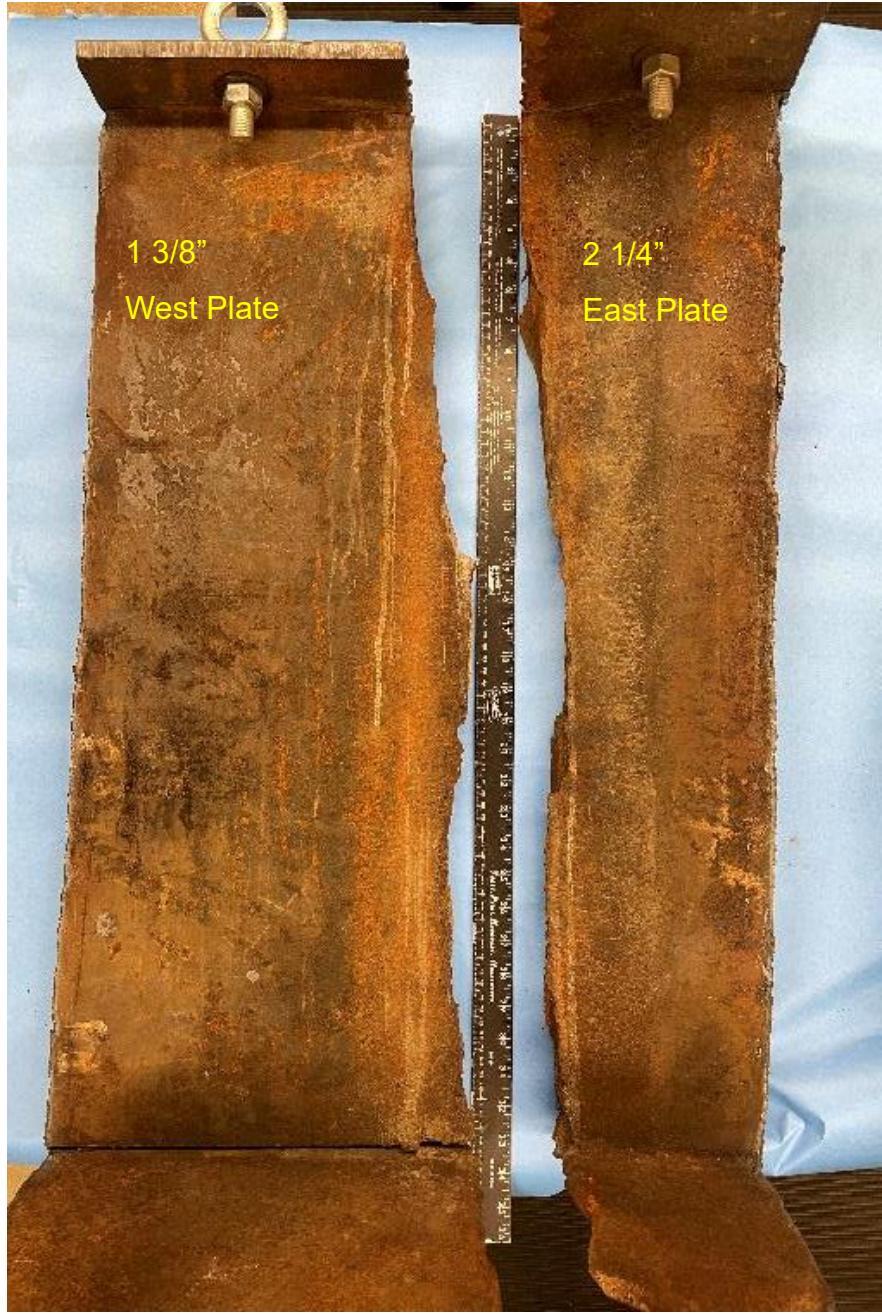
Figure 17 shows the two as-received east and west mating fracture surfaces from location NB222W. The photograph was taken prior to any cleaning or sectioning. Most of the fracture had occurred near the fusion line between the weld metal and the thinner 1 3/8-inch side plate on the west side of the fracture.

Figure 17. As-received sample from the fracture at NB222W for laboratory analysis.

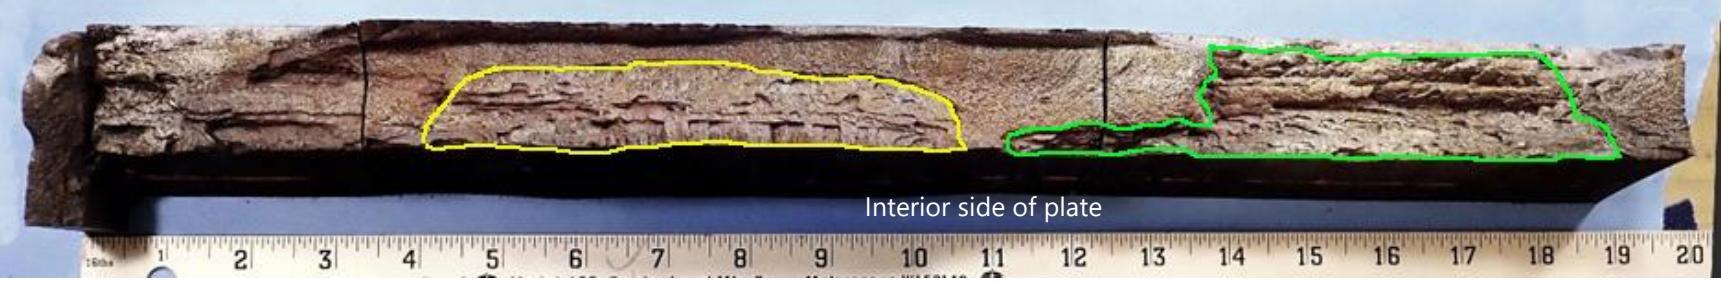
Two regions in the samples exhibited markedly different macrotopography from the rest of the main fracture surfaces and are noted in Figure 20 and Figure 21 as Primary Preexisting Crack and Secondary Preexisting Crack. The former had a maximum depth of about 1 1/16 inch and a length of 6 3/4-inches. The latter extended nearly 1 5/16-inch through the 1 3/8-inch thickness of the side plate with a length of 8 inches. After ultrasonic cleaning in a solution of Alconox in water at ~100 deg. F for about one hour, enough rust had been removed from the east fracture face to discern essentially all of its macrotopography. Radial lines and chevron patterns emanating from both regions indicated that the region closest to the bottom plate, shown as View A in Figure 21, was the overall fracture origin and therefore the primary preexisting crack.

Figure 20. Lower portion of fracture showing Primary Preexisting Crack Region (yellow) and the Secondary Preexisting Crack Region (green).

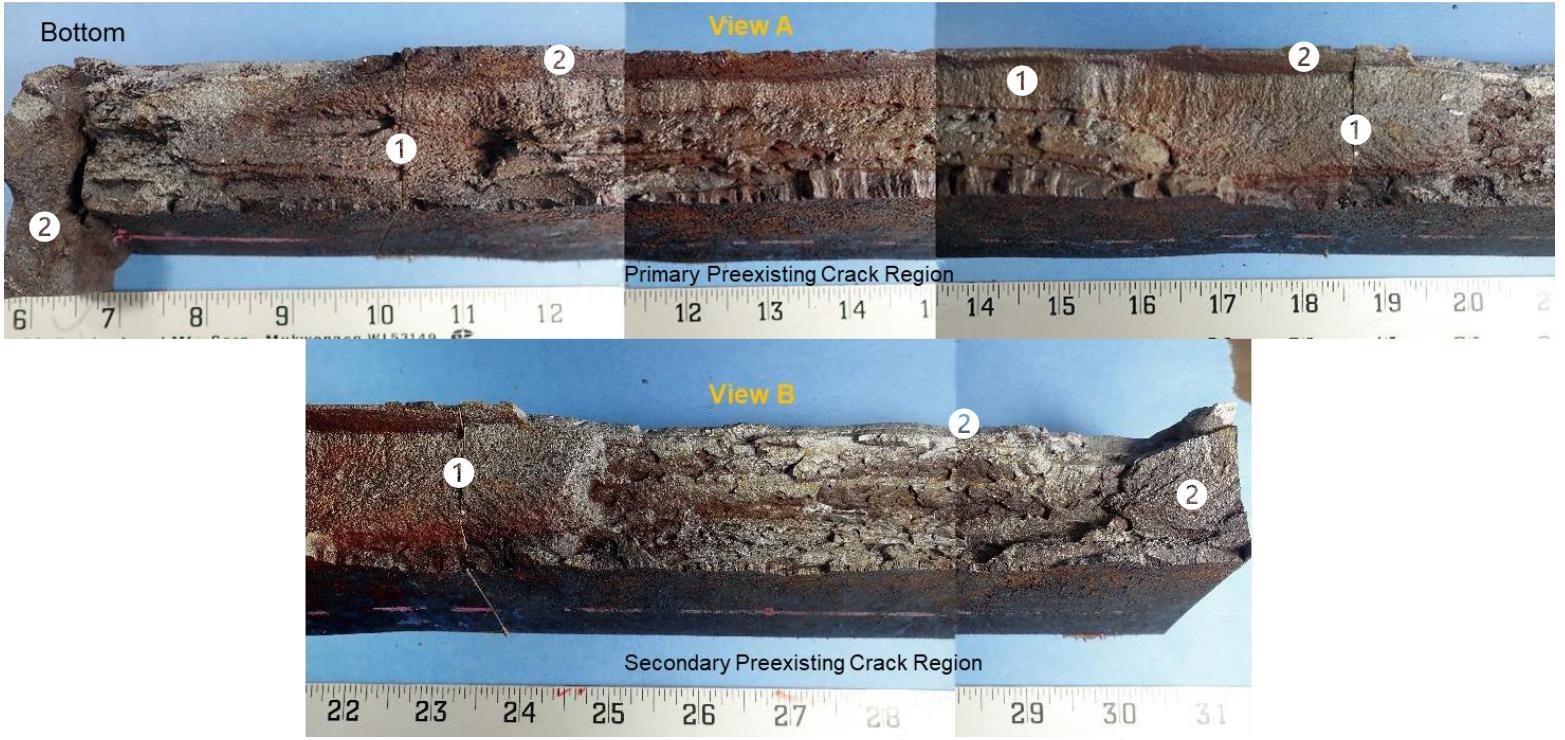
The initial unstable fracture ( $\bigcirc$ ) that propagated out of the primary preexisting crack extended in all possible directions: through a portion of the remaining plate thickness toward the side plate's exterior surface; downward toward the bottom plate, where it arrested at the bottom plate fillet welds; and upward toward the top plate, where it was arrested by the secondary preexisting crack (Figure 21, View B). In the through-thickness direction, the initial fracture was arrested before it reached the external (outboard) surface of the side plate, leaving an intact ligament  $\sim$ 3/16 thick (Figure 21). In the upward direction, the arrest of the initial fracture within the secondary preexisting crack apparently did not rupture the  $\sim$ 1/8-inch-thick ligament that remained between the outer tip of the secondary preexisting crack and the exterior (outboard) surface of the side plate (Figure 21).

The upper tip of the upper, secondary preexisting crack exhibited a second fracture initiation site (Figure 21), from which a fracture (2) extended upward for approximately 8 inches, then rearrested in the 1 3/8-inch plate material. This transient fracture event appears to have caused the tensile-shear rupture of

Figure 21. Higher magnification of the two preexisting crack regions after cleaning (1) first fracture and 2) second fracture).

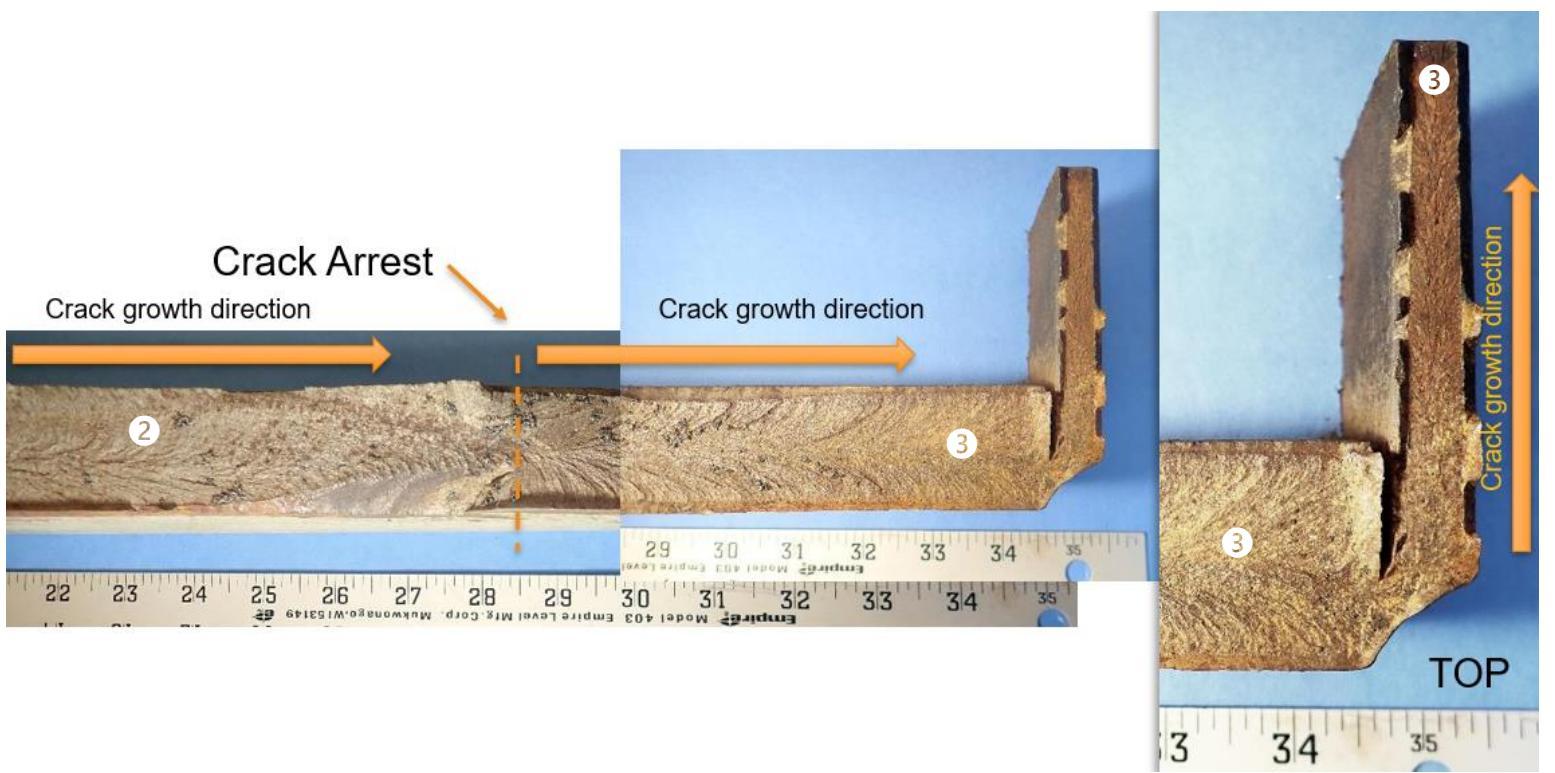
A third fracture initiation (3) resulted in yet another fracture that separated the remaining 6 1/2 inches of the side plate's height and continued into the top cover plate (Figure 22). Careful examination of the entire length and width of the preexisting cracks and fracture surfaces associated with NB222W produced no evidence of fatigue crack growth.

Figure 22. Top section of the crack in the west fracture. The orange arrows indicate the direction of crack growth (2) second fracture and (3) third fracture).

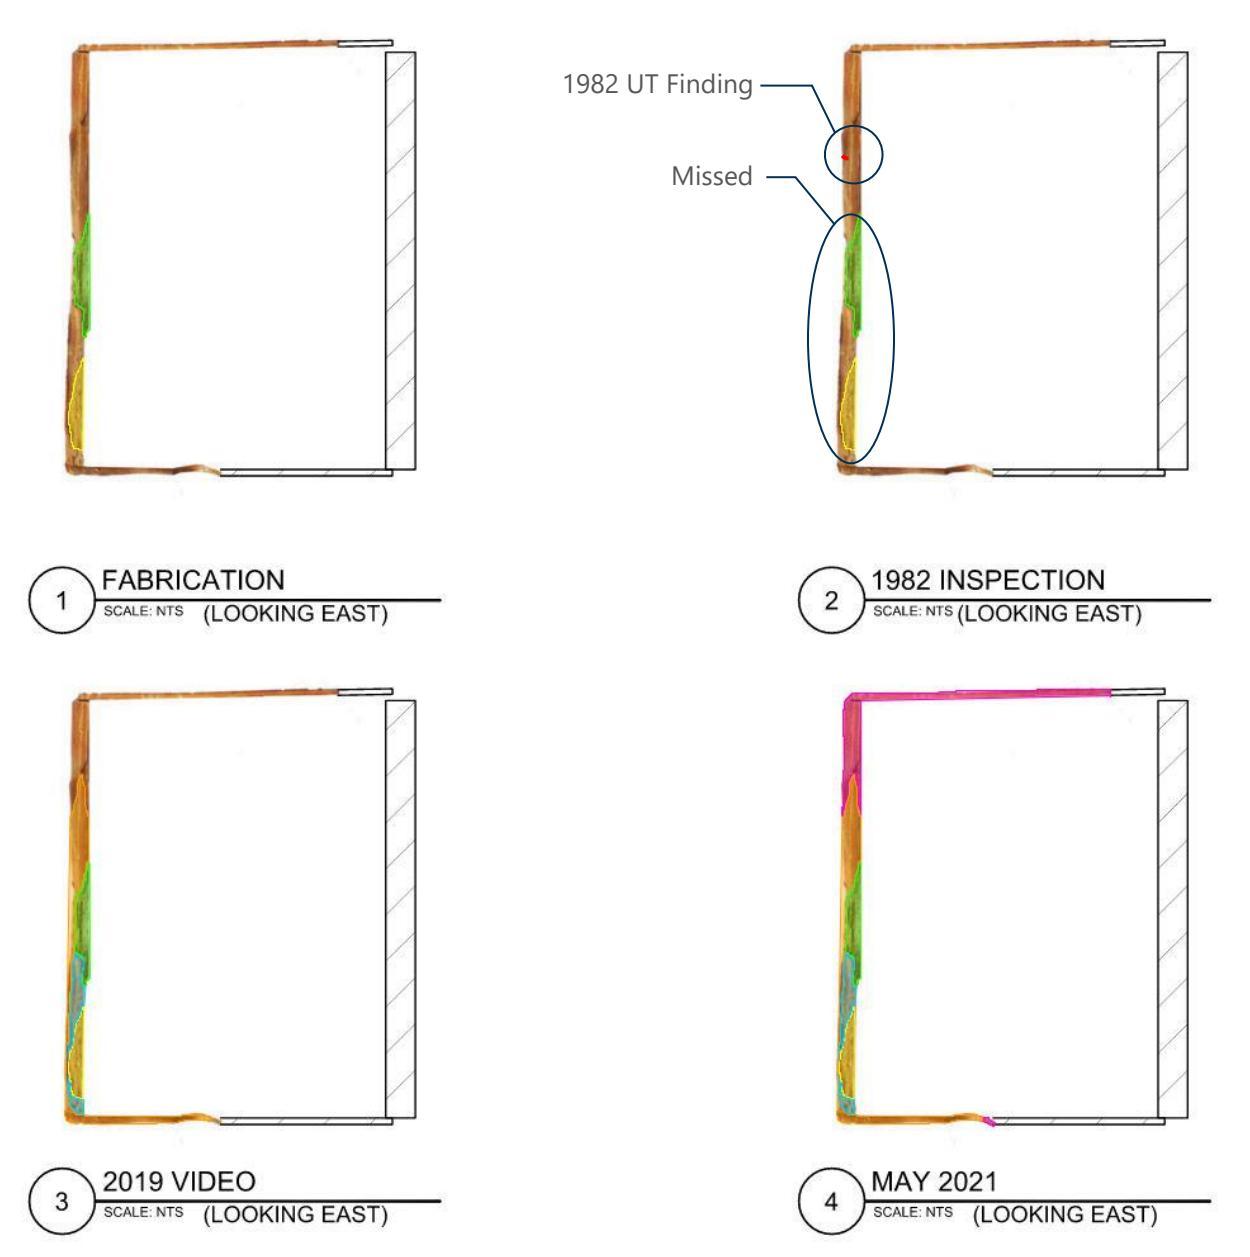
A summary of the fracture propagation through the tie girder cross section is shown in Figure 23. The yellow and green represent the initial preexisting cracks. The colors blue (1), orange (2), and magenta (3) represent the first, second, and third unstable fracture growth, respectively.

Figure 23. Postulated progression of fracture through tie girder cross section. Initial hydrogen cracks (yellow and green). First fracture (blue). Second fracture (orange). Third fracture (magenta).

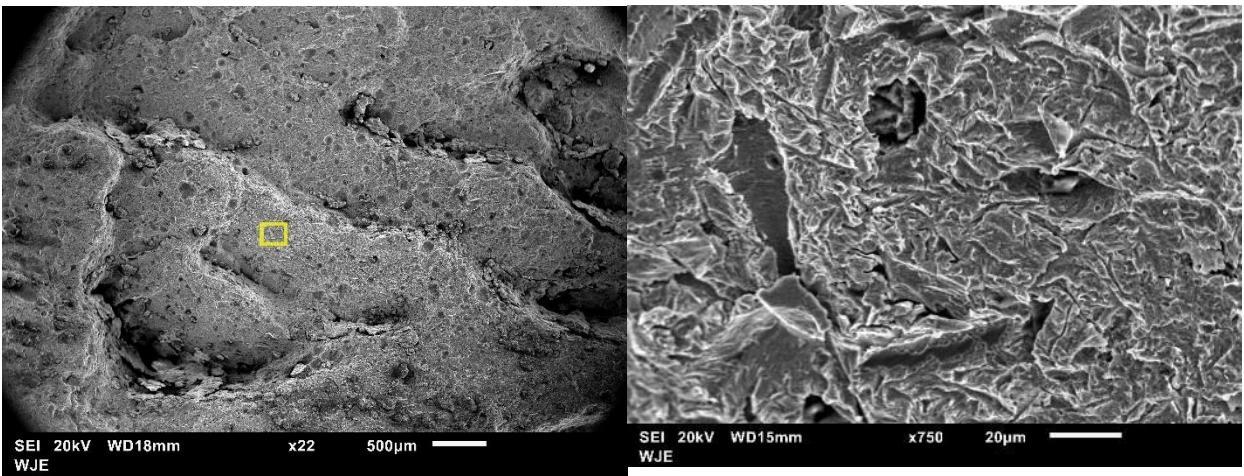
Examination of the fracture surfaces by scanning electron microscopy (SEM) began with the secondary (upper) preexisting crack on the east fracture face since it had been less corroded than the primary (lower) preexisting crack. Although the entire surface was found to be somewhat damaged by sandblast overspray and corrosion, a careful survey of the secondary preexisting crack region like that shown in Figure 24 identified several locations consistent with the microtopography produced by transgranular hydrogen cracking (Figure 25). Weld-related hydrogen cracking may be intergranular or transgranular, depending on the microstructure, hydrogen concentration, and state of stress.

Figure 24 Low-magnification (22X) SEM image of secondary preexisting crack.

Figure 25. More highly magnified (750X) SEM image obtained from region inside box shown in Figure 24.

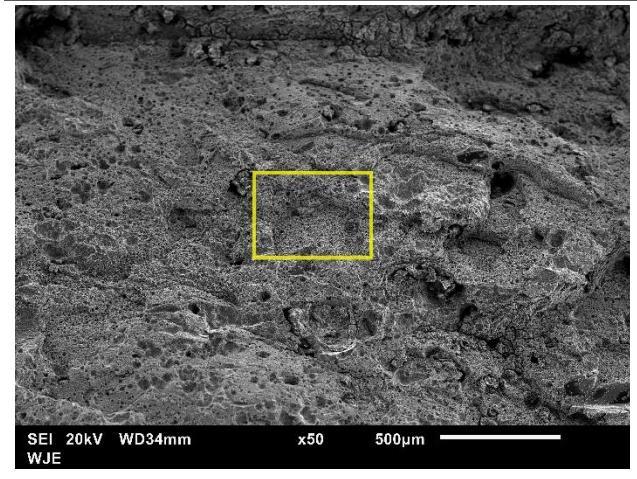
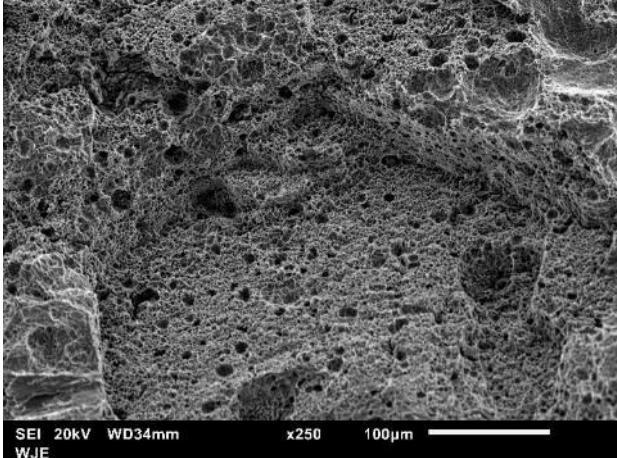
The surface of the primary (lower) preexisting crack (Figure 26) was found to be more extensively damaged by post-failure corrosion, as typified by the pitted microtopography shown in Figure 27. However, a careful search provided fractographic clues at two separate locations within the area shown in Figure 28, just beneath the inside surface of the side plate. As interpreted within the context of the overall macrotopography, the microtopography at these locations indicated plateaus of intergranular hydrogen cracking in columnar-grained weld metal, connected to each other by ductile tearing (Figure 29 and Figure 30).

Figure 26. Low-magnification (50X) SEM image of primary preexisting crack.

Figure 27. More highly magnified (250X) SEM image obtained from region inside box shown in Figure 26.

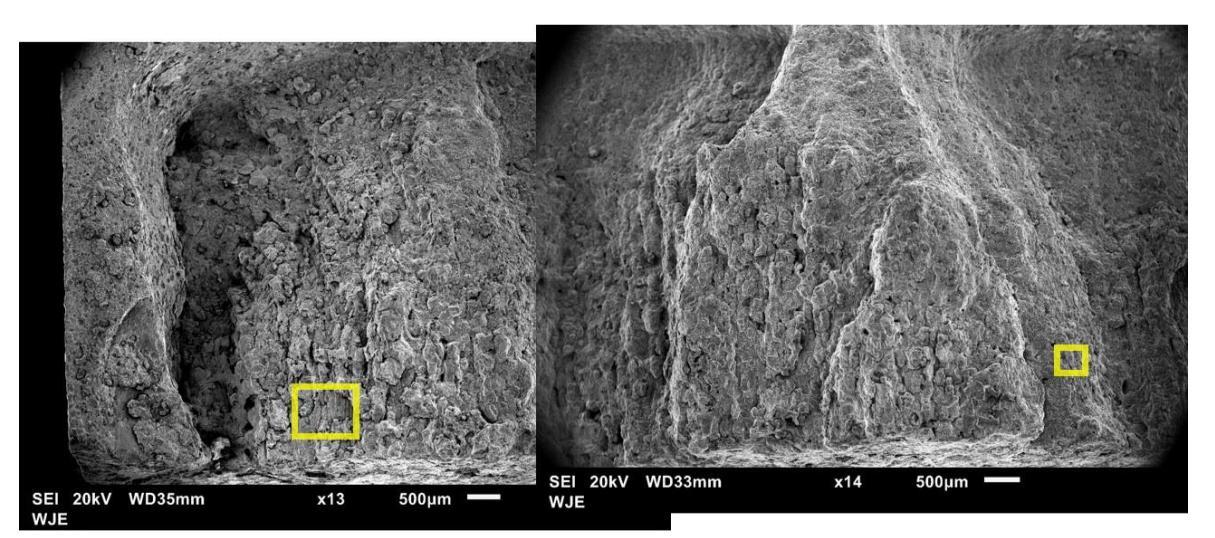
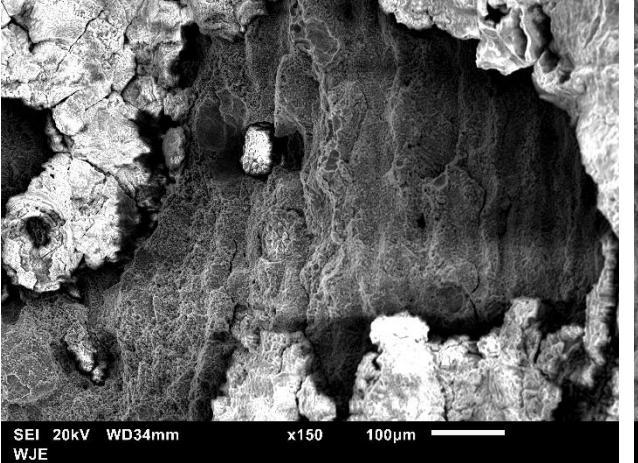
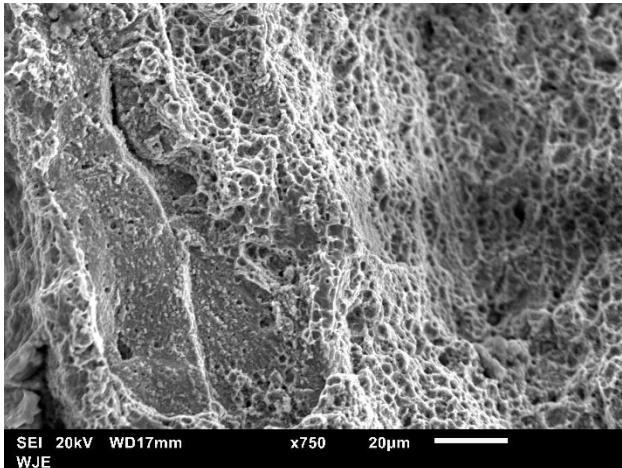
Figure 28. Low-magnification (13X and 14X) SEM images of primary preexisting crack. Internal surface of side plate is visible along bottom.

Figure 29. More highly magnified (150X) SEM image obtained left box within Figure 28

Figure 30. More highly magnified (750X SEM image obtained from right box within Figure 28.

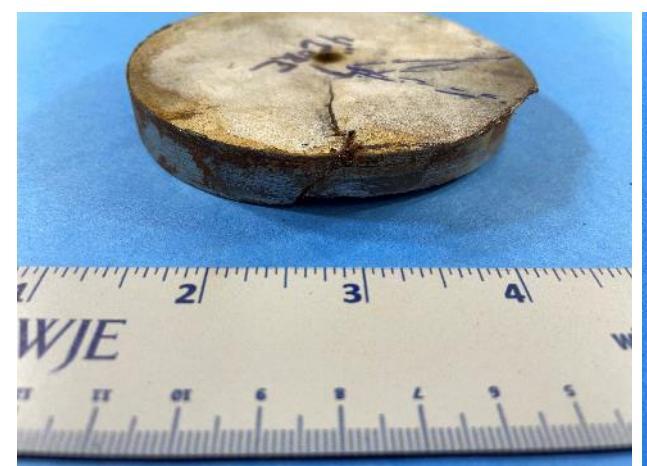
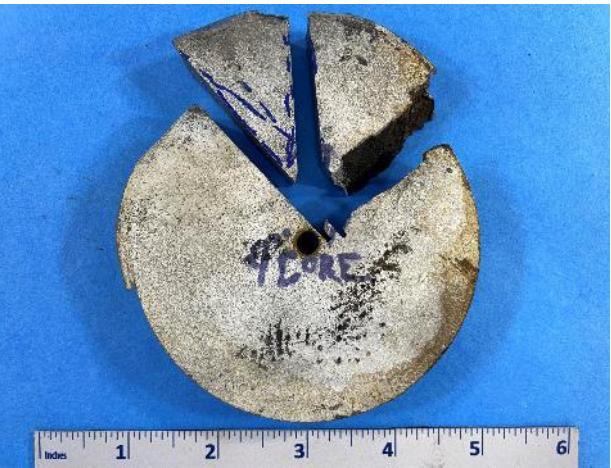
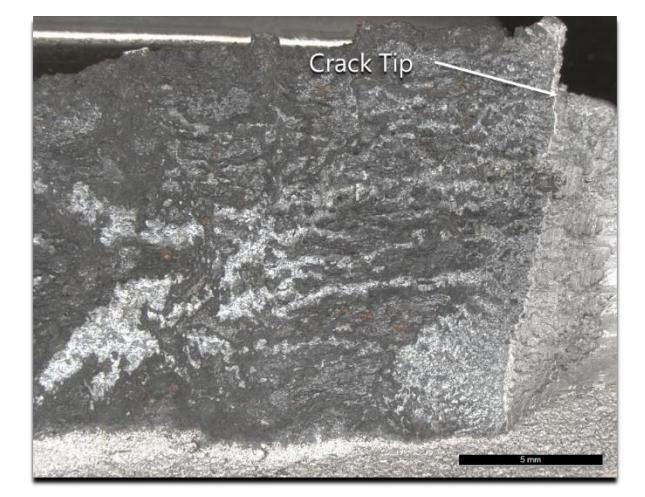
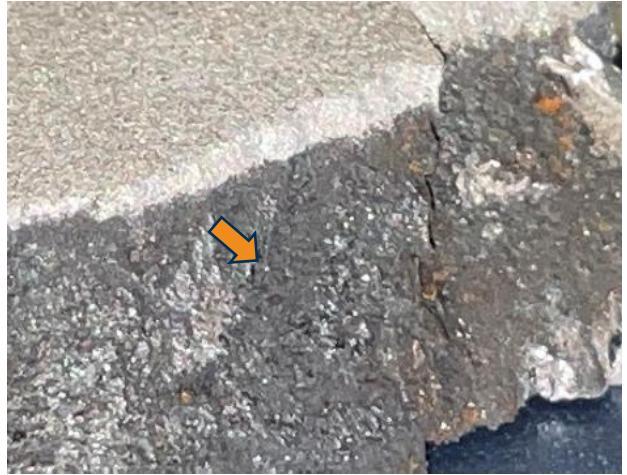
A core sample was taken from the arrested crack tip in the bottom cover plate in preparation to remove the two fracture surfaces from the tie girder. Photographs of the core sample are shown in Figure 31 and Figure 32. A small pie wedge shape was removed from the core and broken open to observe the crack tip at higher magnifications, which revealed shear fracture driven by tension. The exposed crack tip is shown in Figure 33. No evidence of fatigue was observed. Figure 34 depicts a prior arrest mark on the exposed surface.

Figure 31. Core in the bottom flange plate at the arrested crack tip.

Figure 32. Sectioned core from the arrested crack tip.

Figure 33. Arrested crack tip fracture surface.

Figure 34. Previous arrest mark (arrow away from the crack tip).

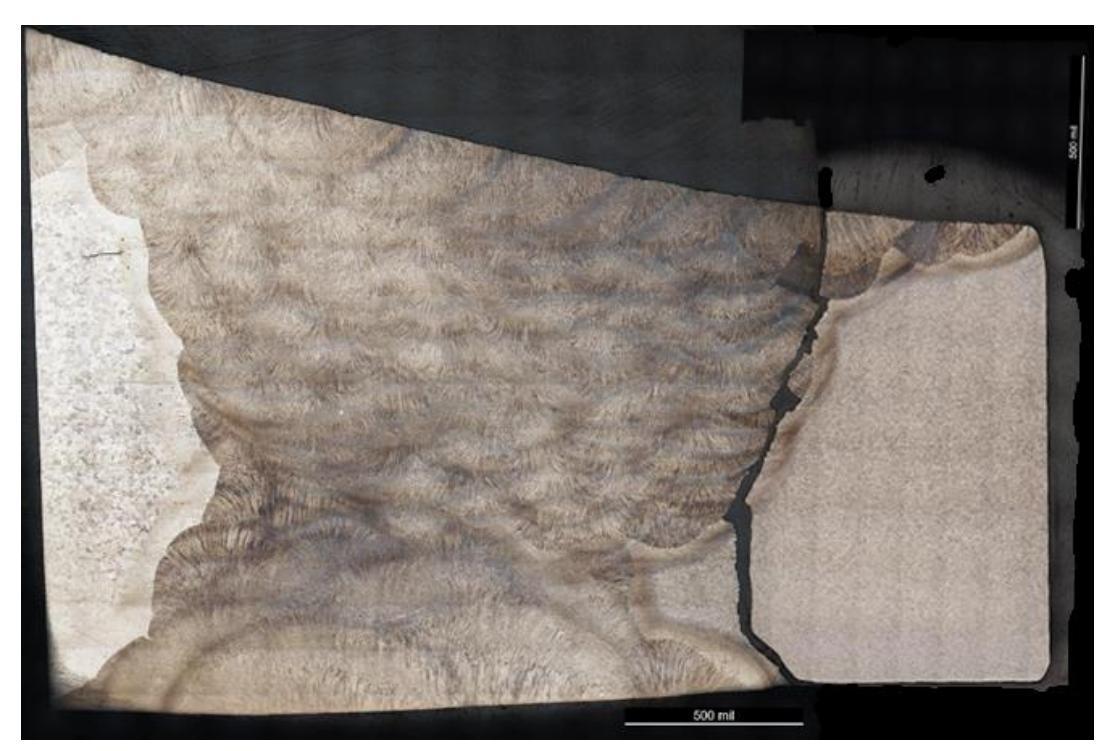
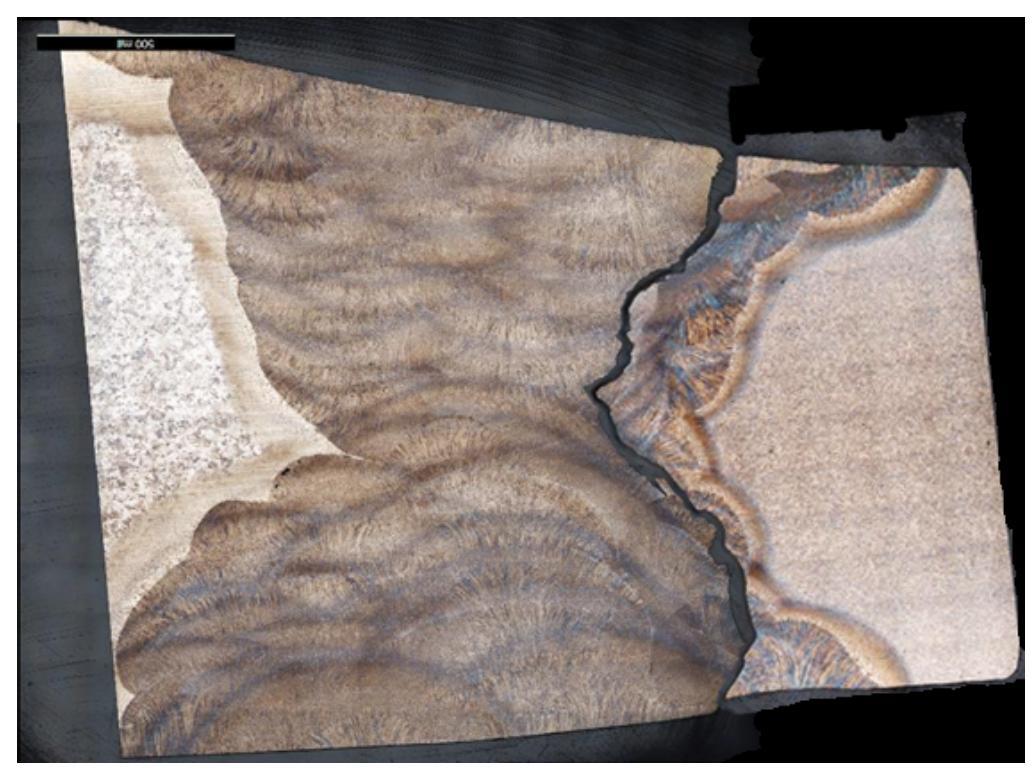
When the two montages of the weld profiles cut from the preexisting crack regions (Figure 36 and Figure 37) were viewed in comparison to the weld region near the top of the fractured side plate or with welds contained in the core samples, the weld profiles from the preexisting crack regions were significantly wider. Figure 39 and Figure 40 show these comparisons. Moreover, the placement of the weld beads differed in that welds shown in Figure 39b and Figure 40a and b indicated the inside bevel weld had been placed first with the two plates laid flat, as shown in the photo, followed by the second bevel weld after the plates were flipped over. In comparison, the welds in the preexisting crack regions showed the inside weld beads having been placed after the outside weld, and the weld bead stacking arrangement appeared to have been misaligned with the root of the weld. This suggested that the two preexisting crack regions were likely weld repairs.

Figure 36. Primary (lower) preexisting crack region shown in a low-magnification montage.

Figure 37. Secondary (upper) preexisting crack region shown in a low-magnification montage.

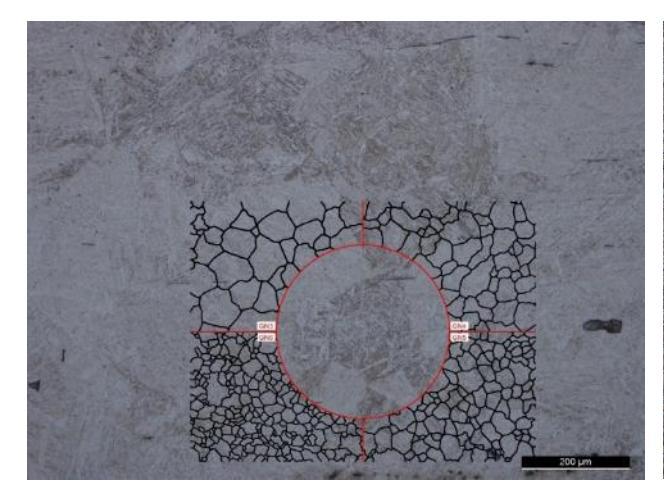
Coarse grains were observed in the base metal of the 2 1/4-inch plate adjacent to the weld fracture. ASTM-A517-69a requires a grain size of 5 or finer for this material. Figure 38a highlights an area in the 2 1/4-inch base metal viewed at a magnification of 100X with a grain size comparator overlayed. The austenite grains are coarser than an ASTM grain size of 1. Using the core samples removed from other welds in the bridge as comparators, samples of the 2 1/4-inch plate were examined and found to have average grain sizes much finer and meeting the ASTM specifications. Micrographs of three core samples are shown in Figure 38b-d.

a. Large grain size in fractured plate.

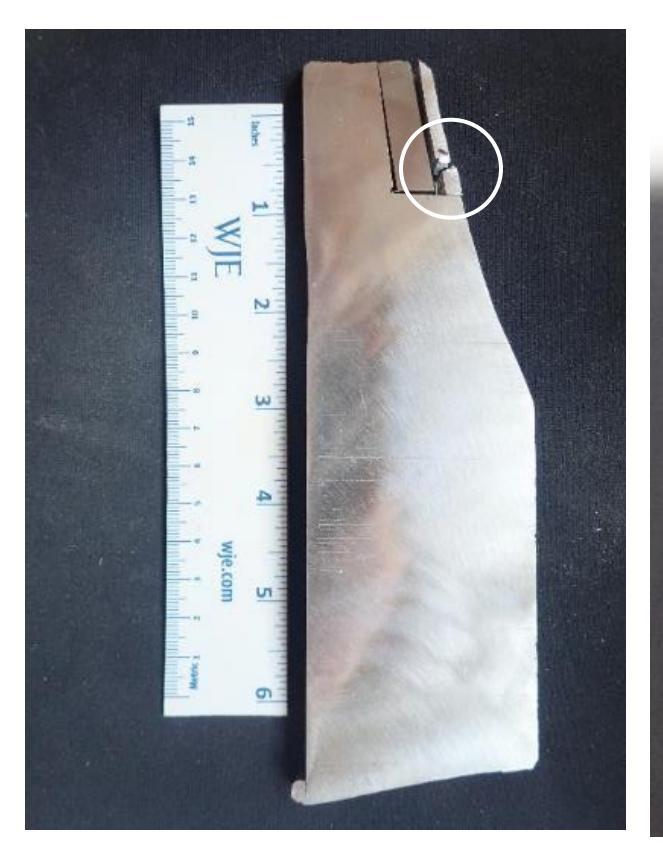
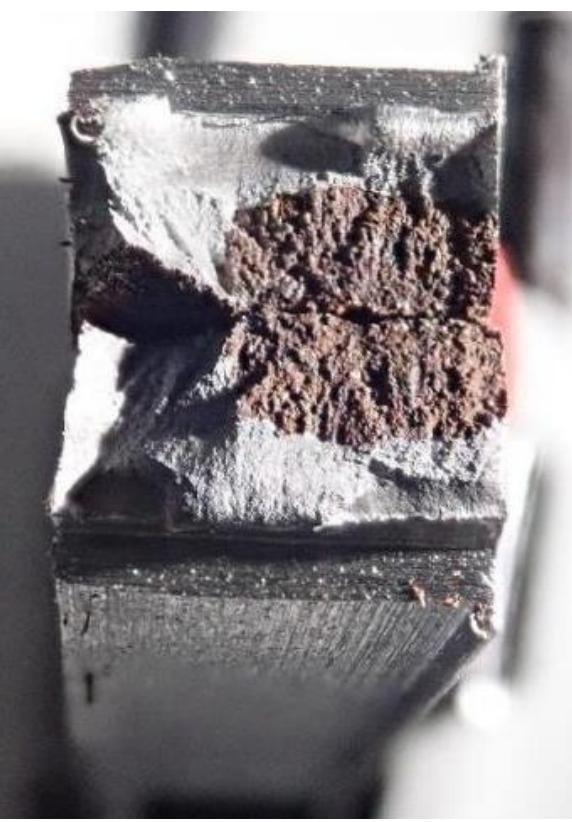
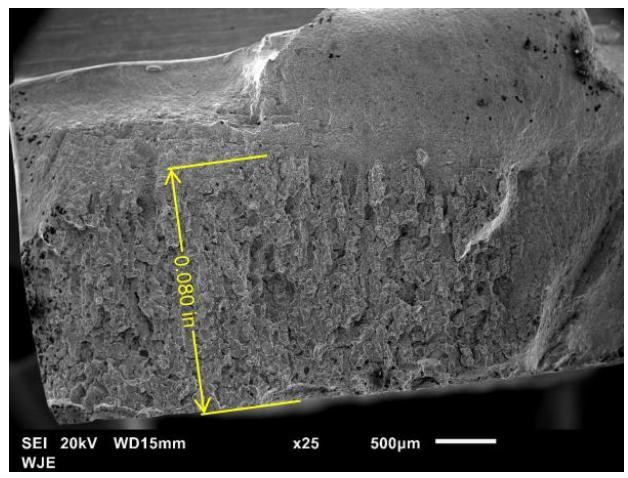
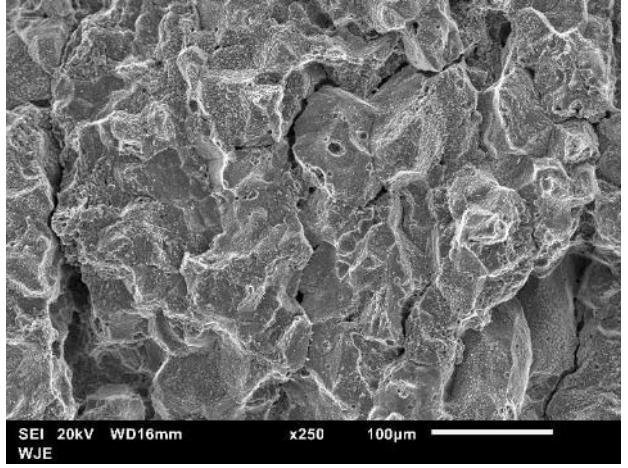
A previously identified flaw in the vicinity of the fracture is shown in Figure 41a. Optical and SEM fractography were performed to evaluate its characteristics. The crack was opened to view the fracture surface (Figure 41b). Surface oxides were present on the fracture surface, which exhibited a typical thumbnail shape. This fracture was further examined in the SEM at magnifications of 25X (Figure 41c) and 250X (Figure 41d). Figure 41d indicates that the fracture mode of the crack was intergranular.

c. SEM micrograph of crack at 25X magnification. Figure 41. 1982 previously identified crack near fracture.

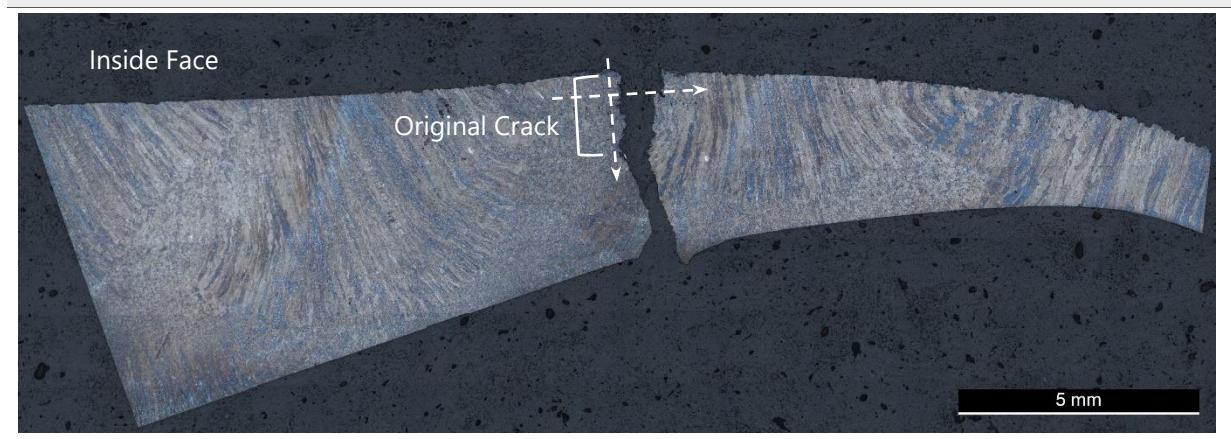
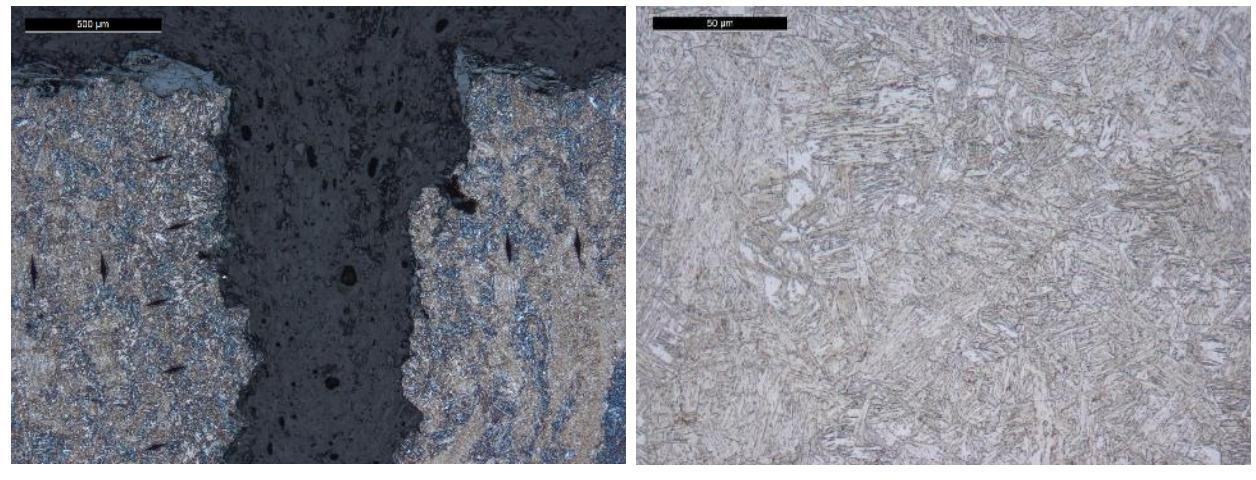
In addition to the 1982 detected flaw, another indication was identified using PAUT by WJE and exposed for metallography. This defect was identified as Indication #4. A montage of this sample is shown in Figure 42. The crack initiated in the weld metal on the bottom surface (relative to the micrograph) and progressed halfway through the sample. Figure 43 provides a closer perspective of the crack tip at 50X magnification. The cracking was predominantly intergranular with limited transgranular cracking. The microstructure of the weld metal is presented at 500X magnification in Figure 44. It is predominantly martensite.

Microhardness readings were taken at Indication #4. Both a vertical and horizontal hardness traverse were performed near the crack. The results are presented in Figure 42. The results exhibited consistent hardness measurements between 360 HV and 385 HV (36.9 HRC to 39.5 HRC).

Figure 42. Microhardness traverse locations (dashed lines )for defect Indication #4.

Figure 43. Micrograph at Indication #4 – 50X magnification.
