Fracture Investigation Memphis, Tennessee

**FINAL REPORT** October 7, 2021 WJE No. 2021.3178.1

The 3.3-mile long I-40 Hernando deSoto Bridge crossing the Mississippi River was closed May 11, 2021 after inspectors performing a routine inspection identified a partial fracture in a tension member that supports one of two tied-arch truss spans. The fracture occurred at a welded plate transition in the upstream (north), box-shaped tension tie member (Figure 1). The six-lane bridge was subsequently closed to traffic.

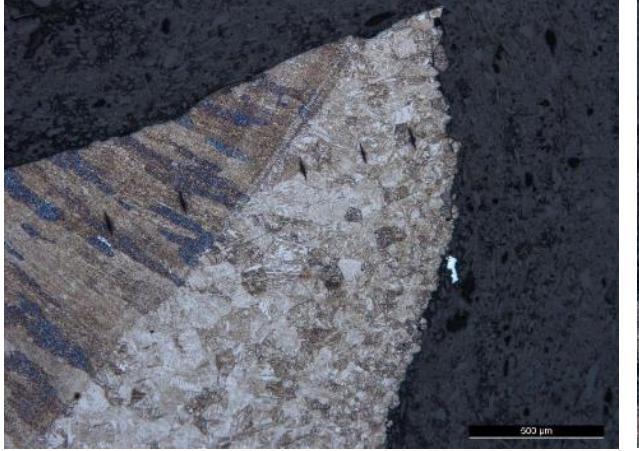
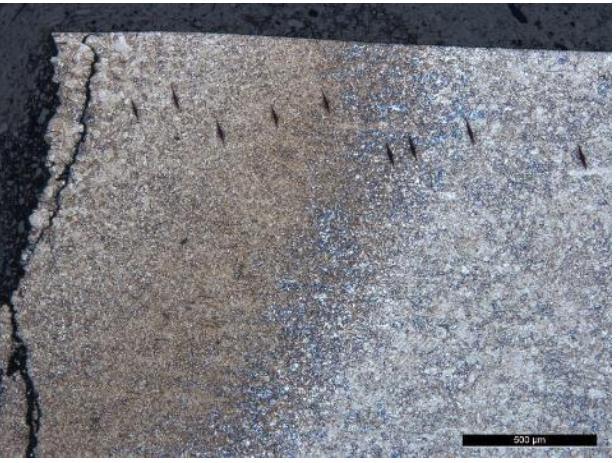
Figure 46 and Figure 47 were captured at 50X magnification near the toe of the weld. The crack exhibited an intergranular path through the GCHAZ and GRHAZ, but had not propagated beyond the ICHAZ. The base metal fracture visible in Figure 45 was caused intentionally in order to separate the crack faces for examination.

Figure 46. Core Sample SA158W on the weld metal side of Figure 47. Core Sample SA158W on the base metal side of the crack – 50X magnification.

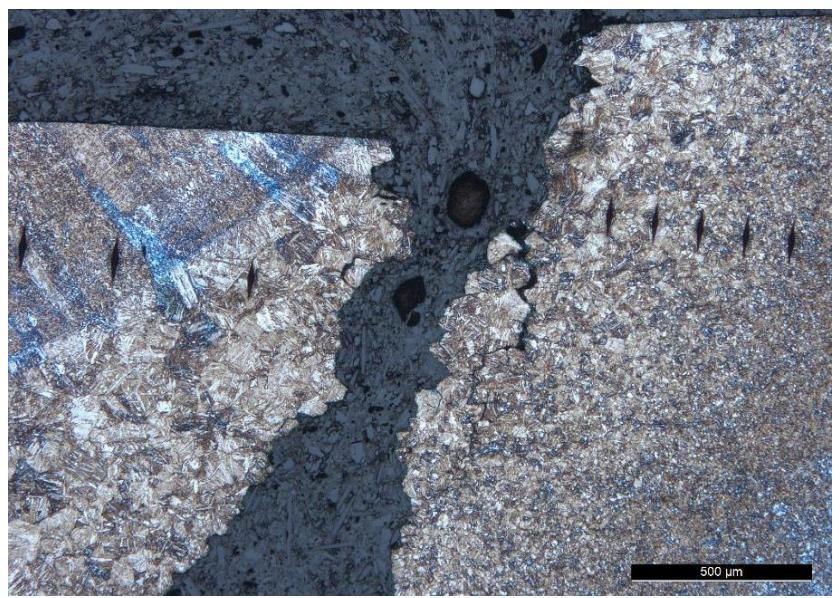
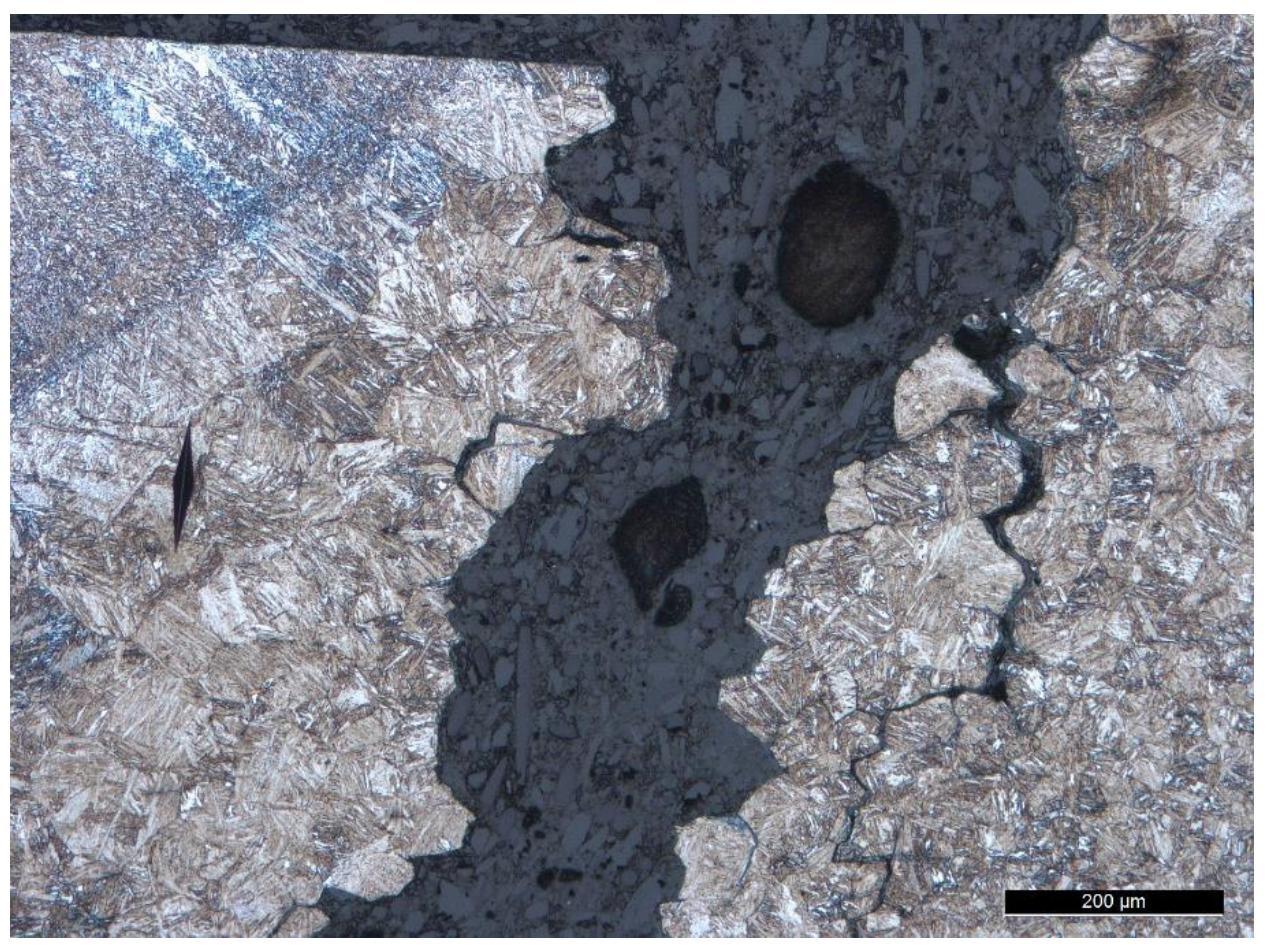
The intergranular path of the crack in Core Sample SA008E is clearly visible in Figure 49 and Figure 50. As in SA158W, it progressed through the GCHAZ and GRHAZ before arresting at the ICHAZ. The base metal fracture visible in Figure 48 was caused intentionally in order to separate the crack faces for examination. At 500X magnification, it was clear that the martensite in the GCHAZ had experienced significantly less tempering (Figure 51) than the base metal (Figure 52).

Figure 49. Core Sample SA008E near crack tip. Knoop hardness indentation marks are shown adjacent to the crack – 50X magnification.

Figure 50. Core Sample SA008E at weld toe. A Knoop hardness indent is shown adjacent to the crack – 100X magnification.

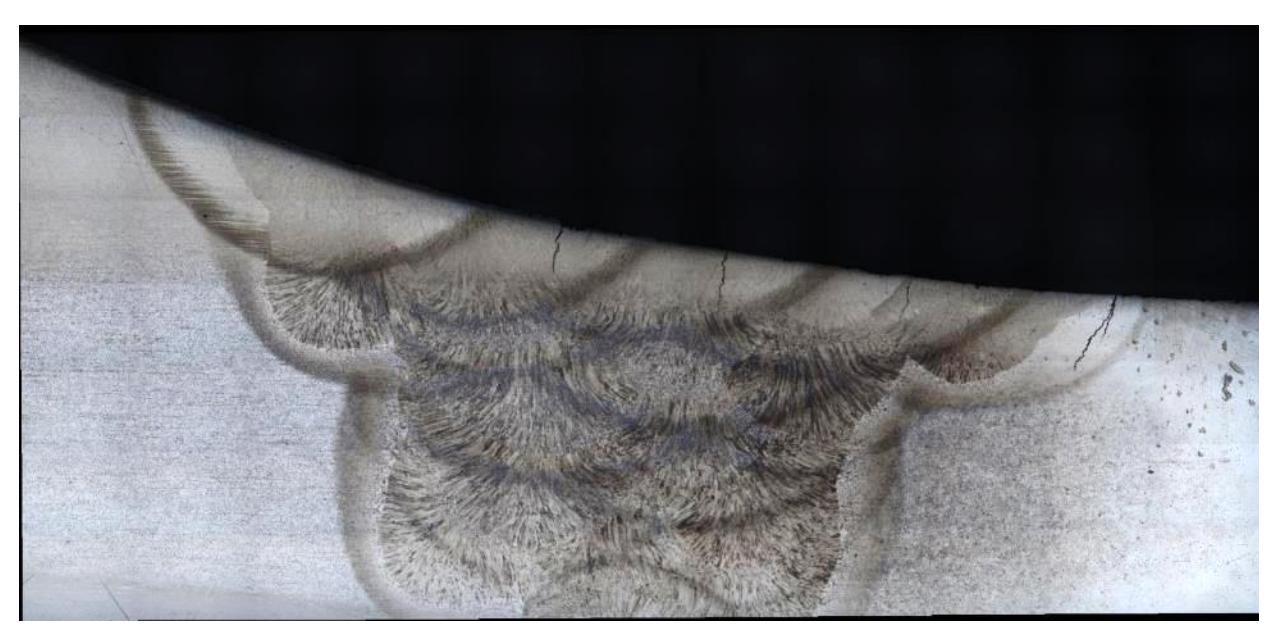
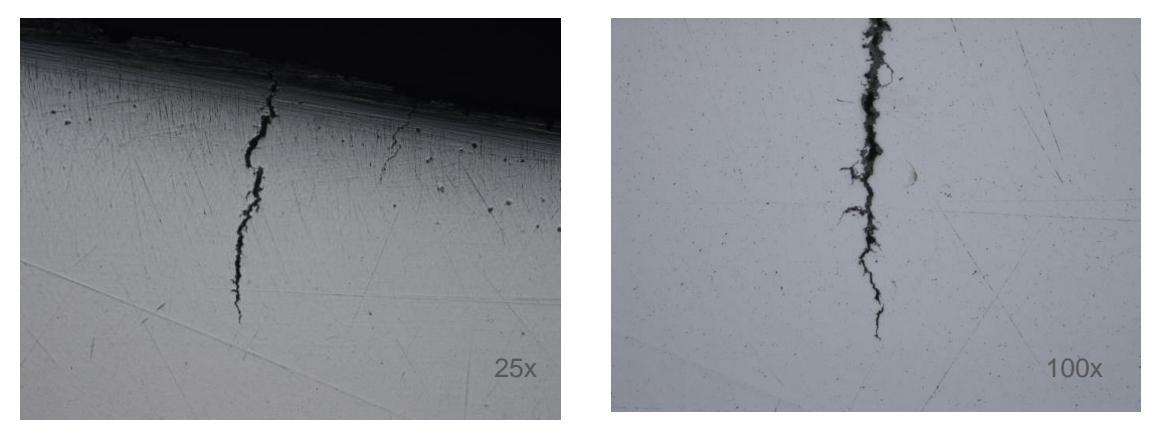
Cracking was observed in the top weld passes in Core Sample SA168W (Figure 54). Higher magnification of the left-most crack from this location is shown in Figure 55.

Figure 54. Cracks in the top weld passes at location SA168W

Figure 55. Higher magnification views of a crack observed in SA168W. Unetched.

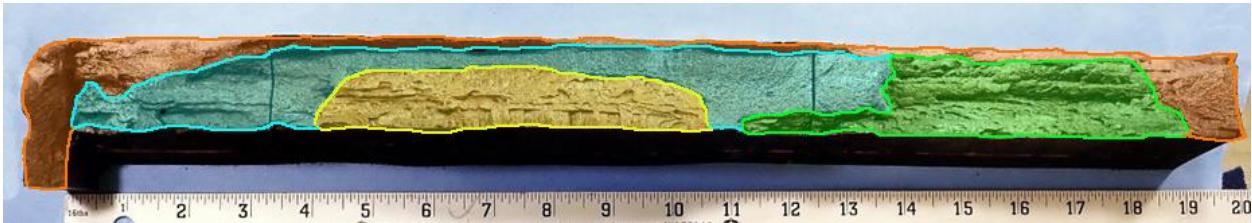
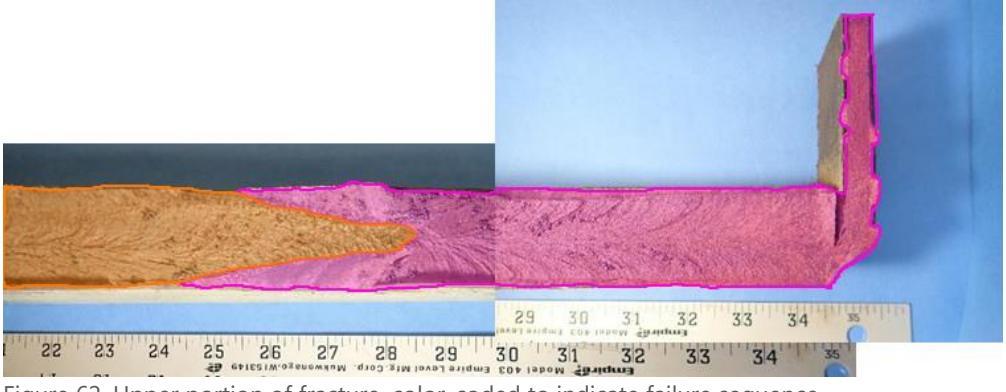
The photographic documentation indicates that at some point after 2019, the crack tip of the arrested second unstable fracture (orange) became unstable, ran upward over the remaining 6 1/2 inches of the side plate's height and continued into the top plate (magenta in Figure 62). It then turned and ran longitudinally along the fillet welded connection between the tie girder top cover plate and the inboard side plate for some distance before it was found in May 2021.

Figure 61. Lower portion of fracture, color-coded to indicate failure sequence.

Figure 62. Upper portion of fracture, color-coded to indicate failure sequence.
