**ECOLOGICAL ASSESSMENT OF  
LAKE ATALANTA  
ROGERS, BENTON COUNTY, ARKANSAS**

**February 7, 2014**

FTN Project No. R04485-0010-001

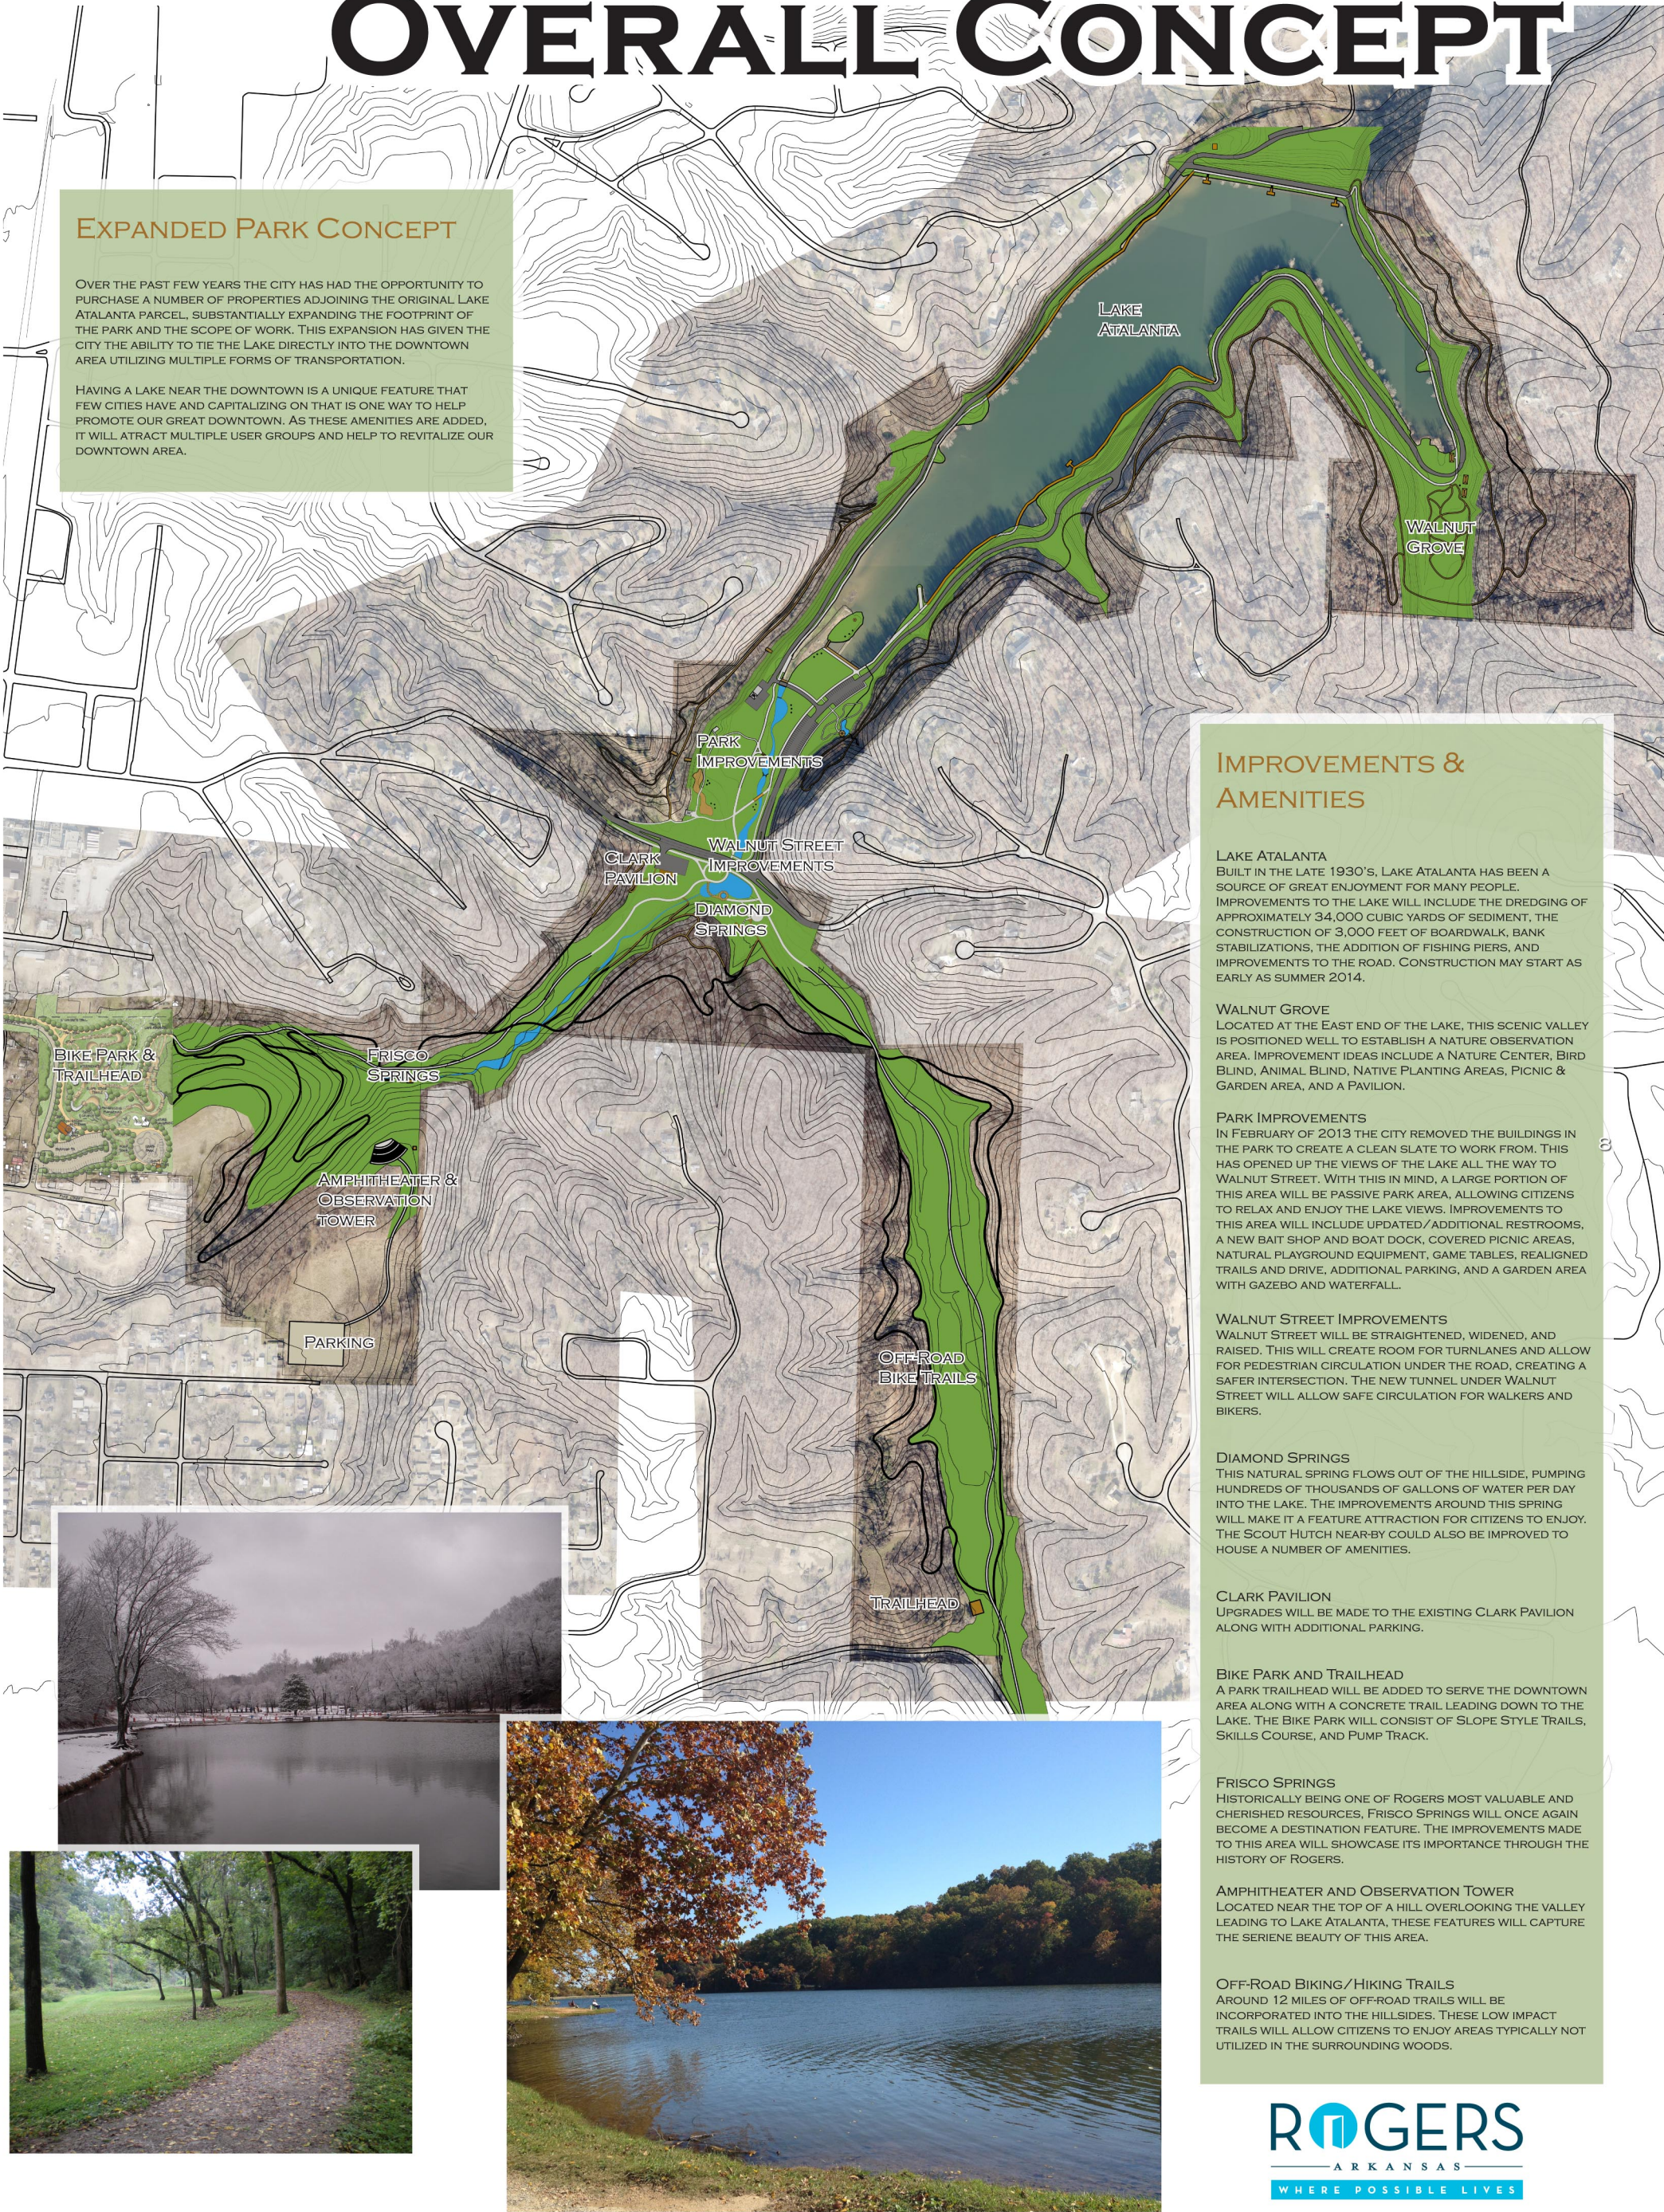
OVER THE PAST FEW YEARS THE CITY HAS HAD THE OPPORTUNITY TO PURCHASE A NUMBER OF PROPERTIES ADJOINING THE ORIGINAL LAKE ATALANTA PARCEL, SUBSTANTIALLY EXPANDING THE FOOTPRINT OF THE PARK AND THE SCOPE OF WORK. THIS EXPANSION HAS GIVEN THE CITY THE ABILITY TO TIE THE LAKE DIRECTLY INTO THE DOWNTOWN AREA UTILIZING MULTIPLE FORMS OF TRANSPORTATION.

Figure 1.2 Lake Atalanta Improvements Overall Concept

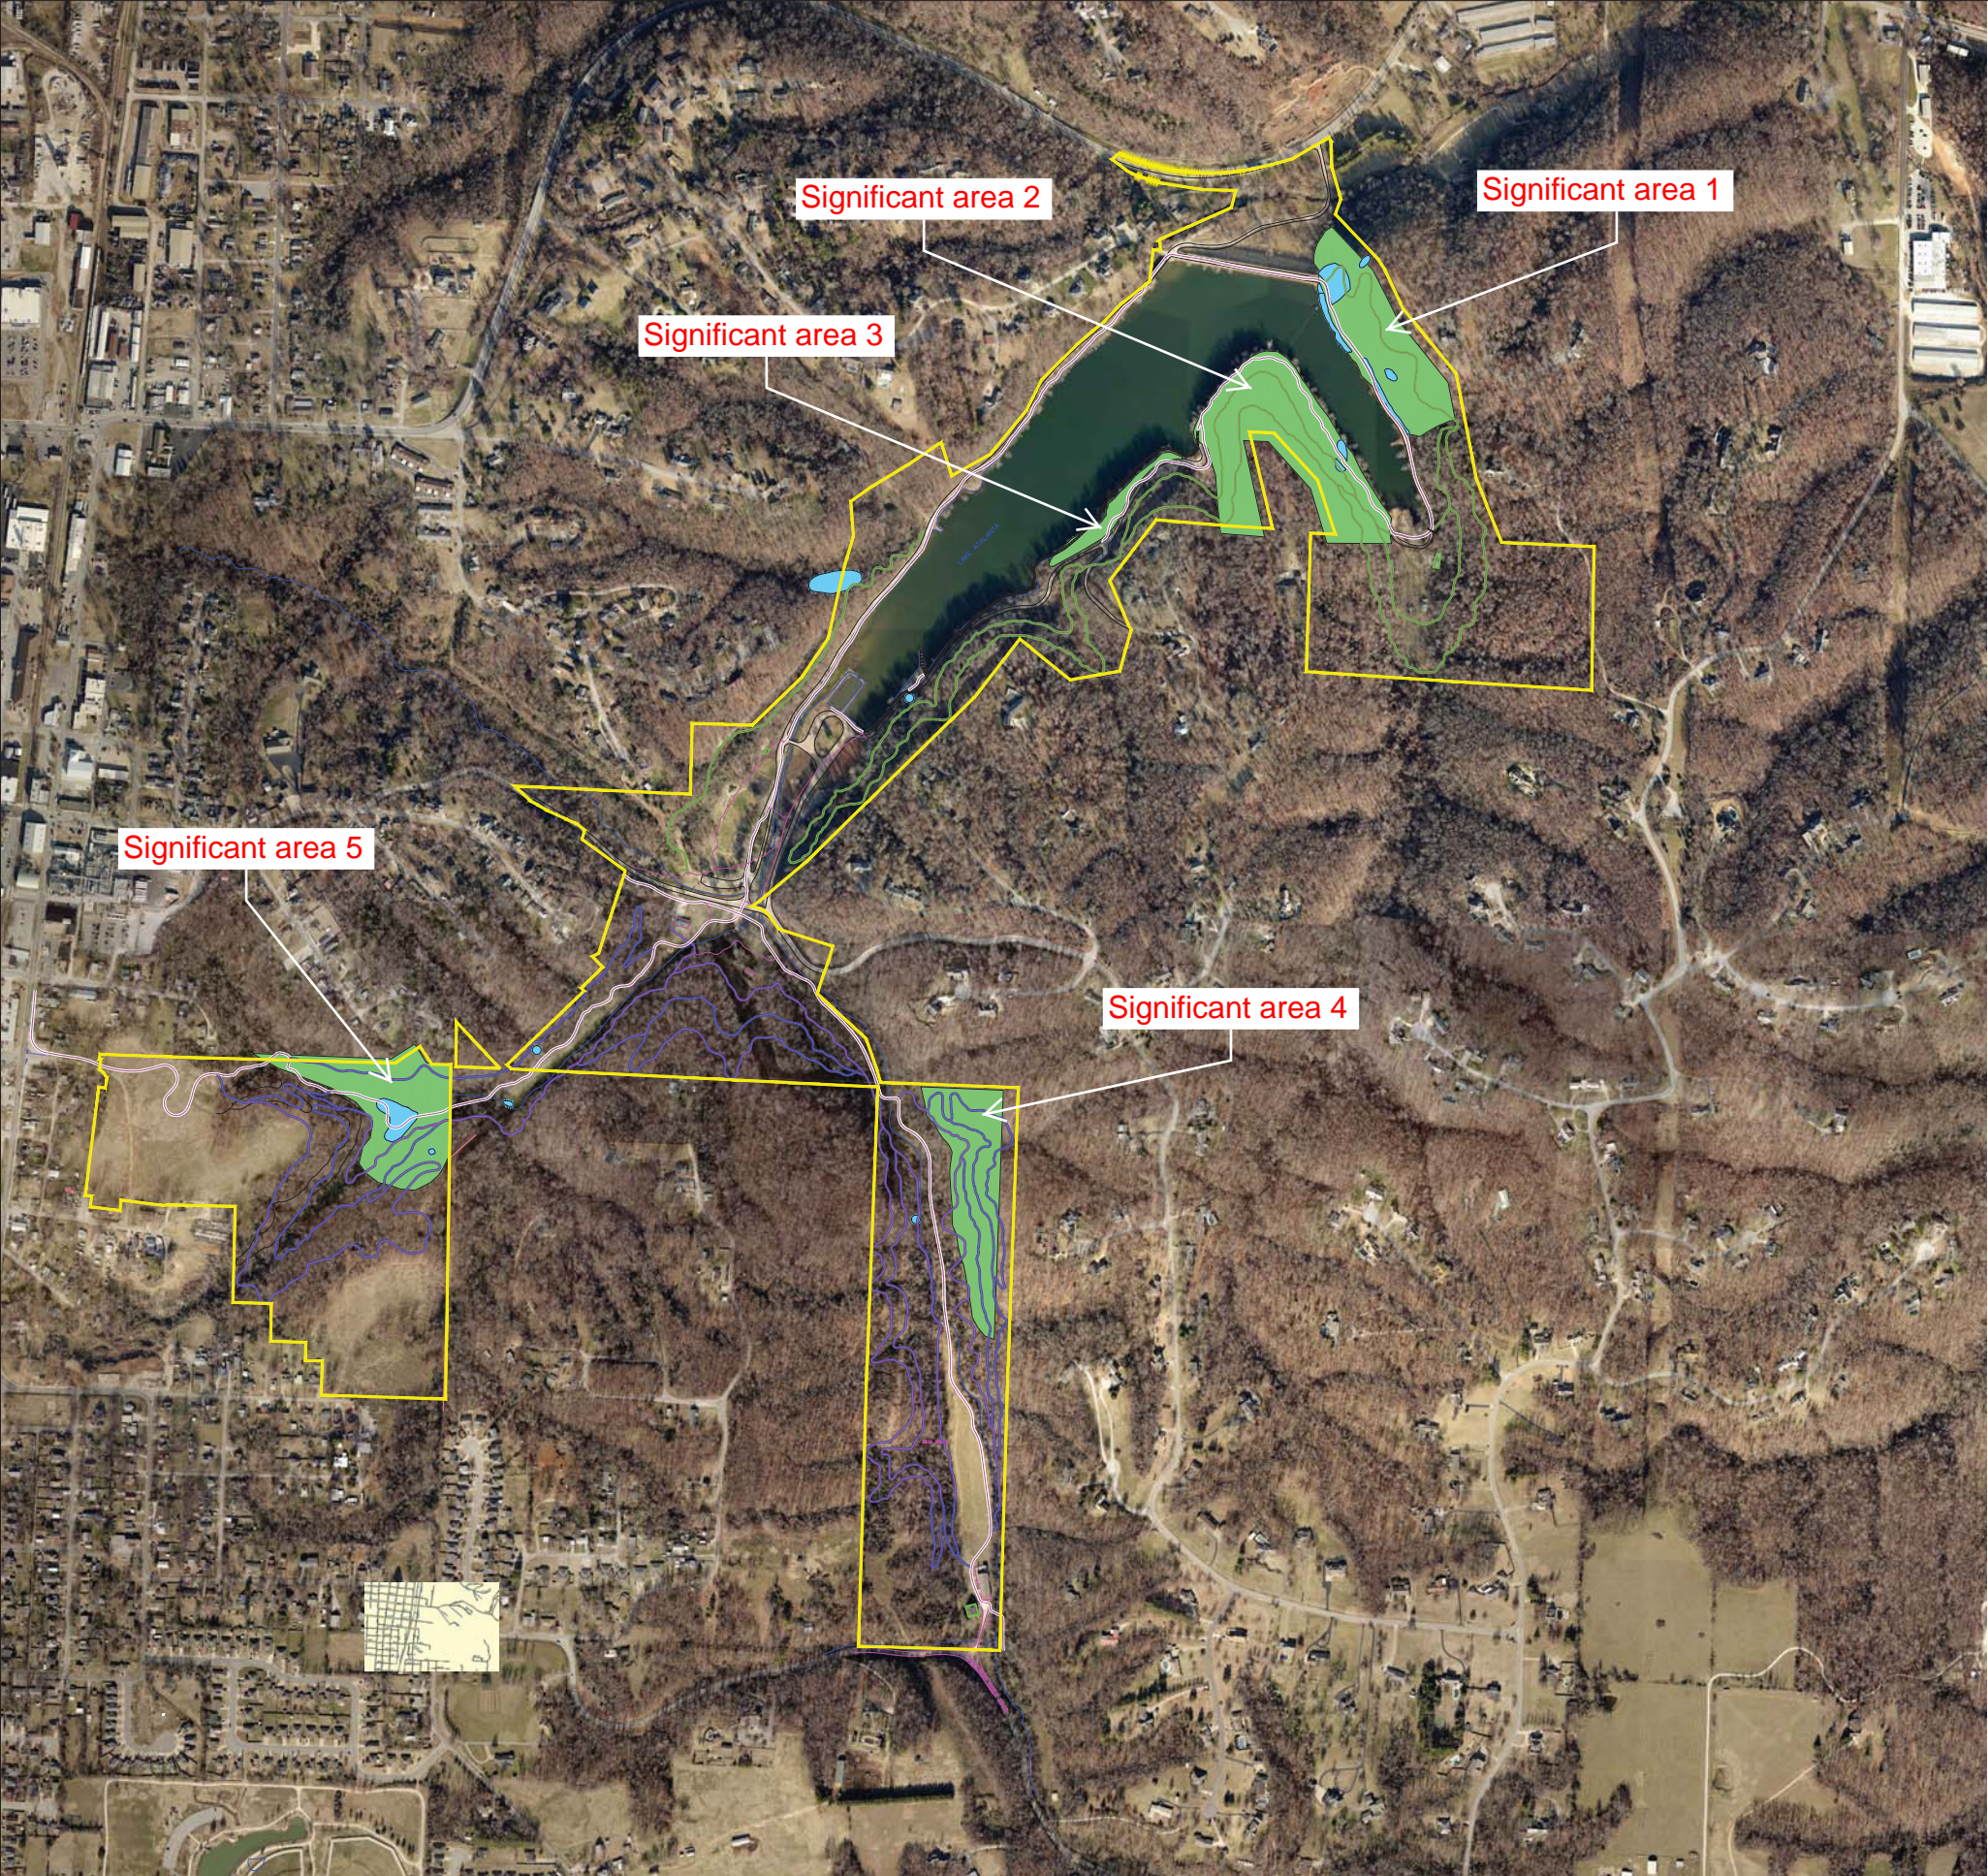
- SIGNIFICANT AREAS
- SENSITIVE AREAS

Figure 1.3 Map showing proposed park extent and sensitive areas

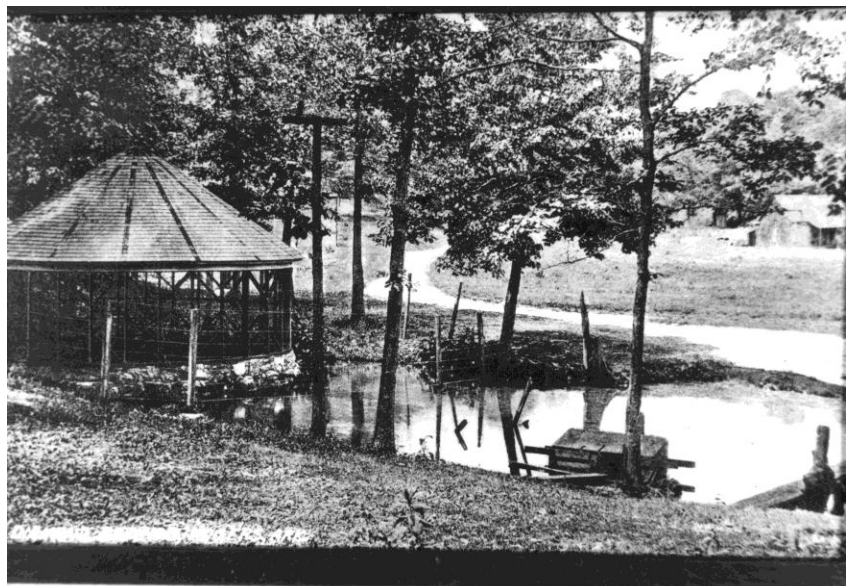
Figure 4.2. View from Diamond Spring to northeast.

upstream of Walnut Street, somewhat similar to the historic pool at Diamond Spring depicted in the photographs below (provide by the Rogers Historical Museum).

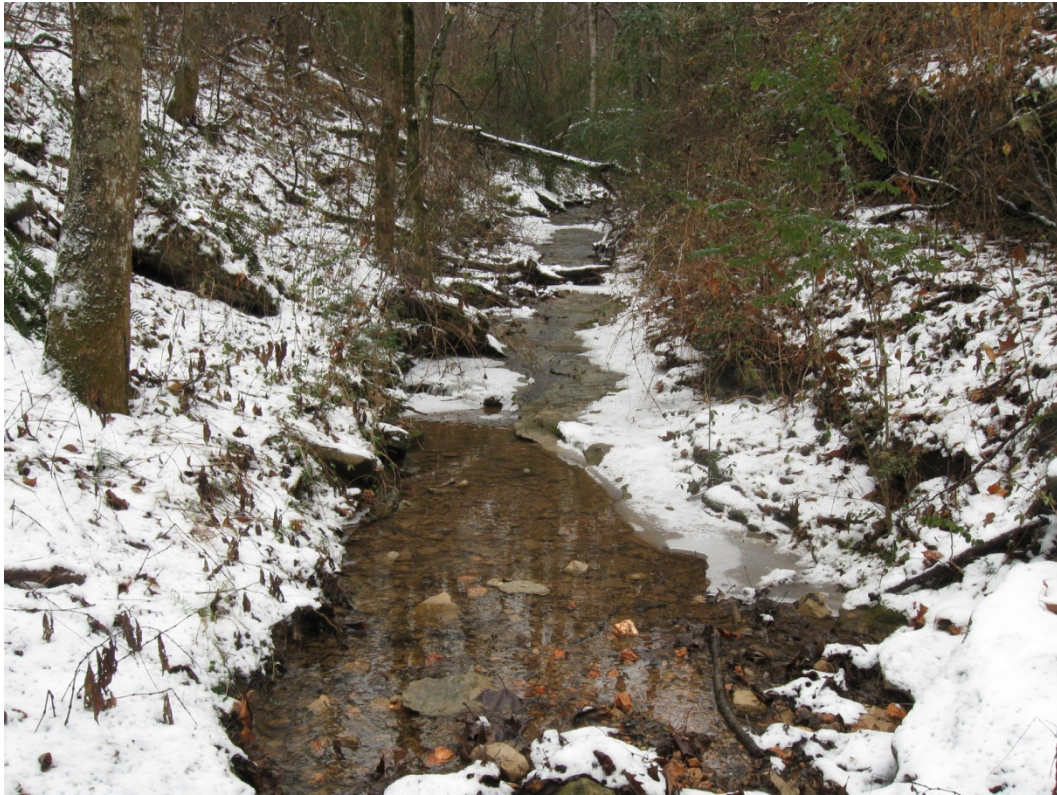
Photo 1. View of intermittent channel common to the project area.

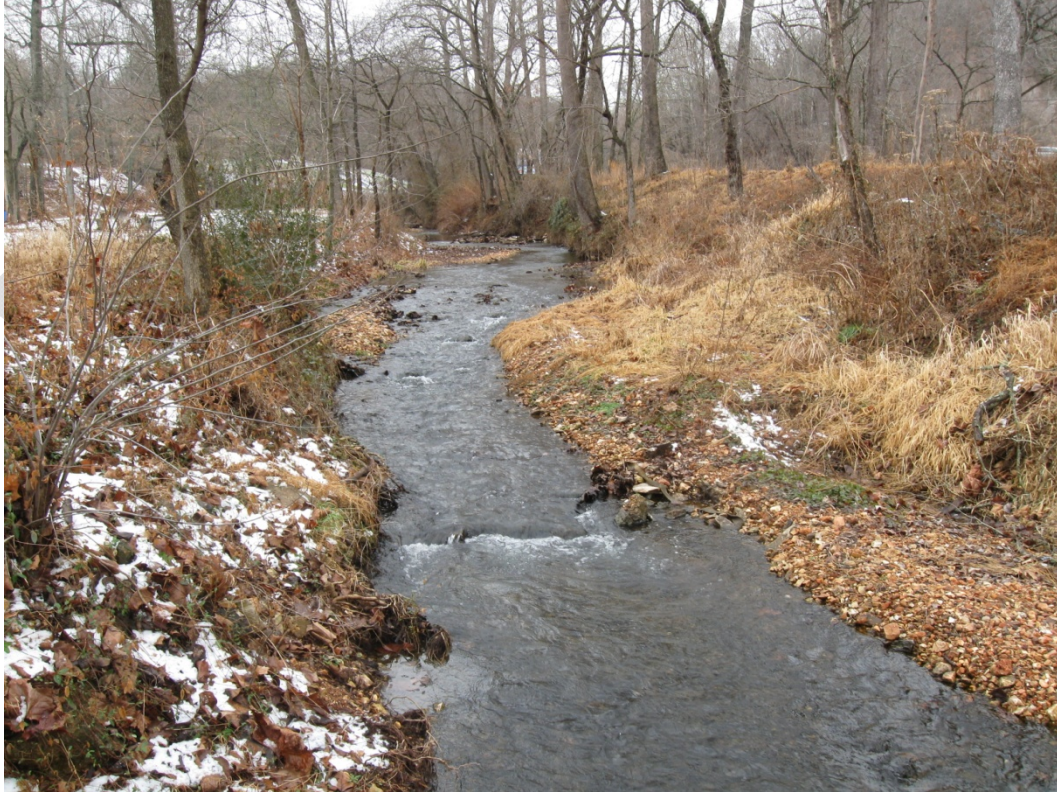
Photo 4. Prairie Creek downstream of Lake Atalanta.

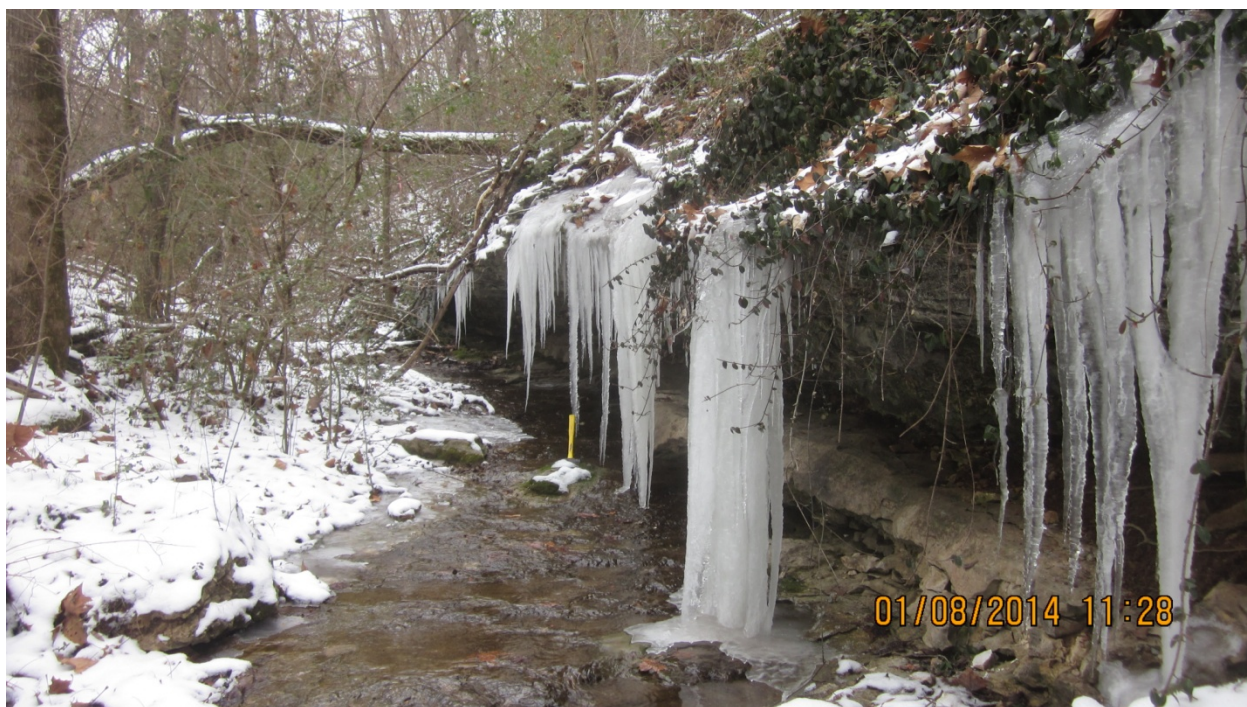
Photo 1. Numerous seeps emerging from base of Boone Formation along a solution enhanced bedding plane. Stream formed by pictured seeps and upgradient Springs SW-01 and SW-03. (SW-04 on Figure 2.1).

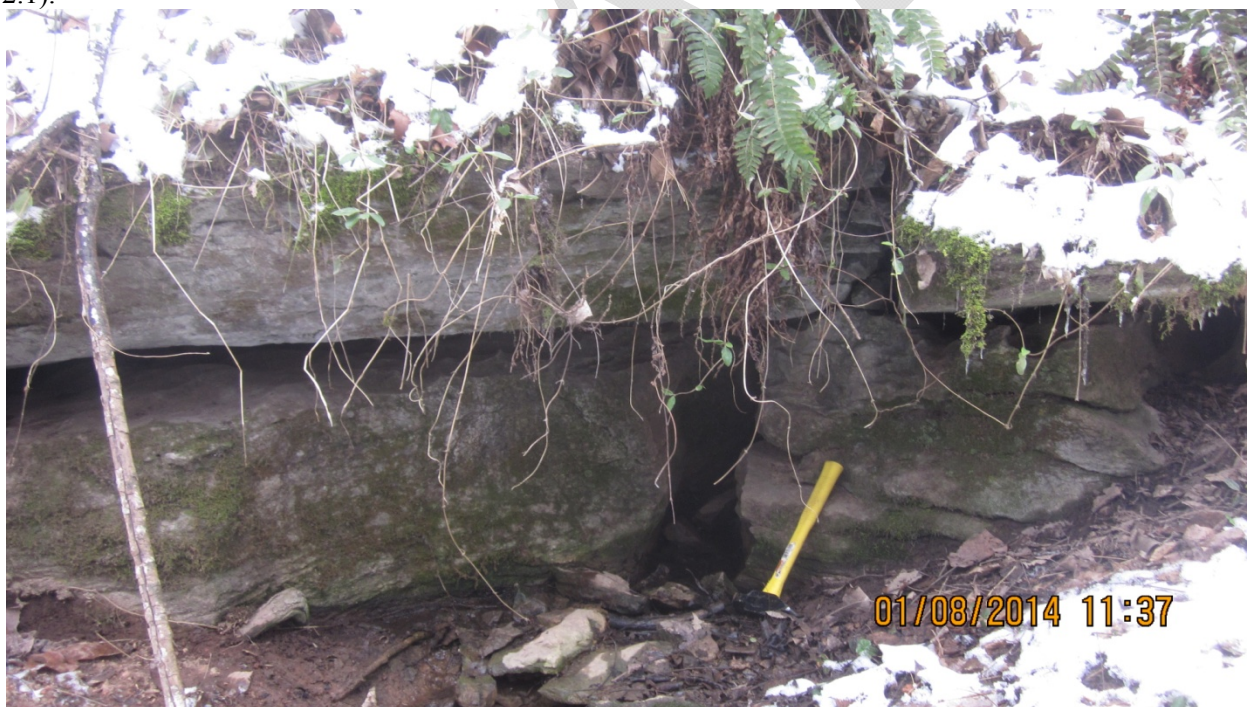
Photo 2. Limestone outcrop of Boone Formation with solution enhanced bedding planes and fracture. Spring emerges from base of fracture (SW-05 on Figure 2.1).

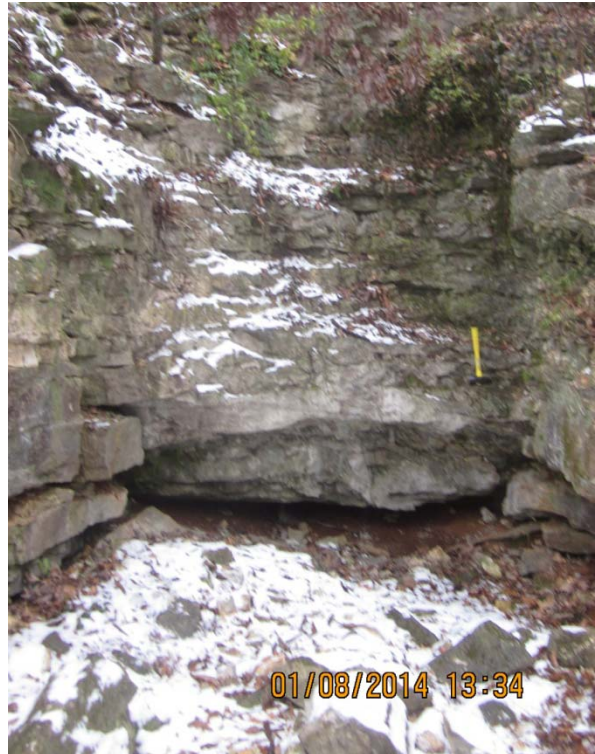
Photo 3. Limestone outcrop of Boone Formation with solution enhanced bedding planes near base of outcrop (SW-13 on Figure 2.1).

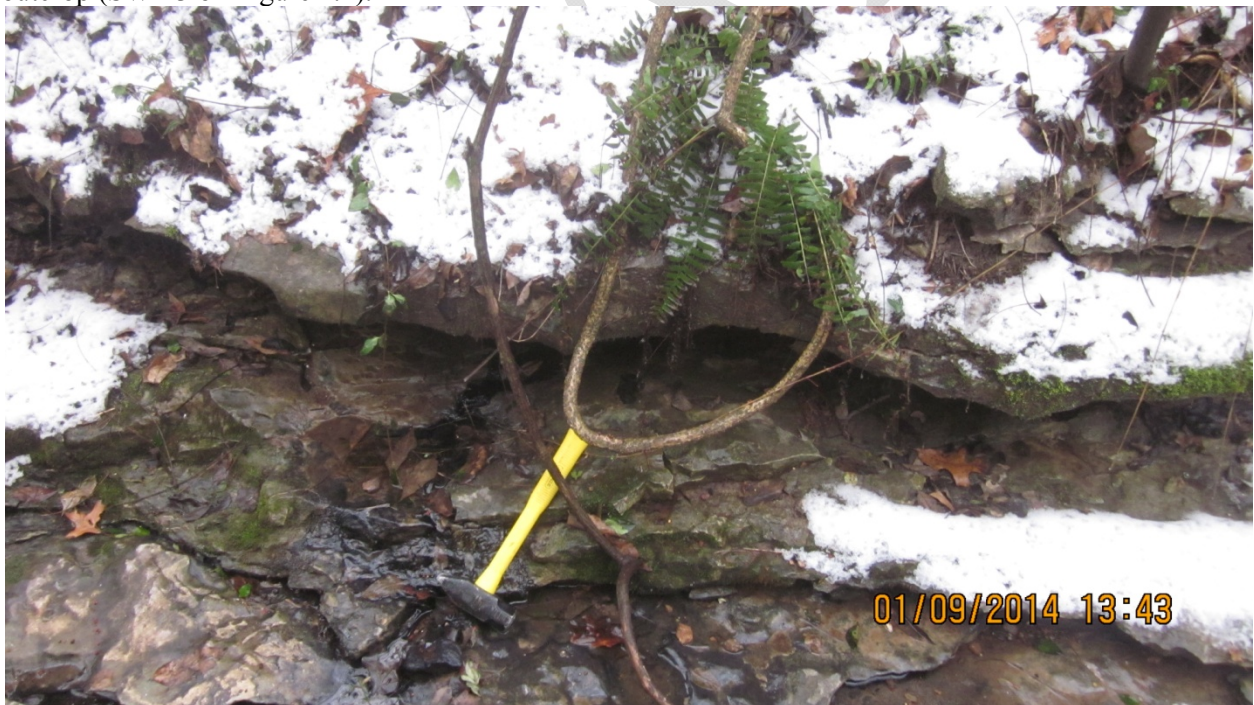
Photo 4. Small spring emerging from Boone Formation along a solution enhanced bedding plane (SW-18 on Figure 2.1).

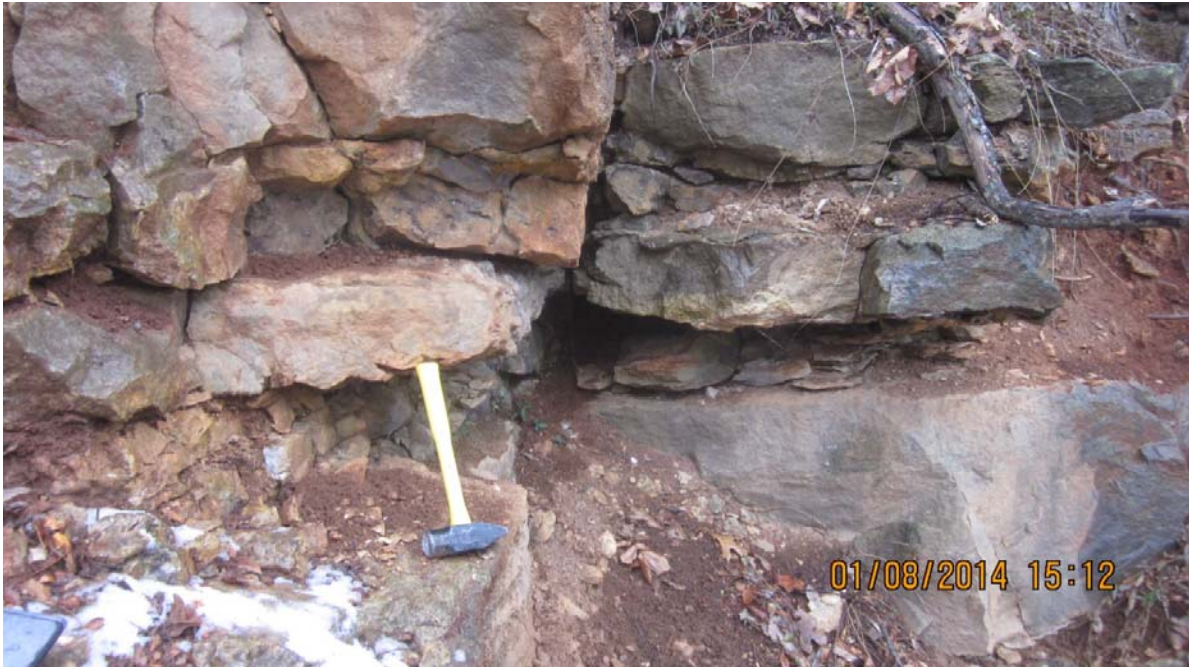
Photo 5. Limestone outcrop of Boone Formation with solution enhanced bedding planes and fracture (LA-02 on Figure 2.1).

LA-01	N36.33892	W94.09938	Outcrop	--	Limestone outcrop of Boone Formation with solution enhanced bedding planes.
LA-02	N36.33318	W94.10499	Outcrop	Photo 5	Limestone outcrop of Boone Formation with solution enhanced bedding planes and fracture.
LA-03	N36.33666	W94.09319	Spring	--	Spring box at old homestead. Small seepage occurs from man-made rock wall.
LA-04	N36.33910	W94.09605	Outcrop	--	Small outcrop of limestone of Boone Formation along east side of lake with solution enhanced bedding planes.
LA-05	N36.33839	W94.09312	Outcrop	Photo 6	Limestone outcrop of Boone Formation with solution enhanced bedding planes. Small spring emerges from one of the bedding planes and flows a short distance before sinking into subsurface.
LA-06	N36.33868	W94.09312	Seeps	--	Multiple seeps emerge from base of limestone outcrop of Boone Formation. Outcrop is highly weathered.

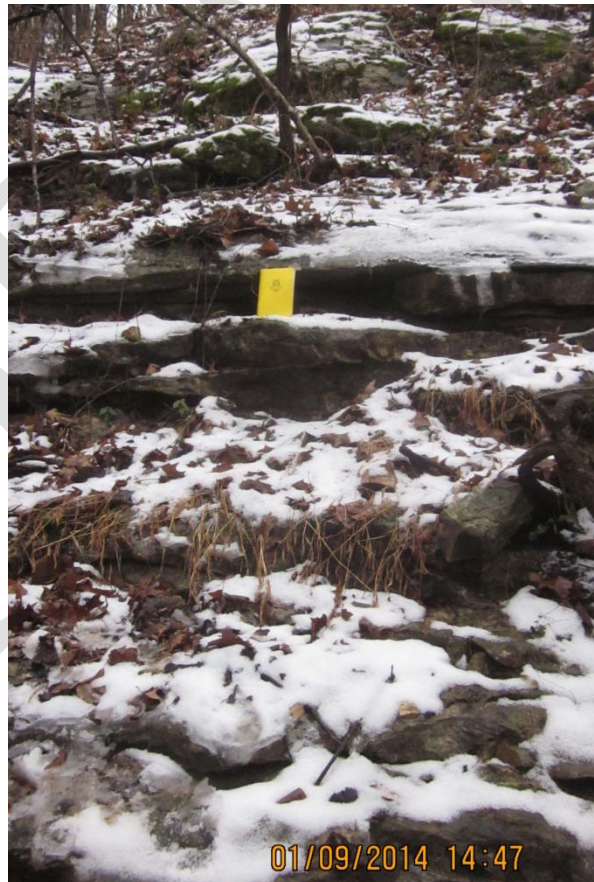
Photo 6. Limestone outcrop of Boone Formation with solution enhanced bedding planes. Small spring emerges from bedding plane just below bottom of picture (LA-05 on Figure 2.1).

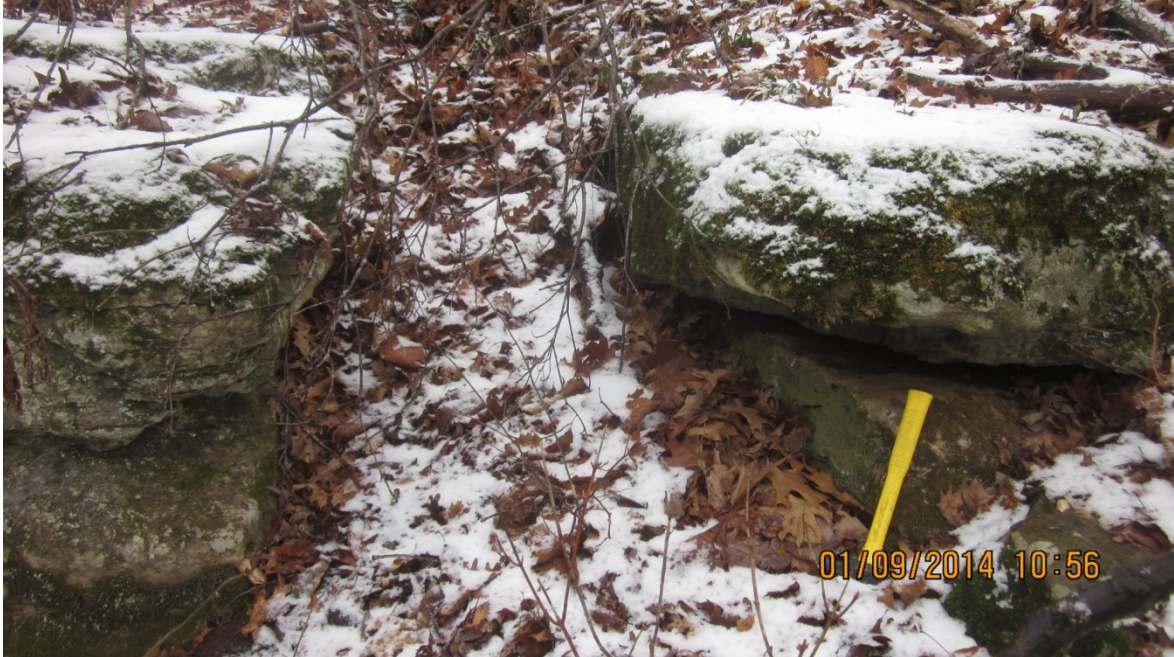
Photo 7. Limestone outcrop with solution enhanced bedding plane and fracture forming an open fissure (SE-03 on Figure 2.1).

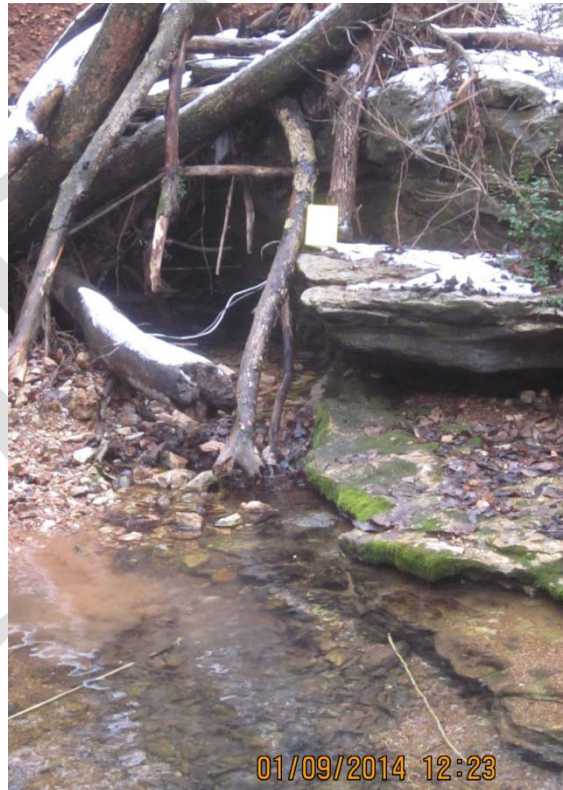
Photo 8. Large spring emerging from limestone outcrop of Boone Formation along a solution enhanced bedding plane (SE-08 on Figure 2.1).

The most significant karst features observed were three springs: Frisco (SW-10), Diamond (SW-16), and an unnamed spring (SE-08) emerging from a limestone outcrop with maturely developed karst features: open fissures, solution enhanced bedding planes, ubiquitous small-scale dissolution features known as karren (Photo 10 in Appendix C) and, on the northern end, a platform of bare limestone (limestone pavement). The 2001 USGS streamflow study reported that Frisco Spring had an instantaneous discharge of 0.44 ft<sup>3</sup>/s and Diamond Spring had an instantaneous discharge of 2.41 ft<sup>3</sup>/s during low-flow conditions. For the 2001 water year, Prairie Creek basin was considered to be drier than normal due to below-average rainfall

SE-07	N36.32255	W94.09989	Spring	--	Spring emerges from cherty regolith near stream bank. Spring discharges from pipe.
SE-08	N36.32157	W94.09941	Spring	Photo 8	Large spring emerges from limestone outcrop of Boone Formation. Outcrop extends upgradient of spring and exhibits well-developed karst features to include solution enhanced bedding planes and fractures (open fissures).
SE-09	N36.32068	W94.09924	Outcrop	Photos 9 and 10	From Spring SE-08 to location SE-09, well-developed karst features exist in limestone outcrop of Boone Formation. Karst features include solution enhanced fractures forming open fissures, ubiquitous small-scale solution features known as karren and, at the northern end, a platform of bare limestone (limestone pavement).

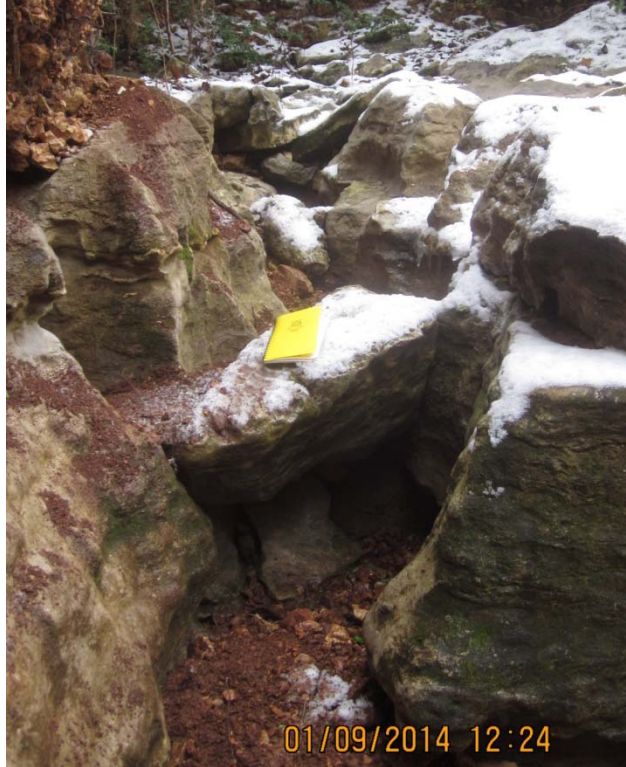
Photo 9. Well developed karst features in outcrop upgradient of Spring SE-08 (SE-09 on Figure 2.1).

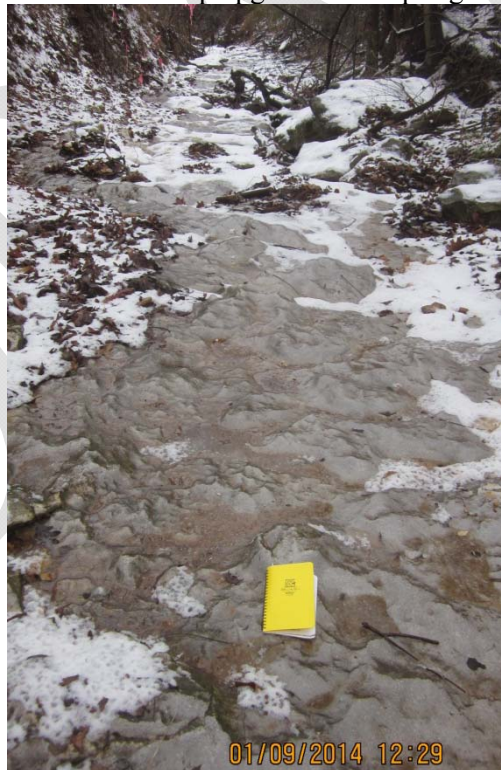
Photo 10. Platform of bare limestone (limestone pavement) containing ubiquitous small-scale solution features known as karren (SE-09 on Figure 2.1).
