**Downstream Areas Data
Assessment Report**

Mayflower Pipeline Incident Response
Mayflower, Arkansas

March 2014

Revision 5

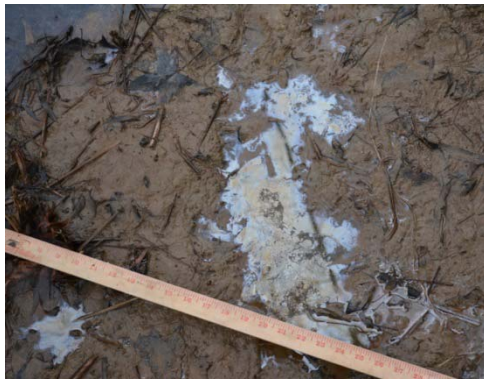
In the A-Main, A-365W, and A-365E drainage ways, brittle and non-brittle sheens of metallic, silver gray, and/or rainbow colors were observed along the banks and on the water surface in the drainage swale (Figure 11-1) between October 21, 2013 and February 23, 2014. Examples of these are shown in the photos below.

**Brittle Rainbow Sheen Cover Observation
on December 28, 2013 (A-Main)**

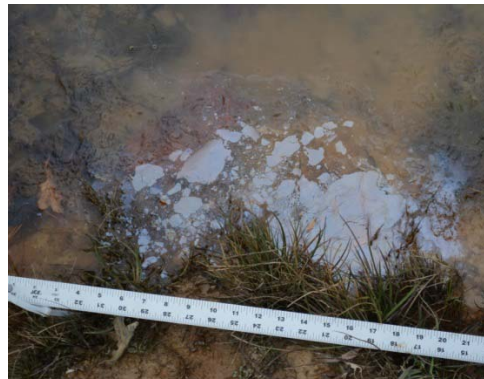
**Brittle Metallic Sheen Patch Observation on
January 4, 2014 (A-365W)**

Patches observed at a single location in these monitoring areas covered typically less than one square foot. Sheen streamers observed in these areas varied in size from 1 inch to 20 feet. At approximately 15 percent of the sheen locations, various patches, cover (no particular structure), and/or streamers covering an area up to 20 feet by 40 feet (up to 70 percent of the water surface) were observed. A summary of sheen observations in the drainage ways is included in the following table.

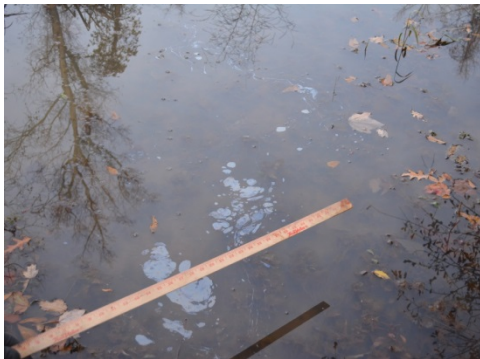
Mainly non-brittle sheens were observed in two monitoring areas of Dawson Cove – Dawson Cove Inlet Channel and Dawson Cove Open Water Area (Figure 11-2) between October 21, 2013 and February 23, 2014. Similar numbers of brittle and non-brittle sheens were observed in the B-On Water area. One brittle sheen was observed in the Dawson Cove Outlet. Examples of these are shown in the photos below.

**Brittle Metallic Sheen Patch Observation on
November 30, 2013
(Dawson Cove Inlet Channel)**
