Subject: Notice of Violation
Harriman Road (Cleveland Local Interstate Connector), Permit # TNR112052
Spring Branch/Johnson Branch watersheds, Cleveland, Bradley County

On July 08, 2013, Micah Gravitt of the Division of Water Resources conducted an inspection along with Mr. Eric McElroy of SSR, Inc. at the above referenced site. The purpose of the inspection was to determine the progress of the required actions set forth in the June 06, 2013 compliance inspection report. The following conditions were observed:

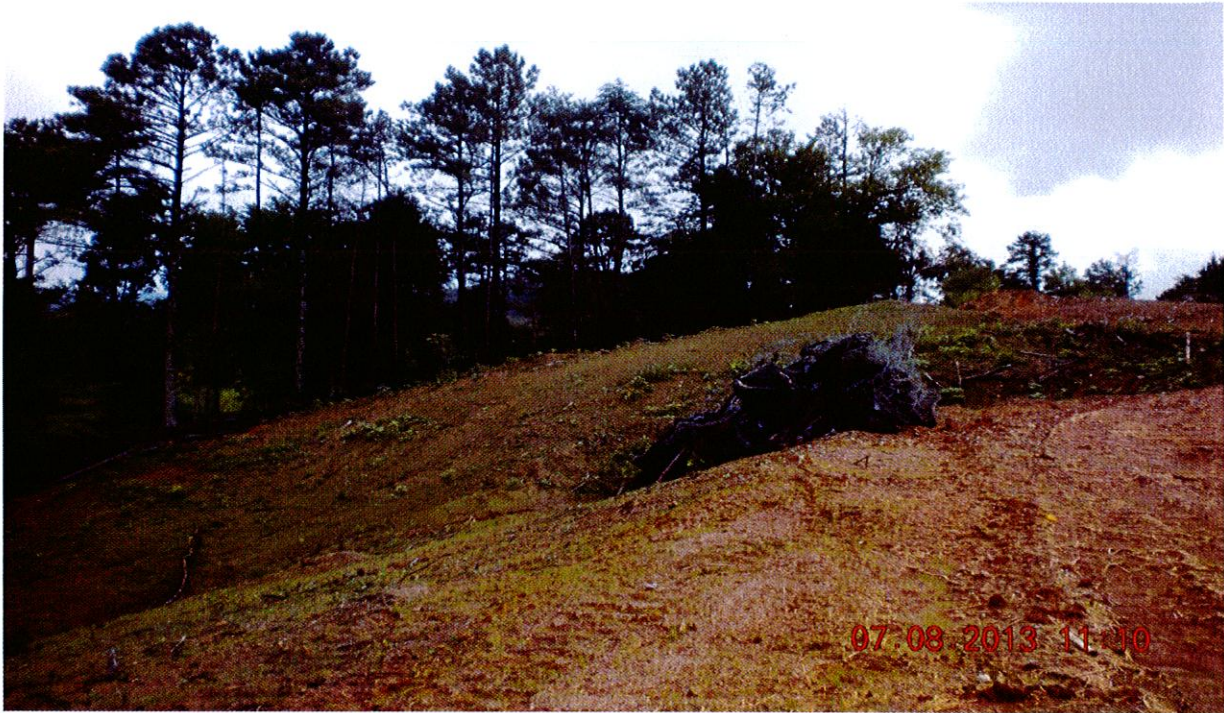
Photograph 1: Photograph showing steep slopes that have been hydro-seeded on one of the private inholdings of the project.

Findings: During the inspection it was observed that stabilization practices have been implemented in the form of seed and straw along with hydro-seeding on steep slopes (>35%). The division therefore considers this action completed, however all newly seeded areas must be monitored to ensure proper vegetative growth becomes established.

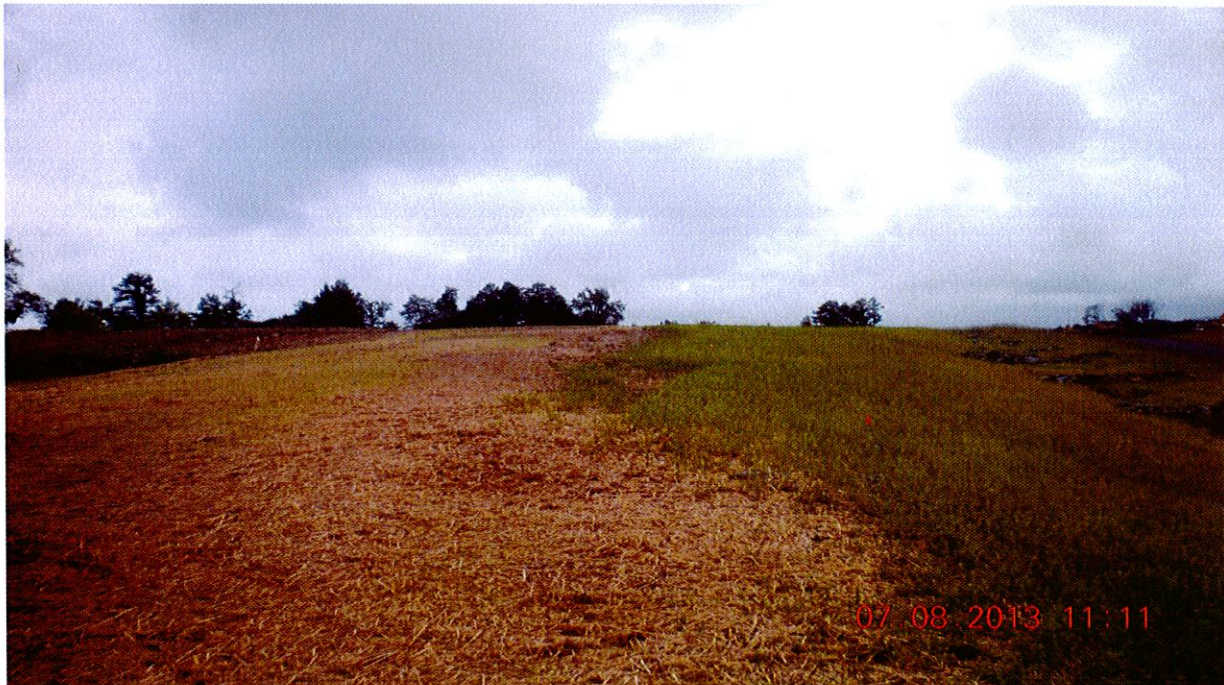
Photograph 2: Photo of the same private inholding showing the flat area above the steep slope in the above picture. Although seed and straw has been utilized, this area and any others with recent stabilization attempts must be monitored to ensure proper vegetative growth is established. Any changes in the grades of this area should be reflected in your amended SWPPP.

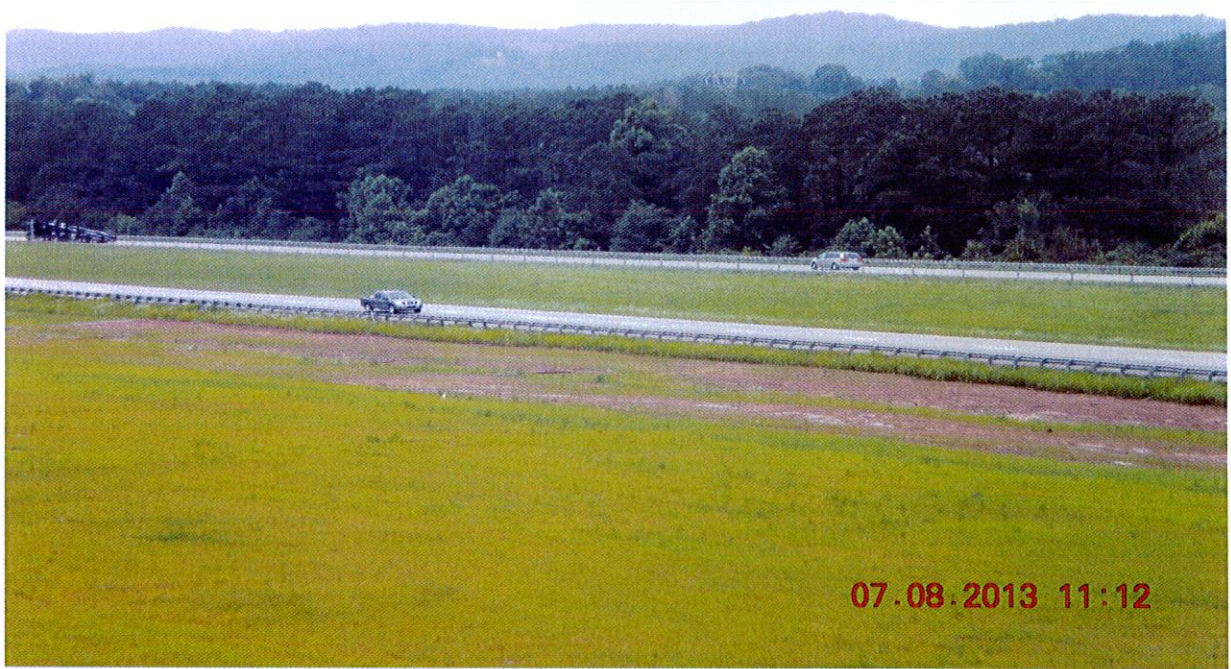
Photograph 3: View of the portion of the project overlapping the right of way for Interstate 75. This area should also be monitored to ensure proper vegetative growth.

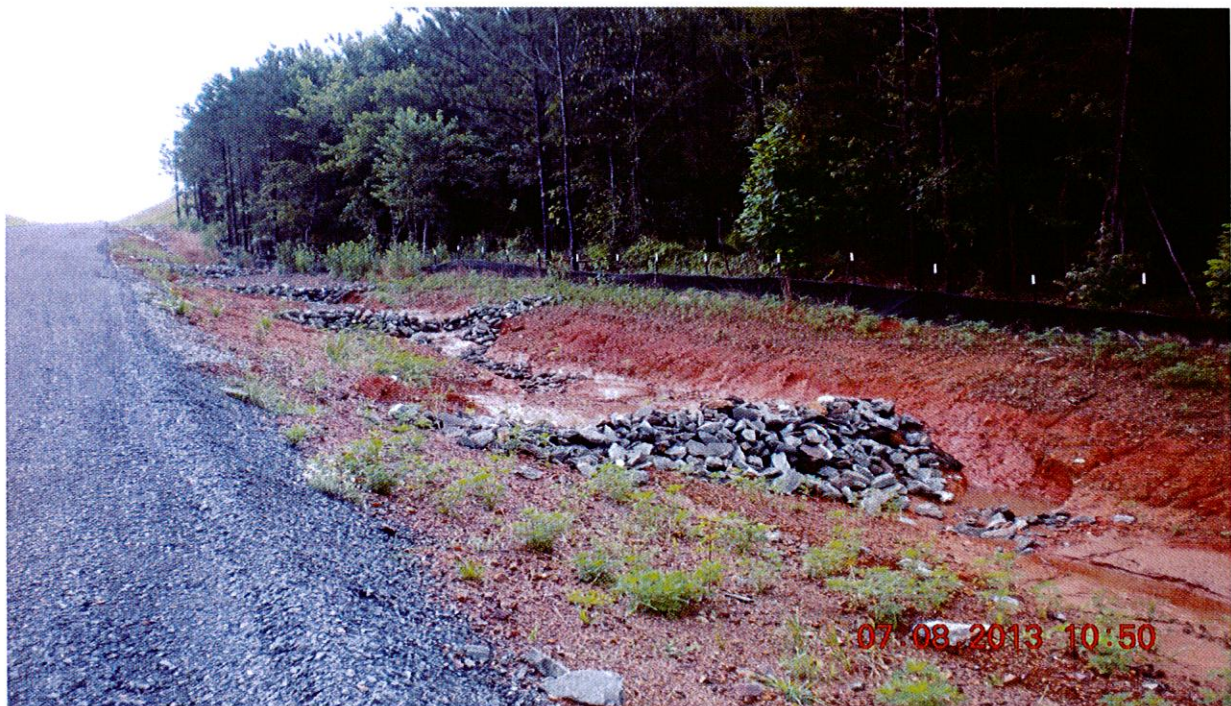
Findings: At the time of the inspection it was observed that some check dams have been removed but not replaced. Also, check dams that were left in place have not been maintained as required.

Photograph 4: Photograph showing check dams in need of maintenance/replacement. This photo also shows the eastern roadside ditch that must be addressed concerning post construction erosion issues.

- No later than July 26, 2013, repair or replace any existing sediment and erosion controls that have become inadequate due to lack of maintenance and/or improper installation.
- No later than June 29, 2013, submit to the Chattanooga Field Office at the address above an updated/amended SWPPP showing all areas related to the project. Also, this plan should include any changes necessary to post development drainage problems so they do not persist and cause future erosion issues.

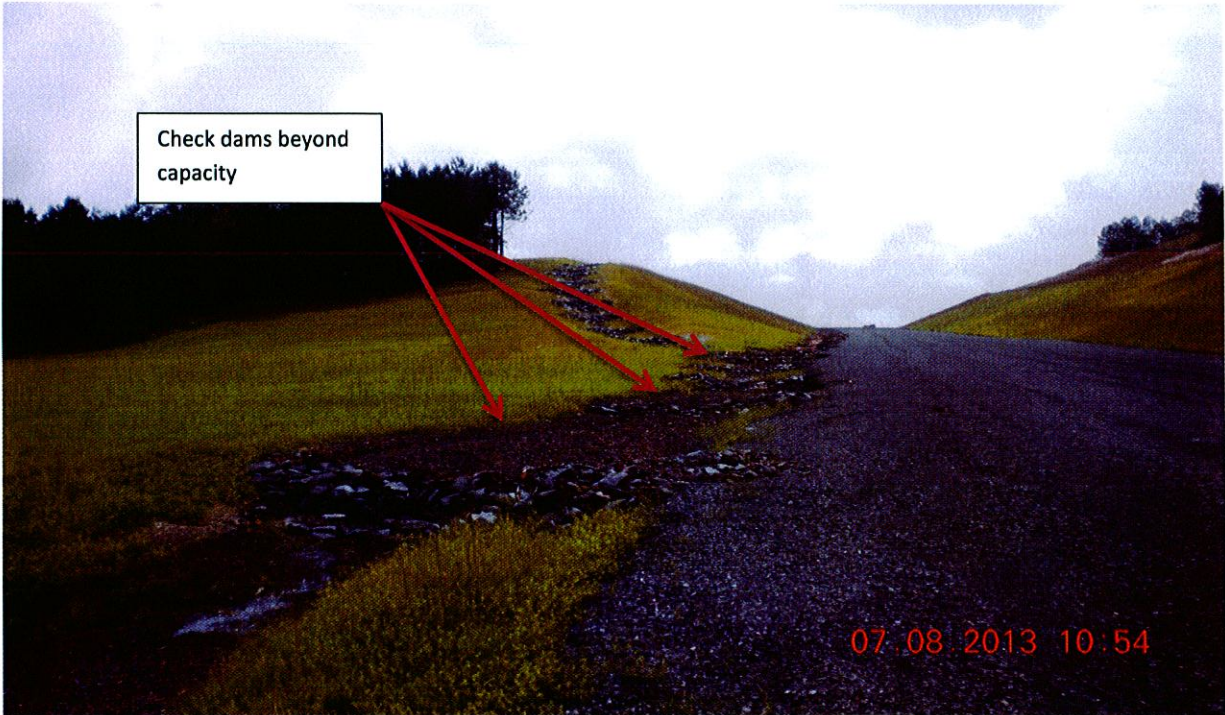
Photograph 5: View of the western roadside ditch in need of proper stabilization in relation to post development drainage. Photo also shows check dams in need of repair and/or replacement.

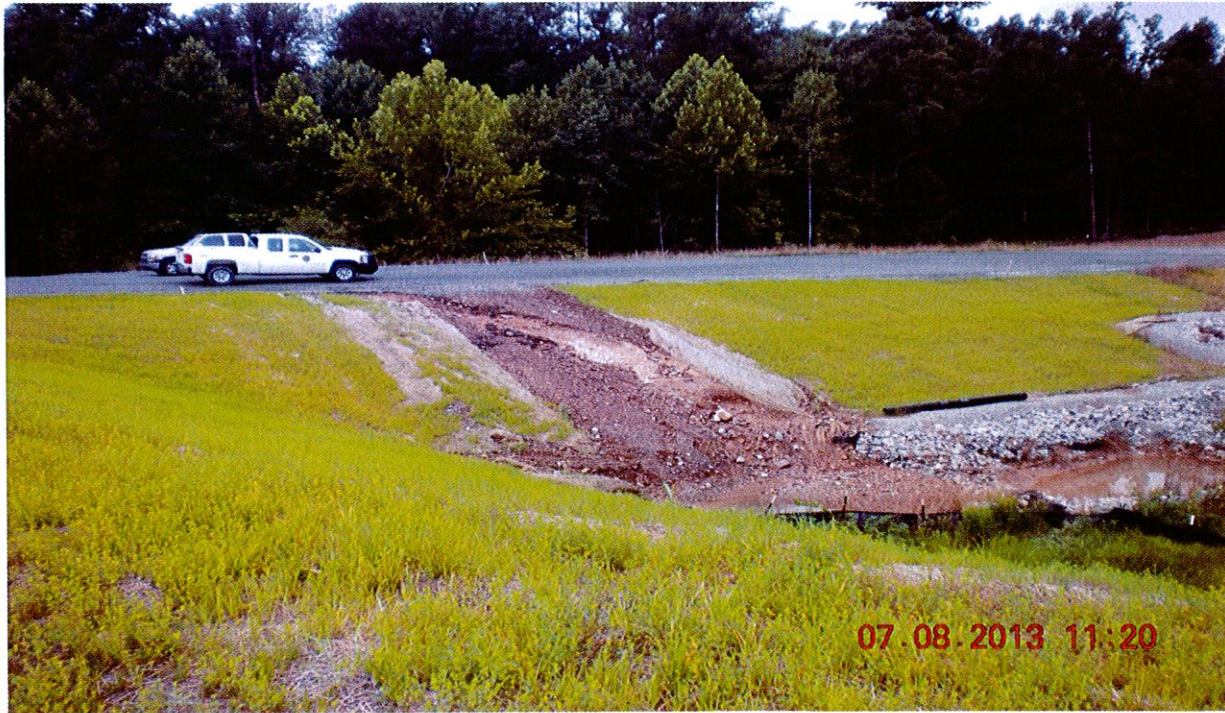
Photograph 6: Slope failure located near the end of the western roadside ditch in photograph 5. This area need to be re-graded and stabilized accordingly.

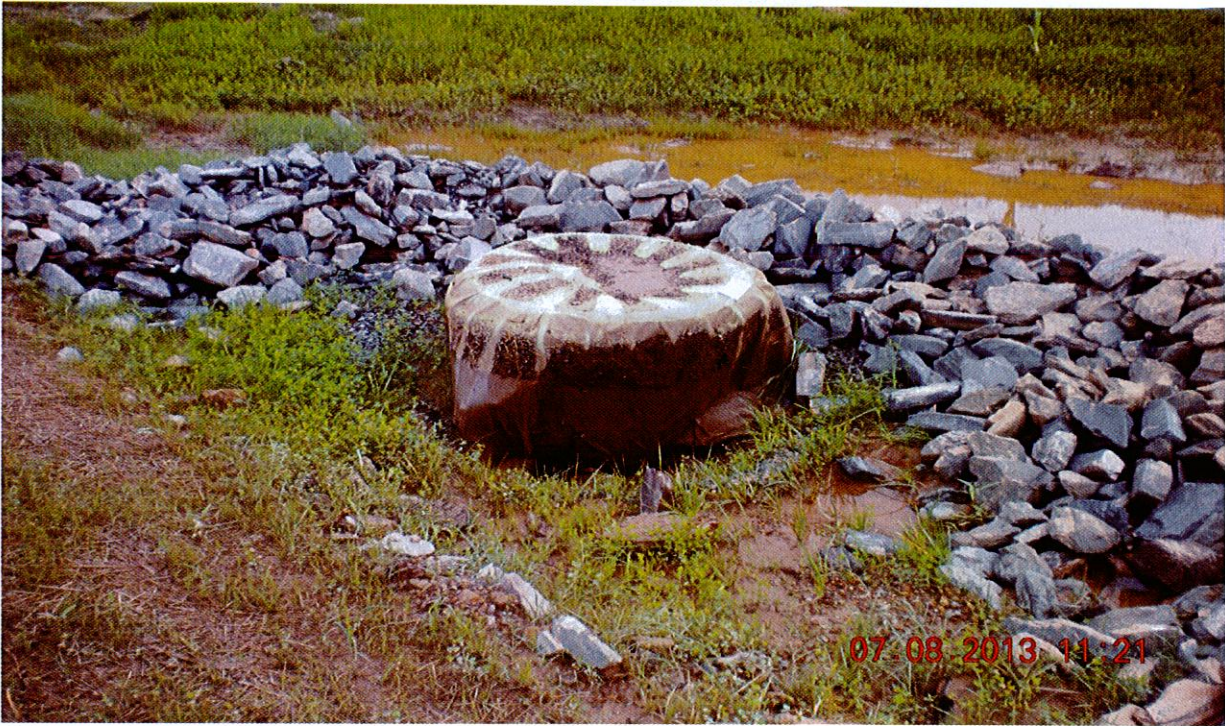
Photograph 7: Inlet protection device in need of maintenance.

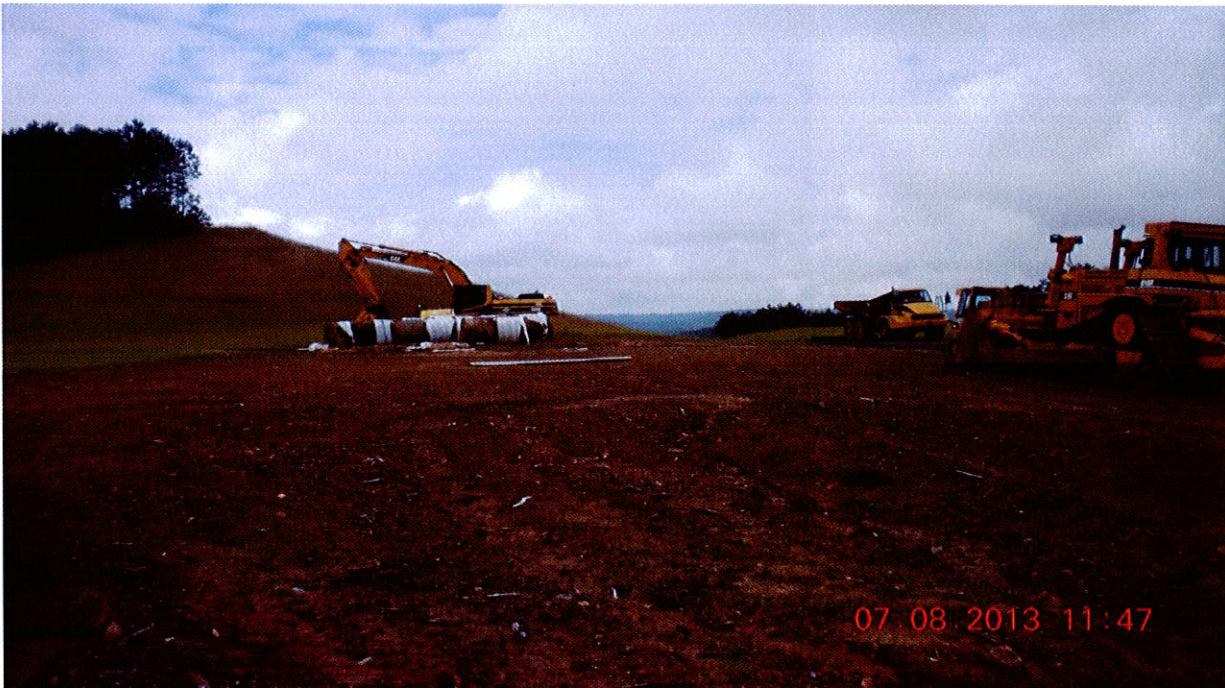
Photograph 8: Photograph showing the remaining equipment staging area. This area should also be stabilized upon project completion.
