*METALLURGICAL INVESTIGATION OF A
FRACTURED SECTION OF THE 20" O.D.
PIPELINE AT MILEPOST 314.77 IN THE
CONWAY TO CORSICANA SEGMENT OF
THE PEGASUS CRUDE OIL PIPELINE*

REPORT NO. 64961, REV. 1

Prepared for
ExxonMobil Pipeline Company and the
Pipeline and Hazardous Materials Safety Administration
pursuant to Corrective Action Order CPF 4-2013-5006H

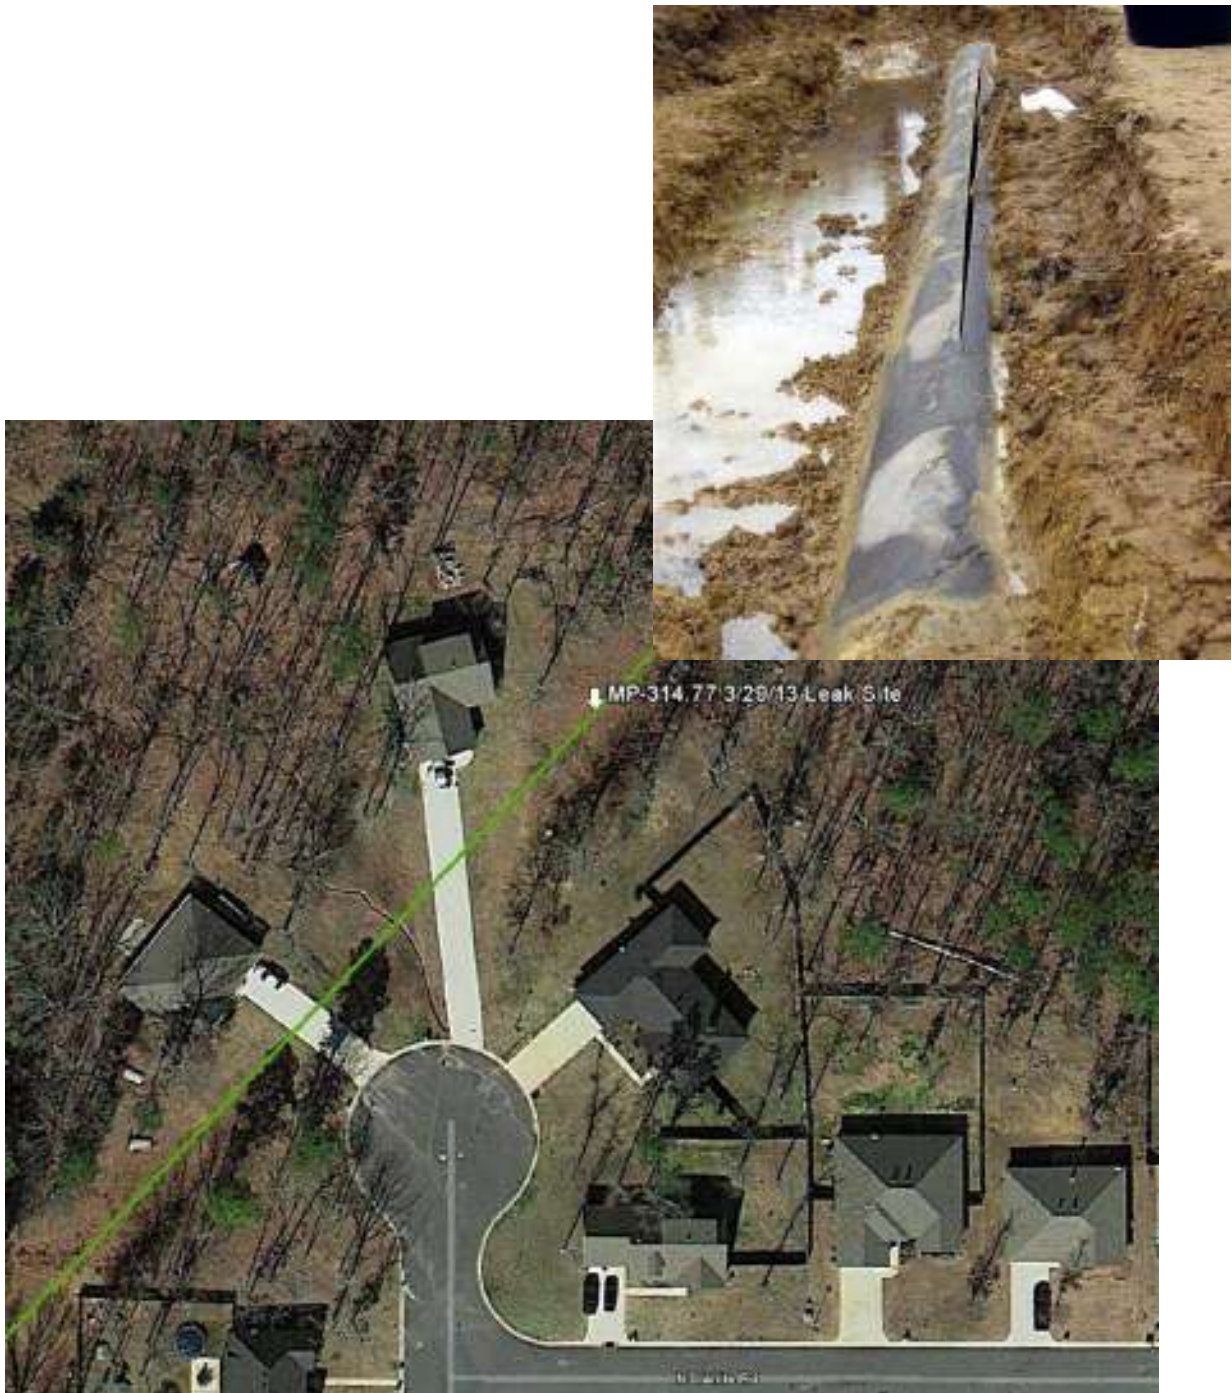
Photograph No. 1

The photographs provided by EMPCo of the 20" O.D. x 0.312" wall pipe at Milepost 314.77 of the Conway to Corsicana Pegasus crude oil pipeline, which failed on Friday, March 29, 2013 at 2:47 pm CST in Mayflower, Arkansas, display a straight, linear crack at approximately the 12:00 o'clock position.

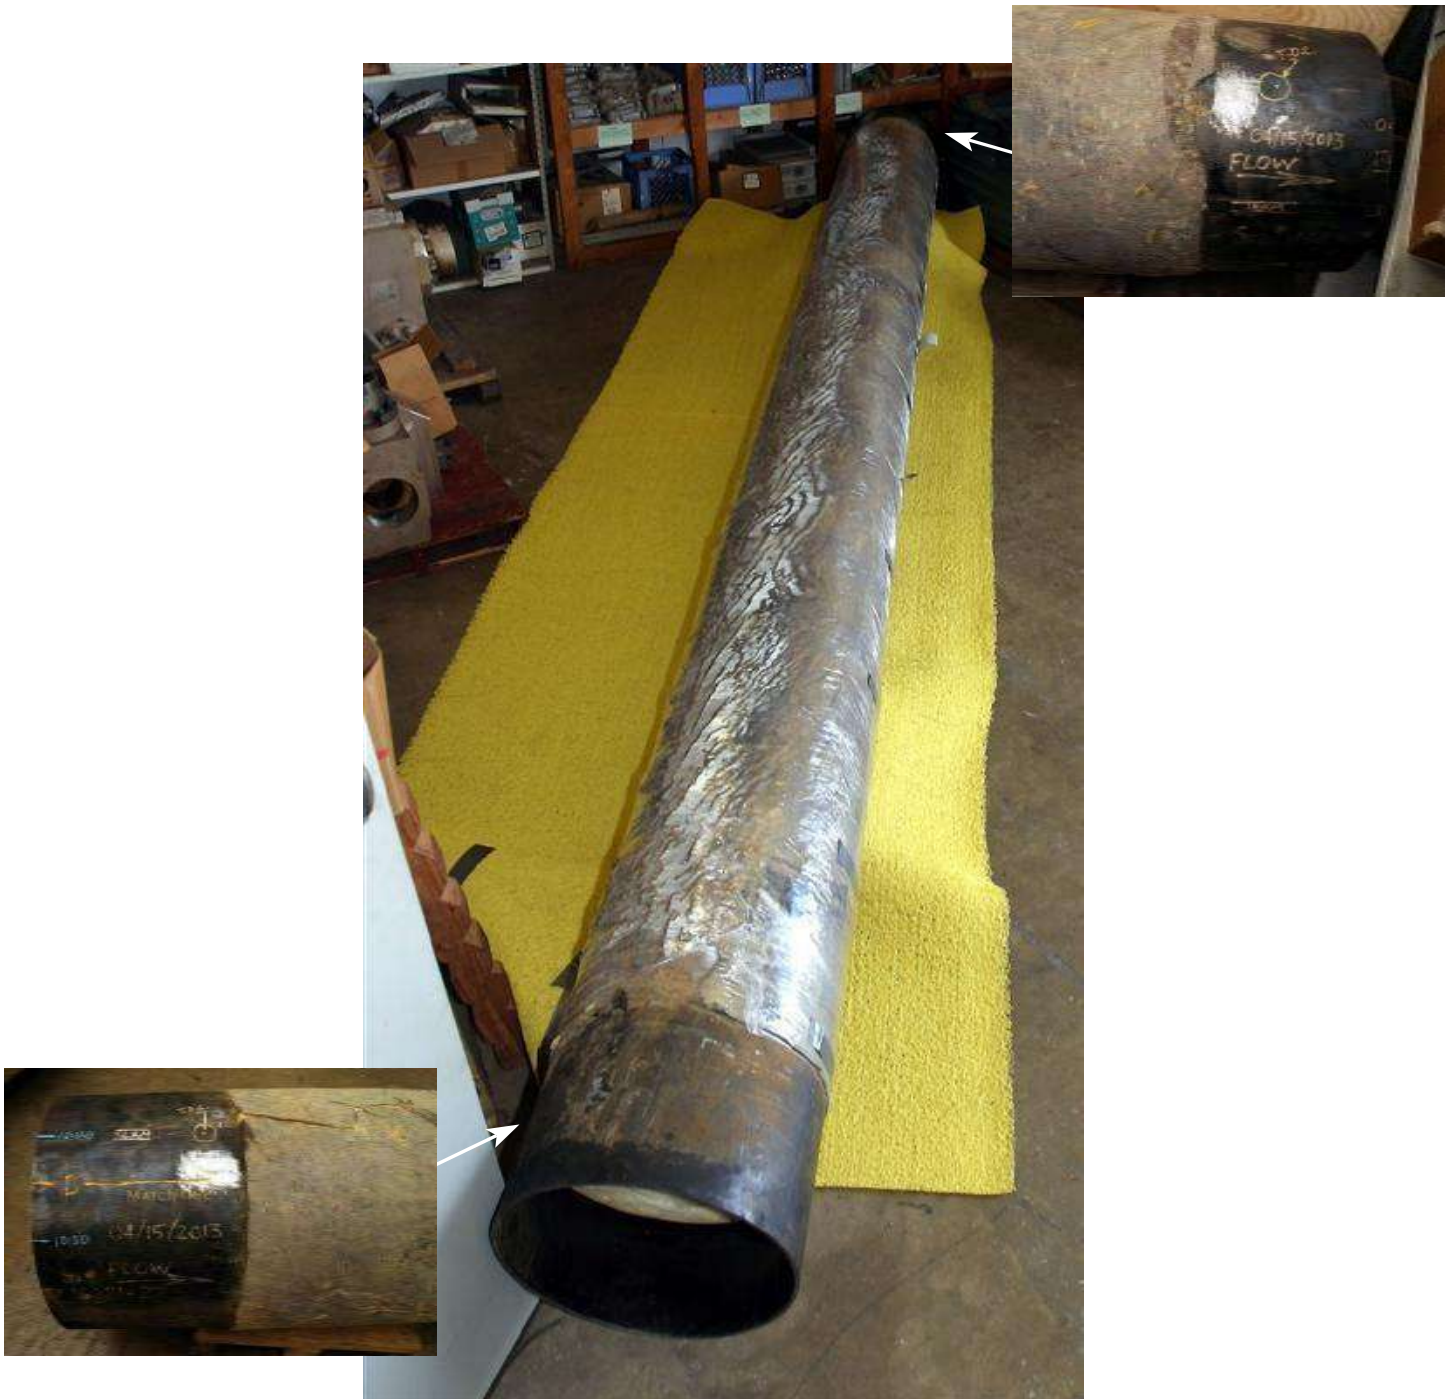
Photograph No. 9

The photograph displays the intact section of the pipe following removal of the 1st protective wrapping material.

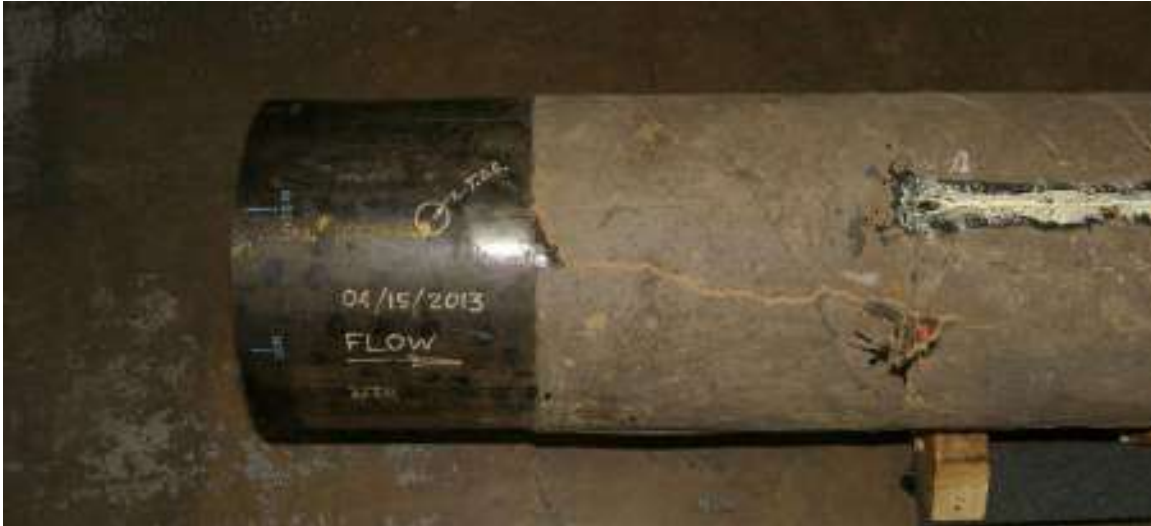
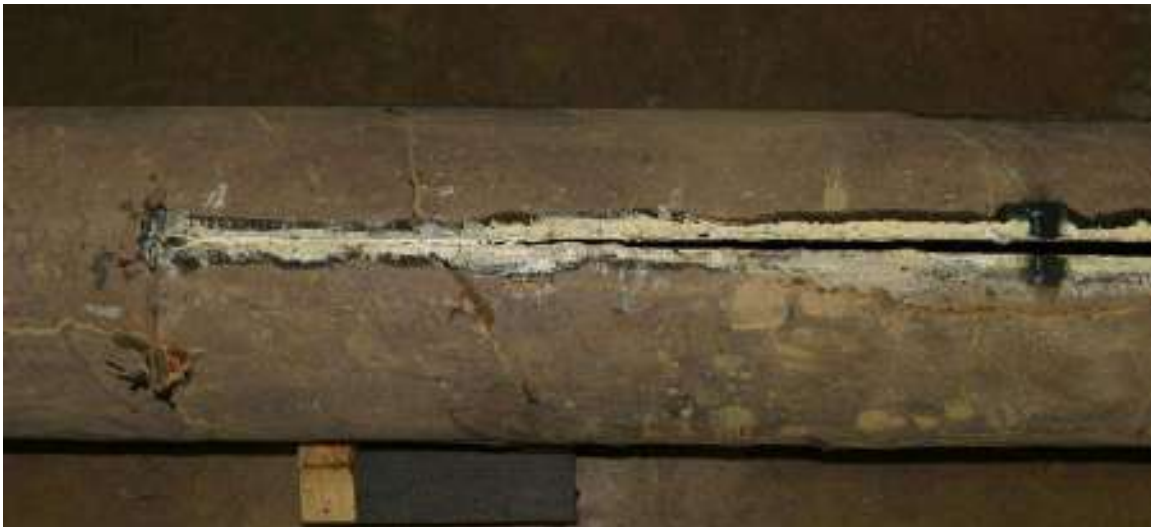
As-received Condition of the Coating			
Circumferential Location	Distance from North Girth Weld	Split Width Maximum	Split Depth Maximum
10:30 o'clock to 1:30 o'clock	-3' to 0'	1"	-
	0' to 4'	2"	0.10"

The photographs display overall top views of the pipe adjacent to the fractured pipe from approximately 3' north of the north girth weld (-3') to the center of the north girth weld (0'), and the fractured pipe from the center of the girth weld to 4' south of the north girth weld, respectively, in the as-received condition prior to removing the coating. The fracture in the pipe along the ERW seam terminated at the north girth weld. The fracture was extremely tight at the girth weld but was measured to be approximately 13/16" in width approximately 4' south of the north girth weld. Relatively narrow longitudinal and transverse splits were present in the coating. The coating had been removed from the adjacent intact pipe prior to sectioning approximately 3' north of the north girth weld.

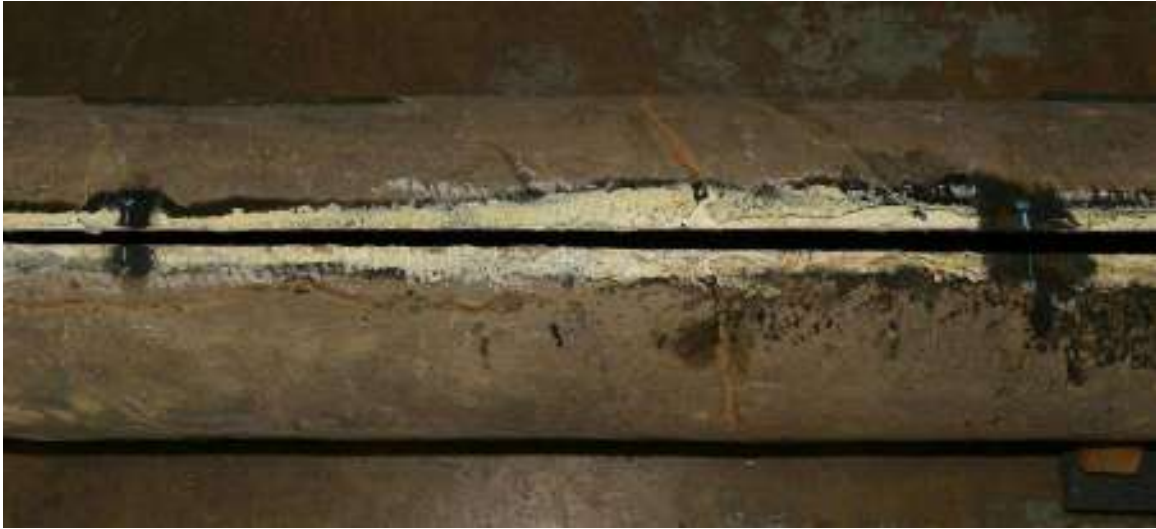
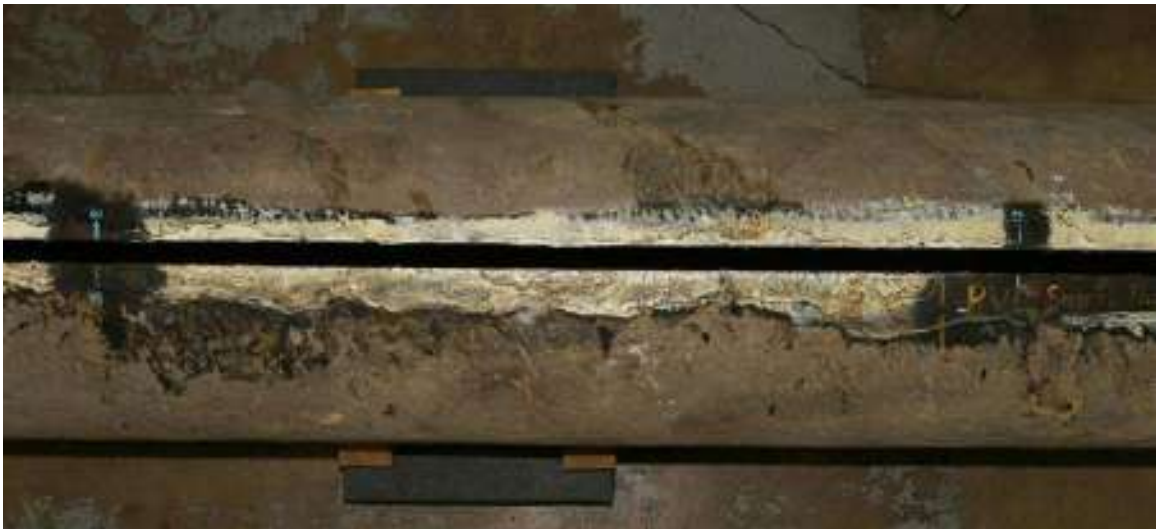
As-received Condition of the Coating			
Circumferential Location	Distance from North Girth Weld	Split Width Maximum	Split Depth Maximum
10:30 o'clock to 1:30 o'clock	4' to 8'	0.5"	0.14"
	8' to 12'	0.5"	-

The photographs display overall top views of the fractured pipe from 4' south to 8' south of the north girth weld, and from 8' south to 12' south of the north girth weld, respectively, in the as-received condition prior to removing the coating. Longitudinal and transverse splitting is present in the coating, and some of the coating is missing on either side of the fracture.

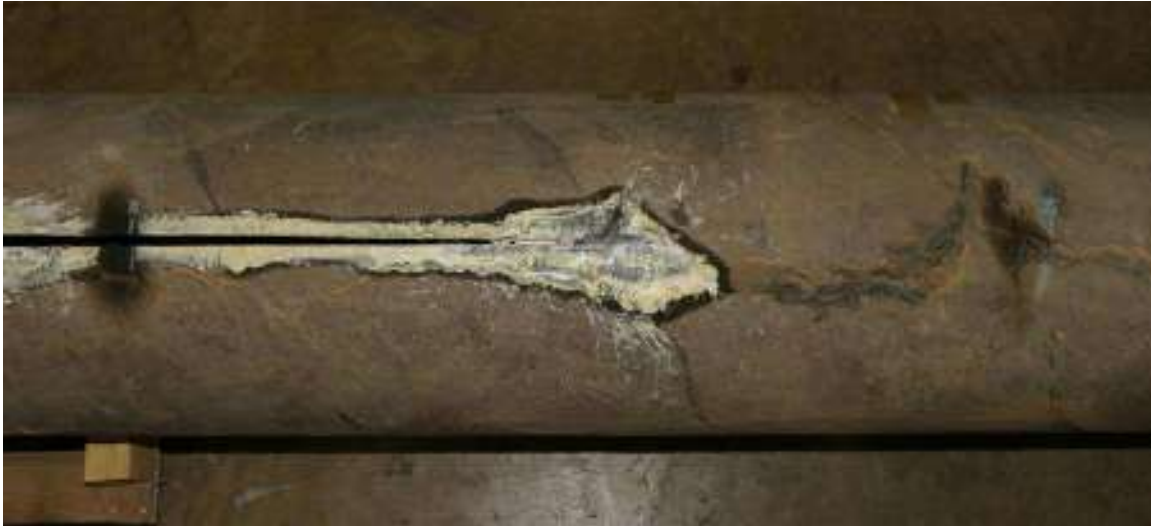
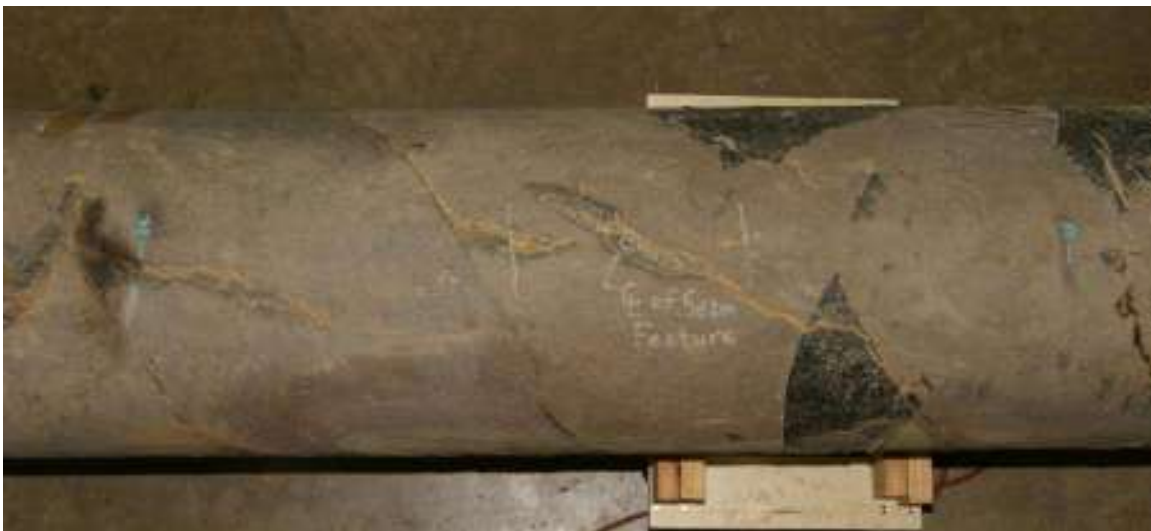
As-received Condition of the Coating			
Circumferential Location	Distance from North Girth Weld	Split Width Maximum	Split Depth Maximum
10:30 o'clock to 1:30 o'clock	20' to 24'	0.5"	0.10"
	24' to 28'	1.5"	0.10"

The photographs display overall top views of the fractured pipe from 20' south to 24' south of the north girth weld, and from 24' south to 28' south of the north girth weld, respectively, in the as-received condition prior to removing the coating. At approximately 22' south of the girth weld, the fracture in the ERW seam turned into the pipe material, progressing several inches prior to terminating. The damaged area of coating near the pipe fracture extended longitudinally past the fracture tip several feet.

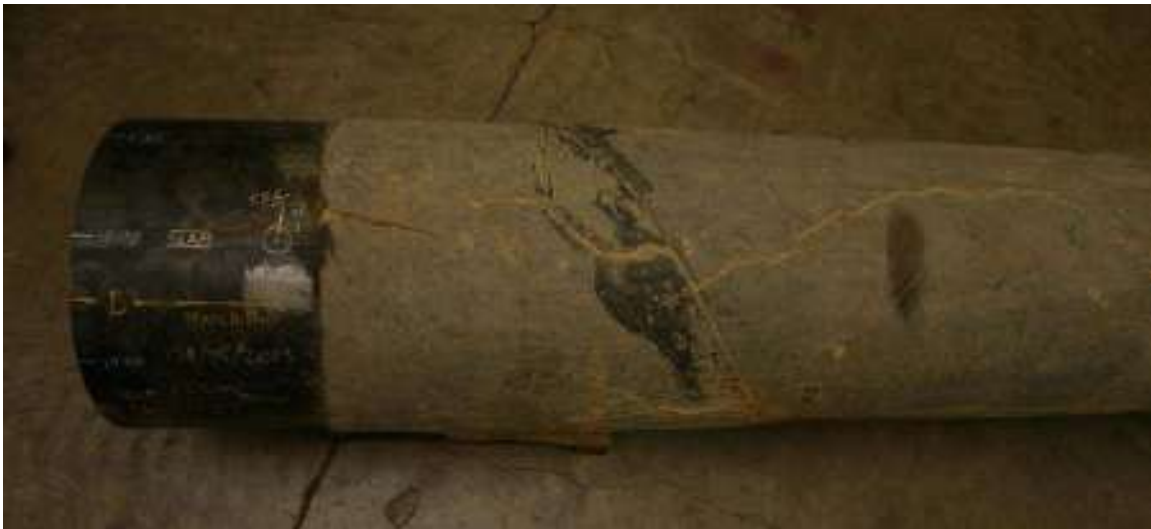
As-received Condition of the Coating			
Circumferential Location	Distance from North Girth Weld	Split Width Maximum	Split Depth Maximum
10:30 o'clock to 1:30 o'clock	28' to 31'	1"	0.05"
	31' to 35'	1"	0.15"

The photographs display overall top views of the fractured pipe from 28' south to 31' south of the north girth weld, and from 31' south to 35' south of the north girth weld, respectively, in the as-received condition prior to removing the coating. The approximately 49' 9-1/2" long pipe was sectioned in the field transversely approximately 31' south of the north girth weld. The coating was removed in the field approximately 13" in either direction from the transverse cut prior to sectioning.

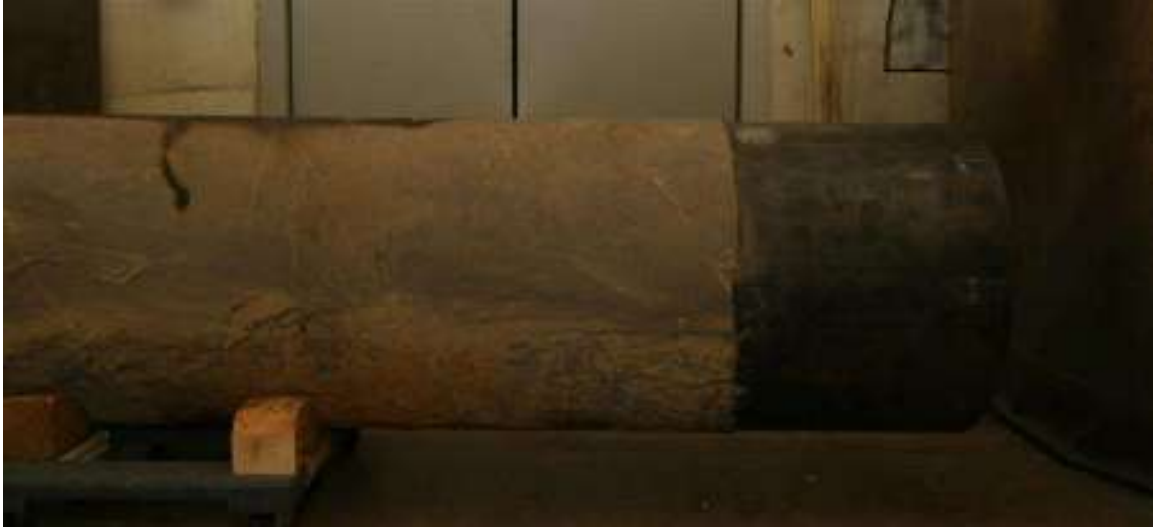
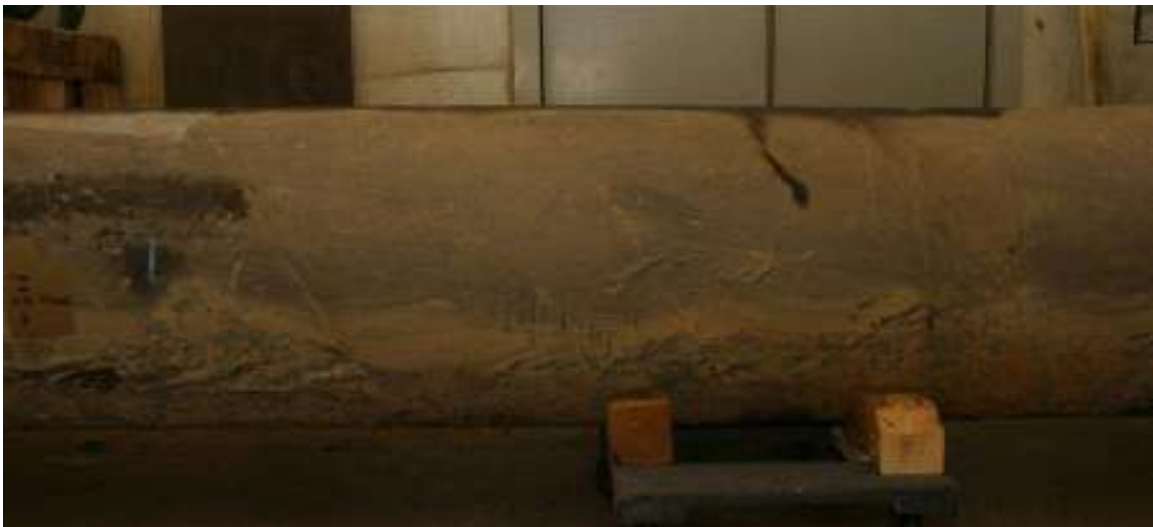
The photographs display overall views of the west side of the pipe from 7:30 to 10:30 o'clock, adjacent to the fractured pipe from approximately 3' north of the girth weld (-3') to the center of the north girth weld (0'), and the fractured pipe from the center of the girth weld to 4' south of the north girth weld (+4'), respectively, in the as-received condition prior to removing the coating. The lower half of the pipe contains disbonded and wrinkled coating.

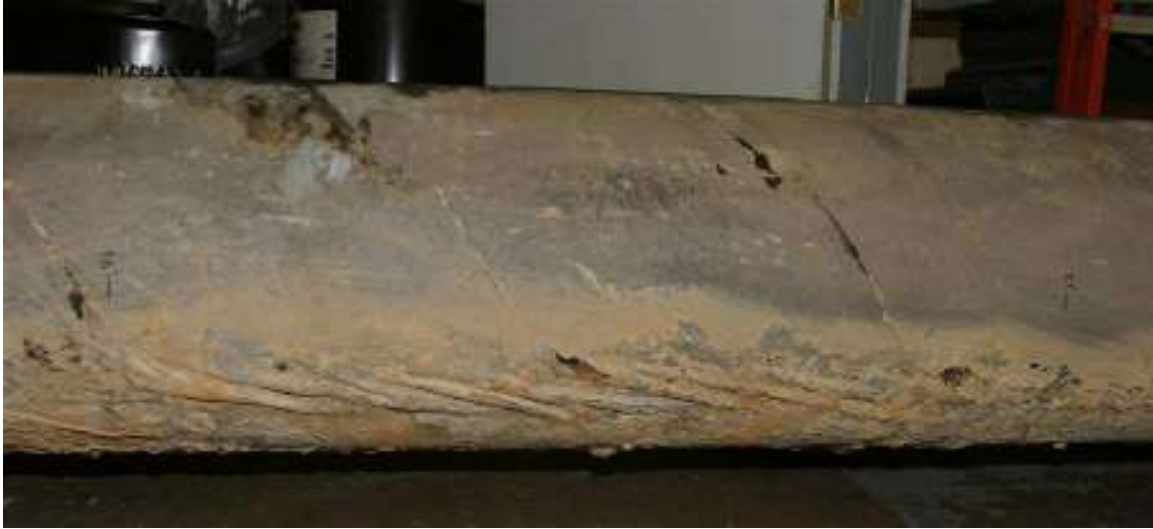
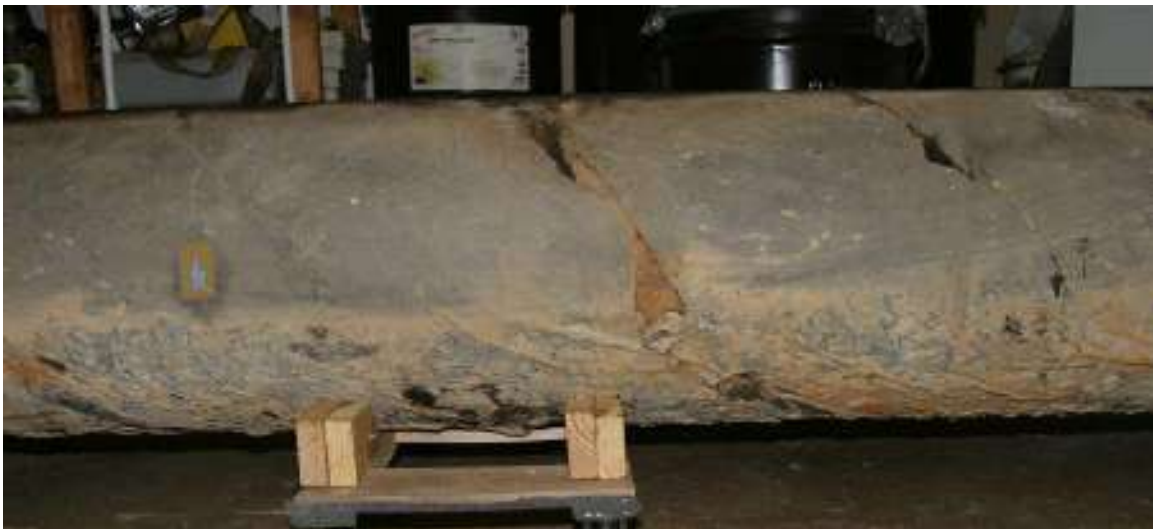
The photographs display overall views of the west side between 7:30 and 10:30 of the fractured pipe from 12' south to 16' south of the north girth weld, and from 16' south to 20' south of the north girth weld, respectively, in the as-received condition prior to removing the coating. The lower half of the pipe contains disbonded and wrinkled coating, along with some openings in the coating.

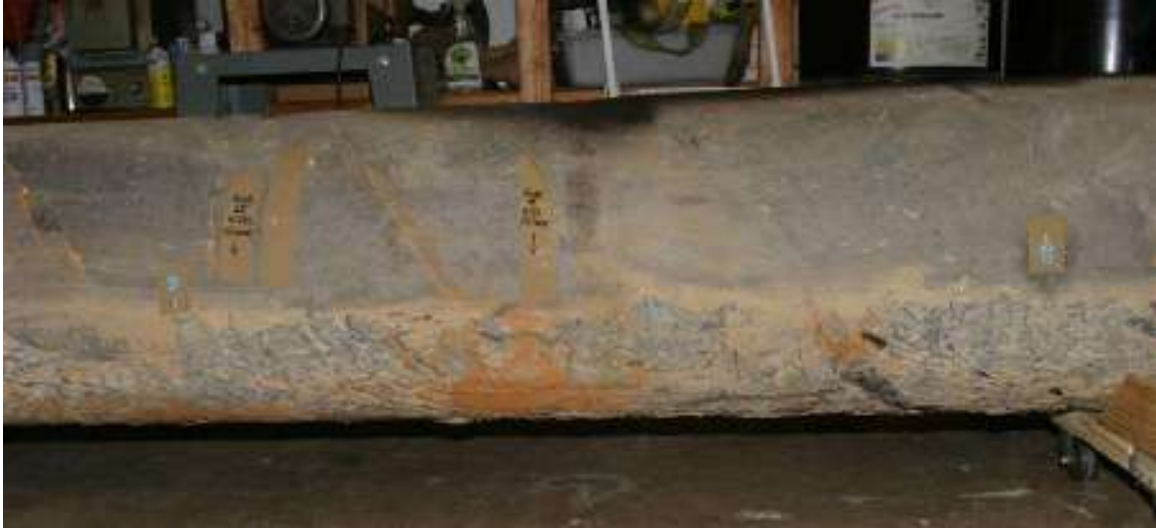
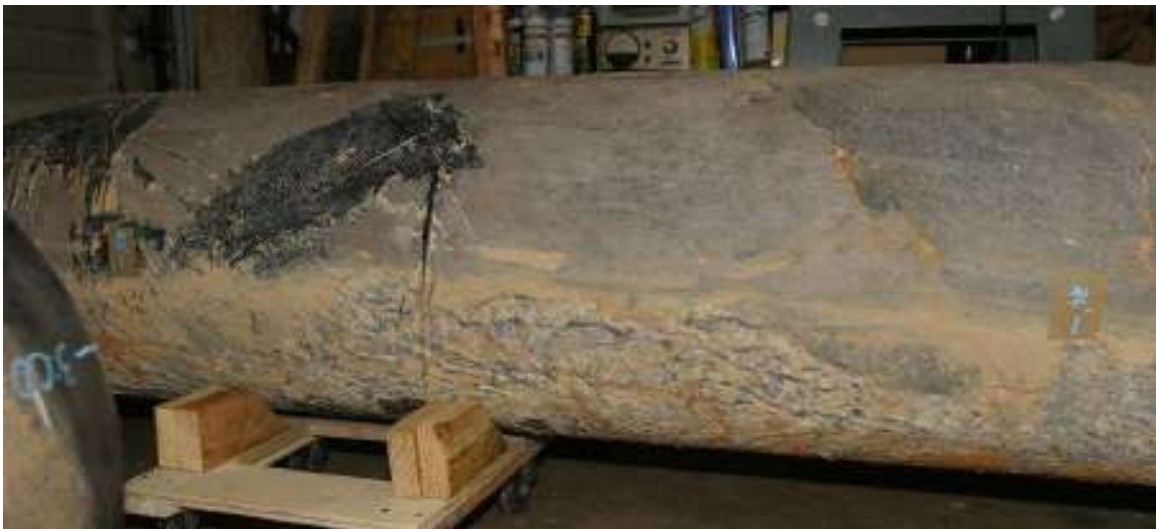
The photographs display overall views of the west side from 7:30 to 10:30 of the fractured pipe from 20' south to 24' south of the north girth weld, and from 24' south to 28' south of the north girth weld, respectively, in the as-received condition prior to removing the coating. The lower half of the pipe contains disbonded and wrinkled coating.

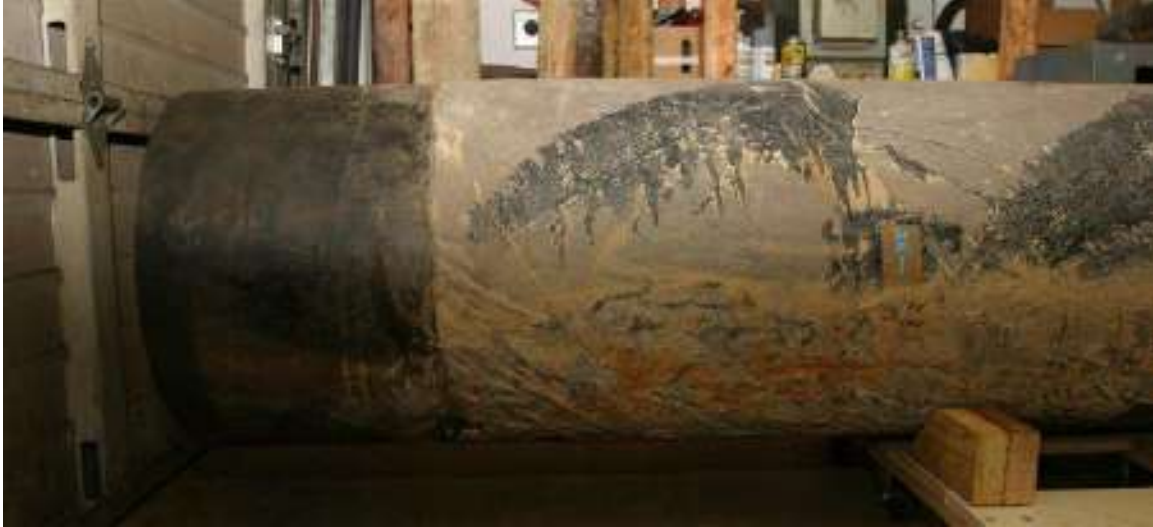
The photographs display overall views of the west side from 7:30 to 10:30 of the fractured pipe from 28' south to 31' south of the north girth weld, and from 31' south to 35' south of the north girth weld, respectively, in the as-received condition prior to removing the coating. The pipe had been sectioned transversely approximately 31' south of the north girth weld. The lower half of the pipe contains disbonded and wrinkled coating.

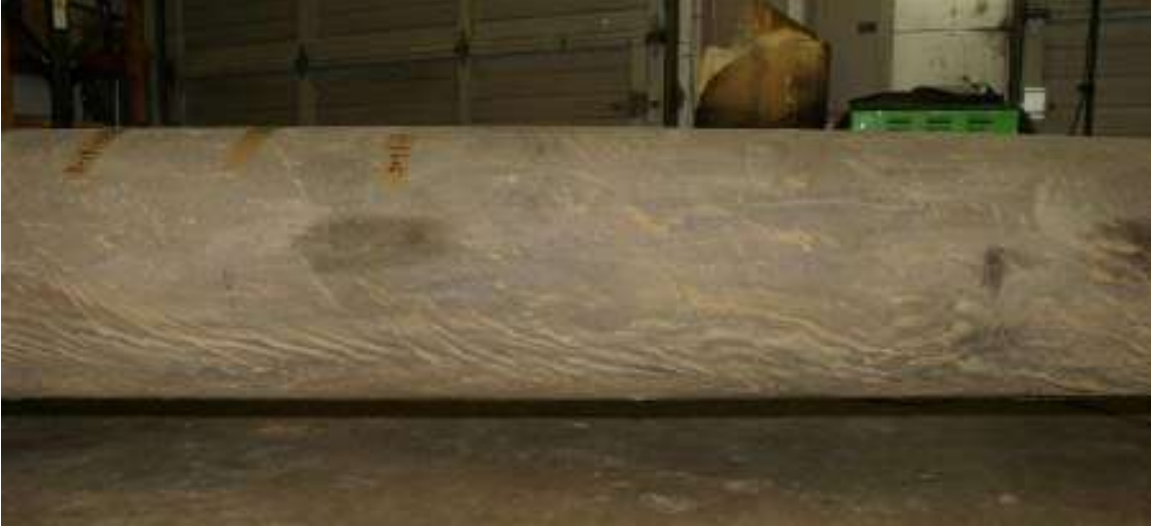
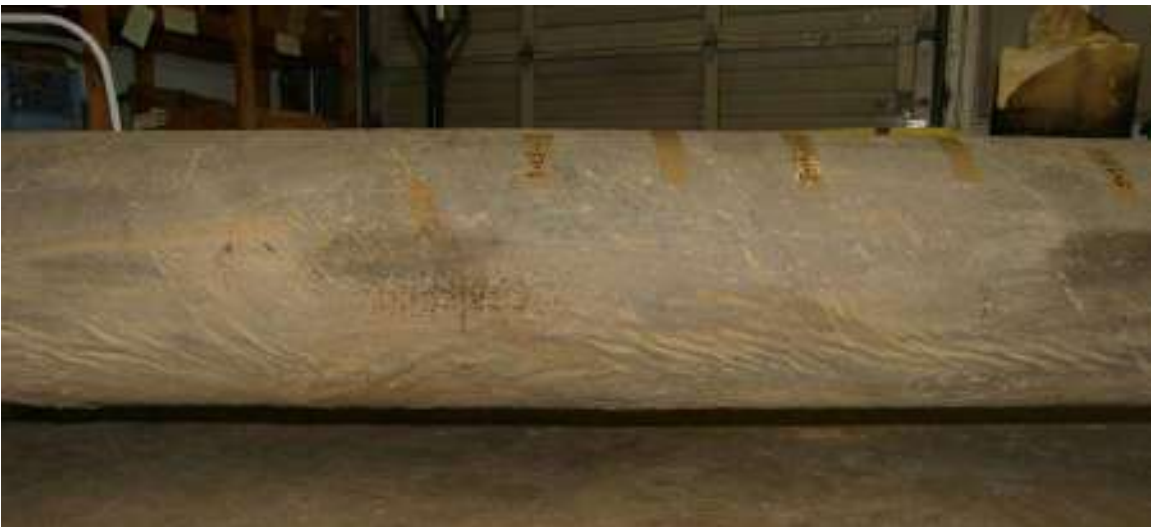
The photographs display overall views of the west side between 7:30 and 10:30 of the fractured pipe from 35' south to 39' south of the north girth weld, and from 39' south to 43' south of the north girth weld, respectively, in the as-received condition prior to removing the coating. The lower half of the pipe contains disbonded and wrinkled coating.

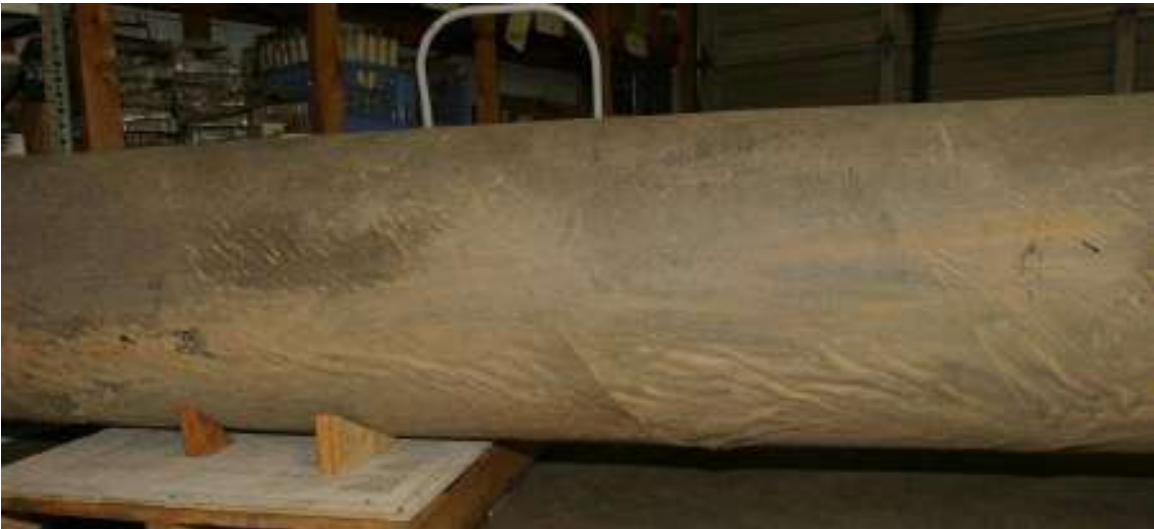
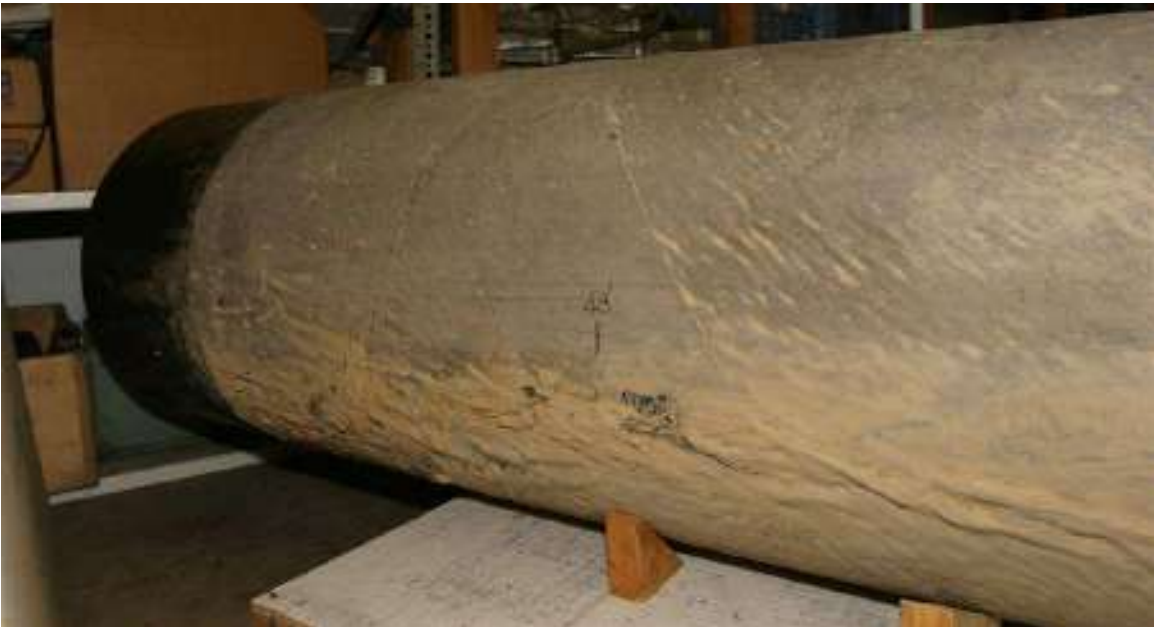
The photographs display overall views of the west side from 7:30 to 10:30 of the fractured pipe and adjacent intact pipe from 43' south to 47' south of the north girth weld, and from 47' south to 51' south of the north girth weld, respectively, in the as-received condition prior to removing the coating. The coating had been removed from the adjacent intact pipe prior to allow for sectioning. The lower half of the pipe contains disbonded and wrinkled coating.

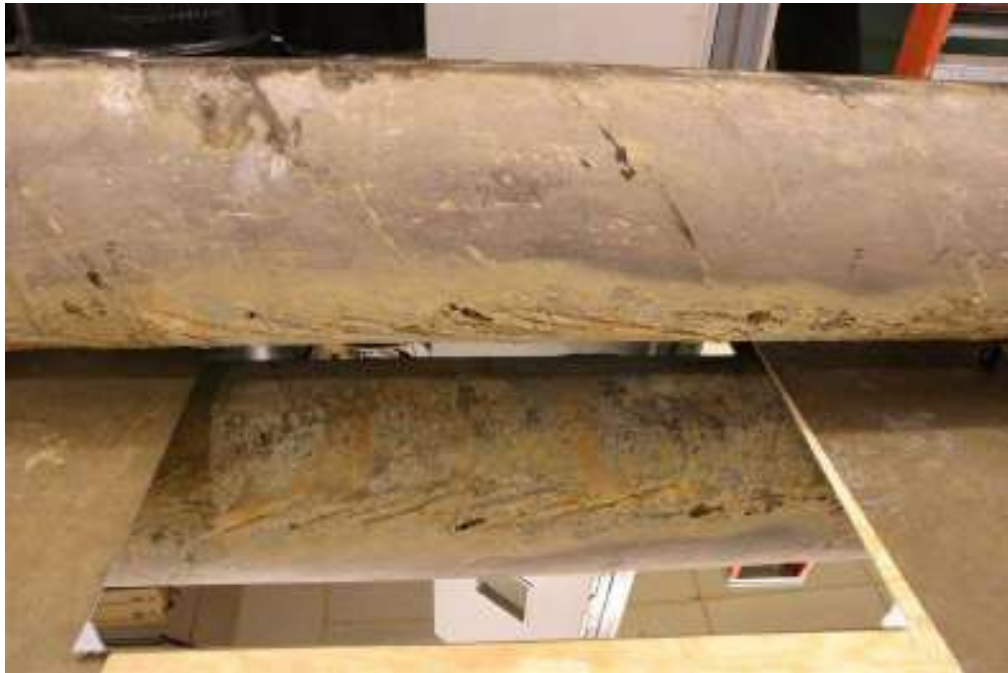
The photographs display overall bottom views of the fractured pipe from 4:30 to 7:30 from 12' south to 16' south of the north girth weld, and from 16' south to 20' south of the north girth weld, respectively, in the as-received condition prior to removing the coating. The coating on the lower half of the pipe contains wrinkles and has sagged.

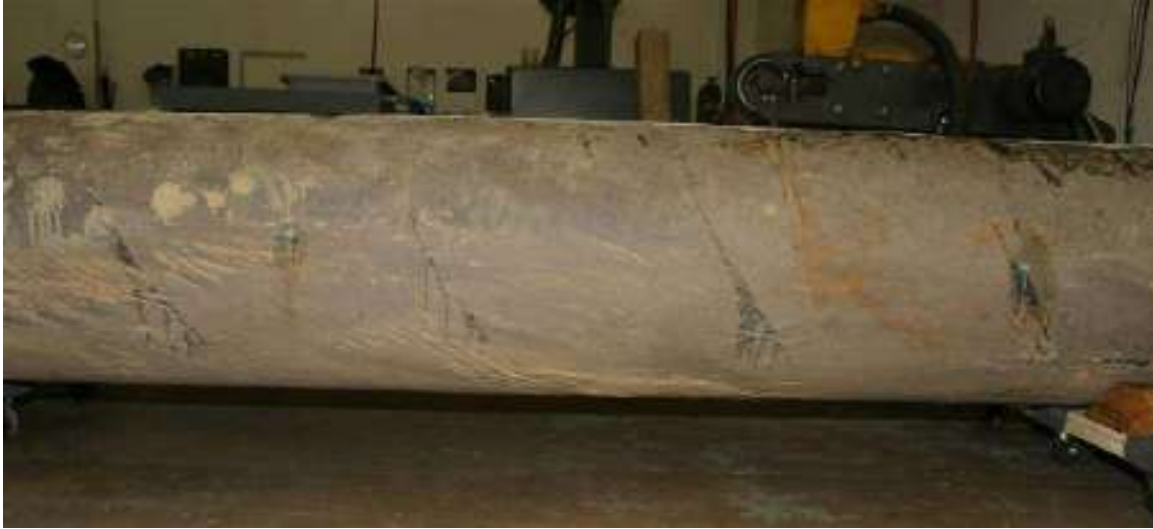
The photographs display overall views of the east side of a pipe from 1:30 to 4:30 adjacent to the fractured pipe from approximately 3' north of the north girth weld (-3') to the center of the north girth weld (0'), and the fractured pipe from the center of the north girth weld to 4' south of the north girth weld (+4'), respectively, in the as-received condition prior to removing the coating. The lower half of the pipe contains wrinkled coating.

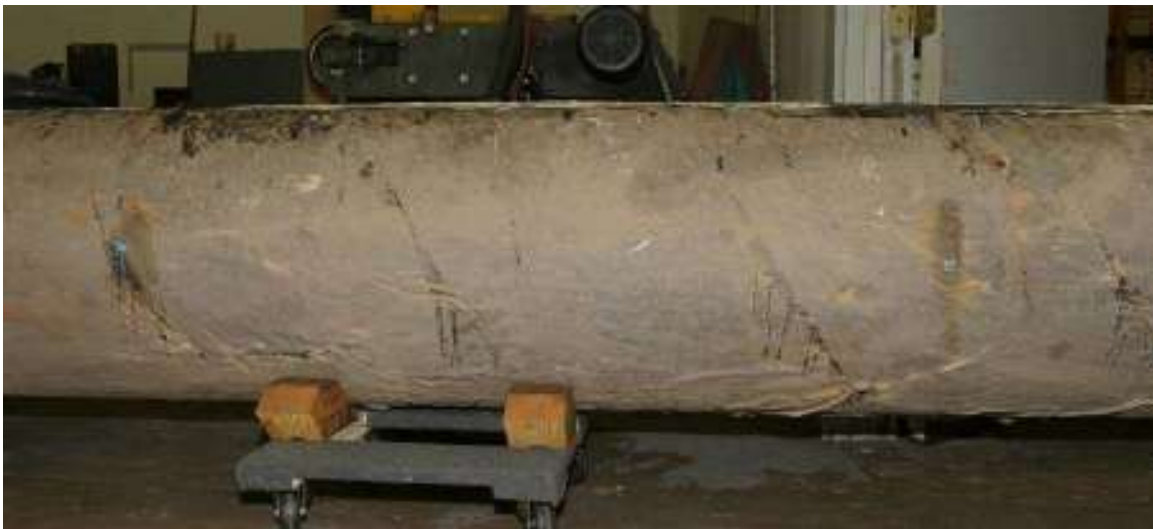
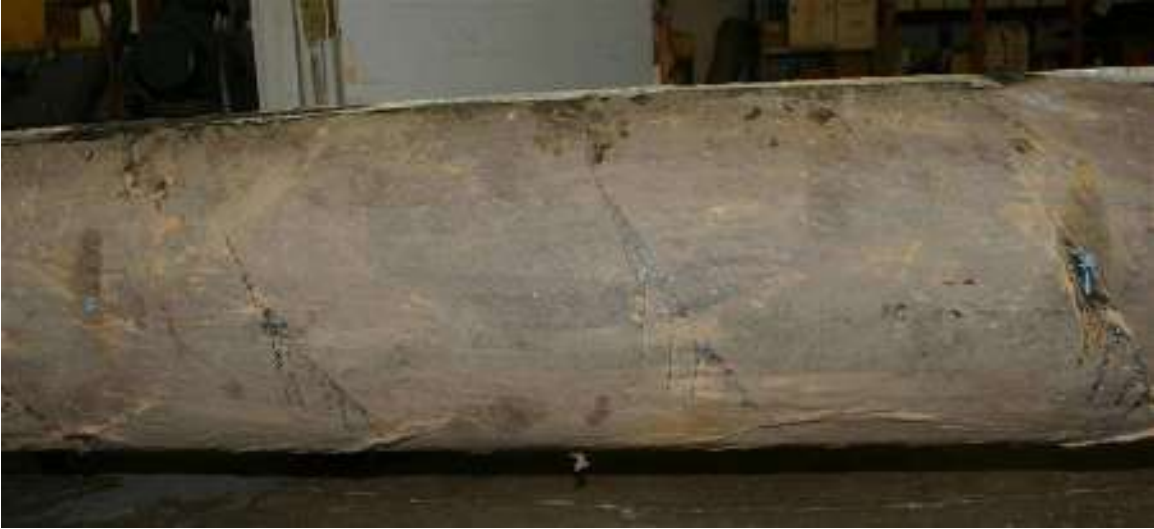
The photographs display overall views of the east side of the fractured pipe from 1:30 to 4:30 from 4' south to 8' south of the north girth weld, and from 8' south to 12' south of the north girth weld, respectively, in the as-received condition prior to removing the coating. The lower half of the pipe contains sagging and wrinkled coating.

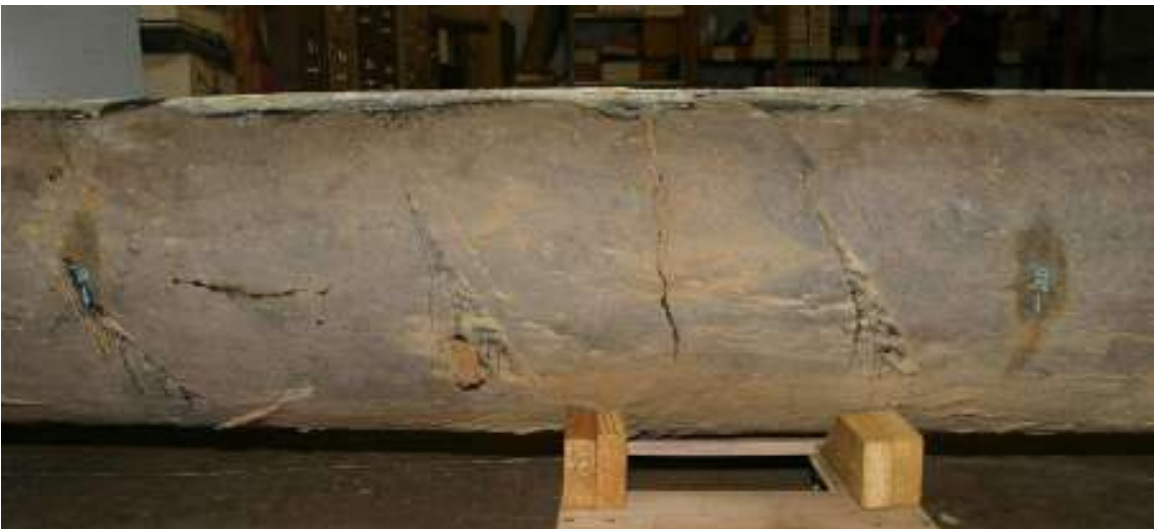
The photographs display overall views of the east side of the fractured pipe from 1:30 to 4:30 from 12' south to 16' south of the north girth weld, and from 16' south to 20' south of the north girth weld, respectively, in the as-received condition prior to removing the coating. The lower half of the pipe contains sagging and wrinkled coating.

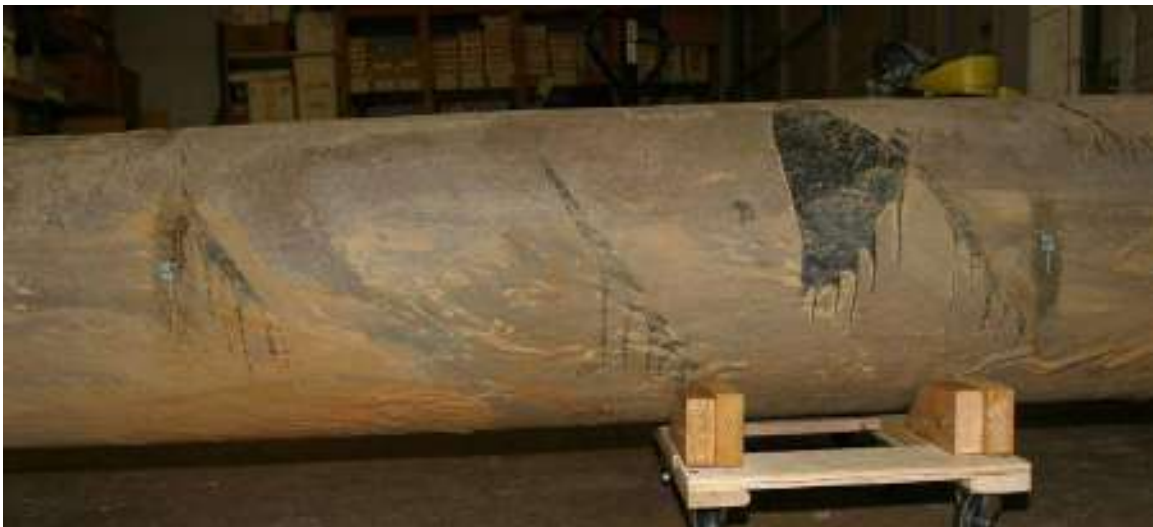
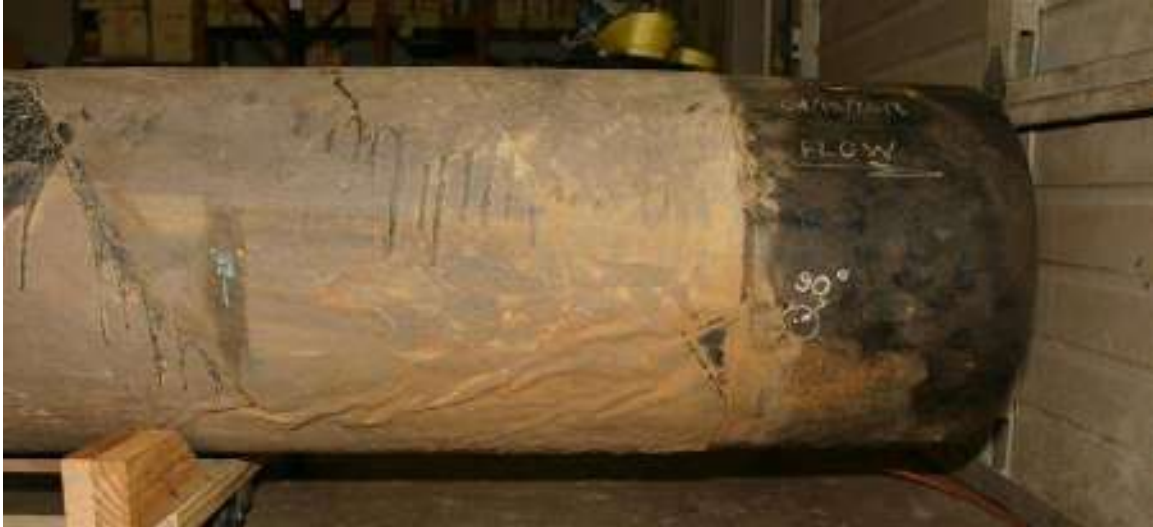
The photographs display overall views of the east side of the fractured pipe from 1:30 to 4:30 from 20' south to 24' south of the north girth weld, and from 24' south to 28' south of the north girth weld, respectively, in the as-received condition prior to removing the coating. The coating on the lower half of the pipe contains sagging and wrinkles.

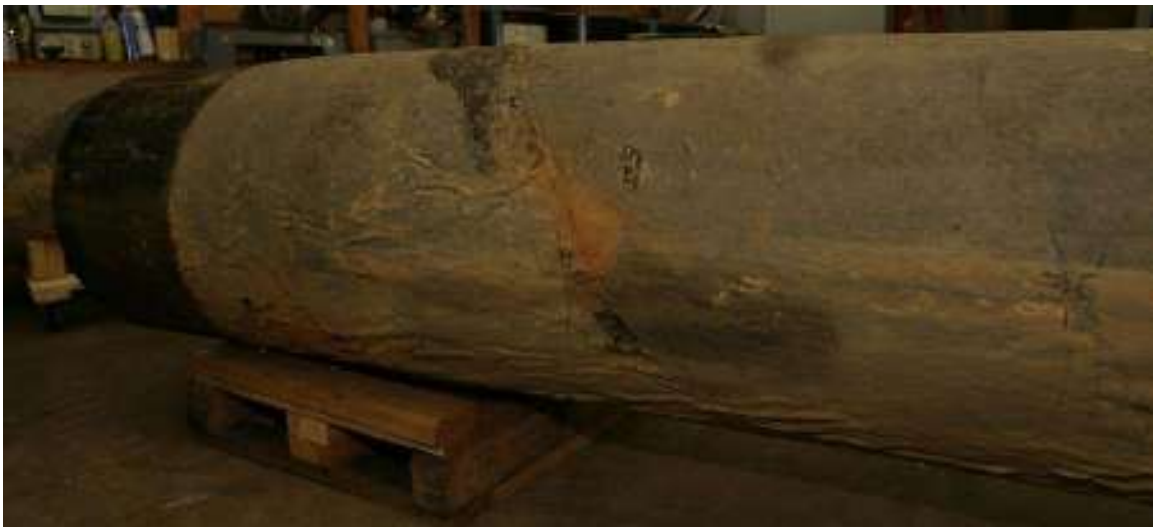
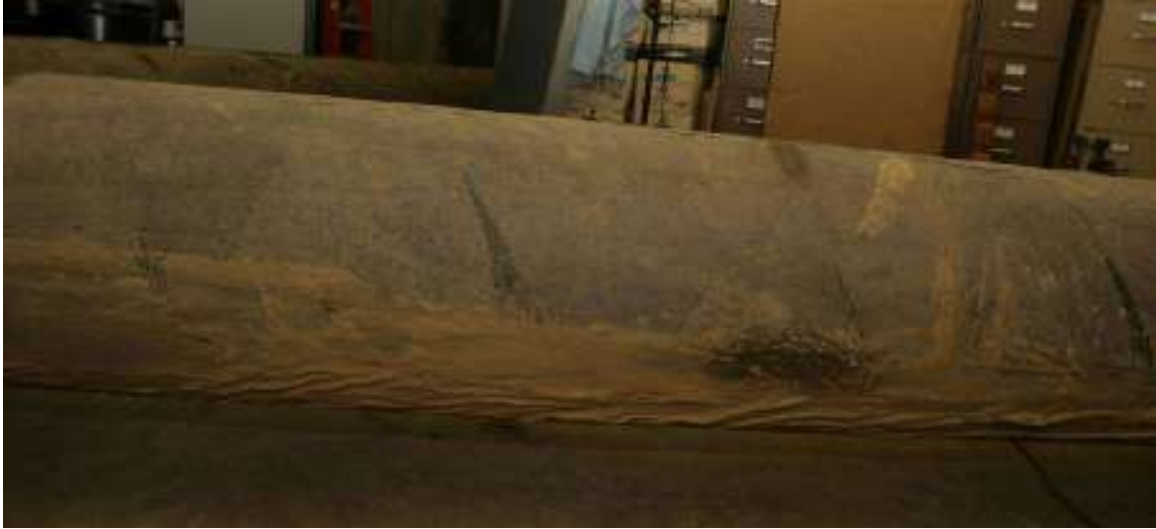
The photographs display overall views of the east side of the fractured pipe from 1:30 to 4:30 from 28' south to 31' south of the north girth weld, and from 31' south to 35' south of the north girth weld, respectively, in the as-received condition prior to removing the coating. The lower half of the pipe contains sagging and wrinkled coating.
