*METALLURGICAL INVESTIGATION OF A
FRACTURED SECTION OF THE 20" O.D.
PIPELINE AT MILEPOST 314.77 IN THE
CONWAY TO CORSICANA SEGMENT OF
THE PEGASUS CRUDE OIL PIPELINE*

REPORT NO. 64961, REV. 1

Prepared for
ExxonMobil Pipeline Company and the
Pipeline and Hazardous Materials Safety Administration
pursuant to Corrective Action Order CPF 4-2013-5006H

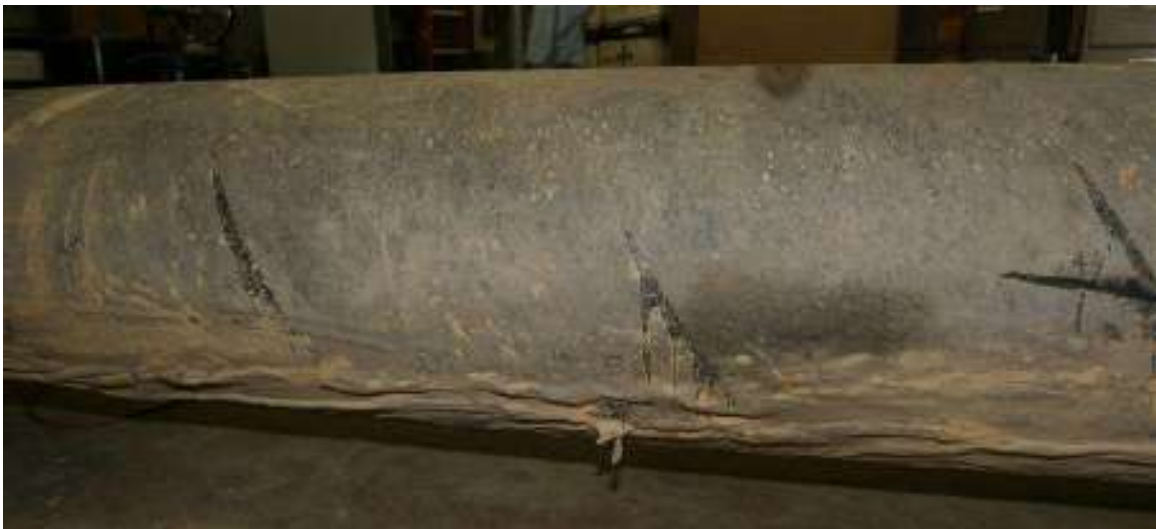
The photographs display overall views of the east side of the fractured pipe from 1:30 to 4:30 from 35' south to 39' south of the north girth weld, and from 39' south to 43' south of the north girth weld, respectively, in the as-received condition prior to removing the coating. The coating on the lower half is wrinkled and sagging.

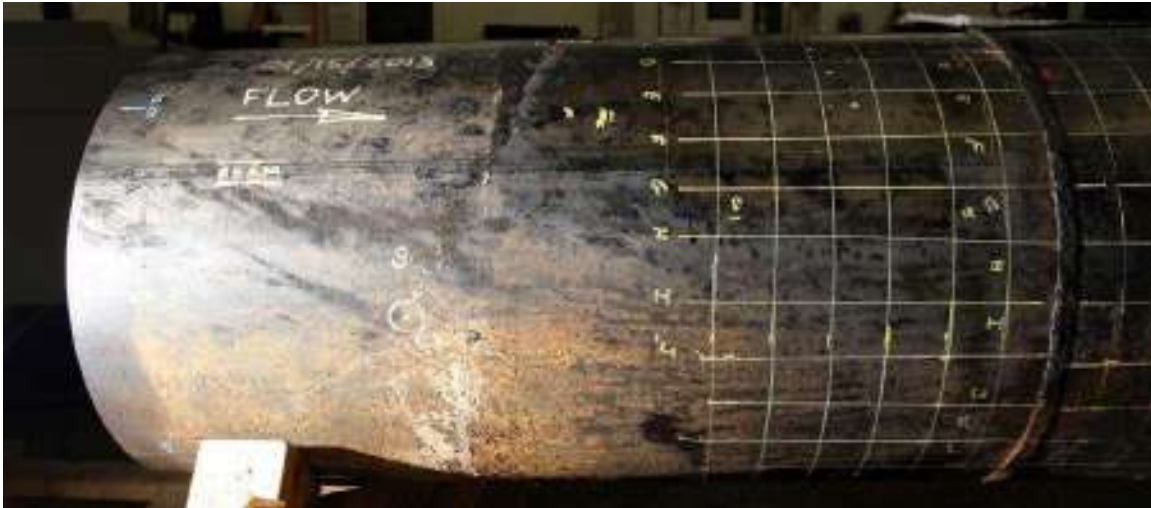
The photographs display overall views of the east side of the fractured pipe from 1:30 to 4:30 and adjacent intact pipe from 43' south to 47' south of the north girth weld, and from 47' south to 51' south of the north girth weld, respectively, in the as-received condition prior to removing the coating. The coating had been removed from the adjacent intact pipe prior to sectioning. The coating on the lower half of the pipe is wrinkled and sagging.

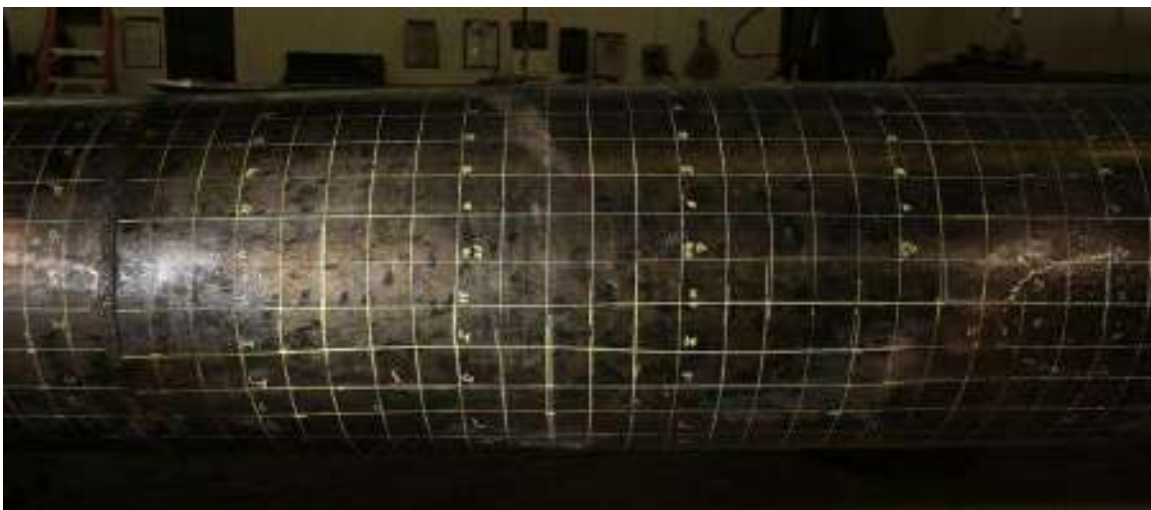
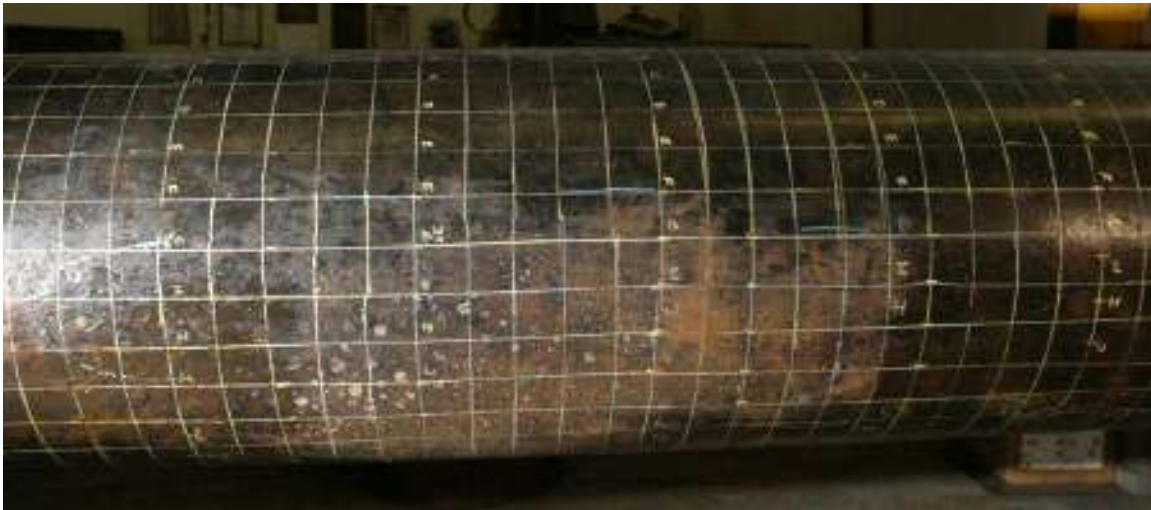
Circumferential Location	Distance from North Girth Weld	Depth of Corrosion Pitting		
		Minimum	Average	Maximum
All	-3' to 0'	No Corrosion Pitting Visible		
7:26 o'clock to 10:07 o'clock	0' to 4'	0.006"	0.017"	0.029"

The photographs display overall views of the west side of the pipe adjacent to the fractured area of the pipe, from approximately 3' north of the north girth weld (-3') to the center of the girth weld (0'), and the fractured pipe from the center of the girth weld to 4' south of the girth weld (+4'), respectively, after the removal of the coating. The lower half of the pipe shows corrosion pitting on the O.D. surface where the coating had wrinkled and sagged.

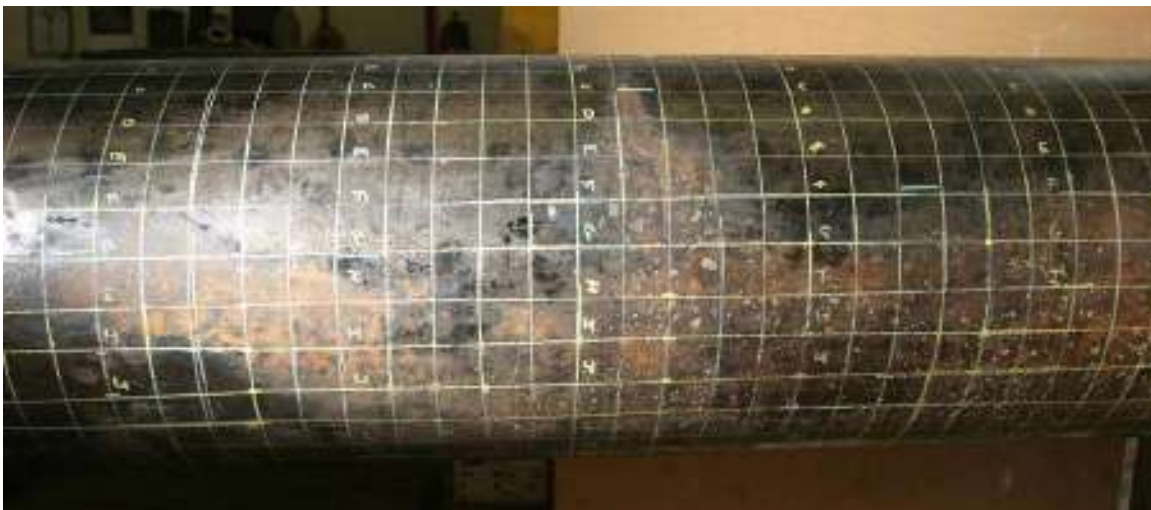
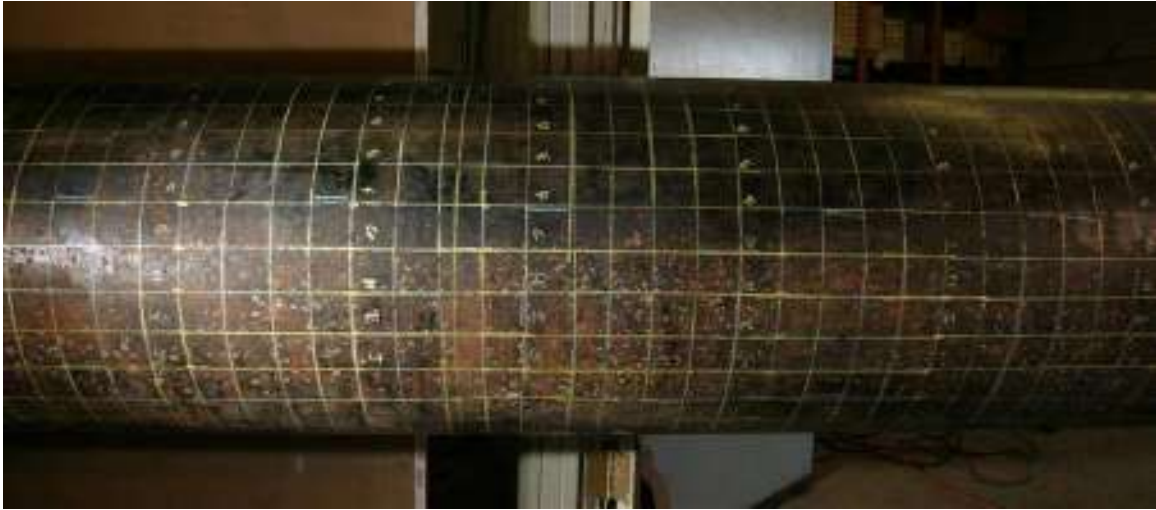
Circumferential Location	Distance from North Girth Weld	Depth of Corrosion Pitting		
		Minimum	Average	Maximum
6:41 o'clock to 10:07 o'clock	4' to 8'	0.002"	0.013"	0.037"
7:03 o'clock to 11:16 o'clock	8' to 12'	0.002"	0.011"	0.026"

The photographs display overall views of the west side of the fractured pipe from 4' south to 8' south of the north girth weld, and 8' south to 12' south of the north girth weld, respectively, after the removal of the coating. The lower half of the pipe shows corrosion pitting on the O.D. surface where the coating had wrinkled and sagged.

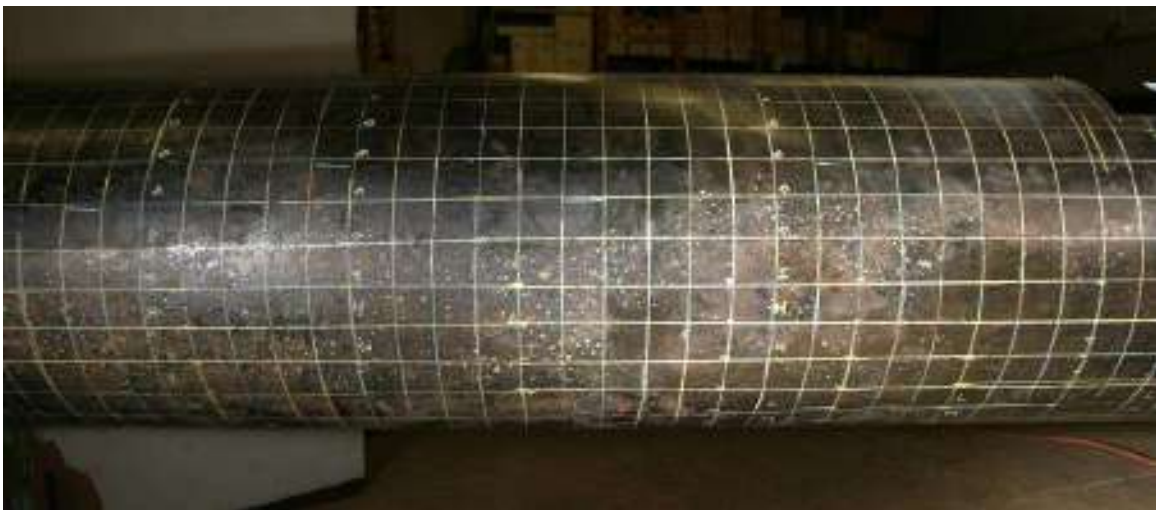
Circumferential Location	Distance from North Girth Weld	Depth of Corrosion Pitting		
		Minimum	Average	Maximum
6:29 o'clock to 9:55 o'clock	12' to 16'	0.003"	0.017"	0.031"
6:52 o'clock to 10:07 o'clock	16' to 20'	0.006"	0.012"	0.021"

The photographs display overall views of the west side of the fractured pipe from 12' south to 16' south of the north girth weld, and 16' south to 20' south of the north girth weld, respectively, after the removal of the coating. The lower half of the pipe shows corrosion pitting on the O.D. surface where the coating had wrinkled and sagged.

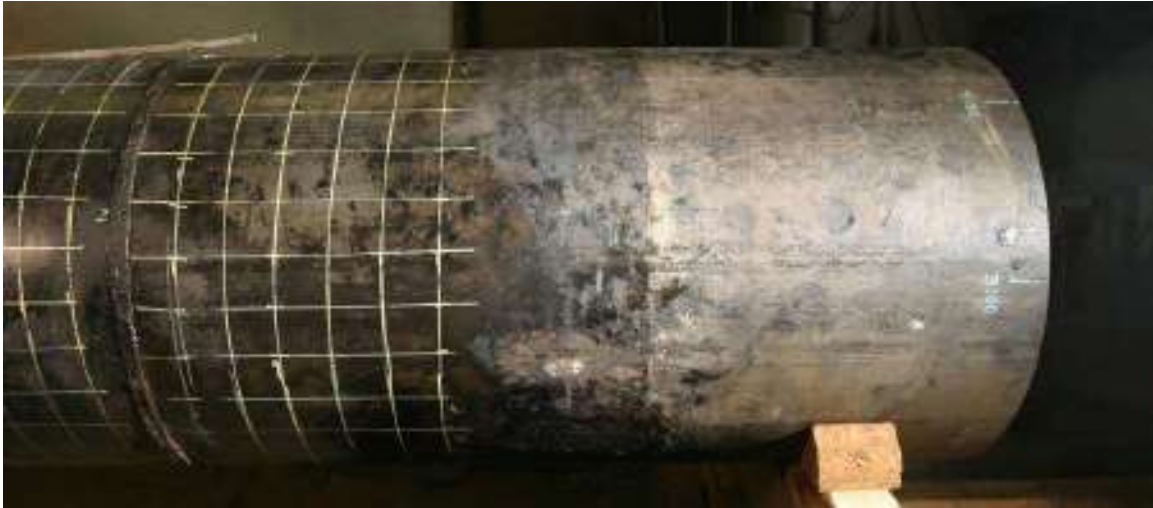
Photograph No. 74

Circumferential Location	Distance from North Girth Weld	Depth of Corrosion Pitting		
		Minimum	Average	Maximum
All	28' to 31'	No Corrosion Pitting Visible

The photograph displays an overall view of the west side of the fractured pipe from 28' south to 31' south of the north girth weld, respectively, after the removal of the coating. The fractured pipe was sectioned in the field transversely approximately 31' south of the north girth weld to allow for removal of the fractured section of pipe. No corrosion pitting is visible on the O.D. surface near the transverse cut at the south end of the fractured section of the pipe.

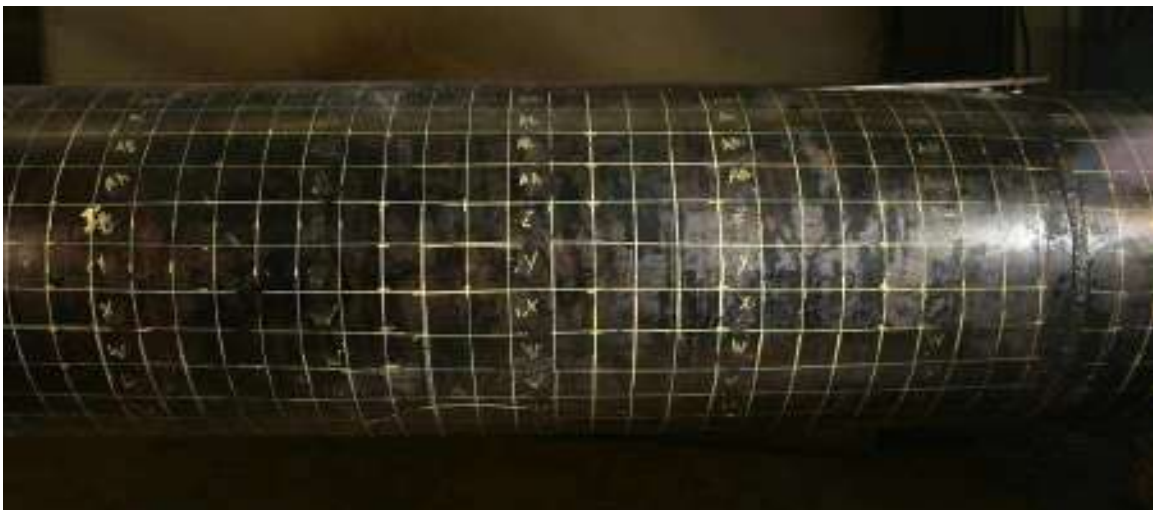
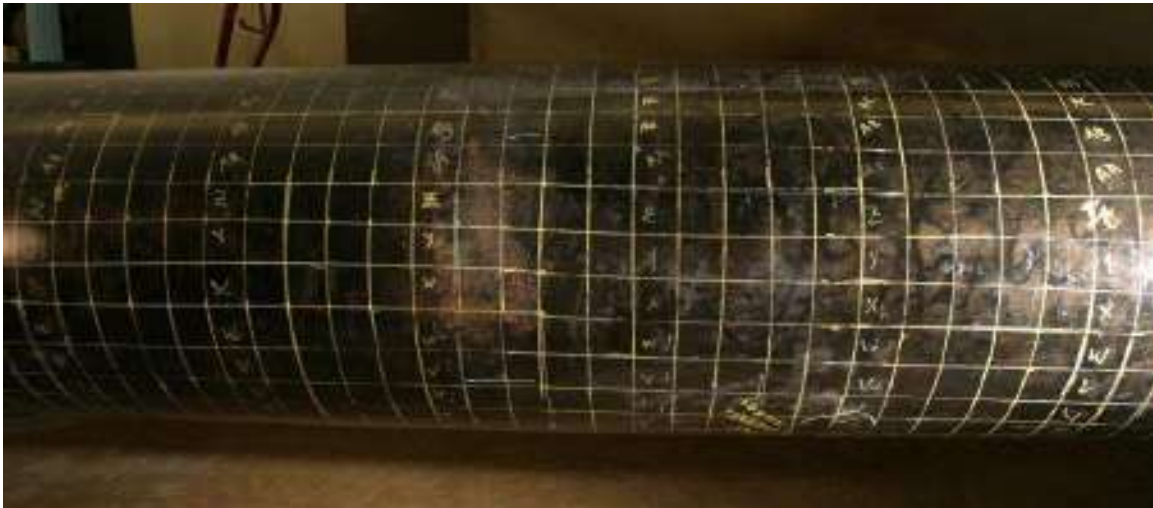
Circumferential Location	Distance from North Girth Weld	Depth of Corrosion Pitting		
		Minimum	Average	Maximum
All	-3' to 0'	No Corrosion Pitting Visible		
All	0' to 4'	No Corrosion Pitting Visible

The photographs display overall views of the east side of the pipe adjacent to the fractured pipe from approximately 3' north of the girth weld (-3') to the center of the north girth weld (0'), and the fractured pipe from the center of the girth weld to 4' south of the north girth weld (+4'), respectively, after the removal of the coating. No corrosion pitting is visible on the O.D. surfaces on the fractured or intact pipe around the north girth weld.

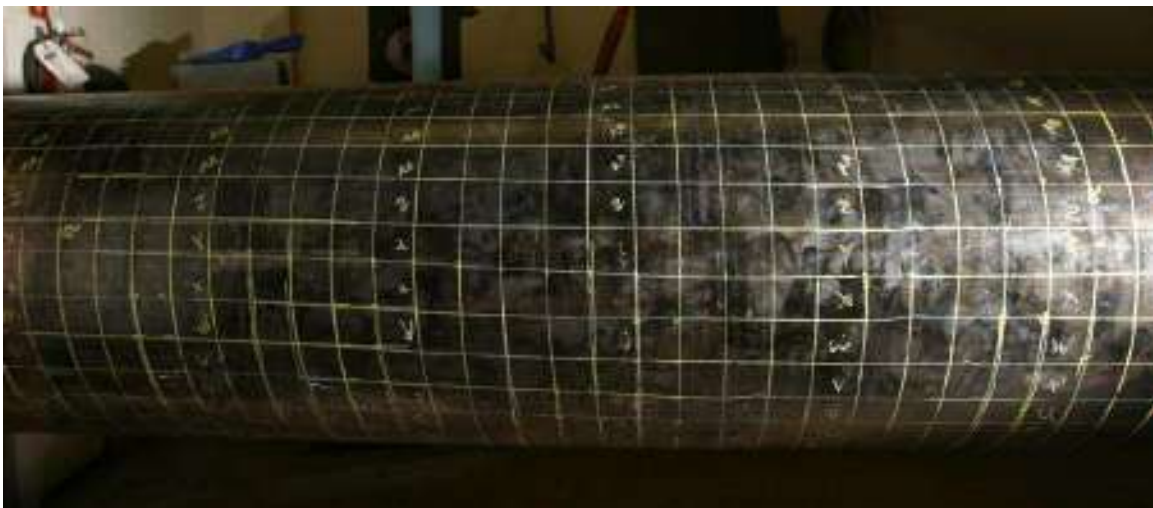
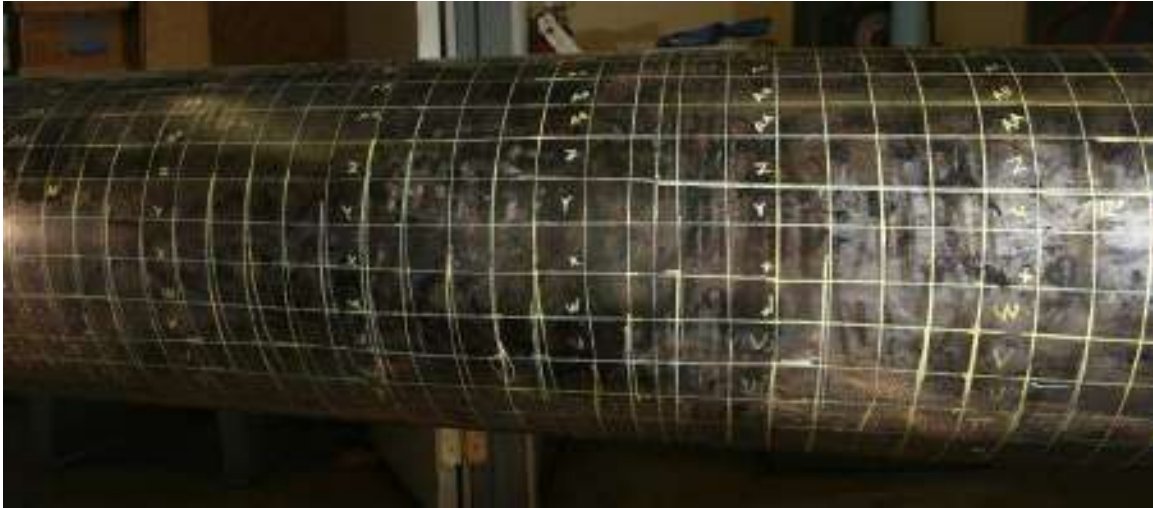
Circumferential Location	Distance from North Girth Weld	Depth of Corrosion Pitting		
		Minimum	Average	Maximum
1:31 o'clock to 3:03 o'clock	4' to 8'	0.008"	0.013"	0.026"
3:49 o'clock to 4:57 o'clock	8' to 12'	0.004"	0.011"	0.022"

The photographs display overall views of the east side of the fractured pipe from 4' south to 8' south of the north girth weld, and 8' south to 12' south of the north girth weld, respectively, after the removal of the coating. The lower half of the pipe shows corrosion pitting on the O.D. surface where the coating had wrinkled and sagged.

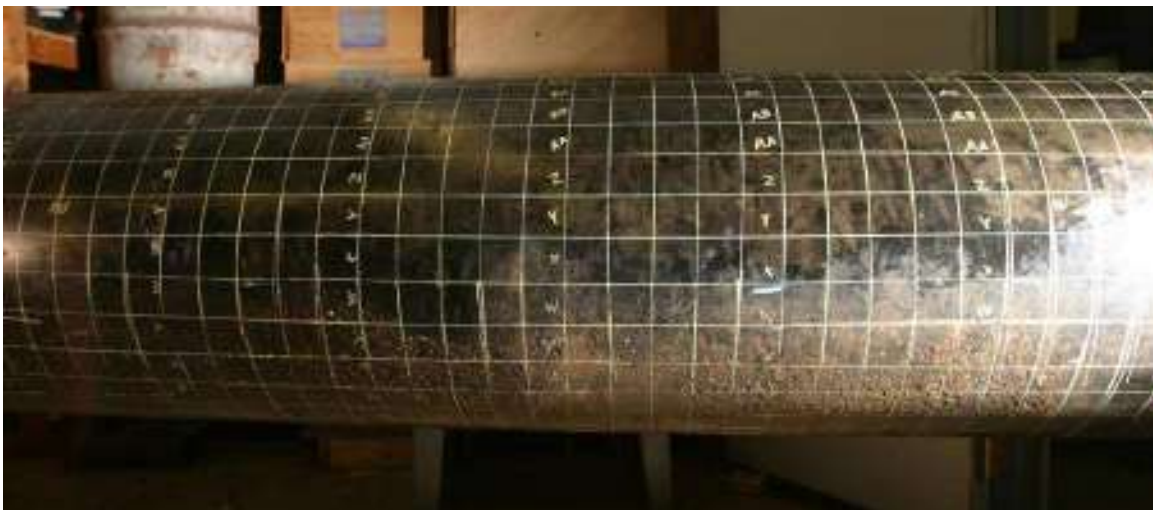
Circumferential Location	Distance from North Girth Weld	Depth of Corrosion Pitting		
		Minimum	Average	Maximum
3:03 o'clock to 4:57 o'clock	12' to 16'	0.003"	0.013"	0.033"
2:40 o'clock to 5:20 o'clock	16' to 20'	0.005"	0.015"	0.031"

The photographs display overall views of the east side of the fractured pipe from 12' south to 16' south of the north girth weld, and 16' south to 20' south of the north girth weld, respectively, after the removal of the coating. The lower half of the pipe shows corrosion pitting on the O.D. surface where the coating had wrinkled and sagged.

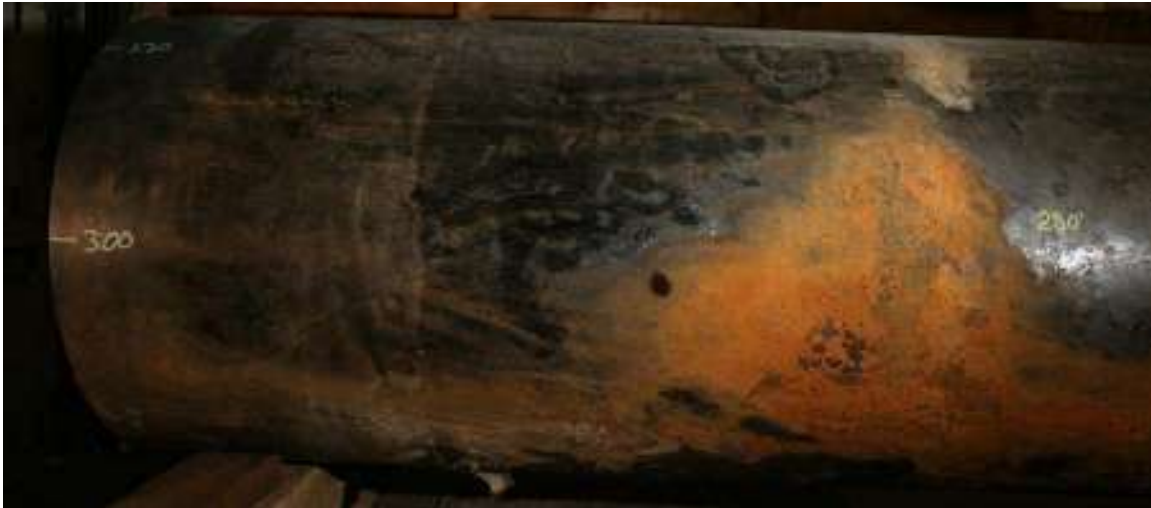
Circumferential Location	Distance from North Girth Weld	Depth of Corrosion Pitting		
		Minimum	Average	Maximum
2:40 o'clock to 4:57 o'clock	20' to 24'	0.004"	0.020"	0.033"
All	24' to 28'	No Corrosion Pitting Visible

The photographs display overall views of the east side of the fractured pipe from 20' south to 24' south of the north girth weld, and 24' south to 28' south of the north girth weld, respectively, after the removal of the coating. The lower half of the pipe shows corrosion pitting on the O.D. surface where the coating had wrinkled and sagged.

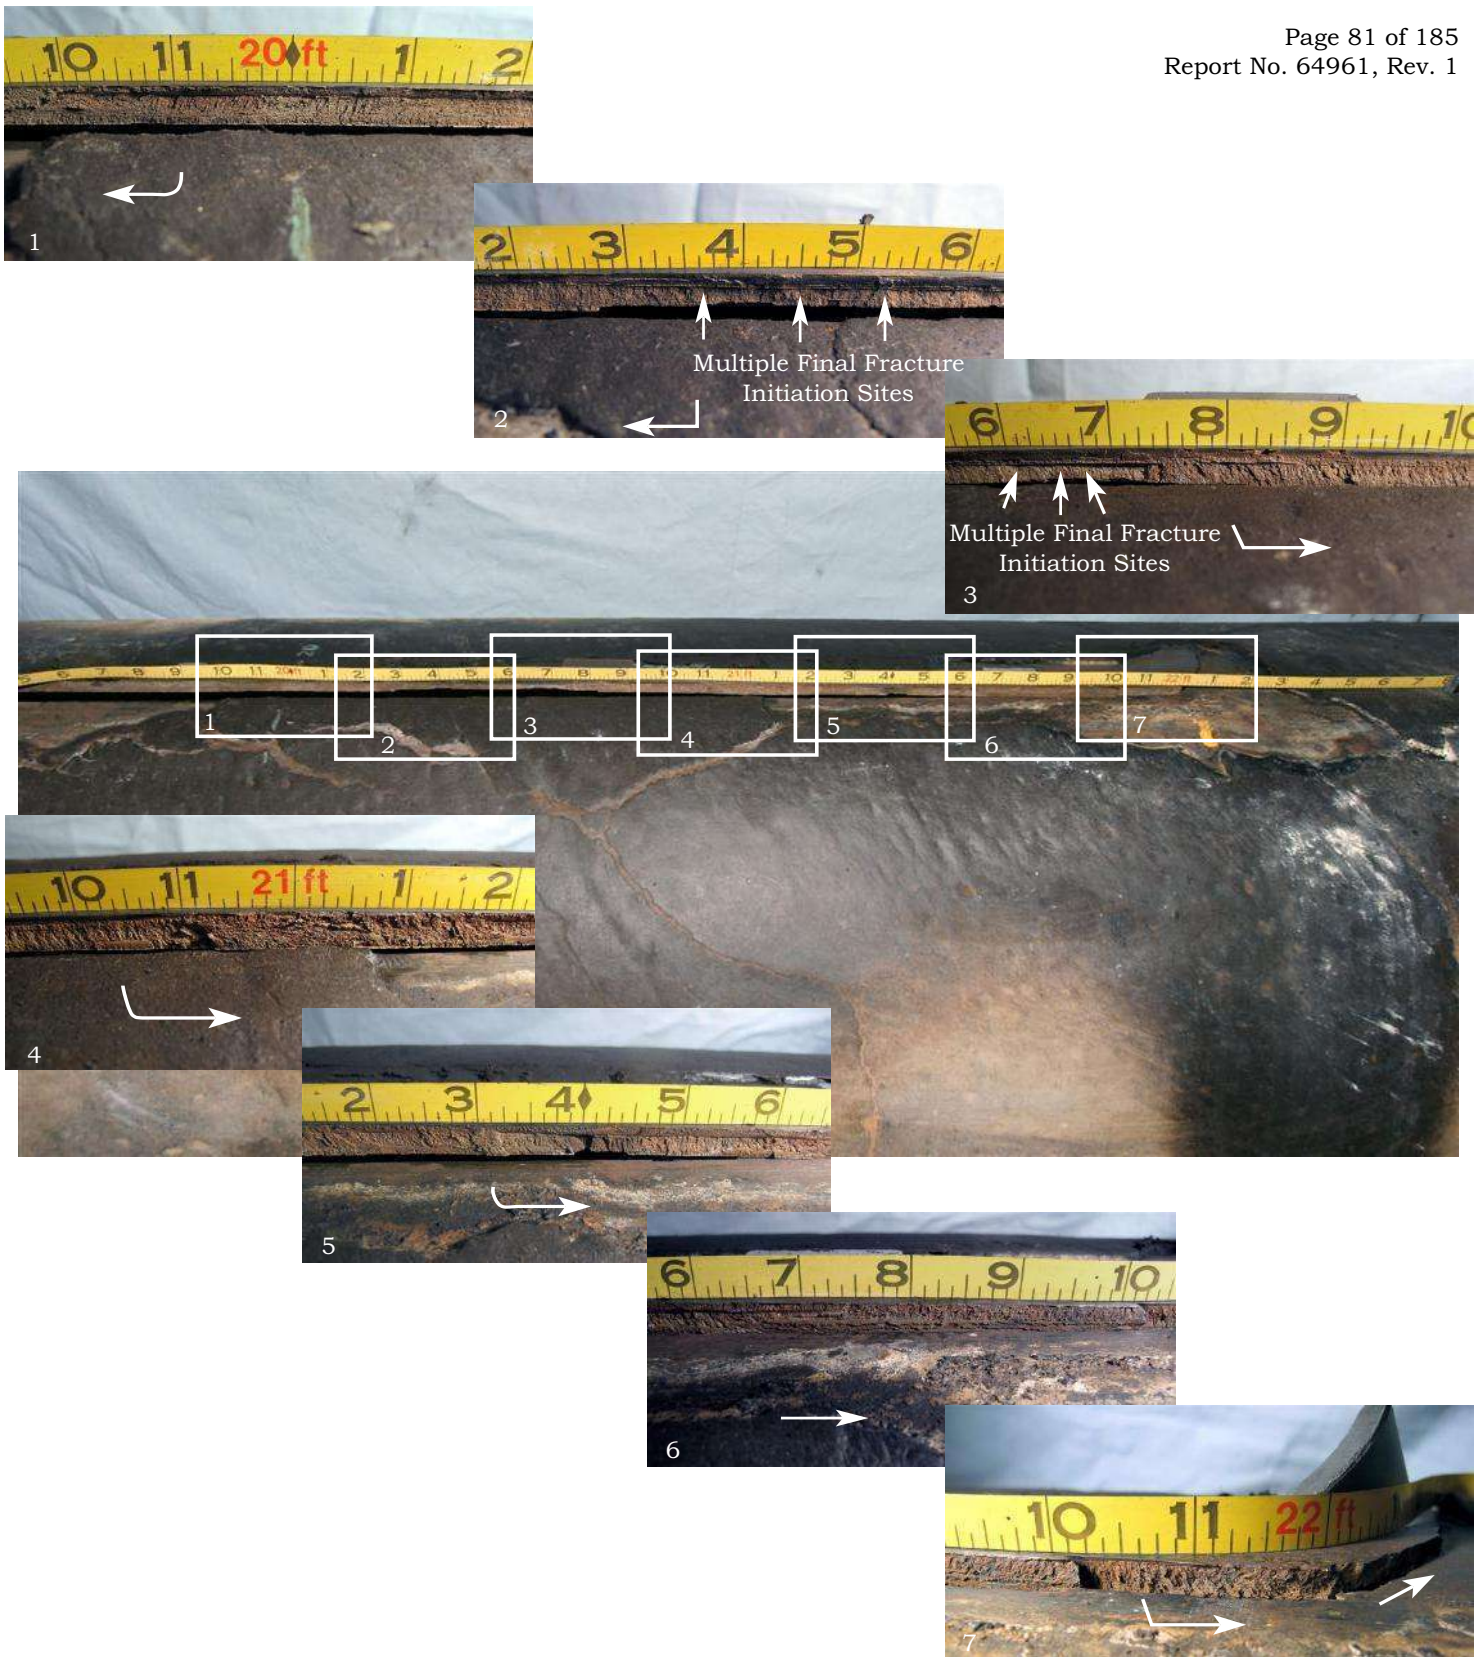
Photograph No. 87

mating fracture faces revealed fine chevrons or radial lines emanating from the fracture zone at a distance between 19' 10" and 21' 6-1/4" from the north girth weld, indicating that the final fracture, which resulted in the leakage of the crude oil, originated from this zone. Visual examination of the mating fracture faces from the distance between 1/4" and 26" south of the north girth weld revealed evidence of upturned grain flow lines or bands, and/or inclusions near the outer wall. However, there was no evidence of any chevron marks pointing to this fracture zone, indicating that the fracture did not initiate from this zone, but rather propagated through the surface imperfections. Photograph No. 86 displays overall and close-up views of the fracture origin and the tip areas, as well as field markings on the pipe.

The photographs display overall and close-up views of one of the mating fracture faces from where the final rupture had occurred, resulting in the leakage of crude oil on March 29, 2013. The fractographs show the presence of hook cracks adjacent to the fusion line near the O.D. surface along the ERW seam, between a distance of 19' 10" and 21' 6-1/4" from the north girth weld, and radial lines emanating from the ends of the hook cracks as well as chevron marks revealing the crack propagation direction, which is denoted by the arrows.

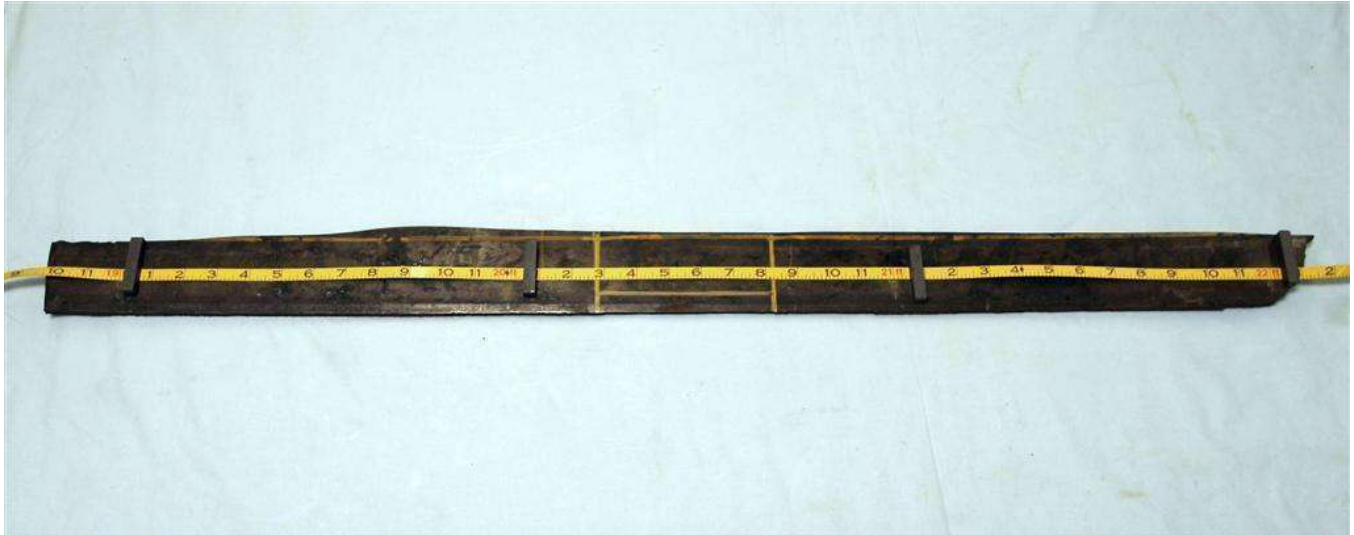
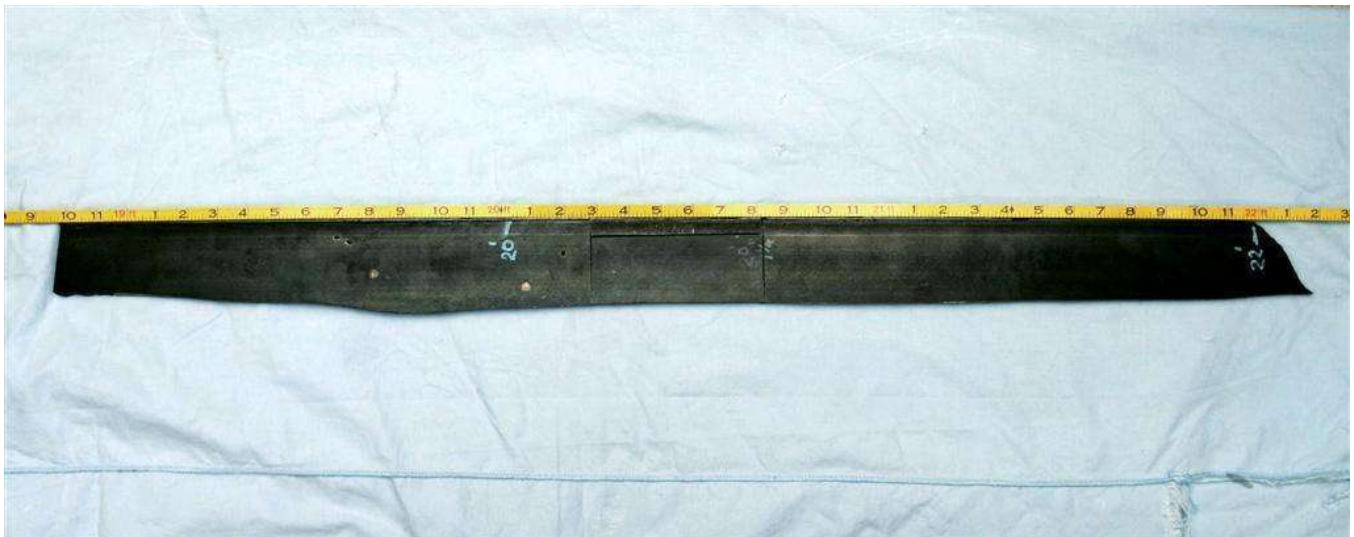
The photographs display the O.D. and I.D. surfaces of a section of the pipe that was removed between a distance of 18' 10" and 22' as measured from the north girth weld and which contained hook cracks along the ERW seam, from where the final failure initiated on March 29, 2013.

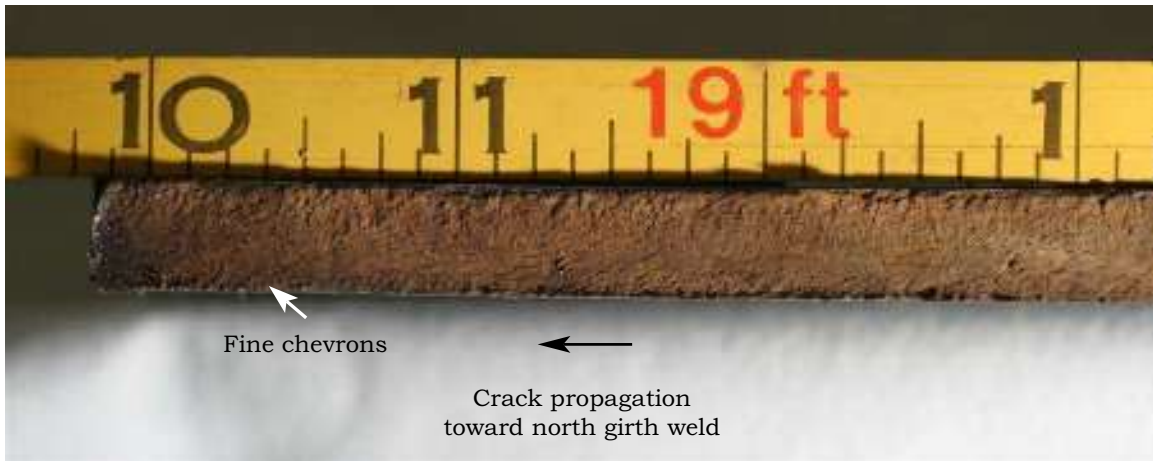
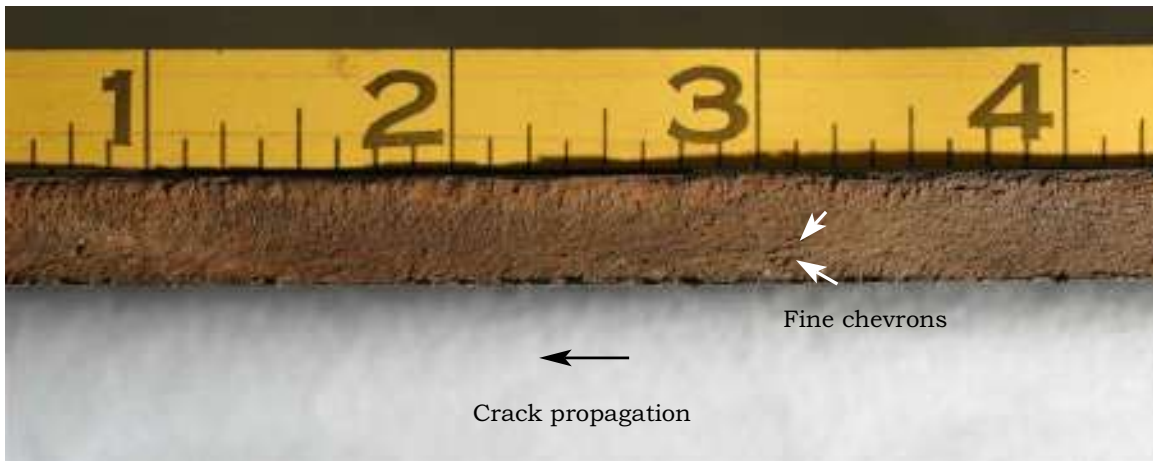
The photographs display close-up views of the fracture face between a distance of 18' 10" and 19' 4" from the north girth weld of the pipe section, showing faint evidence of chevrons pointing toward the right (south end) near the fracture origins.

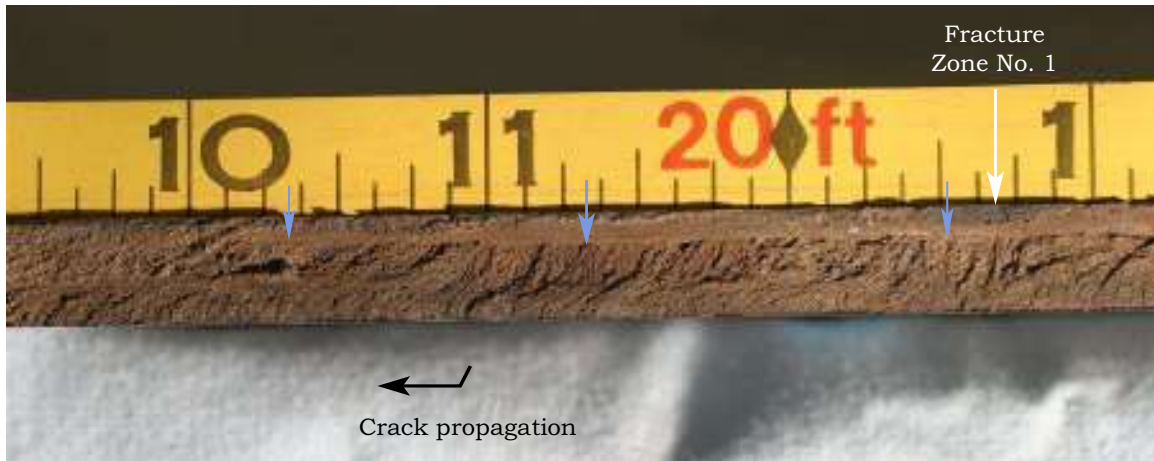
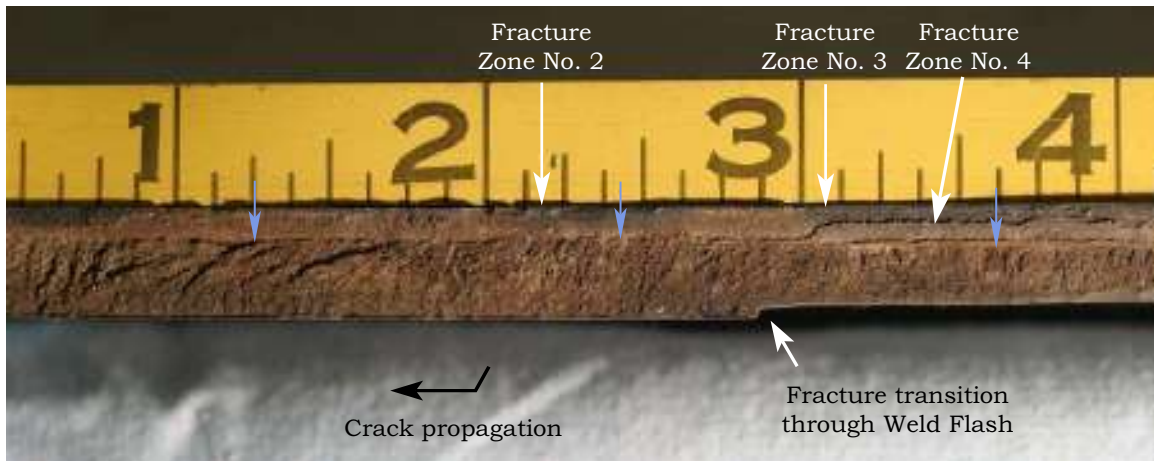
The photographs display close-up views of the fracture face between a distance of 19' 10" and 20' 4" from the north girth weld, showing radial lines, marked by the blue arrows, which originated from hook cracks through the grain flow or banding formed during manufacturing the ERW seam.

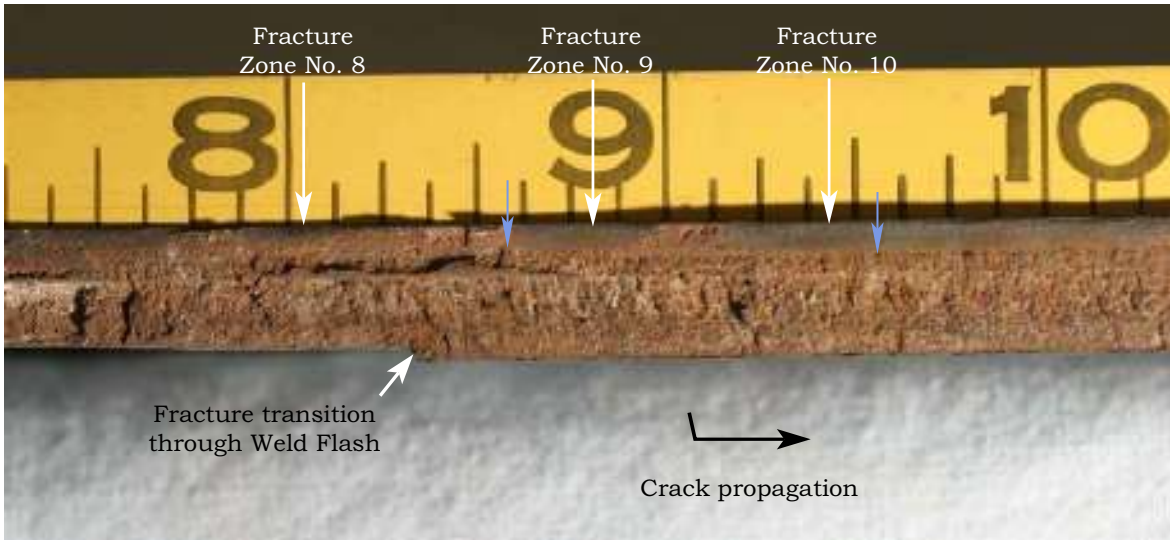
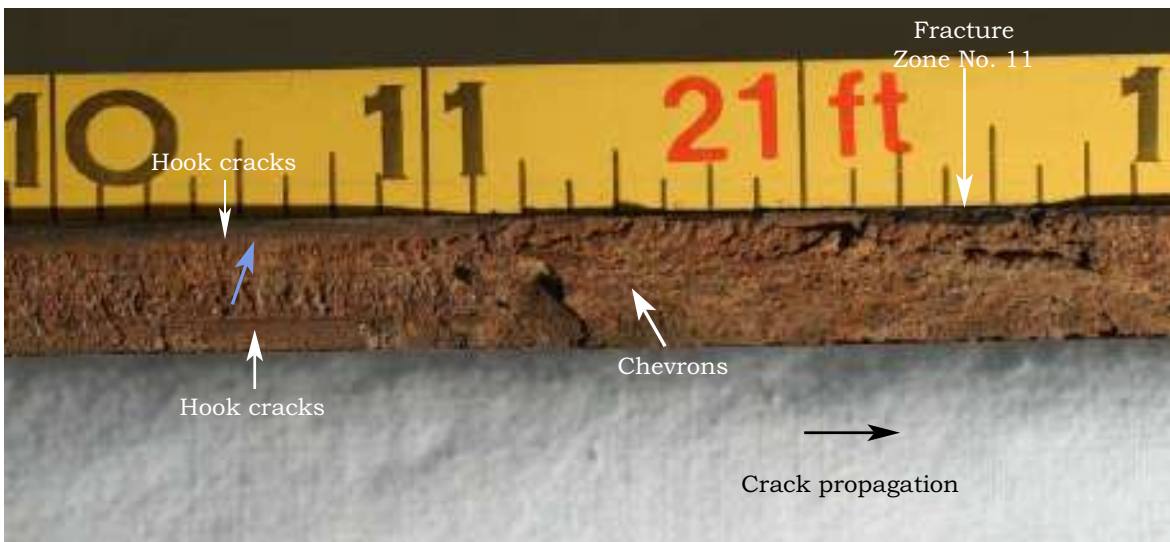
The photographs display close-up views of the fracture face between a distance of 20' 8" and 21' 1" from the north girth weld, showing radial lines emanating from the hook cracks, marked by the blue arrow, and chevrons pointing to the cracks, revealing some of the final fracture origins.

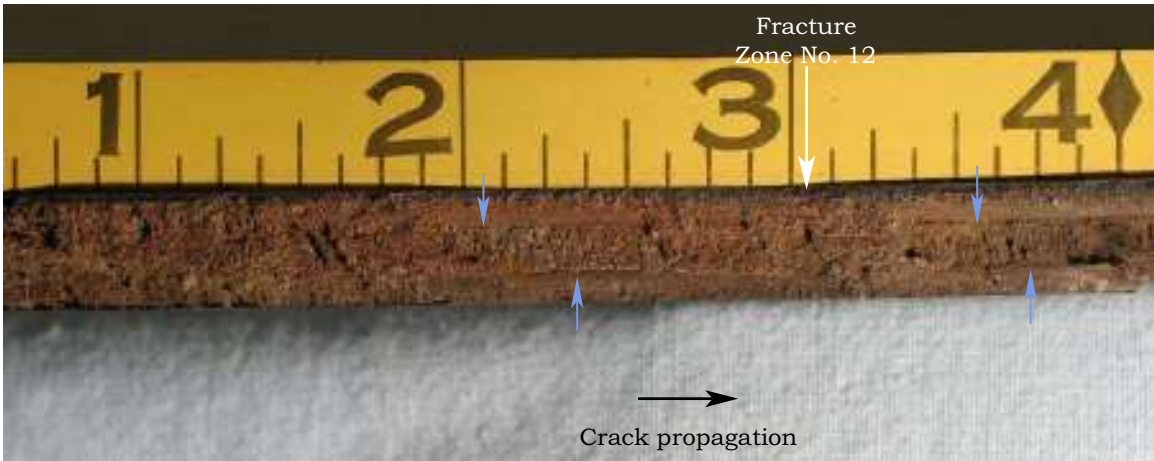
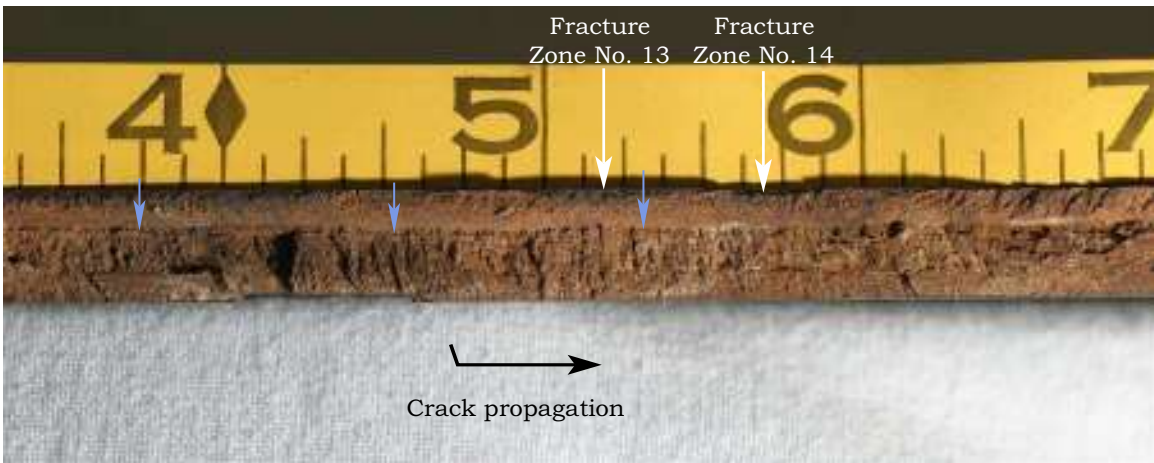
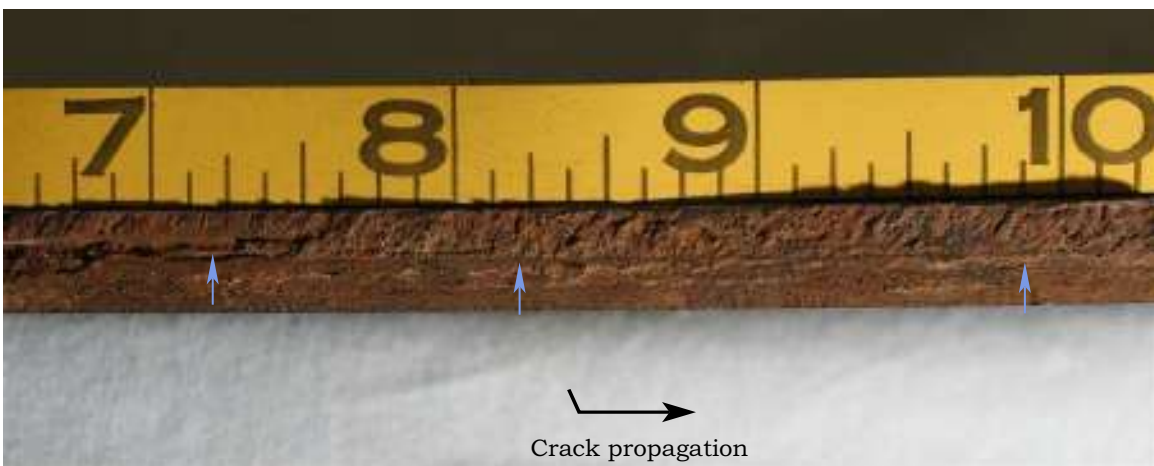
The photographs display close-up views of the fracture face between a distance of 21' 1" and 21' 10" from the north girth weld showing radial lines emanating from the hook cracks. The blue arrows point to the radial lines, indicative of some of the final fracture initiation sites.

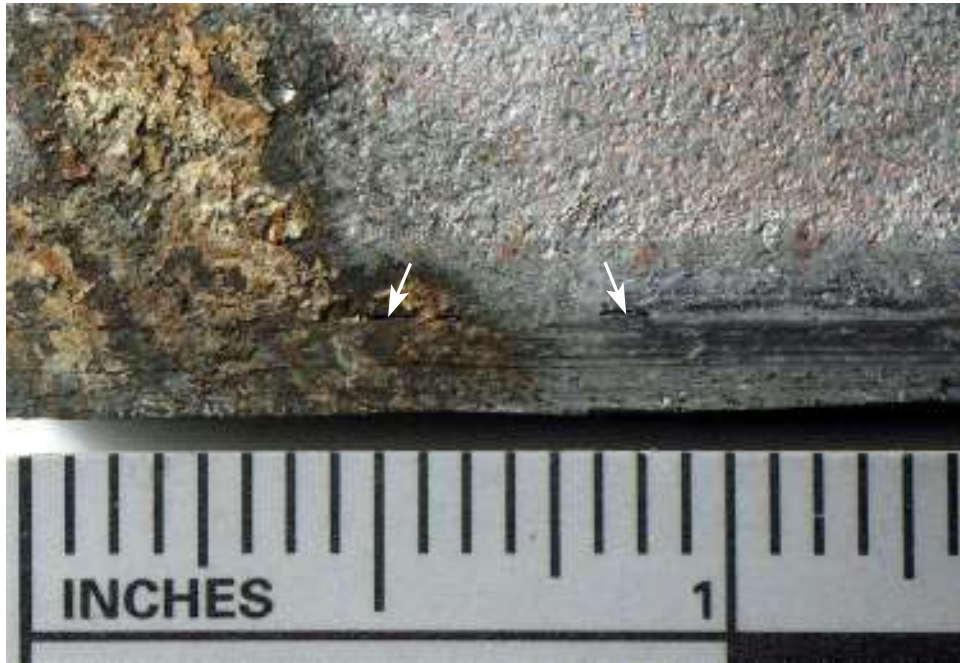
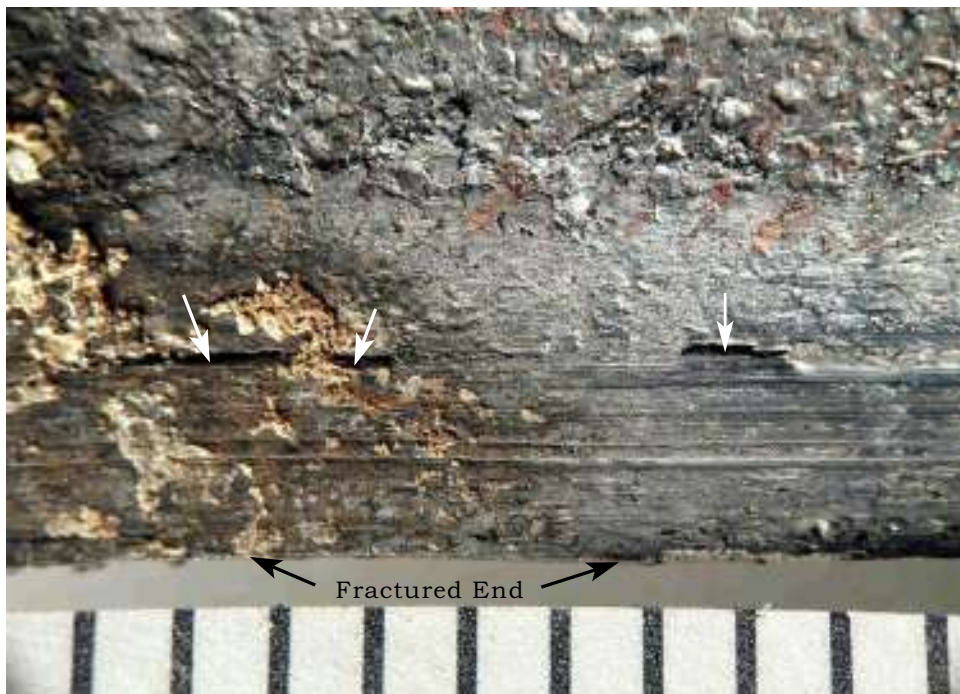
The photographs of the outside surface of the fractured ERW seam at a distance between 20' 4-1/2" and 20' 6" from the north girth weld show evidence of what appears to be crack or melting caused by copper electrode contacts during the ERW seam fabrication. The arrows point to these imperfections.

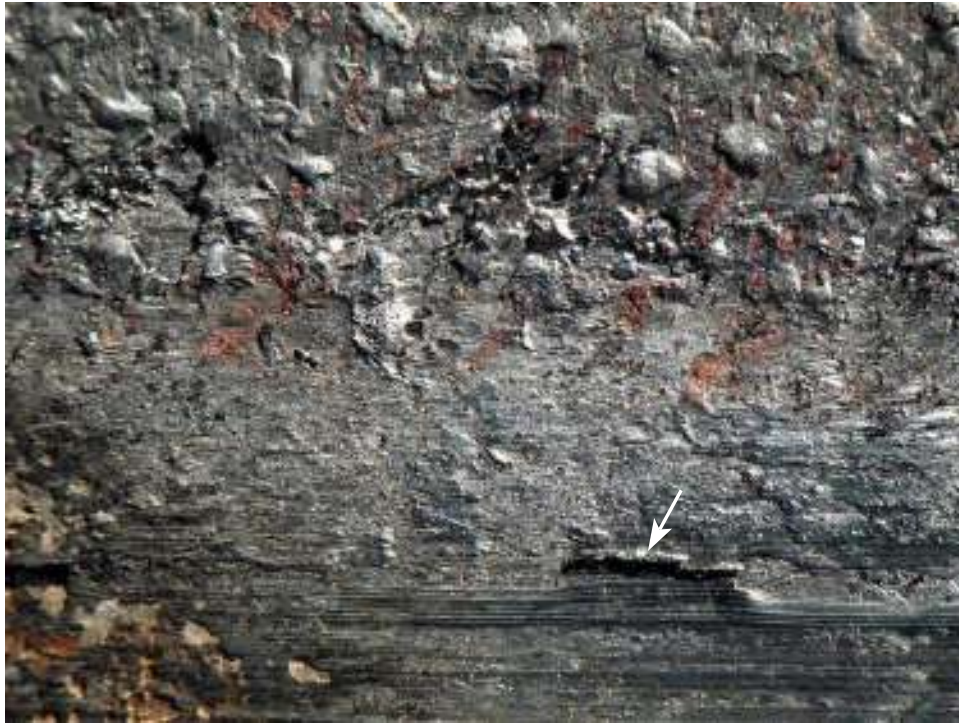
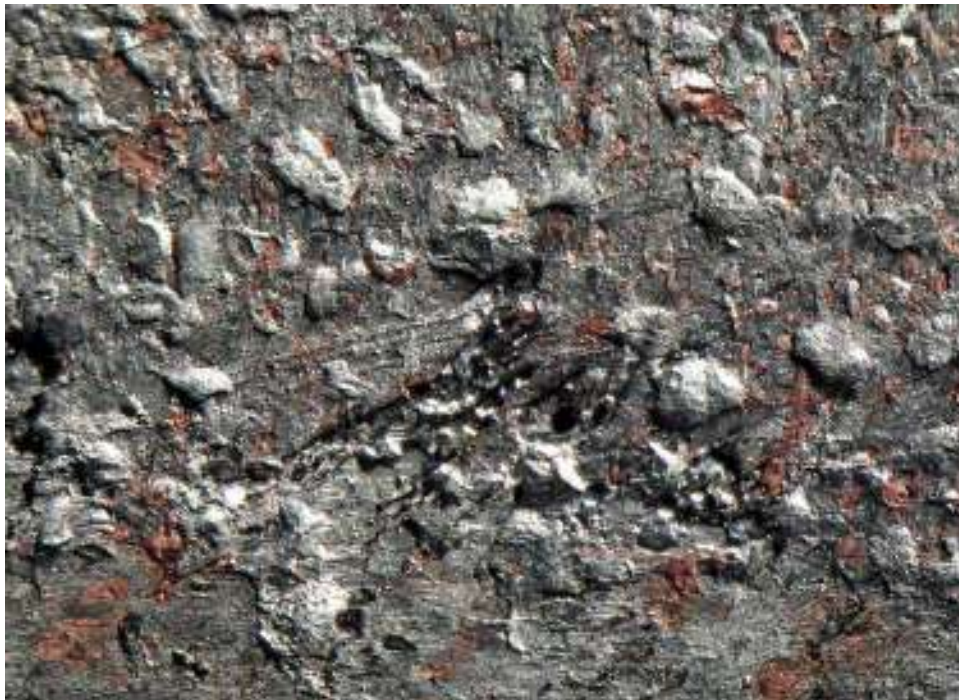
The photographs display close-up views of the copper electrode contact marks in the heat-affected zone of the ERW seam, at the arrow, on the O.D. surface and the presence of copper.

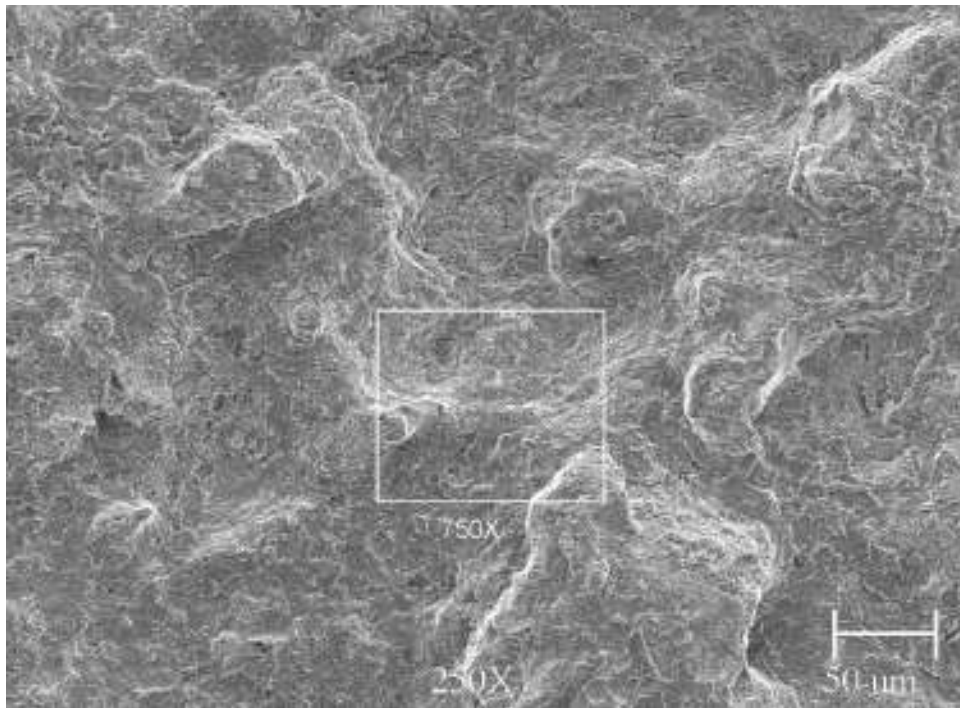
Area-D
Photograph No. 134

The SEM fractograph taken of the Area-D of the hook crack zone, as displayed in Photograph No. 123, reveals a nondescript, featureless fracture surface. The fracture location within the rectangle was examined at a higher magnifications to characterize the fracture morphology.
