*METALLURGICAL INVESTIGATION OF A
FRACTURED SECTION OF THE 20" O.D.
PIPELINE AT MILEPOST 314.77 IN THE
CONWAY TO CORSICANA SEGMENT OF
THE PEGASUS CRUDE OIL PIPELINE*

REPORT NO. 64961, REV. 1

Prepared for
ExxonMobil Pipeline Company and the
Pipeline and Hazardous Materials Safety Administration
pursuant to Corrective Action Order CPF 4-2013-5006H

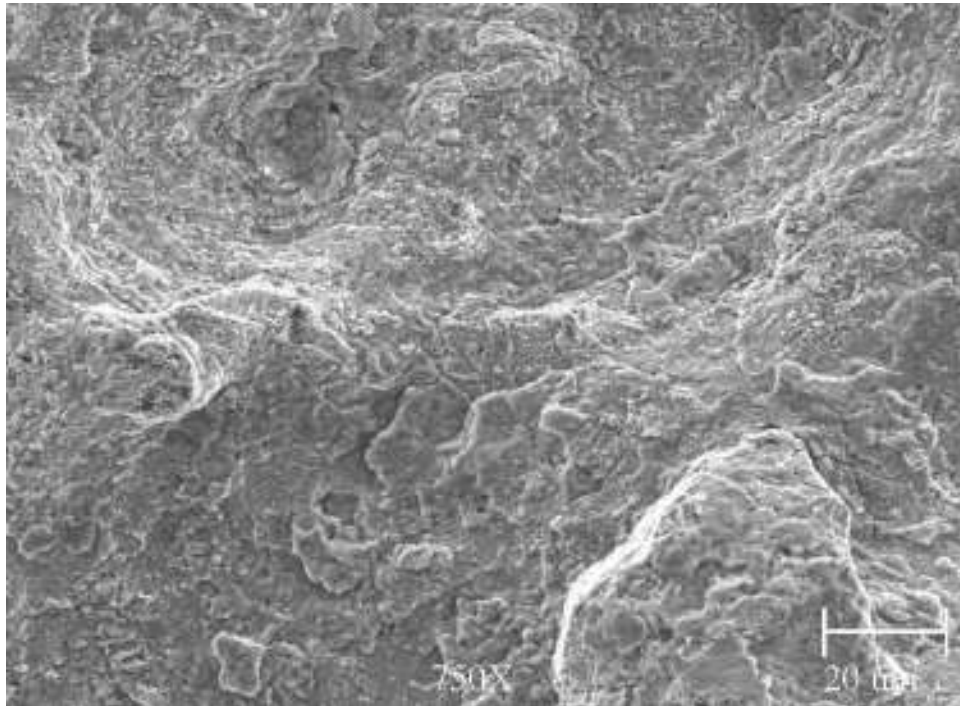
Area-D within the rectangle
Photograph No. 135

The SEM fractograph taken of the Area-D within the rectangle of the hook crack zone, as displayed in Photograph No. 134, reveals tightly adhered oxidation product.

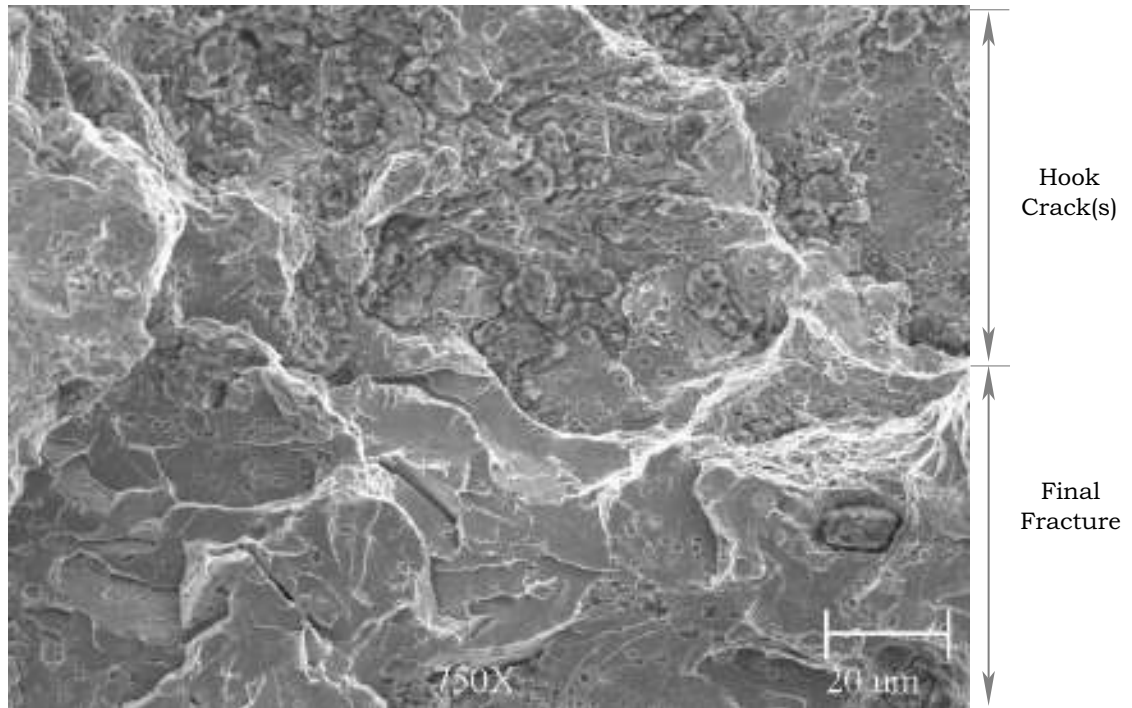
Area-E, Location-5A, Location within rectangle
Photograph No. 138

The SEM fractograph taken of the Area-E at Location-5A, as displayed in Photograph No. 137, confirms the oxidation on the hook cracks and the final fracture in the brittle manner.

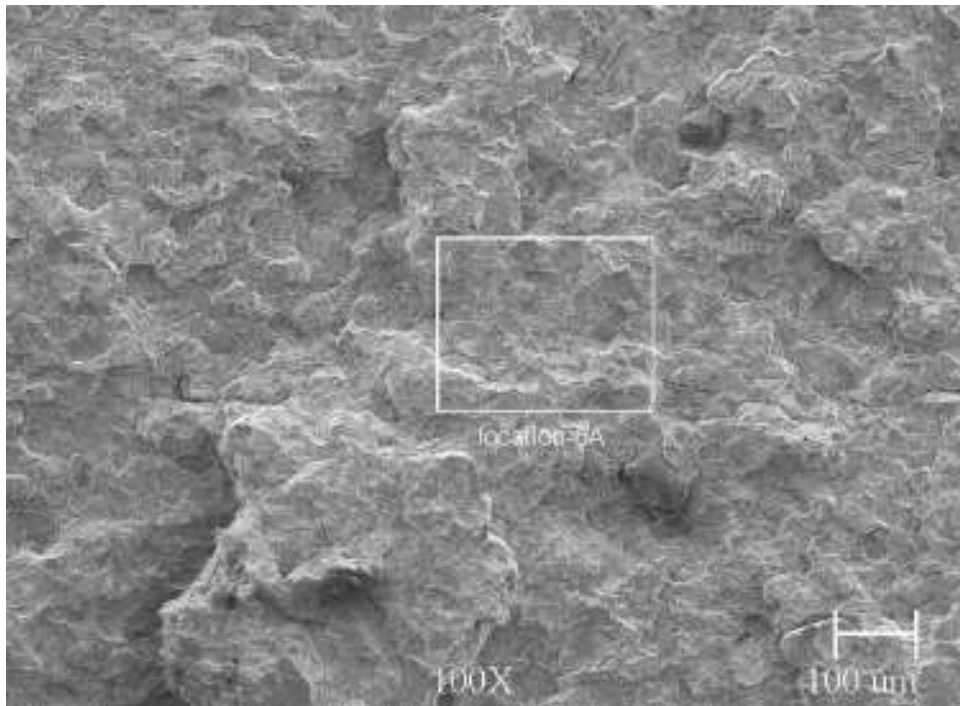
Area-F
Photograph No. 139

The SEM fractograph taken of the Area-F of the final fracture zone, as shown in Photograph No. 123, displays unresolved cleavage separation fracture features and faint evidence of ductile microvoid coalescence.

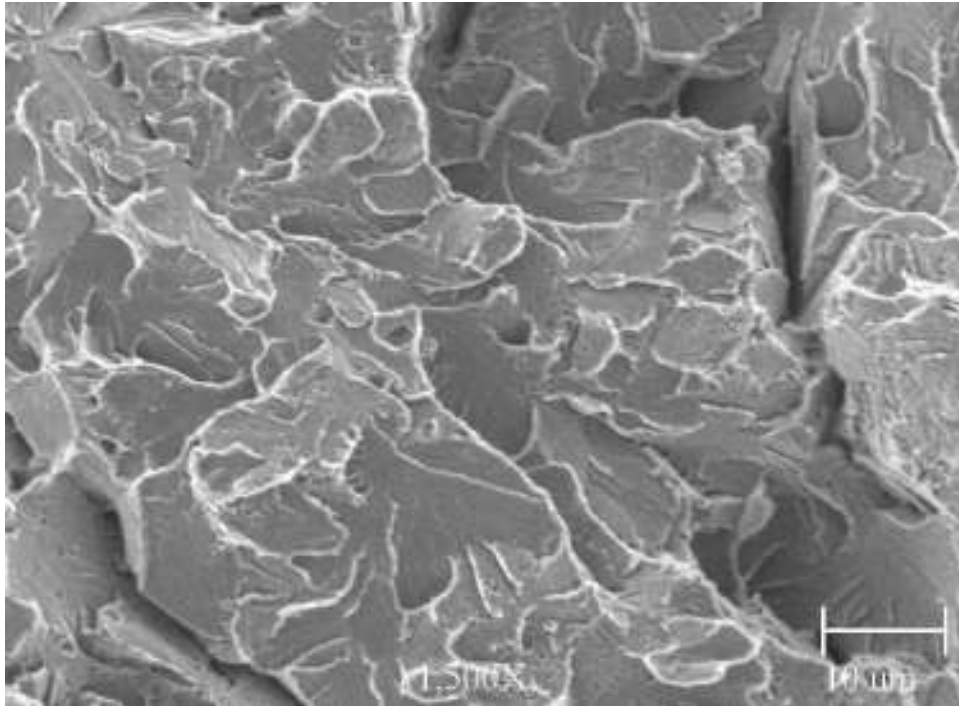
The SEM fractographs taken of the Area-3 of the final fracture zone, as displayed in Photograph No. 141, reveal cleavage separation, indicative of brittle failure.

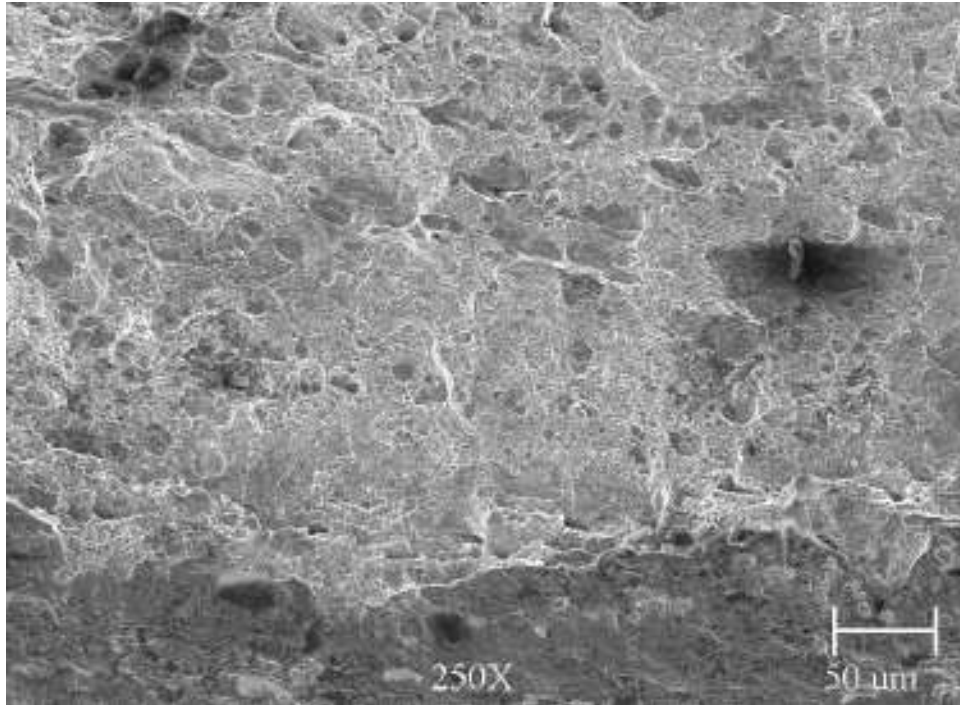
The SEM fractographs taken of the Area-4 of the final shear fracture zone at the I.D. of the pipe reveal evidence of microvoid coalescence, indicative of rapid ductile failure.

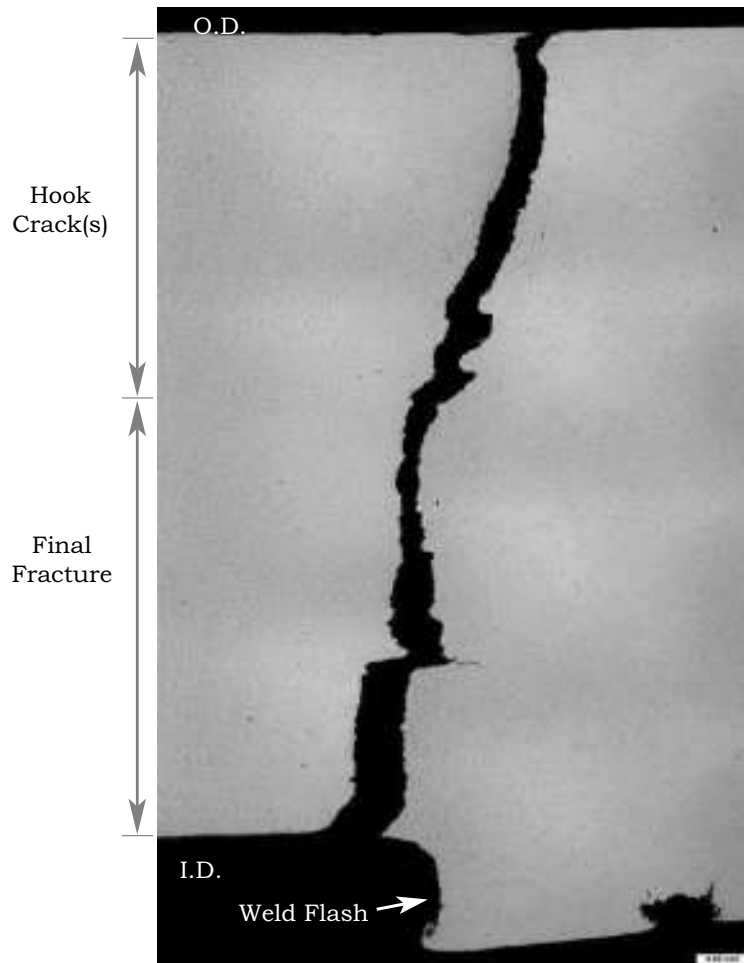
20' 4-7/8" from the North Girth Weld
As-polished, ~25x
Photograph No. 151

A composite view of the mating cross-sections removed through the fracture origins area at a distance of 20' 4-7/8" from the north girth weld and prepared for metallographic examination displays evidence of nonmetallic inclusions along the fracture faces and also parallel to the fusion line near the upper half of the pipe wall. Note that the weld flash on the I.D. surface of the pipe was not trimmed off flush with the I.D. surface.

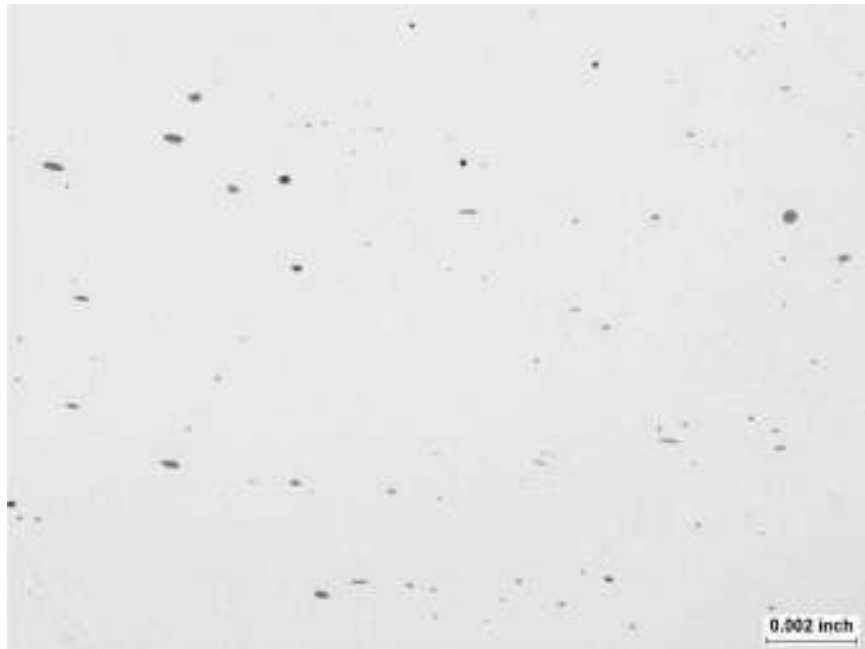
The micrographs display the manganese sulfide inclusions in the axial direction of the pipe near the I.D. surface of the ERW, which were not affected by the welding process.

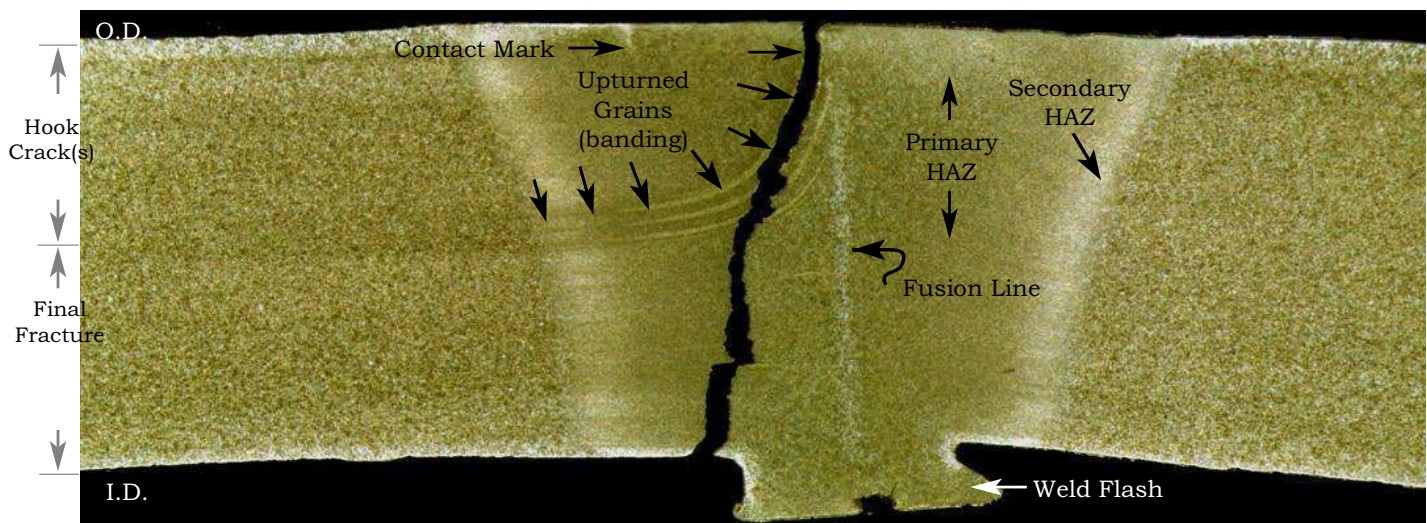
20' 4-7/8" from the North Girth Weld
2% Nital etch, ~20x
Photograph No. 159

A composite view of the mating cross-sections removed through the fracture origins area at a distance of 20' 4-7/8" from the north girth weld and prepared for metallographic evaluation shows hook cracks along the brittle upturned bands in the upset/HAZ area, and the final failure from the tip(s) of the hook crack(s). Again, note that the weld flash was not trimmed off flush with the I.D. surface.

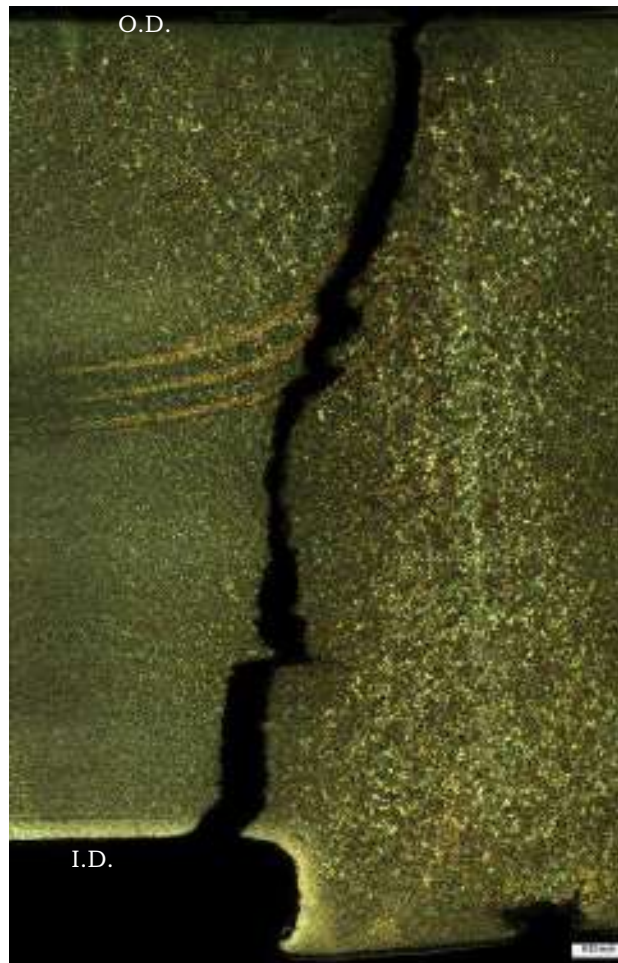
20' 4-7/8" from the North Girth Weld
2% Nital etch, ~25x
Photograph No. 160

The micrograph displays a hook crack through the upturned bands, which consists of untempered brittle martensite in the upset/HAZ of the ERW seam.

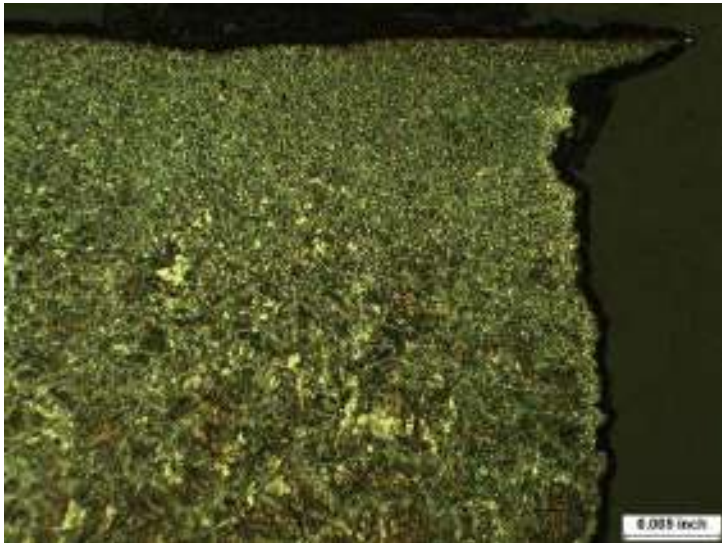
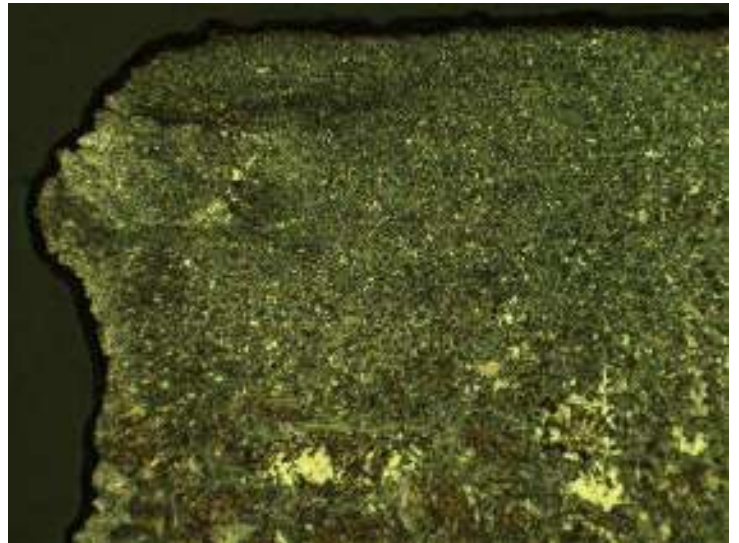
The micrographs display the mating fracture faces of hook cracks near the O.D. of the ERW joint. The microstructure consists of grain boundary ferrite and unresolved bainite with some acicular martensite.

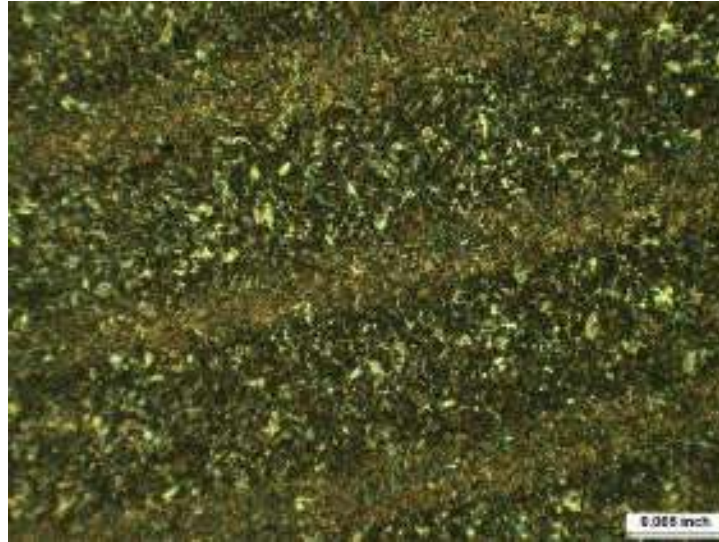
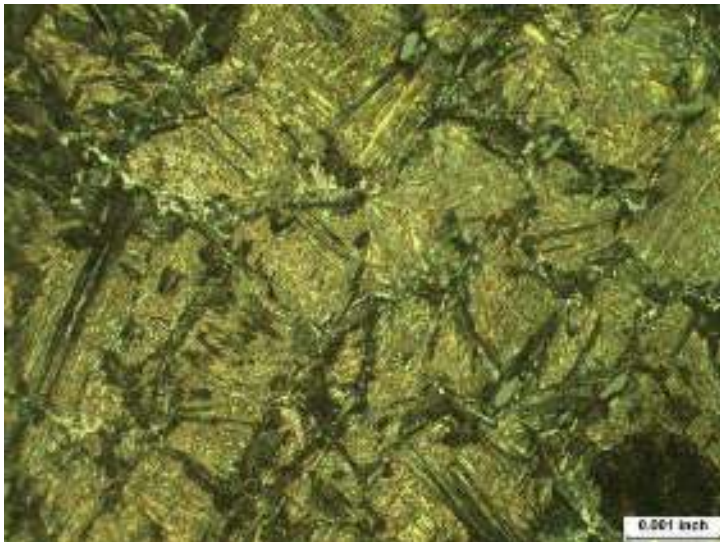
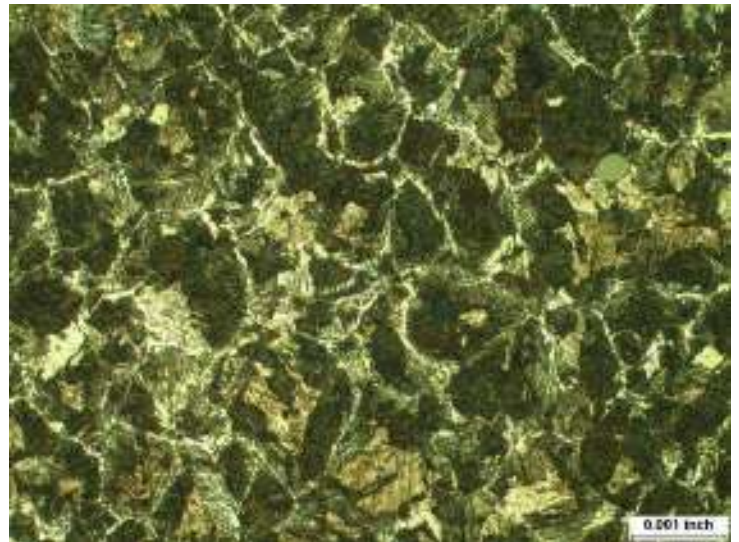
The micrographs display the microstructure of the material in the upset/HAZ between the O.D. and the mid-wall where the upturned bands were formed during the ERW seam manufacturing, consisting of the untempered brittle martensite in the banded area and essentially grain boundary ferrite and unresolved bainite with some patches of untempered martensite in the non-banded area.

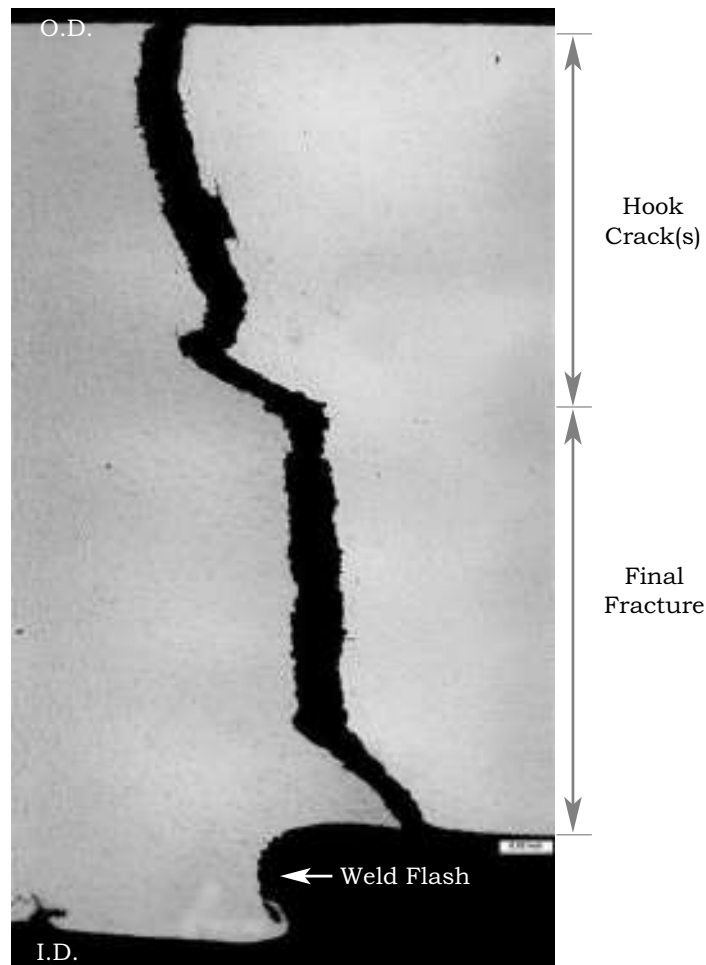
20' 6-13/16" from the North Girth Weld
As-polished, ~25x
Photograph No. 170

A composite view of the mating cross-sections removed through the fracture origins area at a distance of 20' 6-13/16" from the north girth weld and prepared for metallographic examination displays evidence of nonmetallic inclusions along the fracture faces, and also parallel to the fusion line near the upper half of the pipe wall. Note that the weld flash on the I.D. surface was not trimmed off flush with the I.D. surface of the pipe.

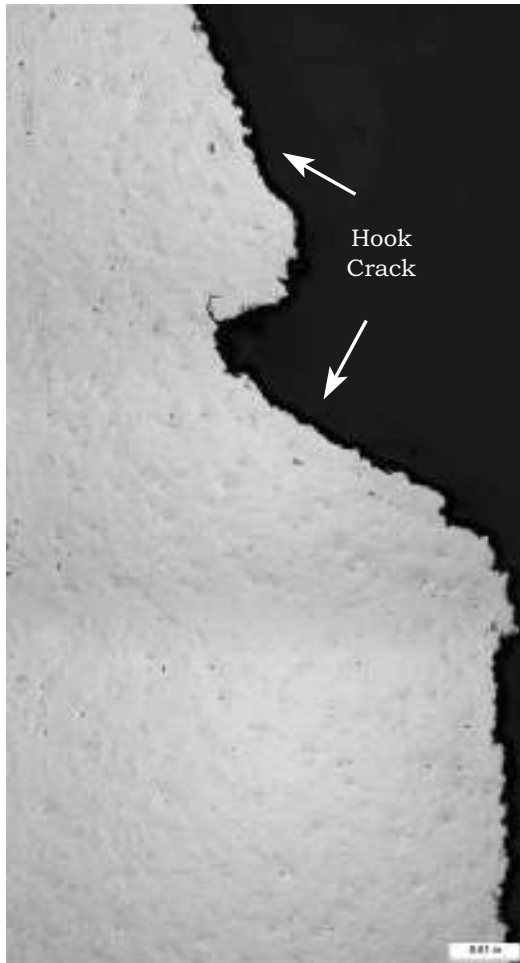
The micrographs display the upturned inclusions essentially parallel to the fusion line in the ERW upset/HAZ area, as well as along the fracture faces.

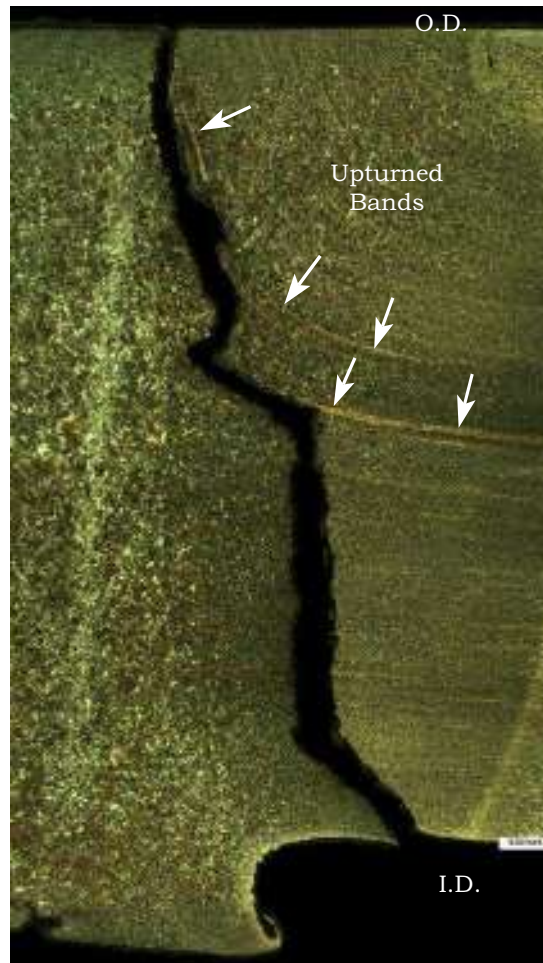
20' 6-13/16" from the North Girth Weld
2% Nital etch, ~25x
Photograph No. 178

The micrograph displays the hook crack(s) following the upturned bands, which consists of untempered brittle martensite.

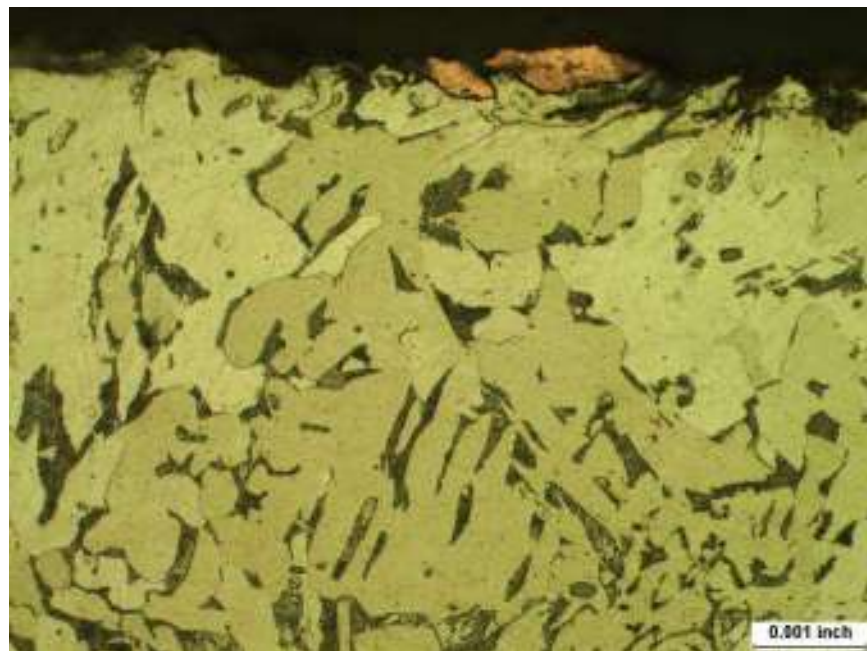
20' 6-13/16" from the North Girth Weld
2% Nital etch, ~500x
Photograph No. 186

The micrographs display the evidence of surface decarburization along the O.D. surface near the ERW seam and the presence of copper from the electrode contact during the initial seam welding of the pipe.

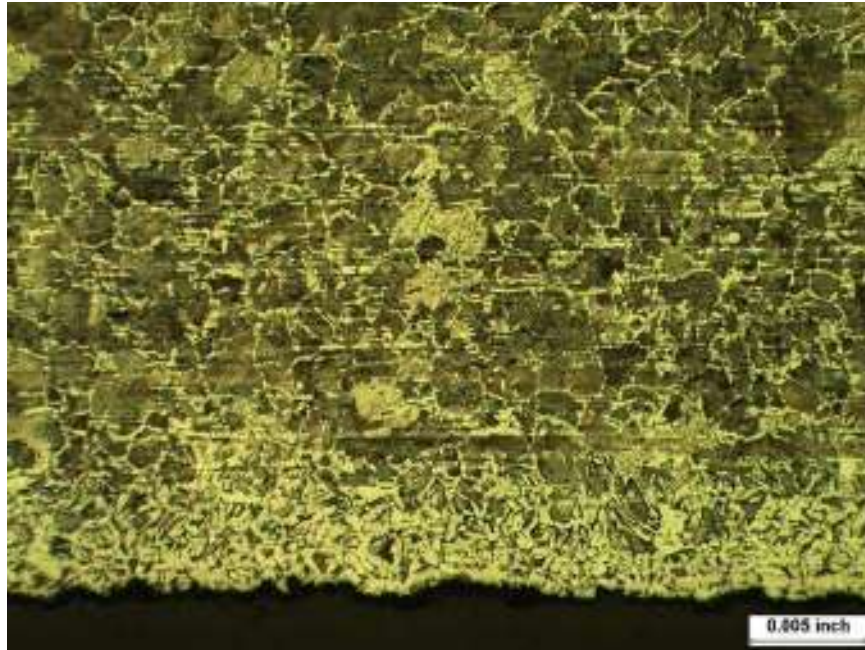
The micrographs display the evidence of surface decarburization along the I.D. surface near the ERW seam.

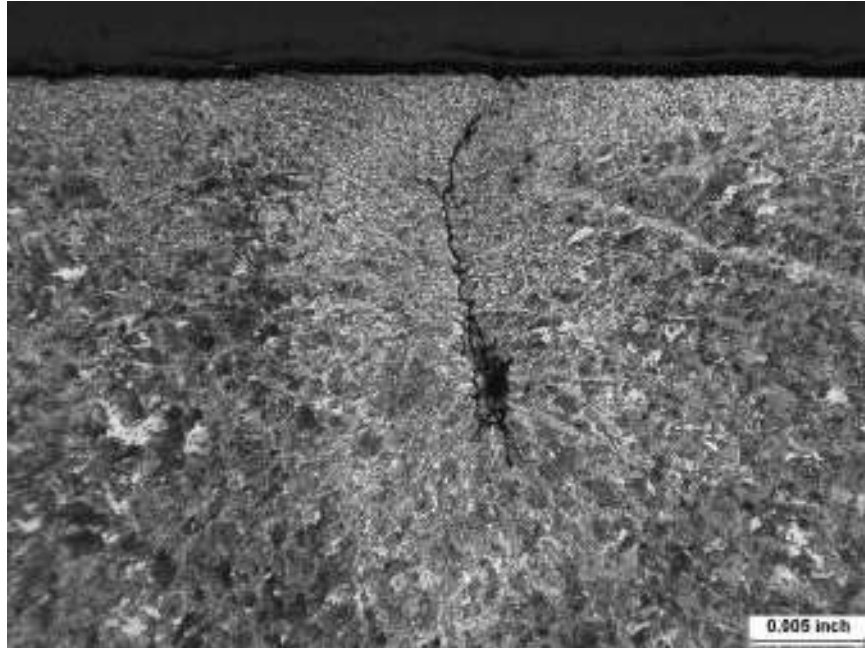
The micrographs display one of the contact marks which resulted from the electrical contact between the electrode supplying the welding current and the pipe surface. Note cracks through resolidified metal near the ERW seam within the primary HAZ.

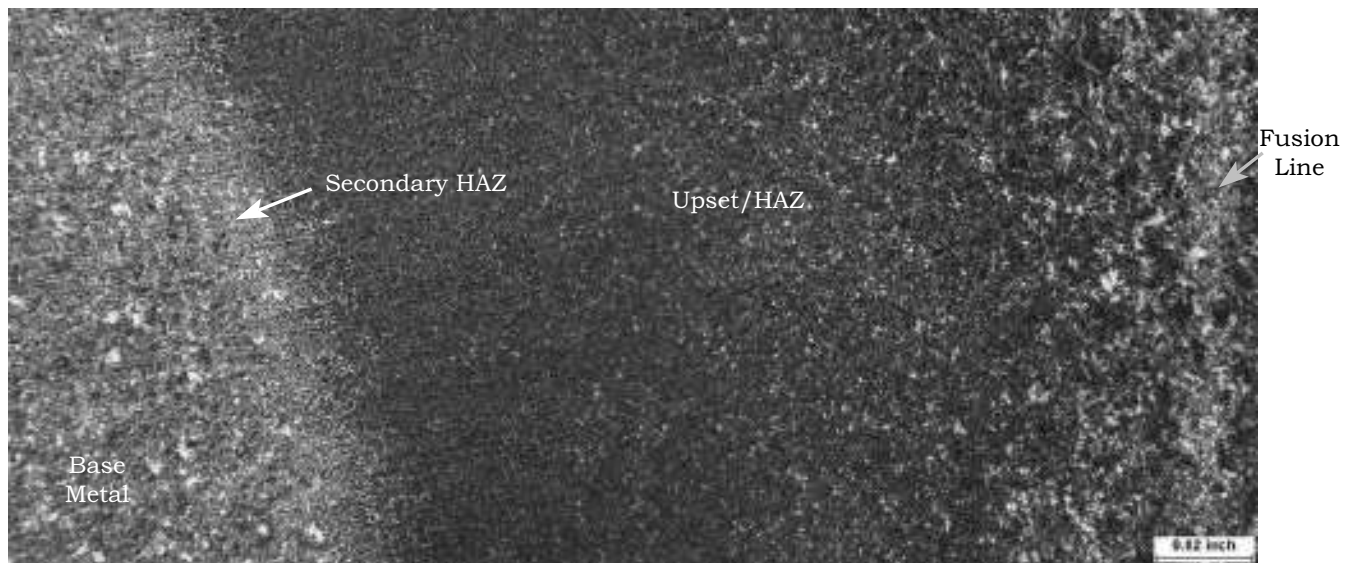
Fusion Line to Base Metal
2% Nital etch, ~25x
Photograph No. 191

The micrograph displays the microstructural phases between the fusion line and the base metal of the ERW seam.

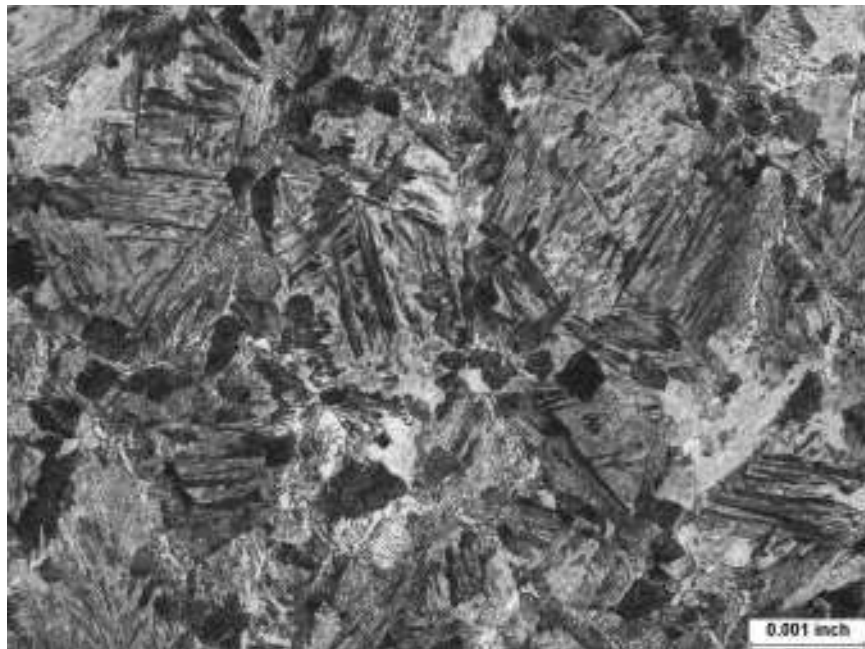
The micrographs of the primary HAZ display mix-microstructure consisting of grain boundary ferrite and untempered acicular martensite.

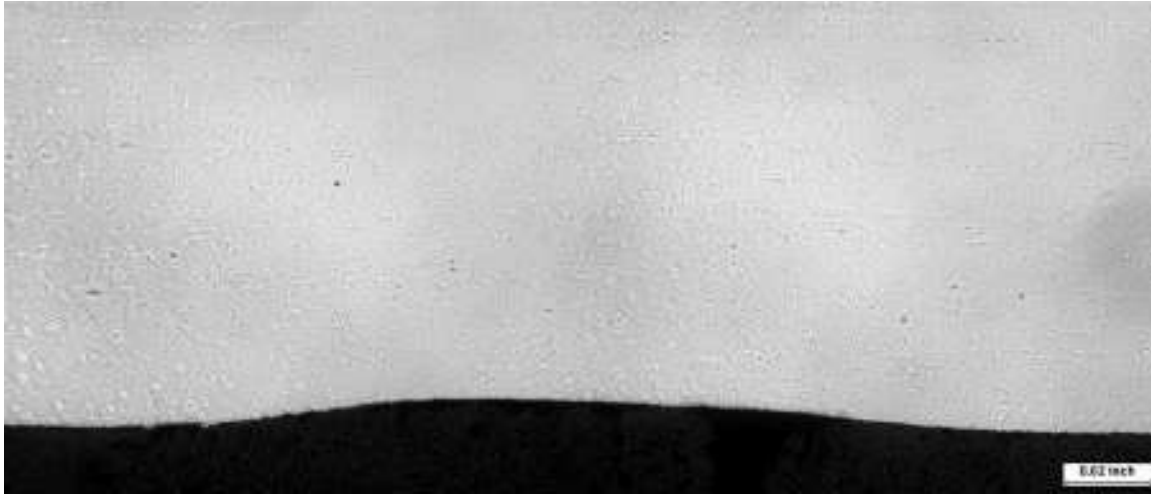
As-polished, ~25x
Photograph No. 225

The composite micrographs display the microstructural condition at another representative area of the I.D. surface of the pipe, showing one of the shallow indentations observed during the visual examination. Note the uniform layer of partial decarburization on the I.D. surface, indicating that the shallow depression is due to a mechanical indentation, most likely when the pipe was manufactured, and not corrosion pitting. The impression measured 0.189" wide and 0.007" deep.

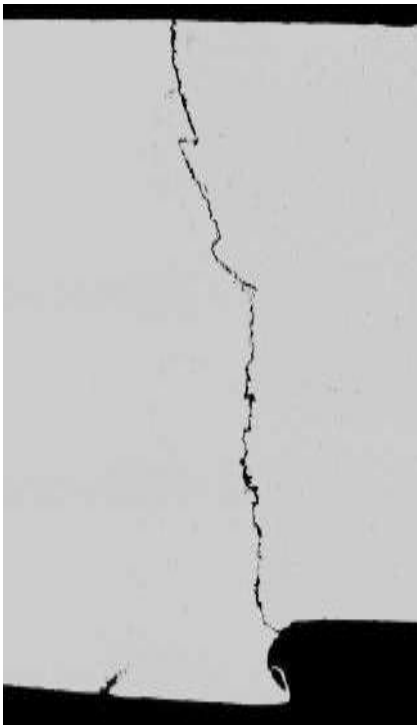
Distance from the North Gird Weld	Hook Crack Width			Hook Crack Depth
	Minimum	Average	Maximum	
20' 3-3/4"	0.0008"	0.0013"	0.0023"	0.145"
20' 4-7/8"	0.0018"	0.0028"	0.0038"	0.145"
20' 5-1/2"	0.0006"	0.0016"	0.0031"	0.133"

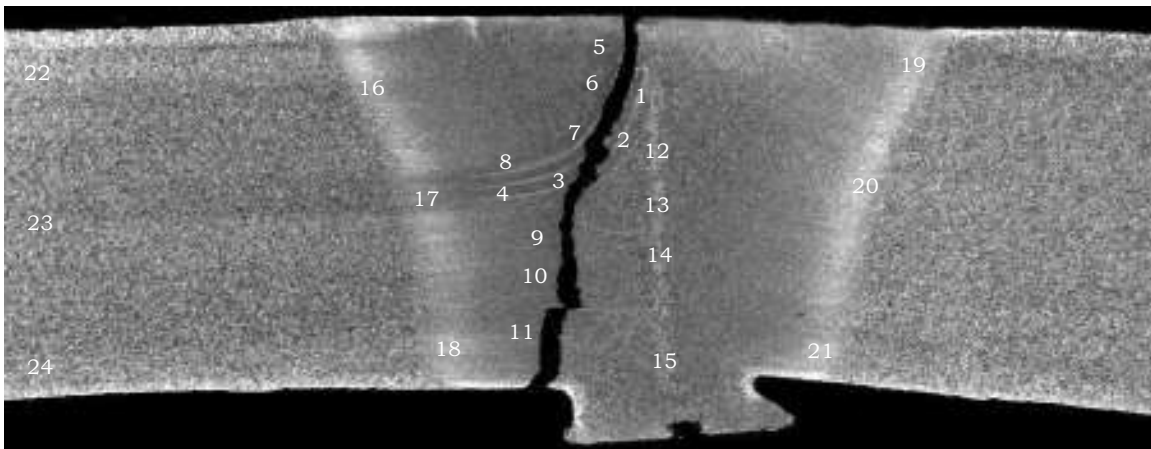
Indentation Number	Test Location	Hardness, HV500g	Conversion to Rockwell Scale	Indentation Number	Test Location	Hardness, HV500g	Conversion to Rockwell Scale
1	Hardened	549	52 HRC	12	ERW Fusion Line	408	42 HRC
2	Upturned	560	53 HRC	13		492	49 HRC
3	Martensitic Grains	574	54 HRC	14		399	41 HRC
4		509	50 HRC	15		335	34 HRC
5		279	27 HRC	16		225	97 HRB
6	Hook	285	28 HRC	17	240	20 HRC	
7	Crack(s)	308	31 HRC	18	Secondary HAZ	226	98 HRB
8		295	29 HRC	19		248	22 HRC
9	Final	280	27 HRC	20	240	100 HRB	
10	Fracture	298	29 HRC	21	240	100 HRB	
11	(Primary HAZ)	280	27 HRC	22	Base Metal	206	94 HRB
				23		228	98 HRB
				24		218	96 HRB

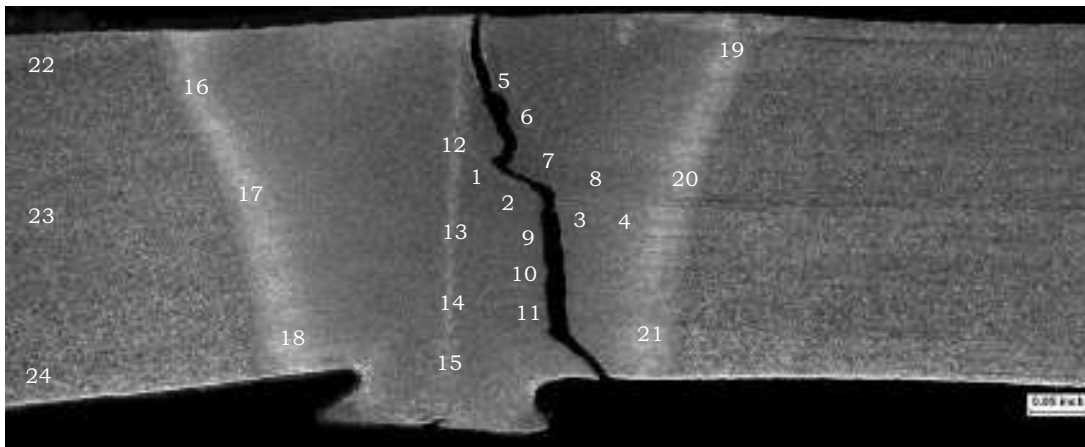
Indentation Number	Test Location	Hardness, HV500g	Conversion to Rockwell Scale	Indentation Number	Test Location	Hardness, HV500g	Conversion to Rockwell Scale	
1	Hardened	483	48 HRC	12	ERW Fusion Line	303	30 HRC	
2	Upturned	483	48 HRC	13		342	35 HRC	
3	Martensitic Grains	499	49 HRC	14		330	33 HRC	
4		502	49 HRC	15		299	30 HRC	
5		281	27 HRC	16	Secondary HAZ	255	23 HRC	
6	Hook	293	29 HRC	17		231	98 HRB	
7	Crack(s)	310	31 HRC	18		246	22 HRC	
8		297	29 HRC	19		233	99 HRB	
9	Final	338	34 HRC	20		258	24 HRC	
10	Fracture	265	25 HRC	21		231	98 HRB	
11	(Primary HAZ)	298	29 HRC	22		Base Metal	223	97 HRB
				23			250	22 HRC
				24			237	100 HRB

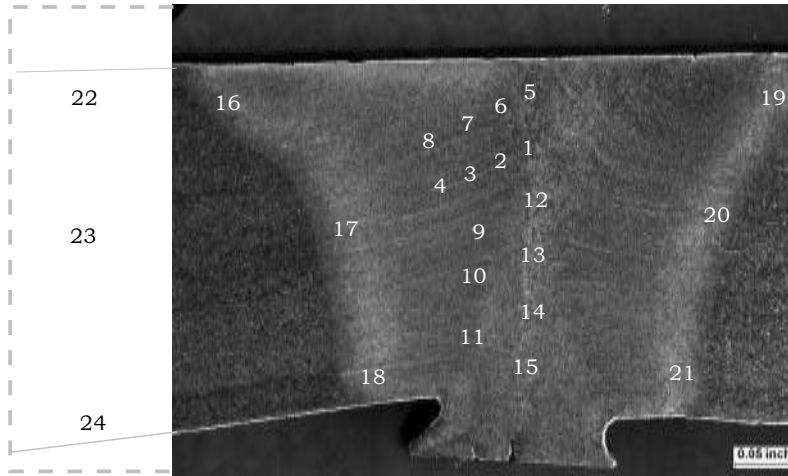
Indentation Number	Test Location	Hardness, HV500g	Conversion to Rockwell Scale	Indentation Number	Test Location	Hardness, HV500g	Conversion to Rockwell Scale	
1	Hardened	580	54 HRC	12	ERW Fusion Line	334	34 HRC	
2	Upturned	586	54 HRC	13		295	29 HRC	
3	Martensitic Grains	391	40 HRC	14		374	38 HRC	
4		444	45 HRC	15	516	50 HRC		
5	Primary HAZ	256	23 HRC	16	Secondary HAZ	237	100 HRB	
6		253	23 HRC	17		241	21 HRC	
7		276	27 HRC	18		228	98 HRB	
8		269	26 HRC	19		253	23 HRC	
9		283	28 HRC	20		234	99 HRB	
10		241	21 HRC	21		219	97 HRB	
11		254	23 HRC	22		Base Metal	232	99 HRB
				23			231	99 HRB
				24			249	22 HRC

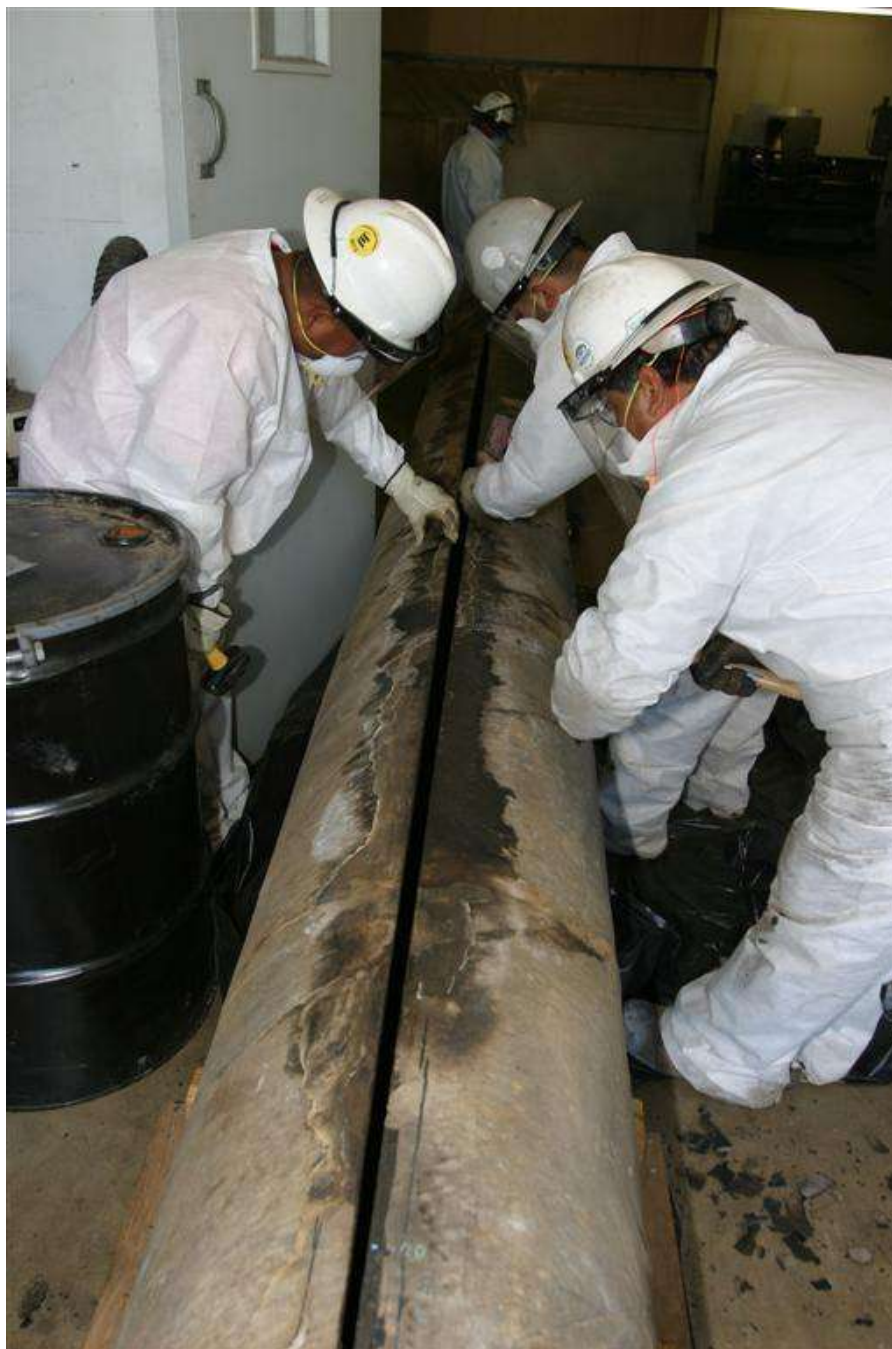
The photograph displays the careful hand removal process of the coating adjacent to the crack.

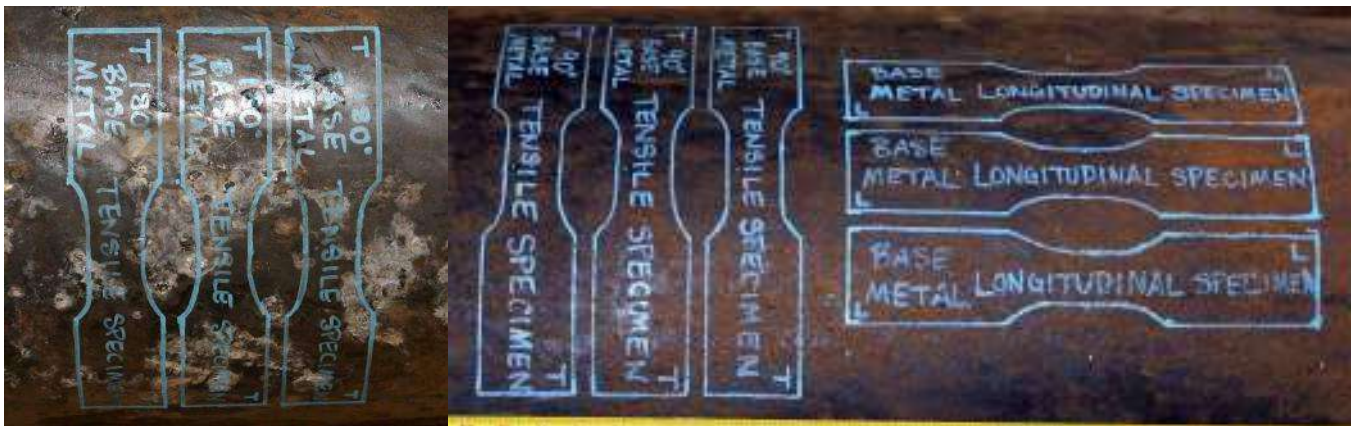
The photographs display an overall view of the area opposite the ERW seam on the intact 19' 10" long section of the pipe, showing where the longitudinal and transverse base metal test specimens were removed from. The insert photograph shows the location of the base metal CVN impact test specimens.

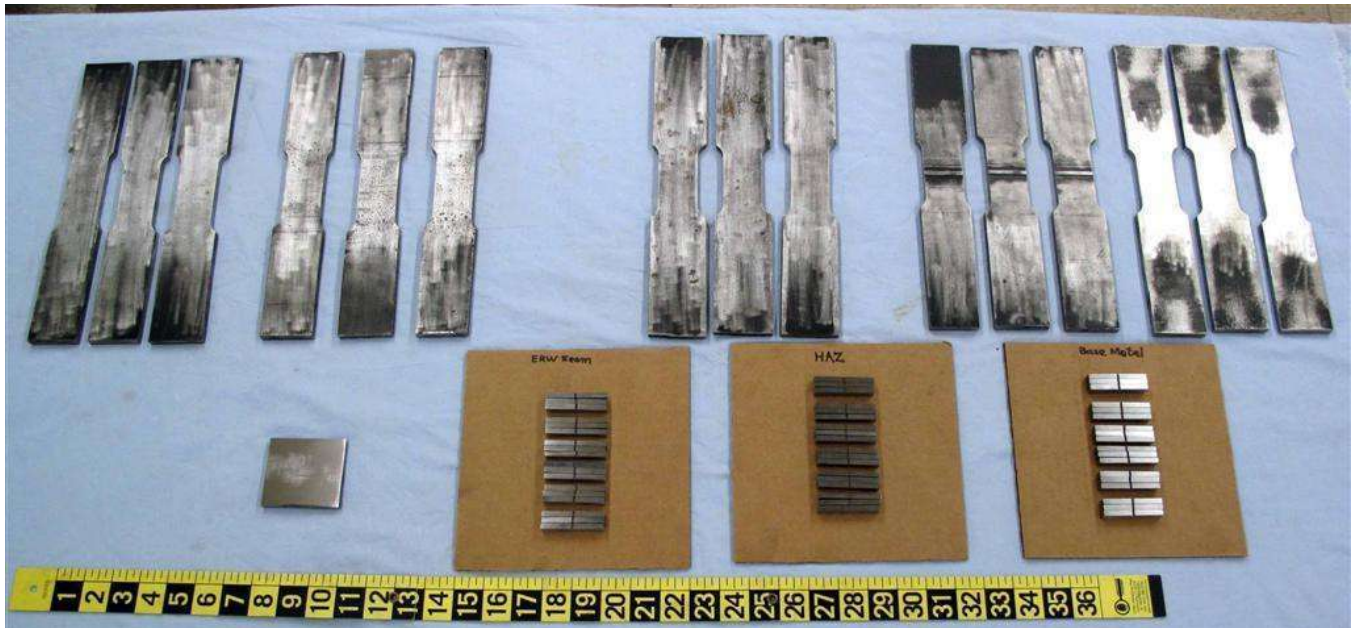
The photograph displays the test specimens that were removed from the intact 19' 10" long section of pipe, after machining and prior to testing. The various test specimens were machined and tested in accordance with ASTM A370-12a and the applicable sections of each edition of API 5L.

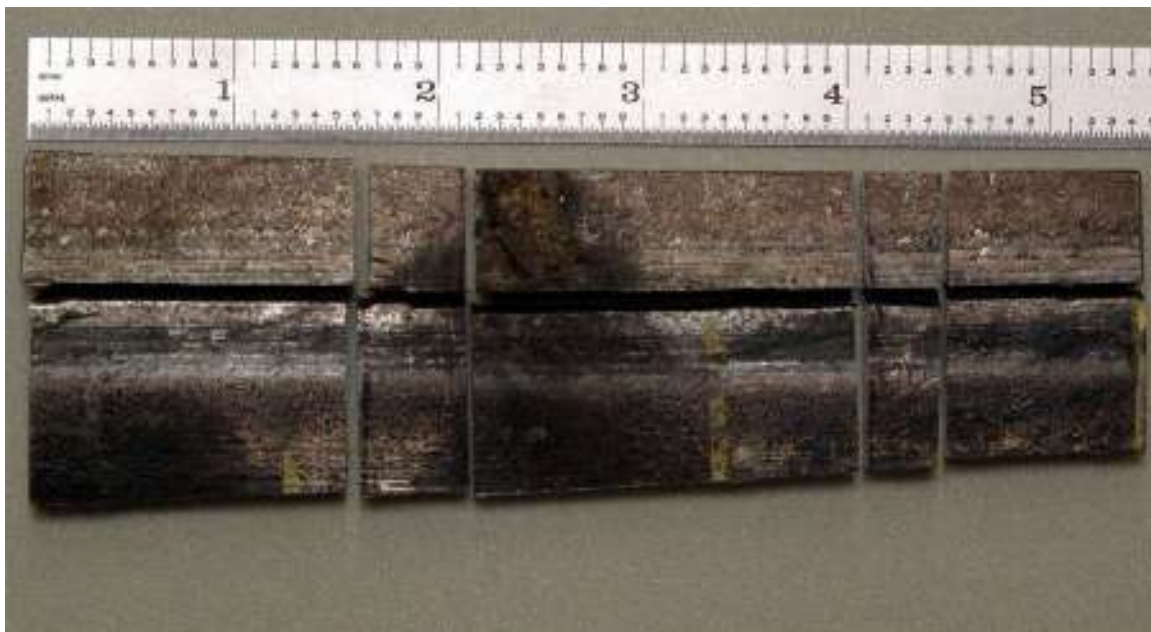
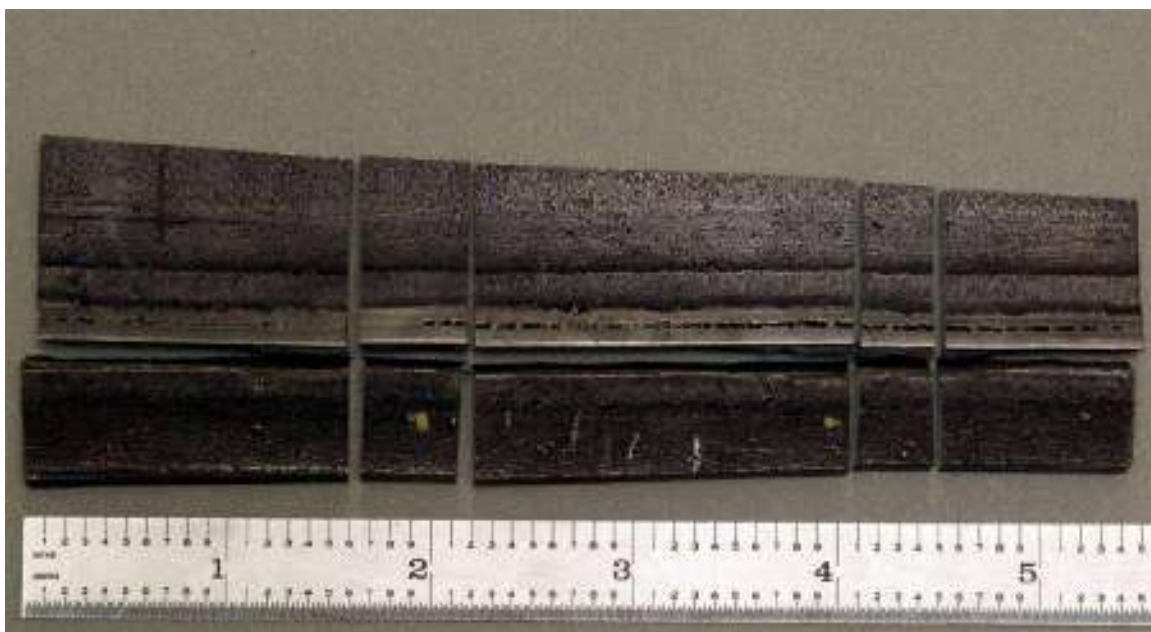
The photographs display the O.D. and I.D. surface, respectively, at the locations where the cross-sections were removed through the fractured area of the ERW seam and metallographically prepared for microstructural evaluation.
