ARKANSAS
Department of Environmental Quality

RE: Inspection/Complaint Investigations
AFIN: 04-00175 Permit Tracking No.: 4438-WR-4

On October 22 and 24, 2013, I performed a compliance inspection at Allen's, Inc. spray irrigation sites west of Butler Road in response to several complaints. On November 13, 2013, Jason Bolenbaugh, Water Division Inspection Branch Manager, and I conducted an inspection at Allen's, Inc. spray irrigation sites east of Turkey Road in response to a complaint. The inspections were conducted in accordance with the provisions of the Arkansas Water and Air Pollution Control Act and the regulations promulgated thereunder. The inspections revealed the following violations:

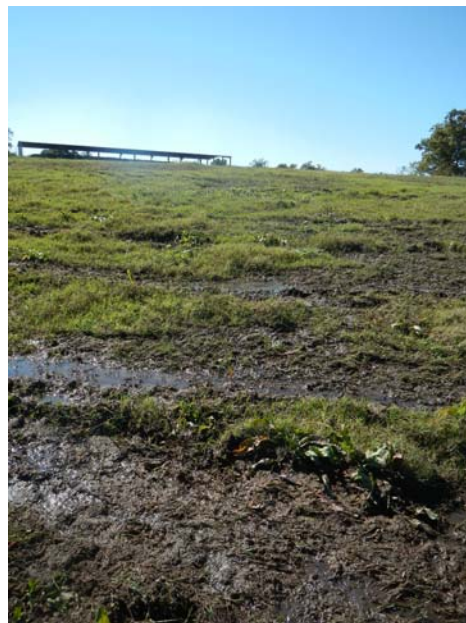
Photographer:	Alison West				Witness:	NA	
Photo #	4	Of	62		Date:	10-22-2013	Time: 12:33 p.m.
Description:	DSCN1400. Near the tree line north of irrigation head 25, looking up the slope towards the irrigation head. Poor vegetative cover. Dark gray is residuals.

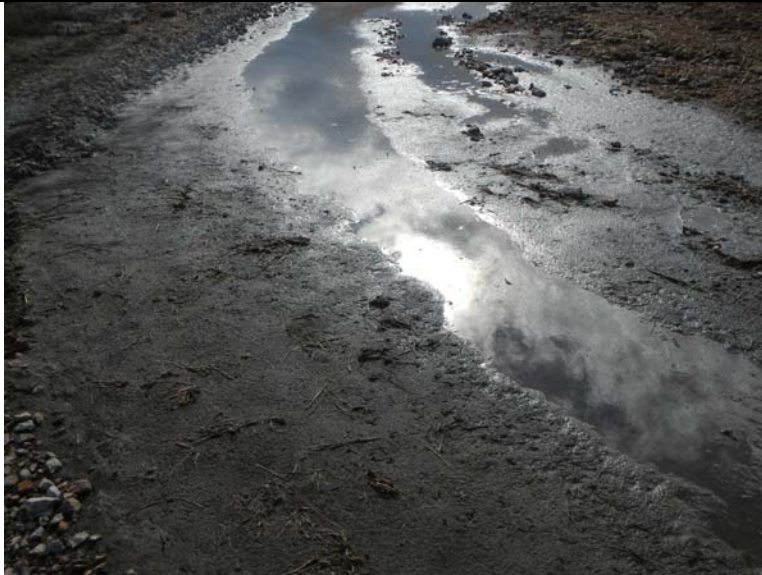
Photo #	13	Of	62	Date:	10-22-2013	Time:	10:40 a.m.
----------------	----	-----------	----	--------------	------------	--------------	------------

Description:	DSCN1281. Irrigation Head 53. Waste was applied in a manner which resulted in pooling. Poor vegetative cover. Dark gray color is residuals. Ground is saturated.						
---------------------	--	--	--	--	--	--	--

- 1) Take the areas around heads 52, 53, and 54 out of service to level, disc, and reseed cover crop. Wait until the cover crop is reestablished prior to using this for irrigation.
- 2) Cap head 25 until we are into warm/dry weather likely in the late spring/early summer.
- 3) Inspect each irrigation head and valve; replace or fix any with problems.
- 4) Provide a mule/4-wheeler for accessing the irrigation field to conduct a complete inspection of every irrigation area (each irrigation head, and each valve) daily to more promptly identify maintenance concerns not visible from access roads. Include inspection points at the end of the ravines by Butler Road.

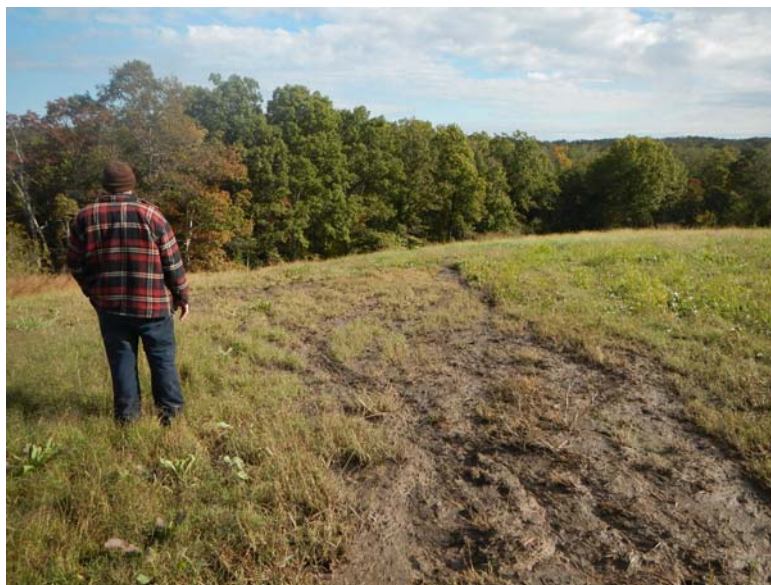
Photographer:	Alison West				Witness:	Jeff Tyler	
Photo #	16	Of	62		Date:	10-22-2013	Time: 10:43 a.m.

Description:	DSCN1285. Flow path of waste north of Irrigation Head 53. Drainage is located in the tree line north of the irrigation head.						
---------------------	--	--	--	--	--	--	--

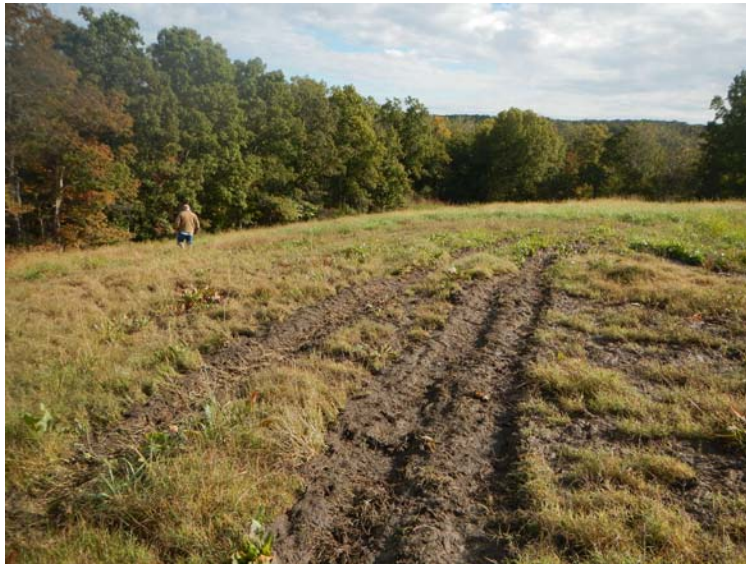
Photo #	17	Of	62	Date:	10-22-2013	Time:	10:43 a.m.
----------------	----	-----------	----	--------------	------------	--------------	------------

Description:	DSCN1286. Ruts located north of Irrigation Head 53 before the tree line.						
---------------------	--	--	--	--	--	--	--

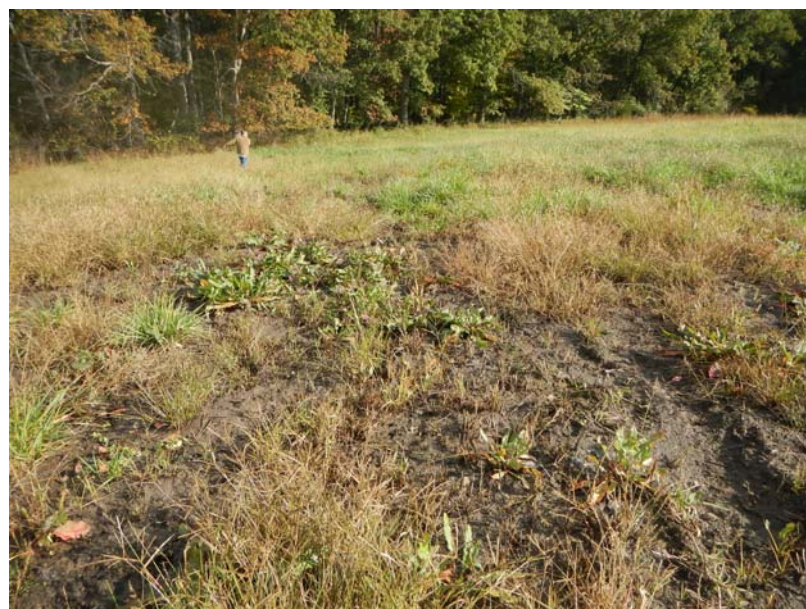
Photo #	18	Of	62	Date:	10-22-2013	Time:	10:43 a.m.
----------------	----	-----------	----	--------------	------------	--------------	------------

Description:	DSCN1288. Flow path of waste north of Irrigation Head 53. Drainage is located in the tree line north of the irrigation head.						
---------------------	--	--	--	--	--	--	--

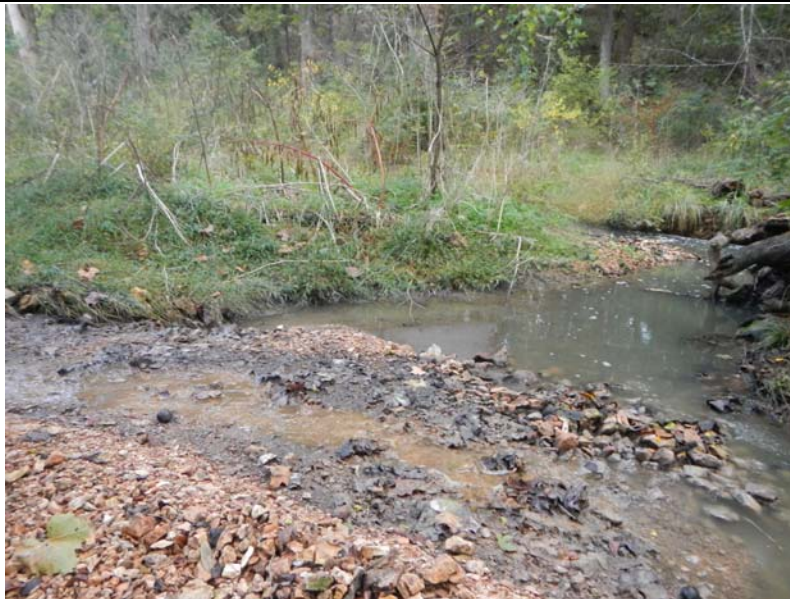
Photographer:	Alison West				Witness:	NA	
Photo #	26	Of	62		Date:	10-22-2013	Time: 10:55 a.m.

Description: DSCN1304. Sludge on gravel substrate. The Unnamed Tributary of the Illinois River is visibly turbid, discolored, and foamy. This is where confluence of the drainage north of irrigation heads 57-53 drains into the Unnamed Tributary of the Illinois River.

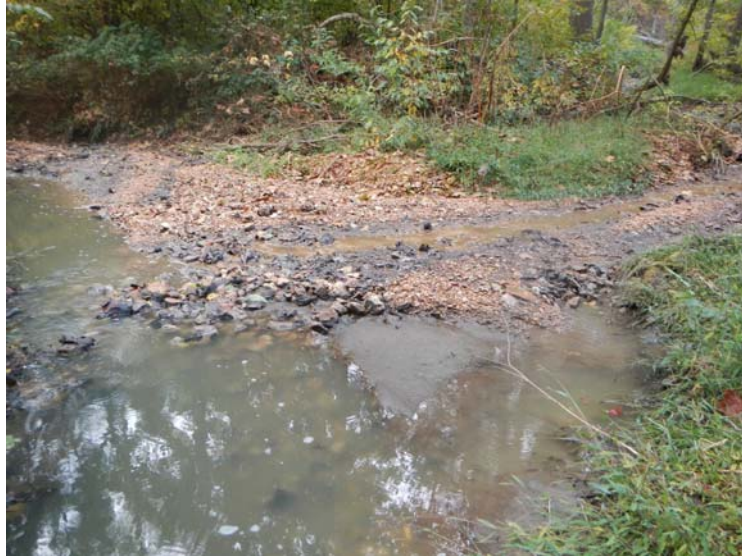
Description: DSCN1308. Looking down the Unnamed Tributary of the Illinois River. The drainage to the right of the picture is a branch north of Irrigation Heads 57-53. Sludge deposits in point bar. Discolored sludge on gravel substrate. The Unnamed Tributary of the Illinois River is visibly turbid, discolored, and foamy.

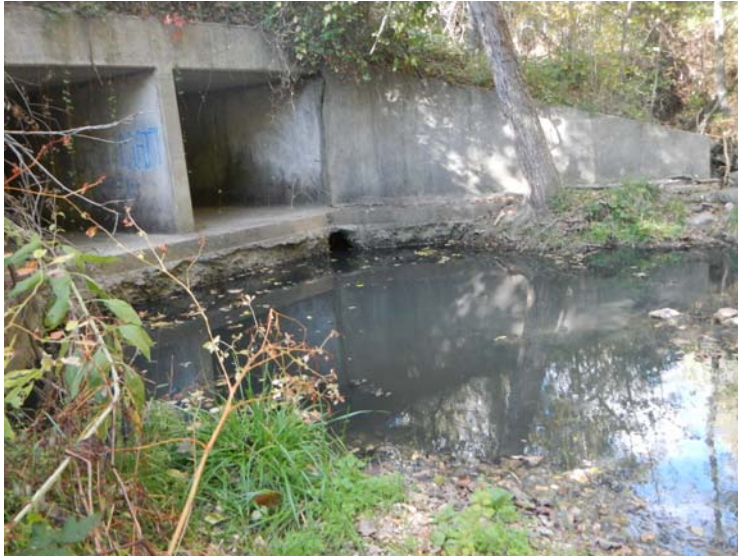
Photo #	29	Of	62		Date:	10-22-2013	Time:	16:18 p.m.
----------------	----	-----------	----	--	--------------	------------	--------------	------------

Description:	DSCN1423. The Unnamed Tributary of the Illinois River is visibly turbid and discolored on the east side of Old Highway 68.							
---------------------	--	--	--	--	--	--	--	--

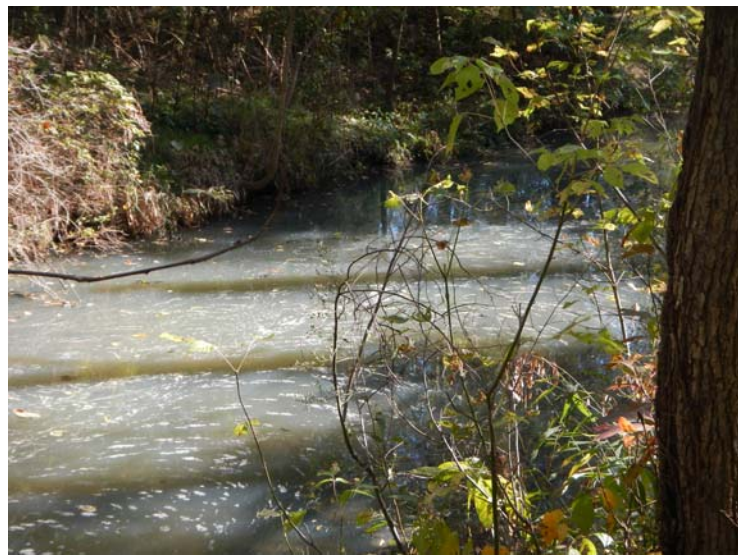
Photo #	30	Of	62		Date:	10-22-2013	Time:	15:50 p.m.
----------------	----	-----------	----	--	--------------	------------	--------------	------------

Description:	DSCN1410. The Unnamed Tributary of the Illinois River is visibly turbid, discolored, and foamy across the road from 16323 Butler Road in Siloam Springs, AR.							
---------------------	--	--	--	--	--	--	--	--

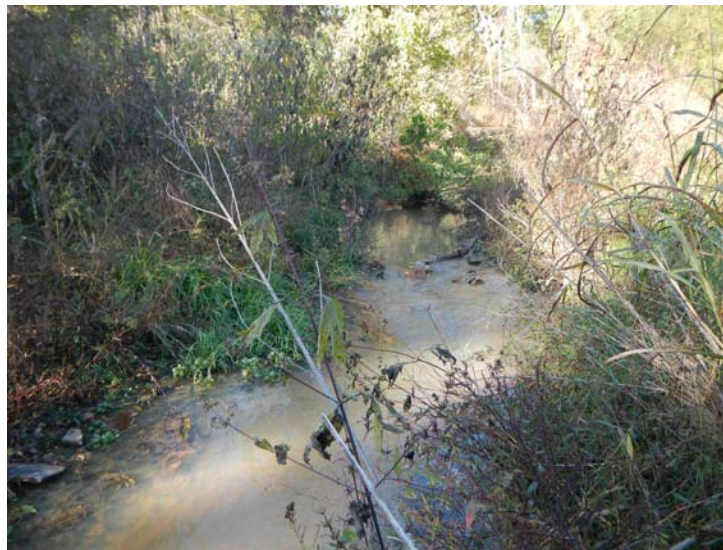
Photo #	33	Of	62		Date:	10-22-2013	Time:	15:58 p.m.
----------------	----	-----------	----	--	--------------	------------	--------------	------------

Description:	DSCN1416. The Unnamed Tributary of the Illinois River is visibly turbid south of 16614 Butler Road in Siloam Springs, AR.							
---------------------	---	--	--	--	--	--	--	--

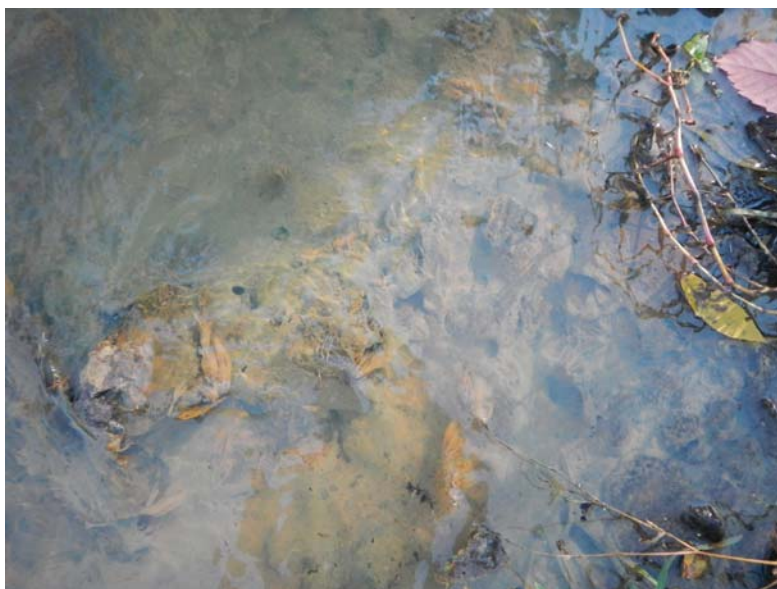
Photo #	34	Of	62		Date:	10-22-2013	Time:	15:58 p.m.
----------------	----	-----------	----	--	--------------	------------	--------------	------------

Description:	DSCN1418. Bottom deposits in unnamed tributary of the Illinois River south of 16614 Butler Road in Siloam Springs, AR.							
---------------------	--	--	--	--	--	--	--	--

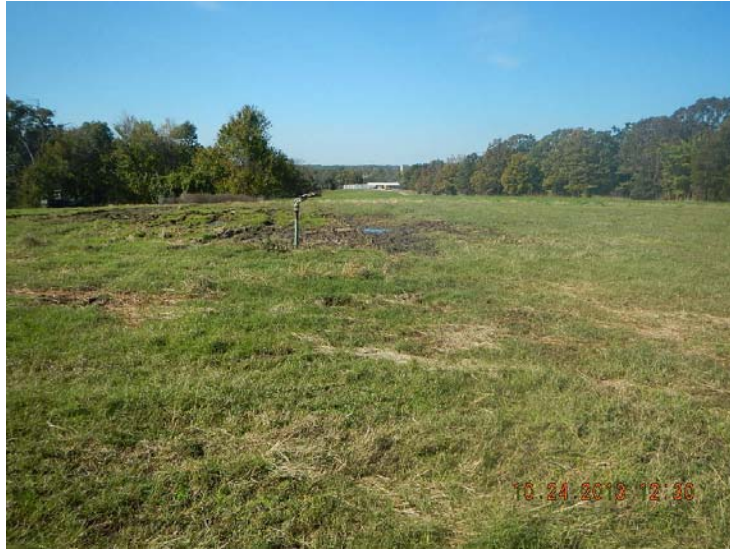
Location:	Allen's, Inc.-Country Plant						
Photographer:	Alison West				Witness:	NA	
Photo #	36	Of	62		Date:	10-24-2013	Time: 12:30 p.m.
Description:	DSCN1471. Irrigation Head 1- Run-off towards drainage located in the tree line west of the irrigation head.

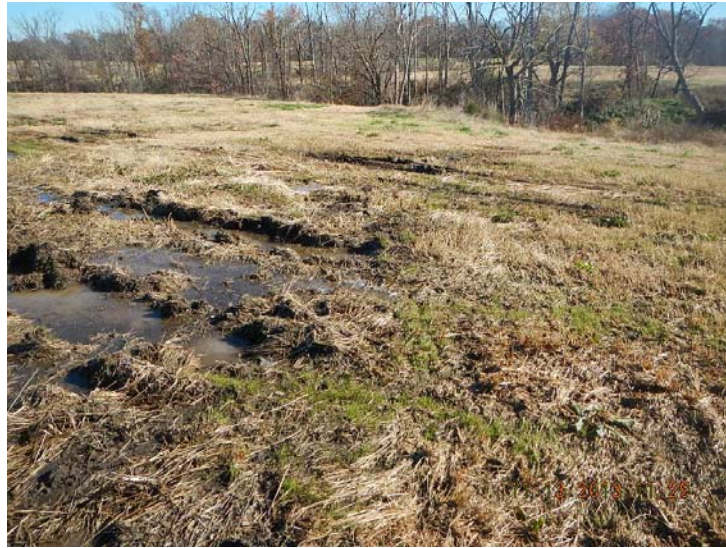
Photo # 46 **Of** 62 **Date:** 11-13-2013 **Time:** 10:29 a.m.

Description: DSCN1680. Irrigation Head C5 at Turkey Ridge. Run-off towards drainage located in the tree line east of the irrigation head.

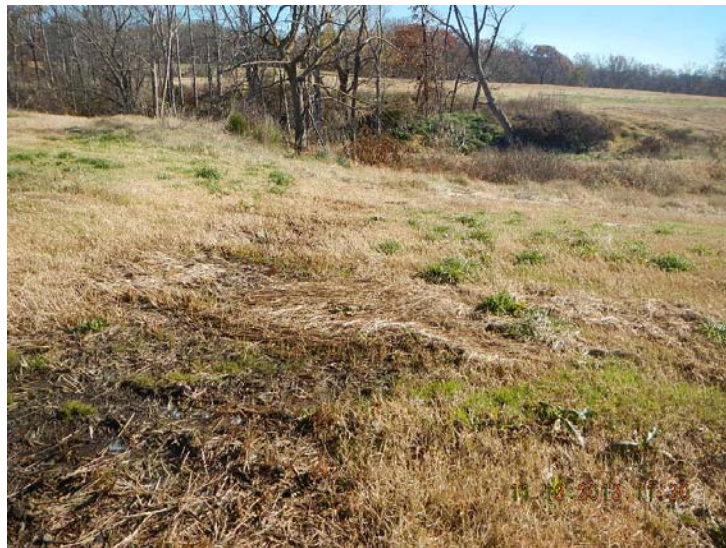
Photo # 47 **Of** 62 **Date:** 11-13-2013 **Time:** 10:30 a.m.

Description: DSCN1681. Irrigation Head C5 at Turkey Ridge. Run-off towards drainage located in the tree line east of the irrigation head.

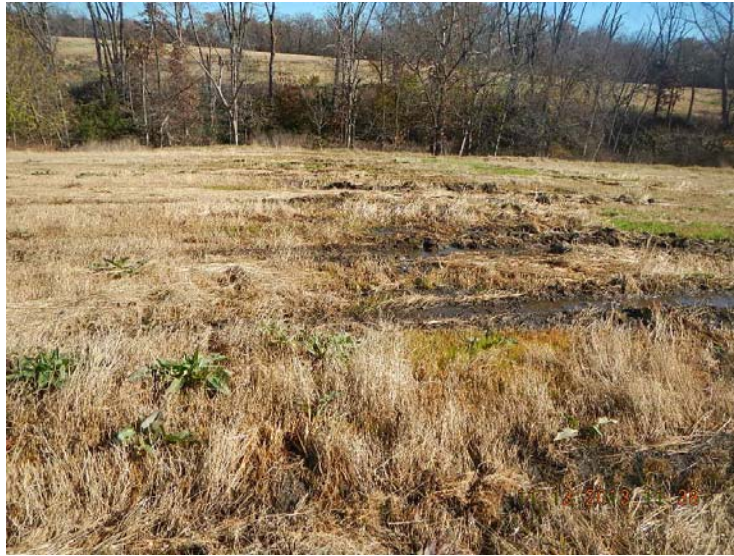
Photo # 50 **Of** 62 **Date:** 11-13-2013 **Time:** 10:38 a.m.

Description: DSCN1686. Irrigation Head C9 at Turkey Ridge. Run-off towards drainage located in the tree line east of the irrigation head.

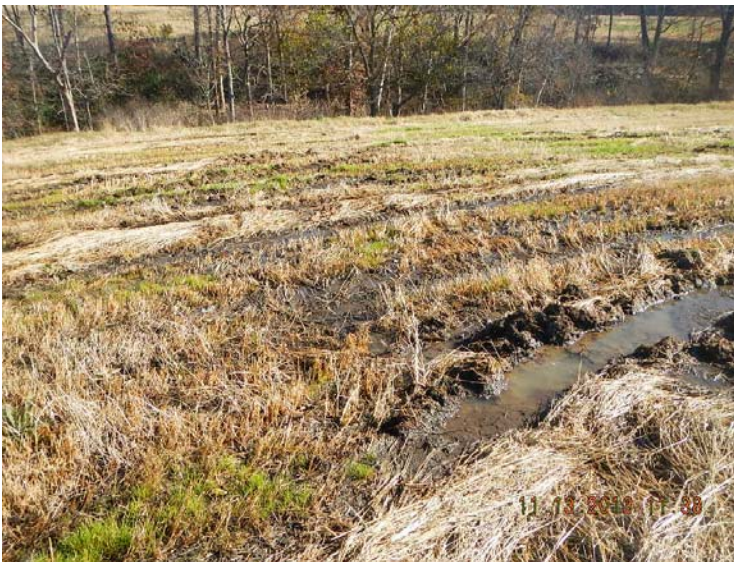
Photo # 51 **Of** 62 **Date:** 11-13-2013 **Time:** 10:38 a.m.

Description: DSCN1687. Irrigation Head C9 at Turkey Ridge. Run-off towards drainage located in the tree line east of the irrigation head.

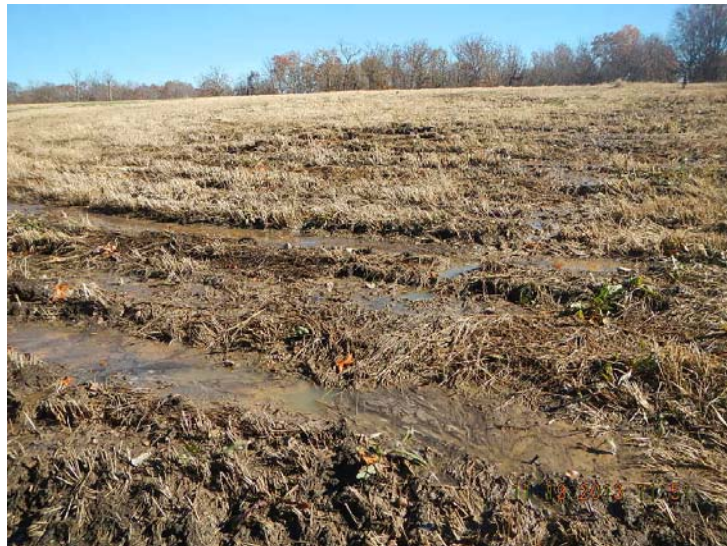
Photo # 55 **Of** 62 **Date:** 11-13-2013 **Time:** 10:51 a.m.

Description: DSCN1697. Irrigation Head A14 at Turkey Ridge. Looking east towards Irrigation Head, run-off towards drainage west of the irrigation head. Ground is saturated. Waste was applied in a manner which resulted in pooling. Poor vegetative cover.

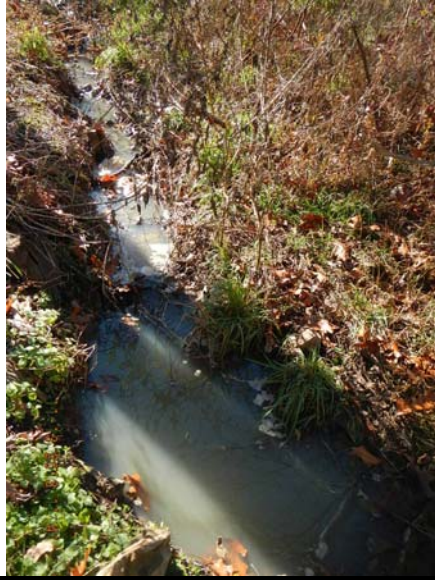
Location:	Allen's, Inc.-Country Plant						
Photographer:	Alison West			Witness:	Jason Bolenbaugh		
Photo #	56	Of	62	Date:	11-13-2013	Time:	10:41 a.m.
Description:	DSCN1691. Drainage runs in the tree line between Irrigation Heads C9 and A14. The drainage is visibly turbid.

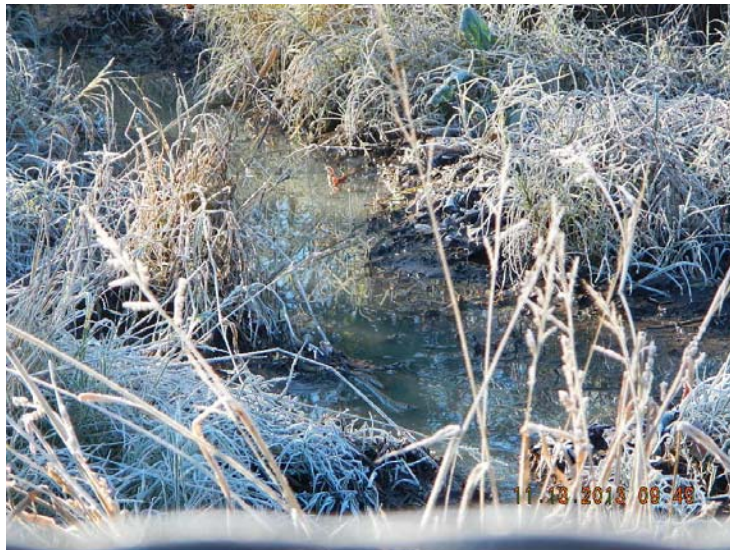
Photographer:	Alison West			Witness:	Jason Bolenbaugh		
Photo #	57	Of	62	Date:	11-13-2013	Time:	8:49 a.m.
Description:	DSCN1644. Drainage is visibly turbid on Allen's, Inc. property prior to flowing onto Paul Young's property.

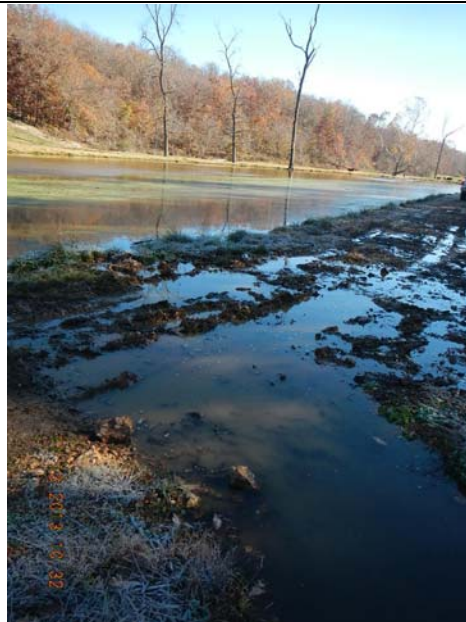
Photographer:	Alison West			Witness:	Jason Bolenbaugh		
Photo #	61	Of	62	Date:	11-13-2013	Time:	9:32 a.m.

Description: DSCN1655. Flow from swath drains into Mr. Young's spring fed pond.

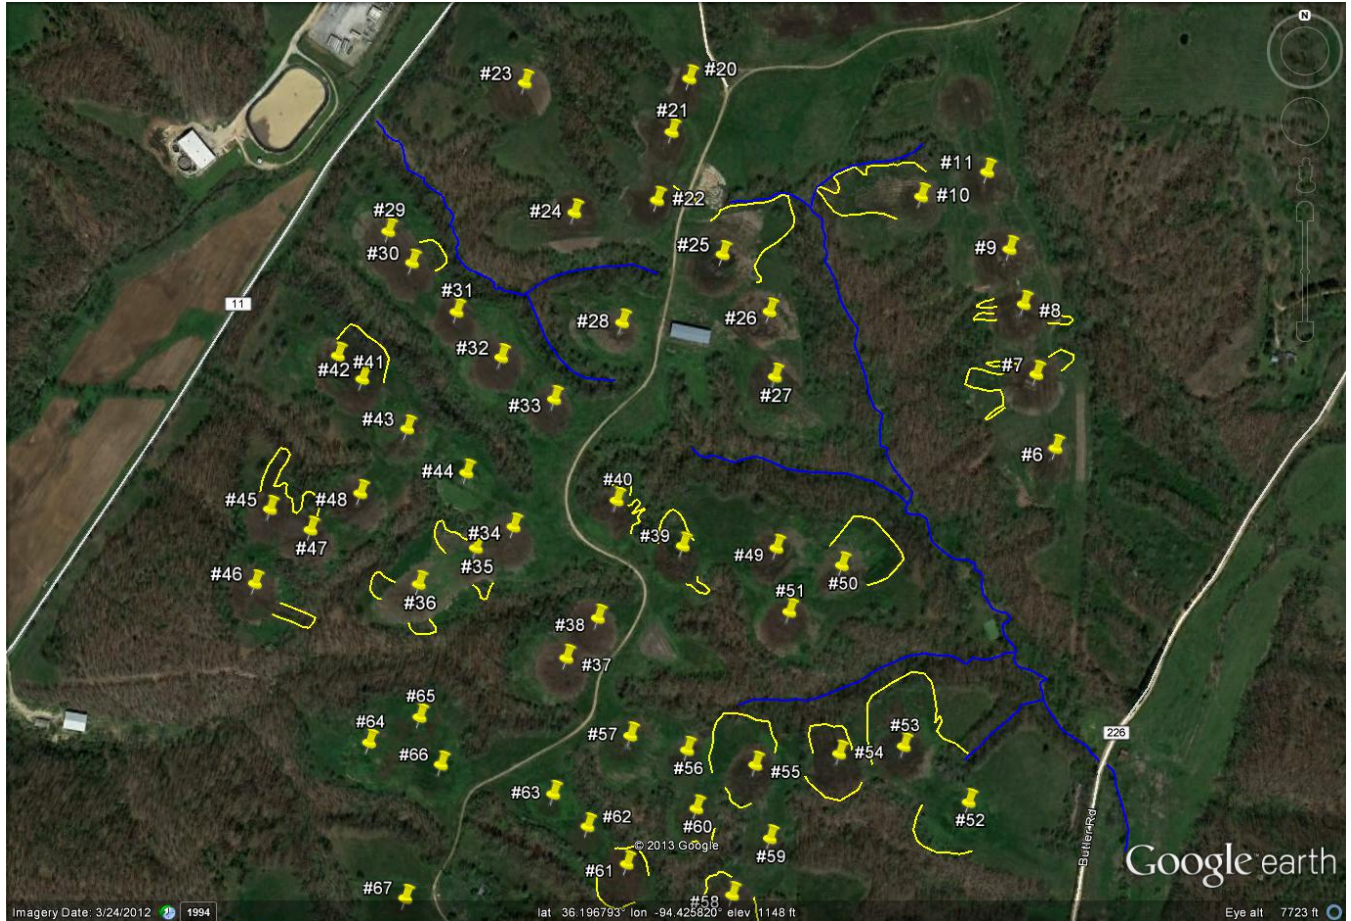
3/24/2012 Google Earth Image 1.

Allen Canning spray irrigation sites. The approximate location and identification number of each irrigation nozzle is indicated by the push pins. The plant waste water impoundment is in the upper left corner of the image while Butler Road (CR 226) is in the lower right corner of the image for reference. Surface water drainage is highlighted in blue. Likely surface runoff of land applied waste water and sludge at the time of the air photo is outlined in yellow.

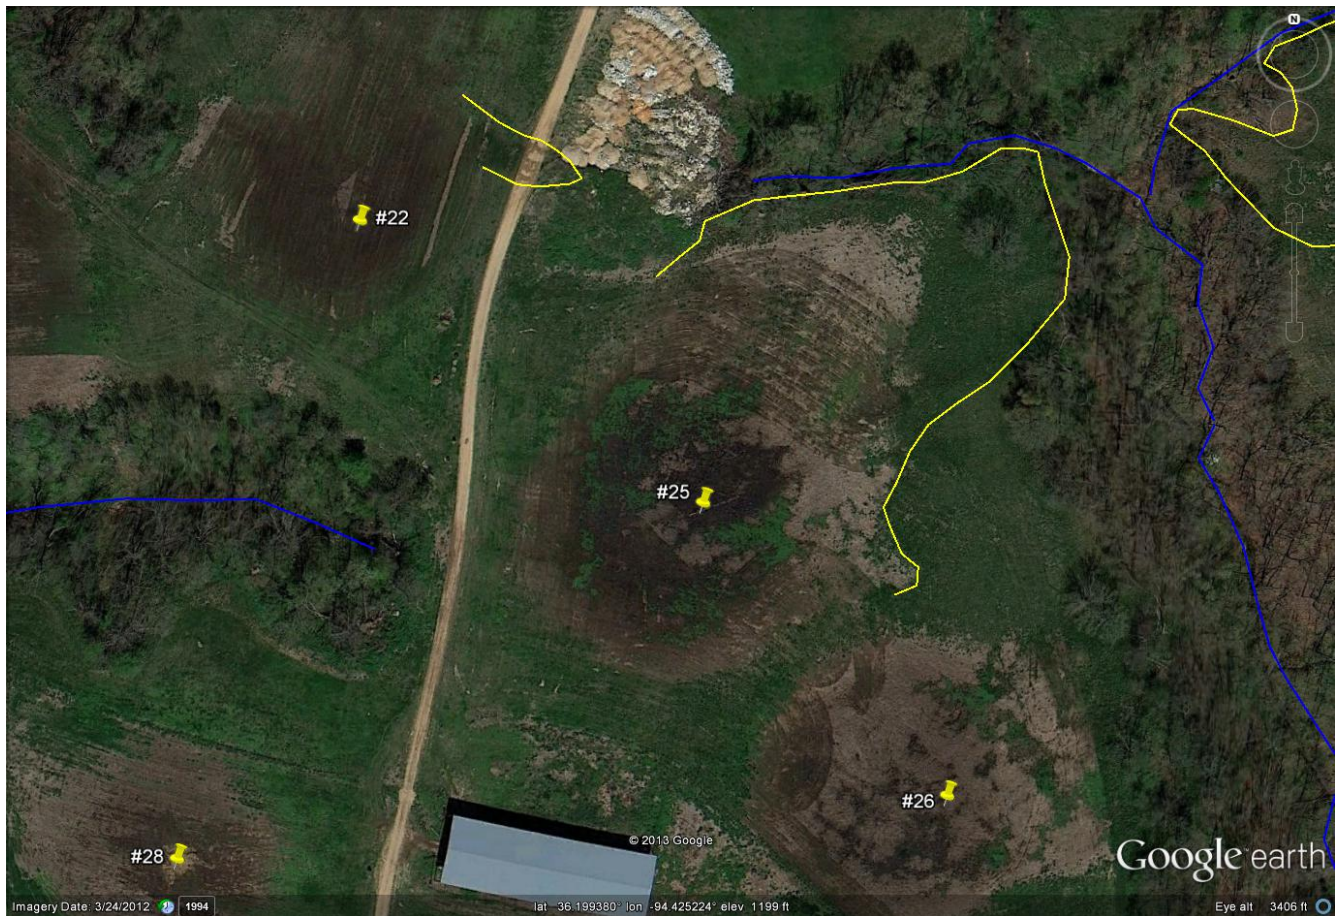
3/24/2012 Google Earth Image 2.

Spray Irrigation nozzle #25 located west of Butler Road. Surface water drainage is highlighted in blue. Likely surface runoff of land applied waste water and sludge at the time of the air photo is outlined in yellow.

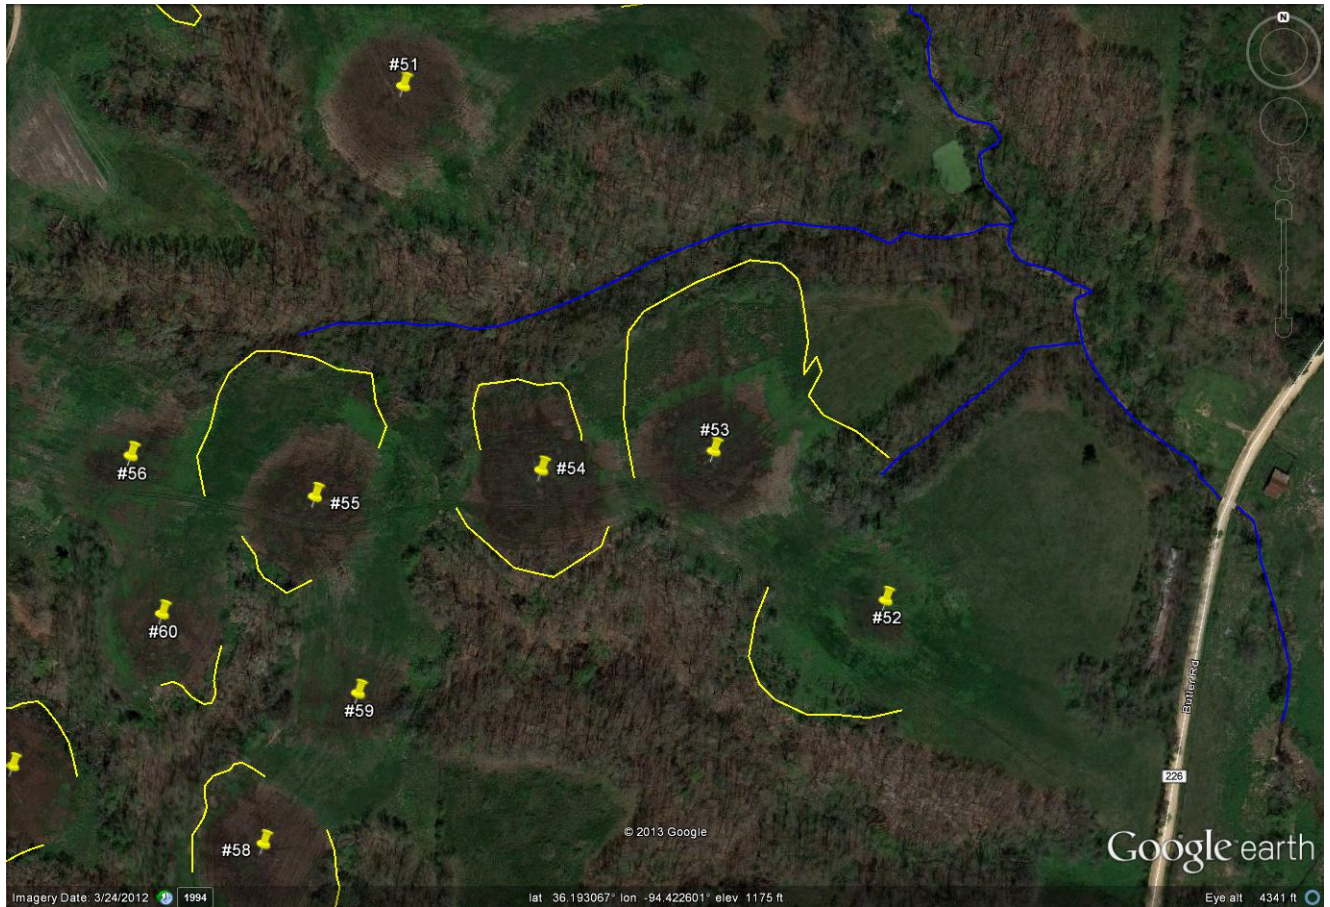
3/24/2012 Google Earth Image 3.

Spray Irrigation nozzle #53 located east of the Allen Canning Plant. Surface water drainage is highlighted in blue. Likely surface runoff of land applied waste water and sludge at the time of the air photo is outlined in yellow.

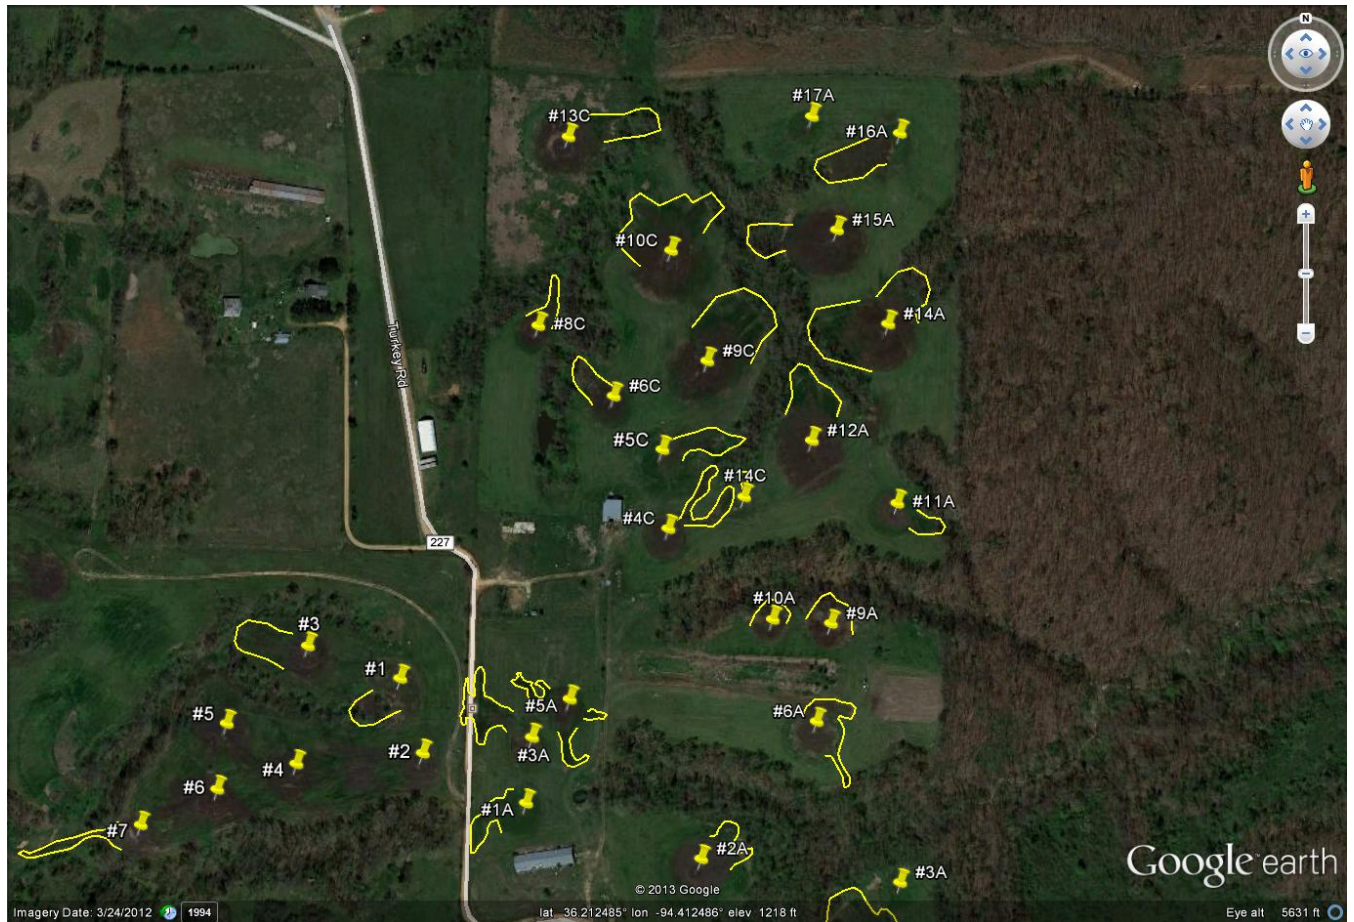
3/24/2012 Google Earth Image 4.

Northeast Irrigation Sites Overview (Turkey Ridge) located north of Logan Cave Road. The approximate location of irrigation heads and assigned identification numbers are indicated by push pins. Likely surface runoff of land applied waste water and sludge at the time of this photo is outlined in yellow.

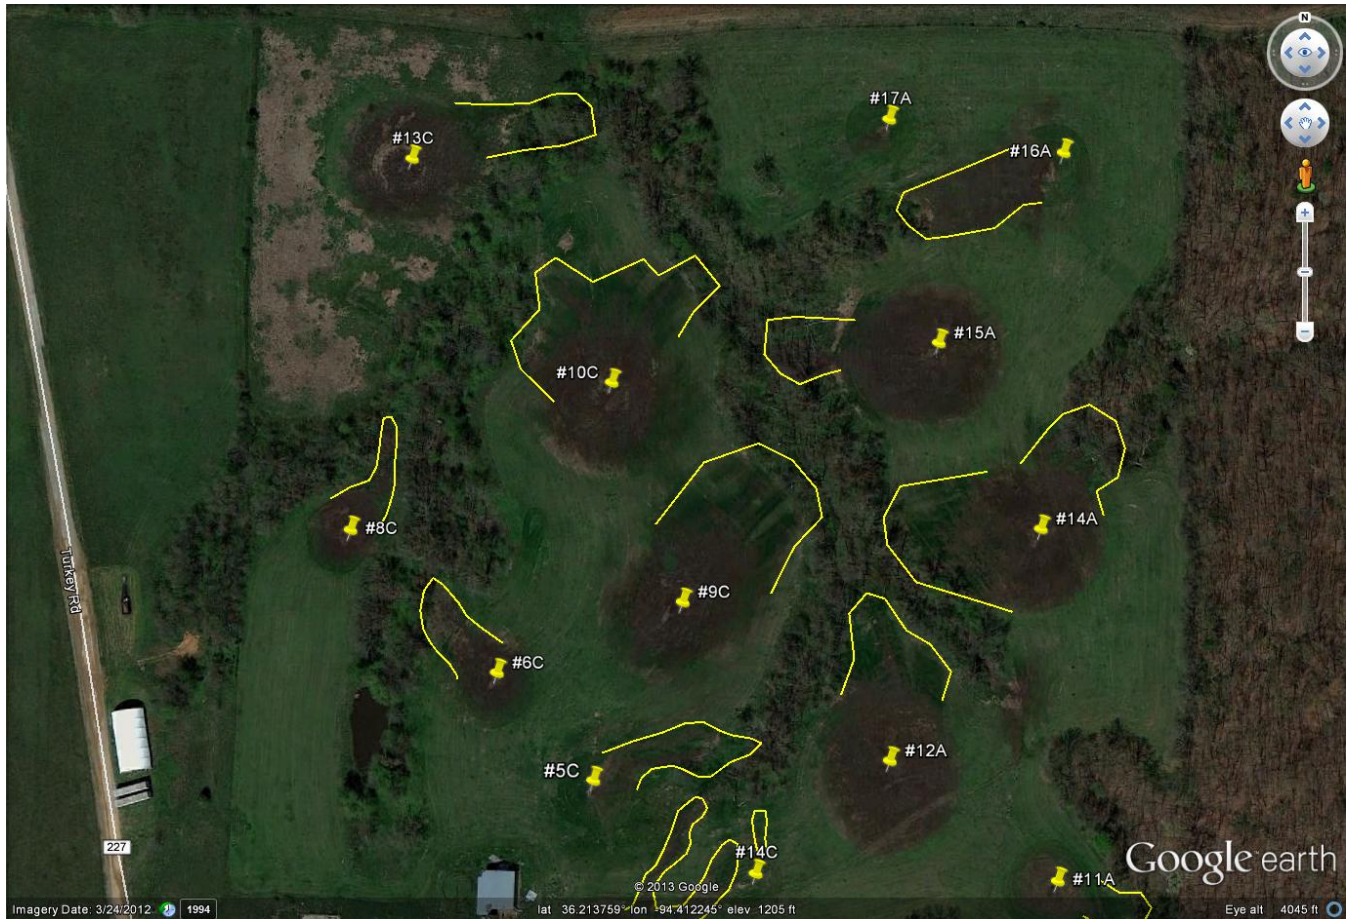
3/24/2012 Google Earth Image 5.

Northern Turkey Ridge Irrigation Sites. The approximate location of irrigation heads and assigned identification numbers are indicated by push pins. Likely surface runoff of land applied waste water and sludge at the time of this photo is outlined in yellow.
