Bridge Investigation Report

May 5, 2015

Investigation Overview

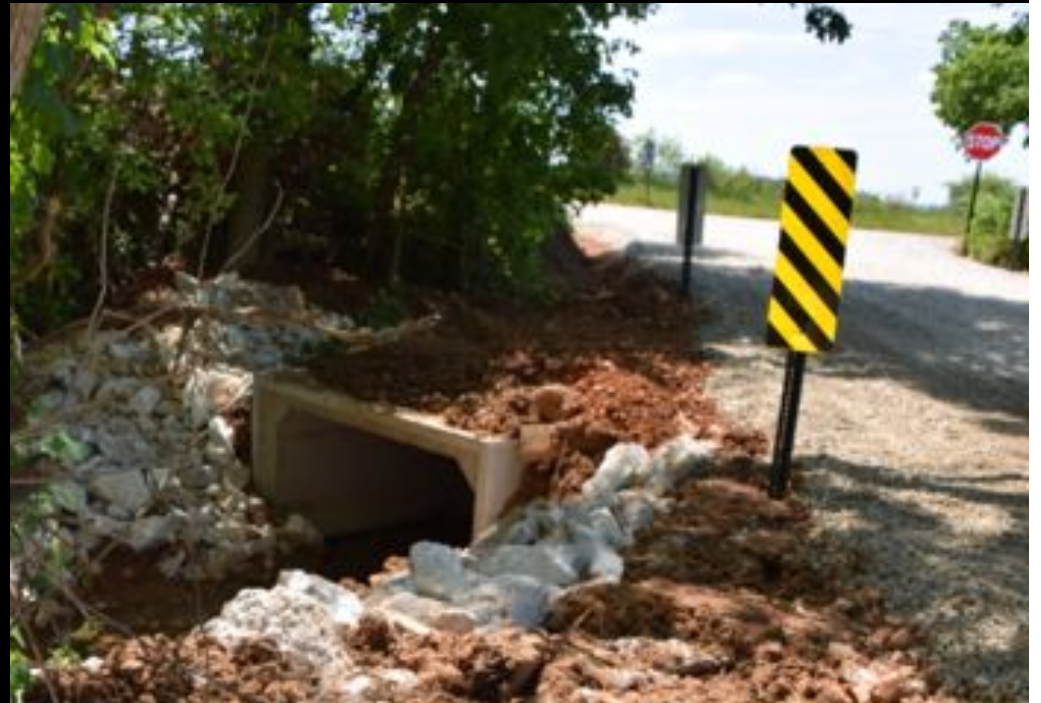
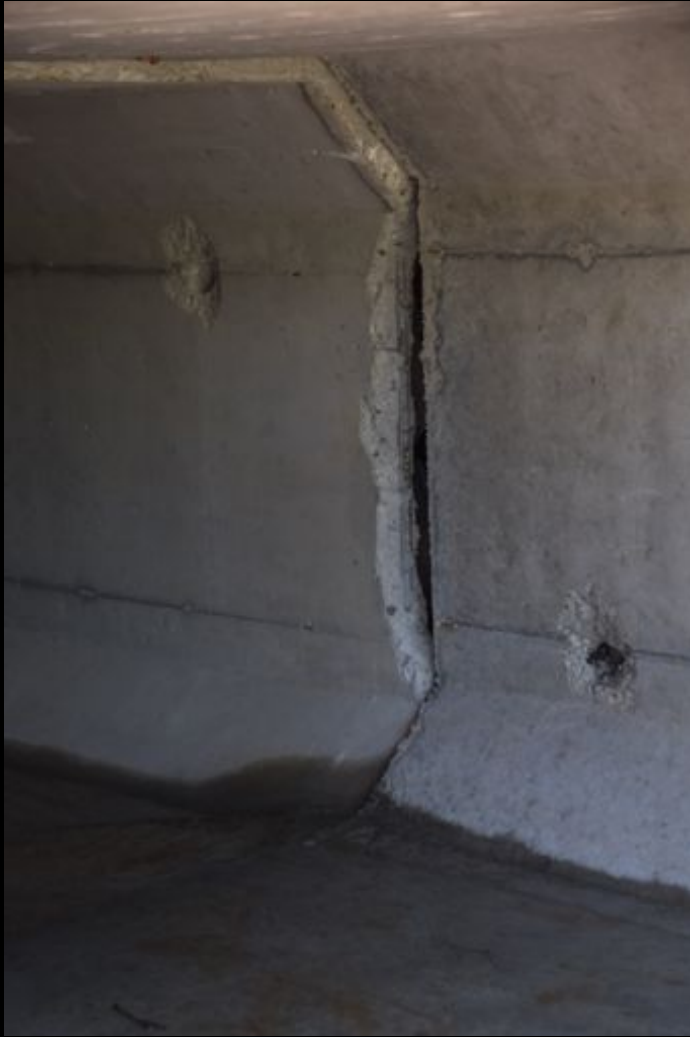
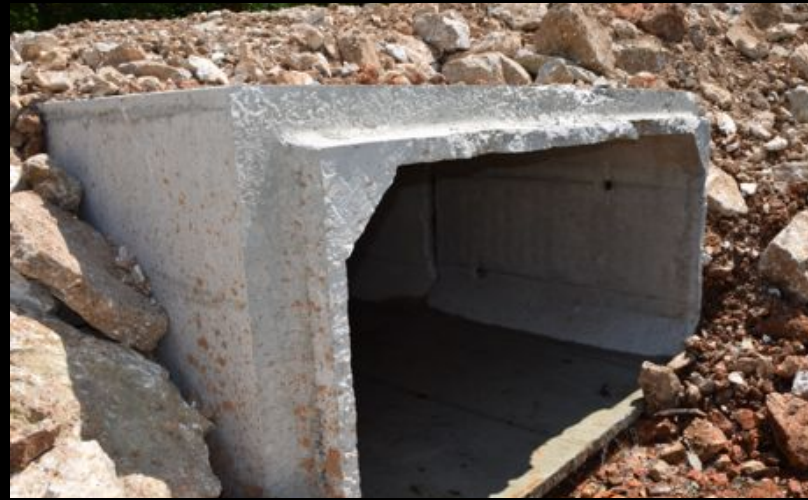
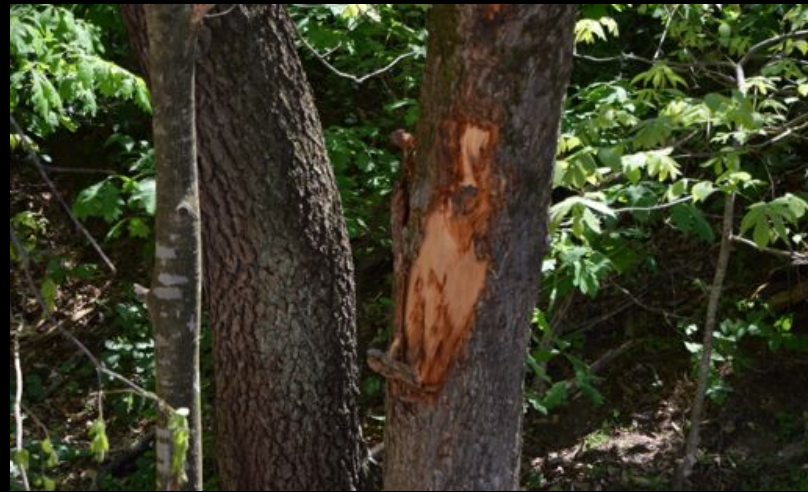
- During the investigation, we learned of deficiencies with a box culvert north of Highway 412, west of Elm Springs, on Osage Creek Road.
- We were told it should be “condemned immediately” because concrete and water erosion had caused part of the road to cave in.
- We heard this from two witnesses; one showed us photos on his phone.
- They said they had been complaining for months, without success. Prior temporary fixes to the bridge had been unsuccessful.

- We promptly notified the County Judge's office the day we learned of the problem.
- The bridge was replaced the following day, on Thursday, April 30.

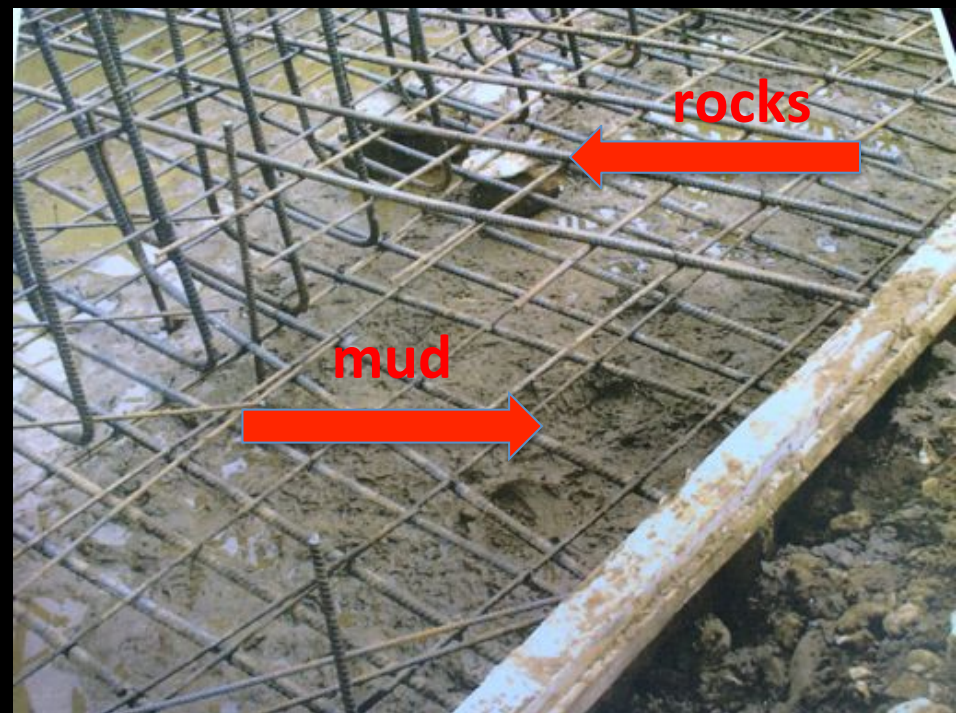
- In some instances, when surfaces were not level, rocks were used to prop up steel mats, which is contrary to AHTD standards (although common).

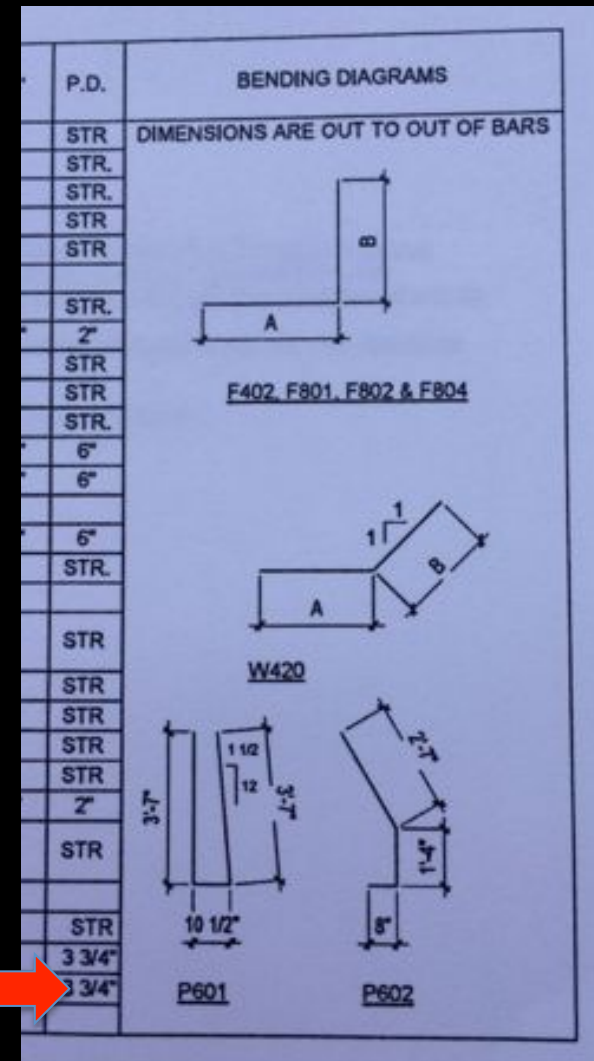
- In some applications, including particularly in footers, bent rebar was replaced with straight rebar.
- In other applications, rebar was bent with a torch/heat, mostly on-site.
- Why? Road Department did not order rebar bent to specs, but ordered it straight. Bent in shop with older machine. Bars would break sometimes. Unable to bend above #6 rebar.
- Acquired proper bender in December 2014.

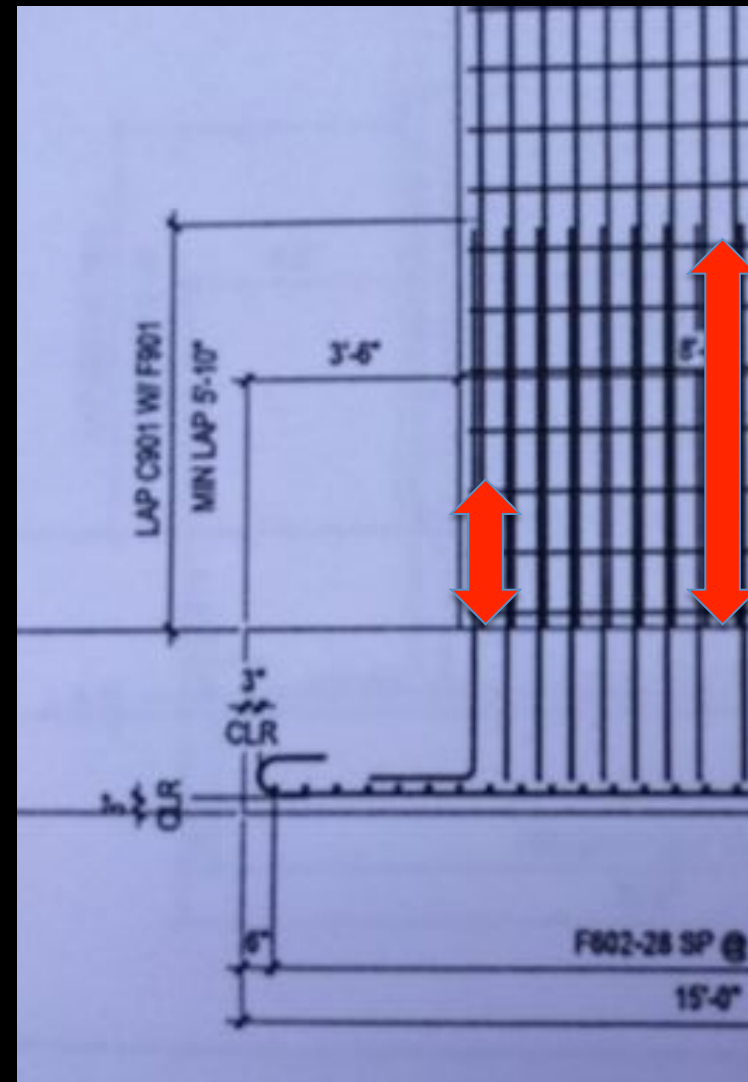
- Crews understood 2' or 3' was always sufficient for lap length.

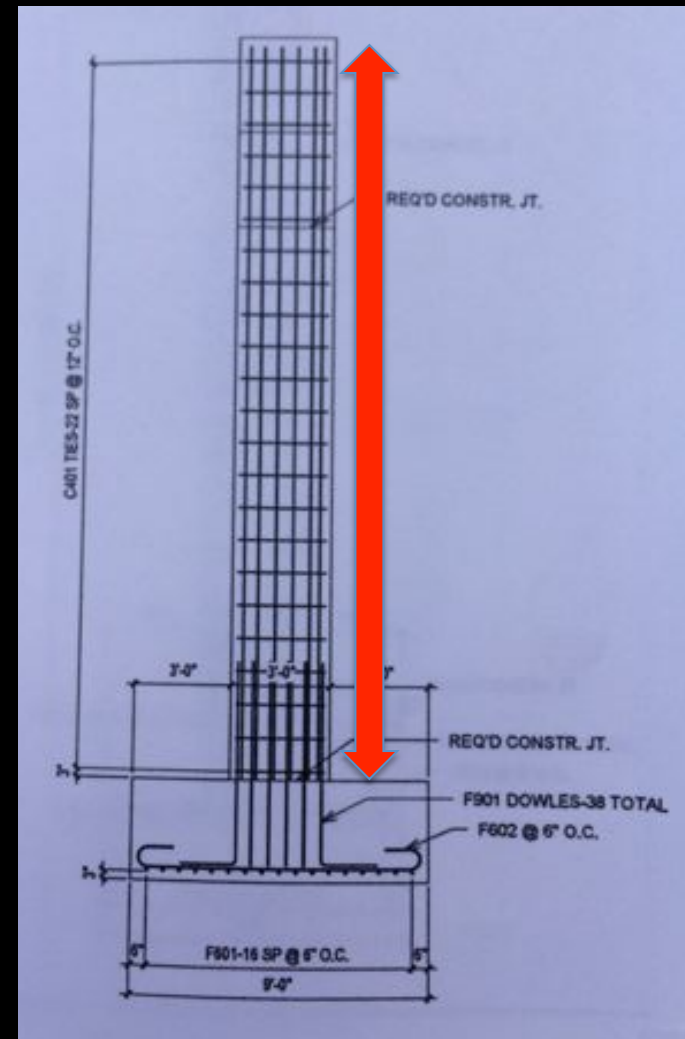
- Plans call for continuous steel bars
- Crews did not use continuous steel due to difficulty keeping it held up and prior experiences with it falling
- Lapped bars together instead

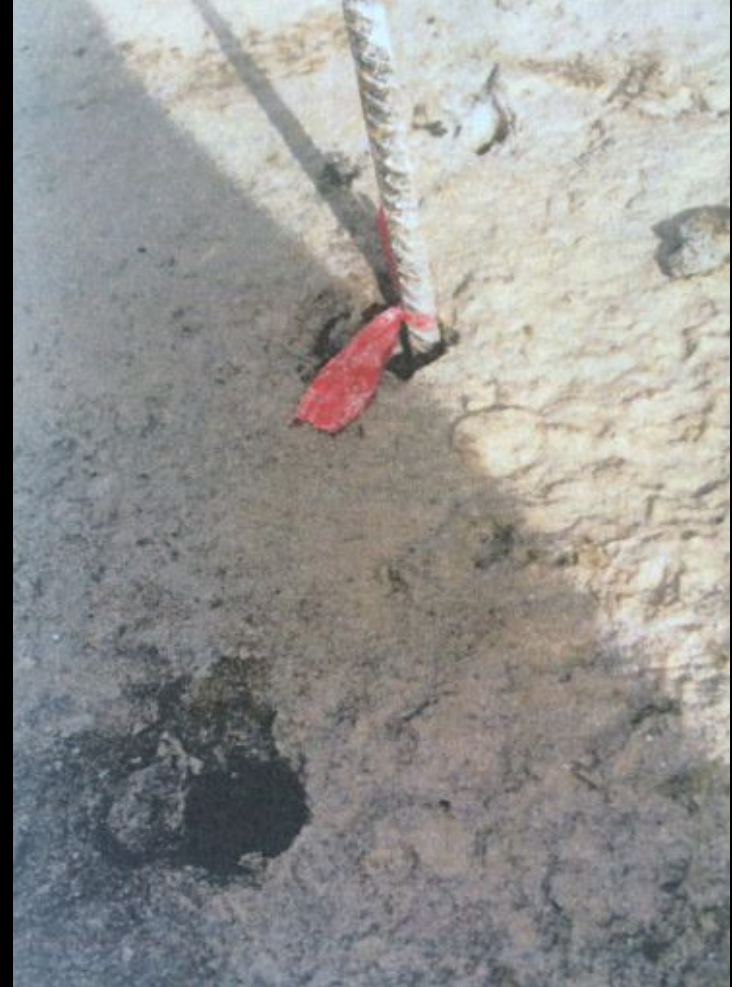
- In some instances, crews did not place steel before the concrete pour.
- Steel was added to the wet concrete after the fact and thus not tied in.
- In some instances, crews drilled holes into set concrete to add steel after the fact.

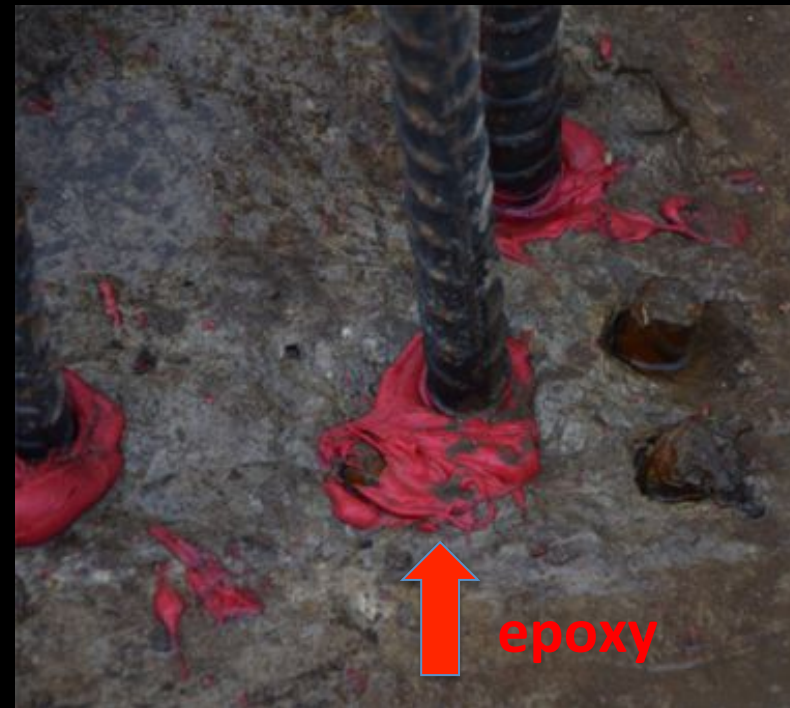
- Crews were unfamiliar with epoxy.
- Did not use epoxy until sometime in late fall 2014 after questions were raised about the bridges.
- Used in east/Prairie Grove side abutment wall of Stonewall.

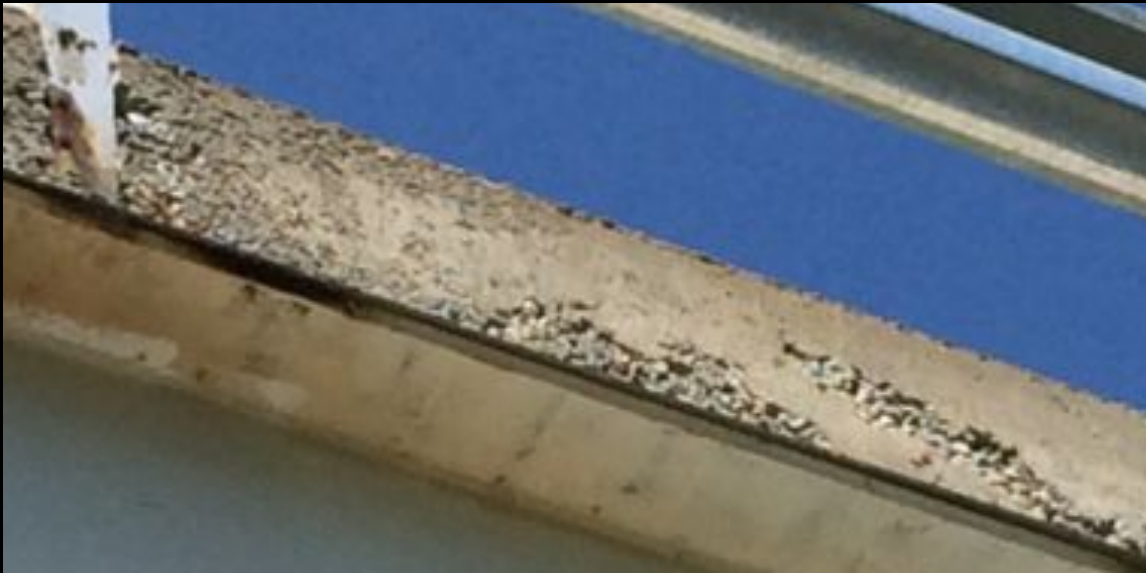
Harvey Dowell Decking

- Honeycombing due to lack of vibration (required by AHTD standards)
- From American Concrete Institute (ACI):
Honeycomb = “voids left in concrete between coarse aggregates due to inadequate consolidation.”
- Honeycombing will accelerate deterioration of the concrete due to freeze-thaw because moisture can easily work its way into the honeycomb areas.

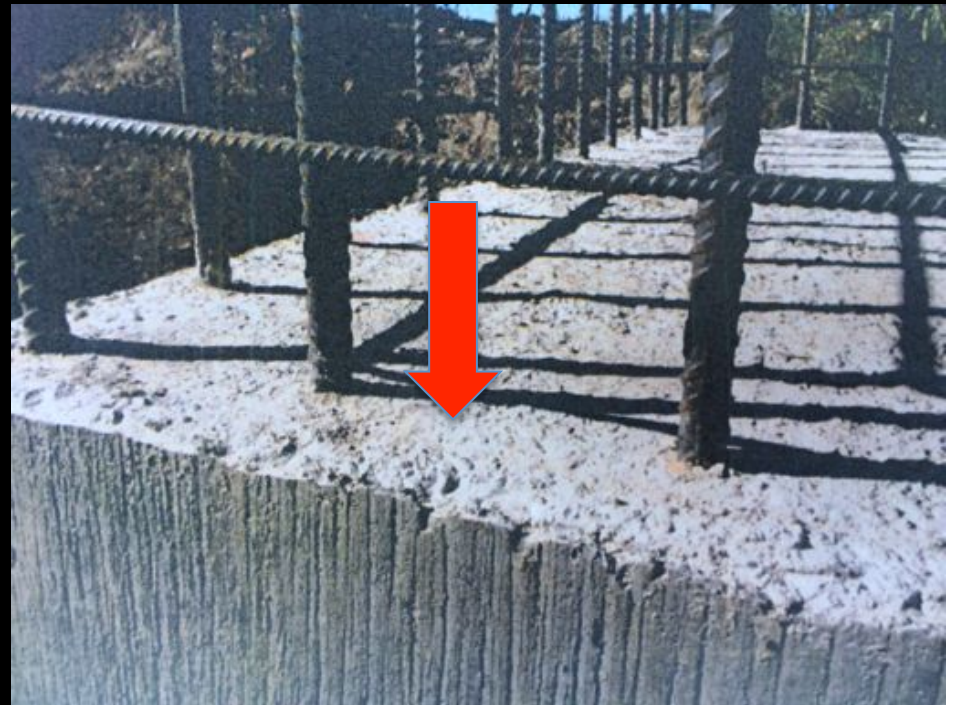
- Dry concrete was not prepared to ensure wet concrete adhered to dry concrete at joints.
- Typically, you clean and score dry concrete before next pour.

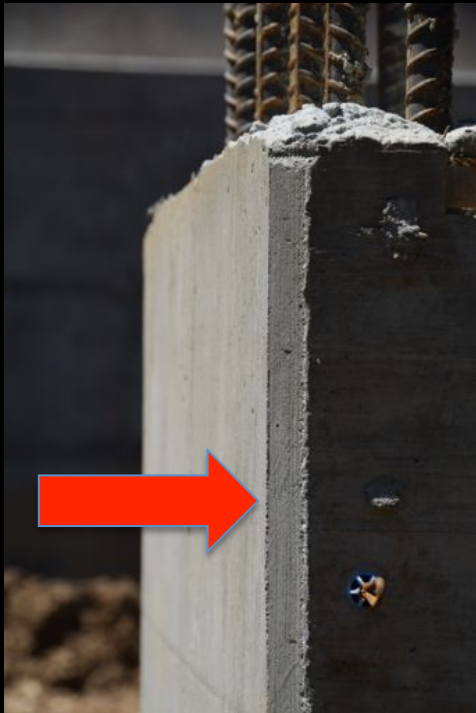
New pier at Stonewall

- Plans: “All exposed corners shall be chamfered $\frac{3}{4}$ ” unless otherwise noted.

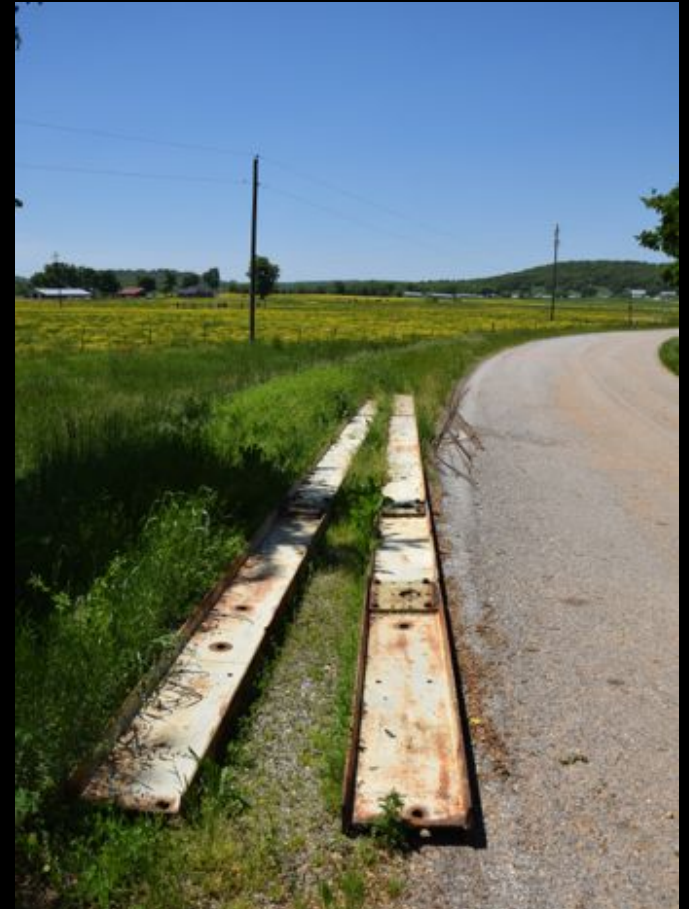
- No concrete test cylinders performed until late in process at Stonewall – done to test strength and quality
- No materials certifications
- Used red iron with no certifications

Beams and rebar left at
Stonewall site

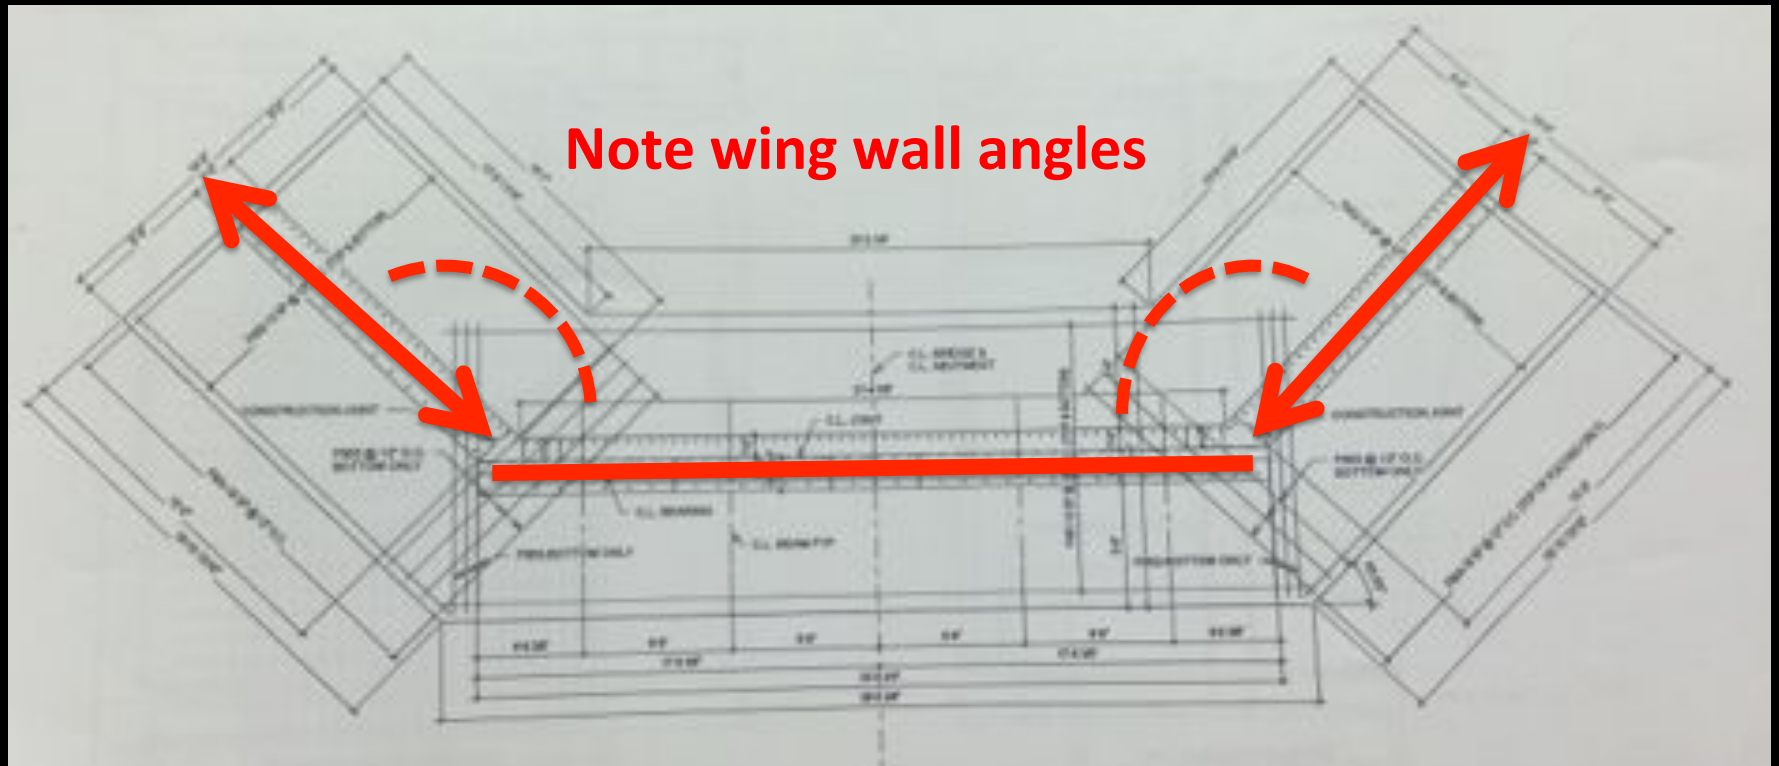
South Abutment at Harvey Dowell

plans

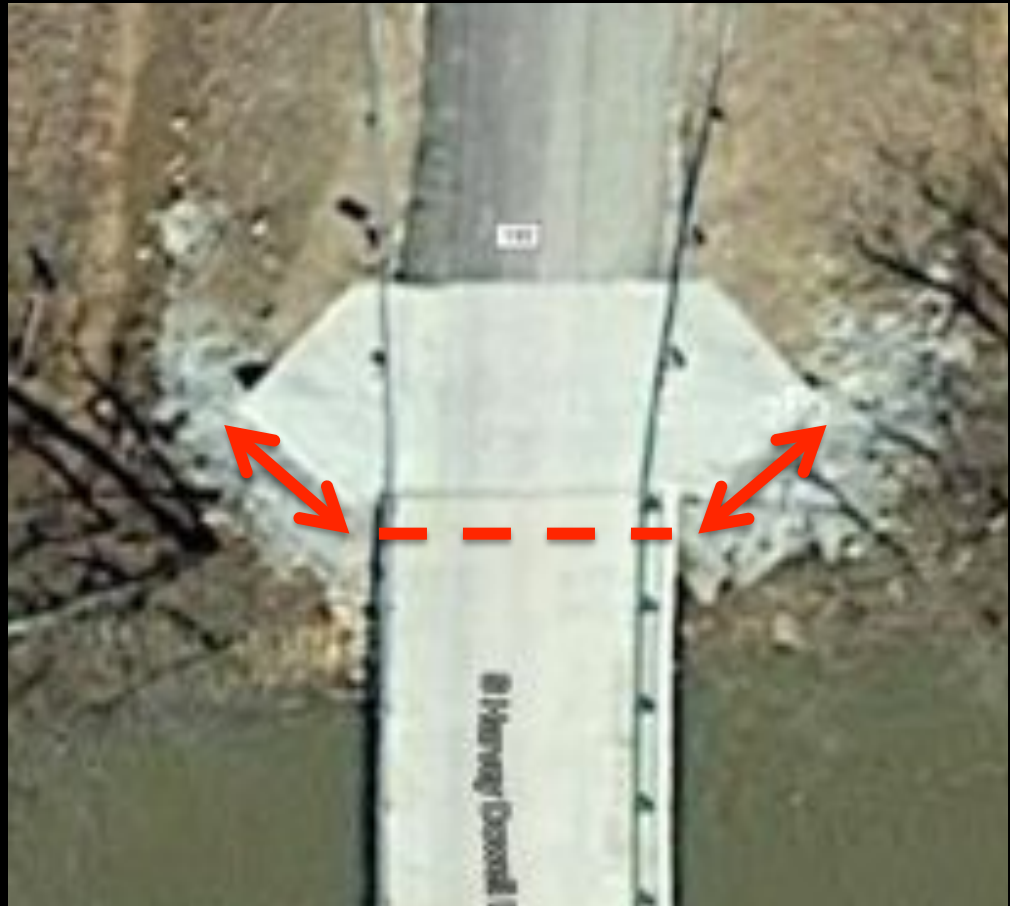
South Abutment at Harvey Dowell

- Compare wing wall angles on north abutment, which are “to plan”

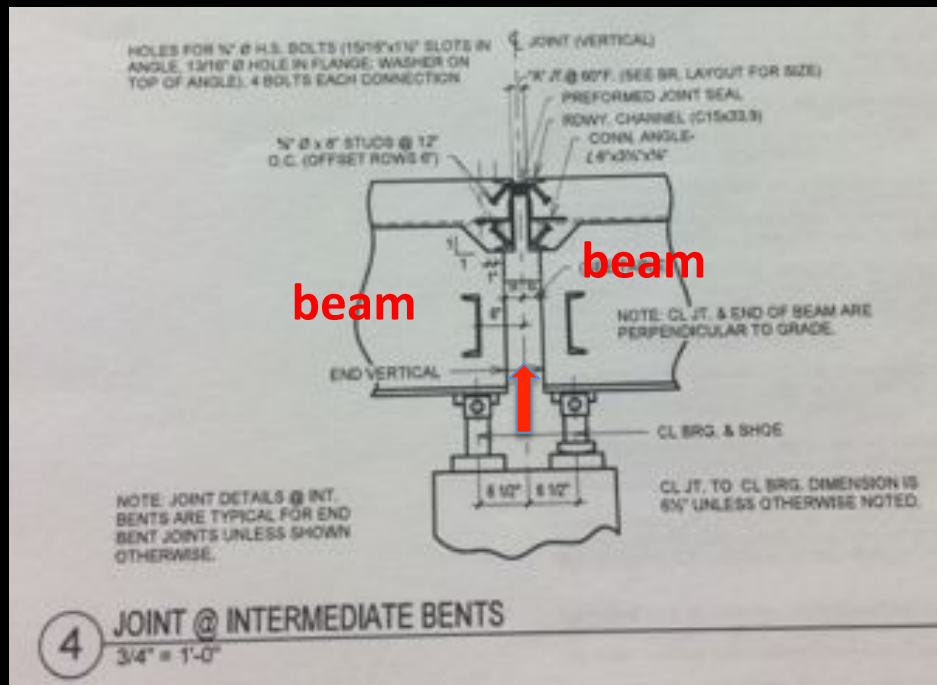
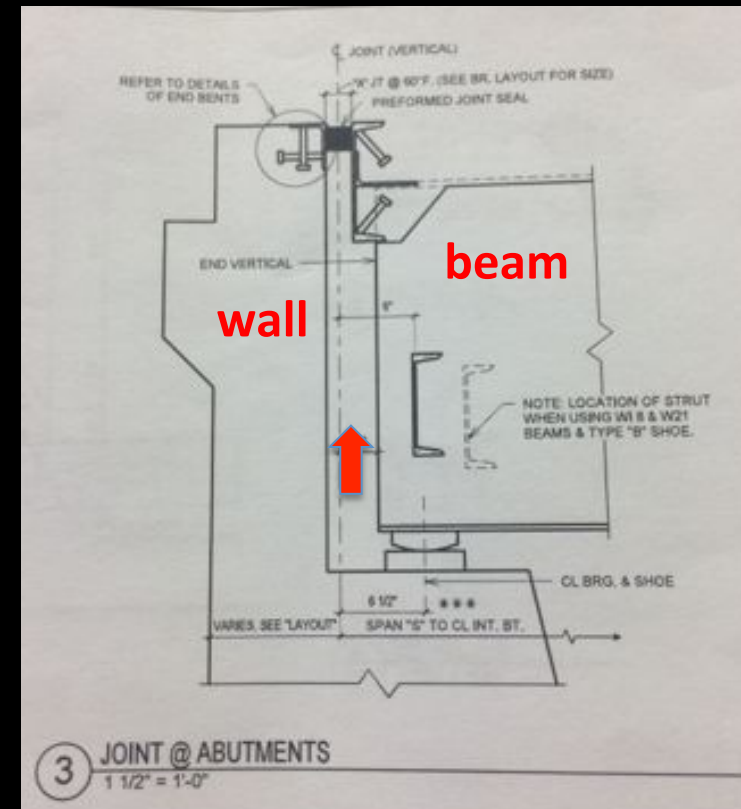
Harvey Dowell Beams

- Plans call for steel-to-concrete spacing of $1\frac{3}{4}"$ at joint abutments.

- Allows for bridge to expand/contract

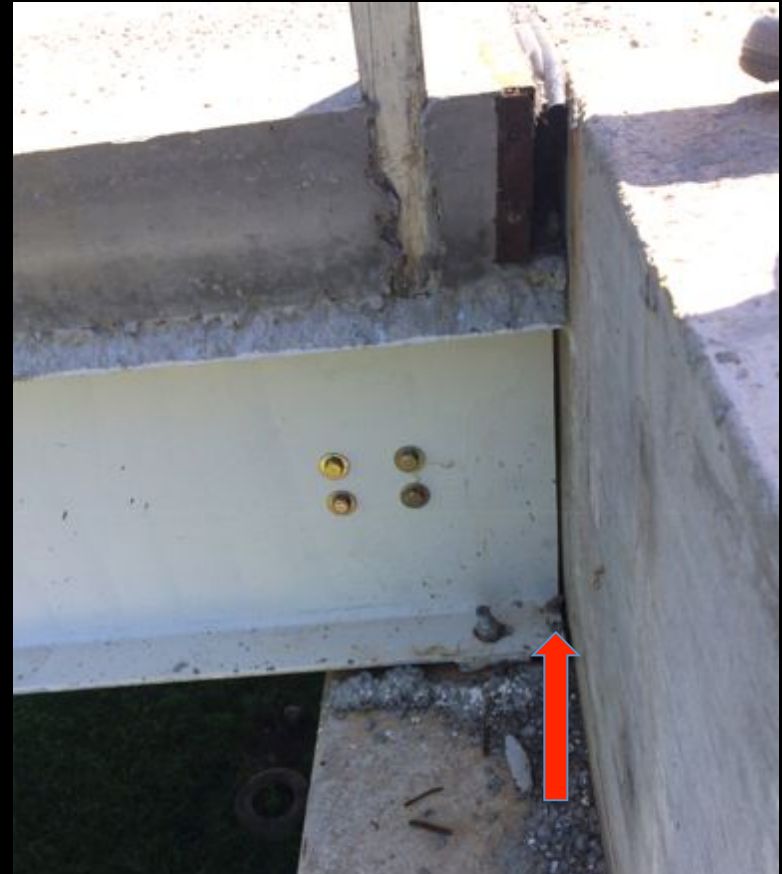
Beam resting on south abutment wall

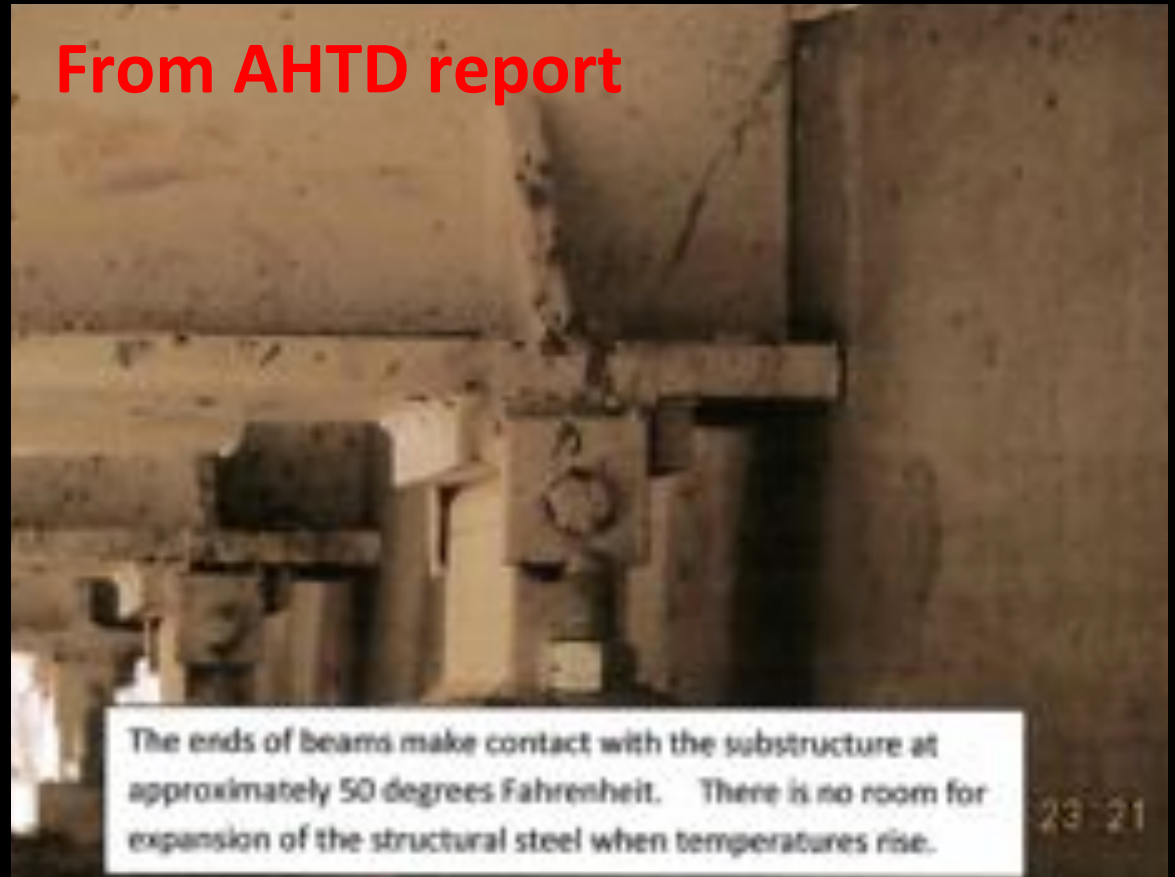
From AHTD report

- Addressed in AHTD report in Dec. 2013 and repair made, but problem still appears today.

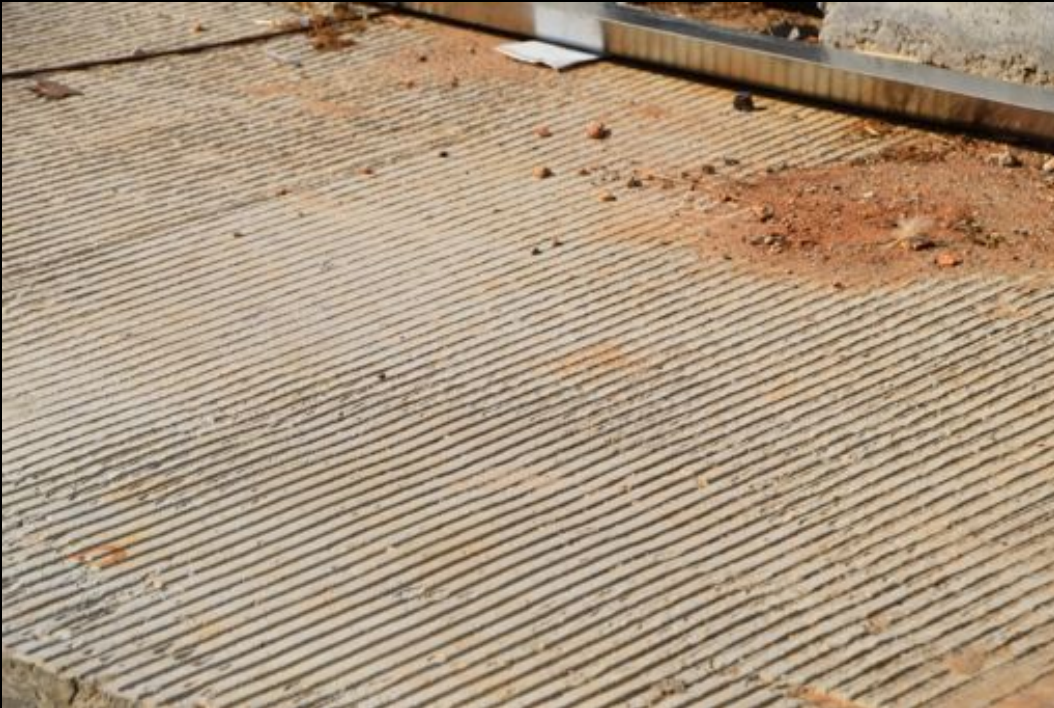
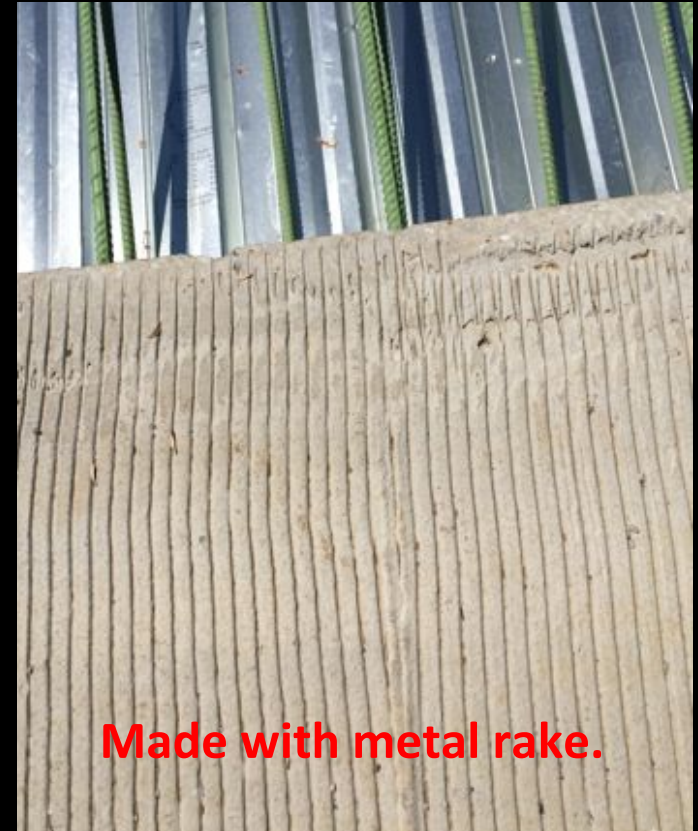
Tine Finish

- Plans state: “Bridge deck: the concrete bridge deck shall be given a tine finish as specified for final finishing in subsection 802.19 for Class S Tined Bridge Roadway.”
- Tine finish increases safety by allowing for better traction.
- Then “Class 1 protective surface treatment shall be applied to the roadway surface,” i.e., boiled linseed oil.

Made with metal rake.

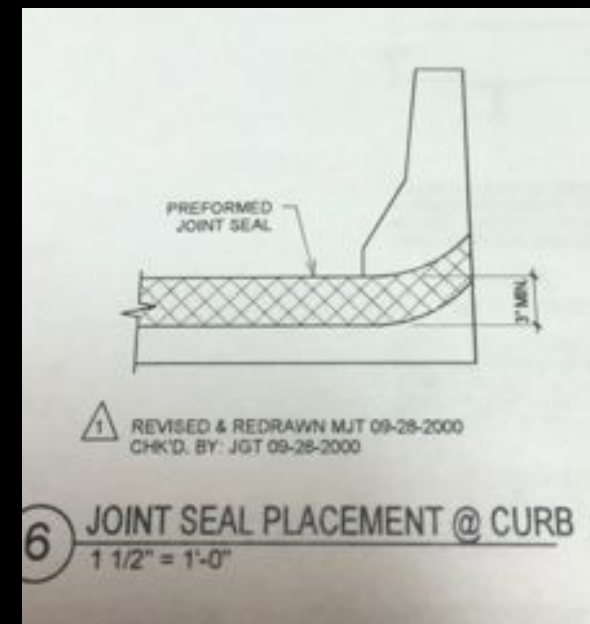
- Plans call for curbed concrete wall at road deck edge.
- No curb installed, so nothing at road edge.
- Used guard rail instead.
- Plan deviation is visible to anyone.
- Did not think they had ability (e.g., forms) to do per plan.

Harvey Dowell Curb/Guard Rail

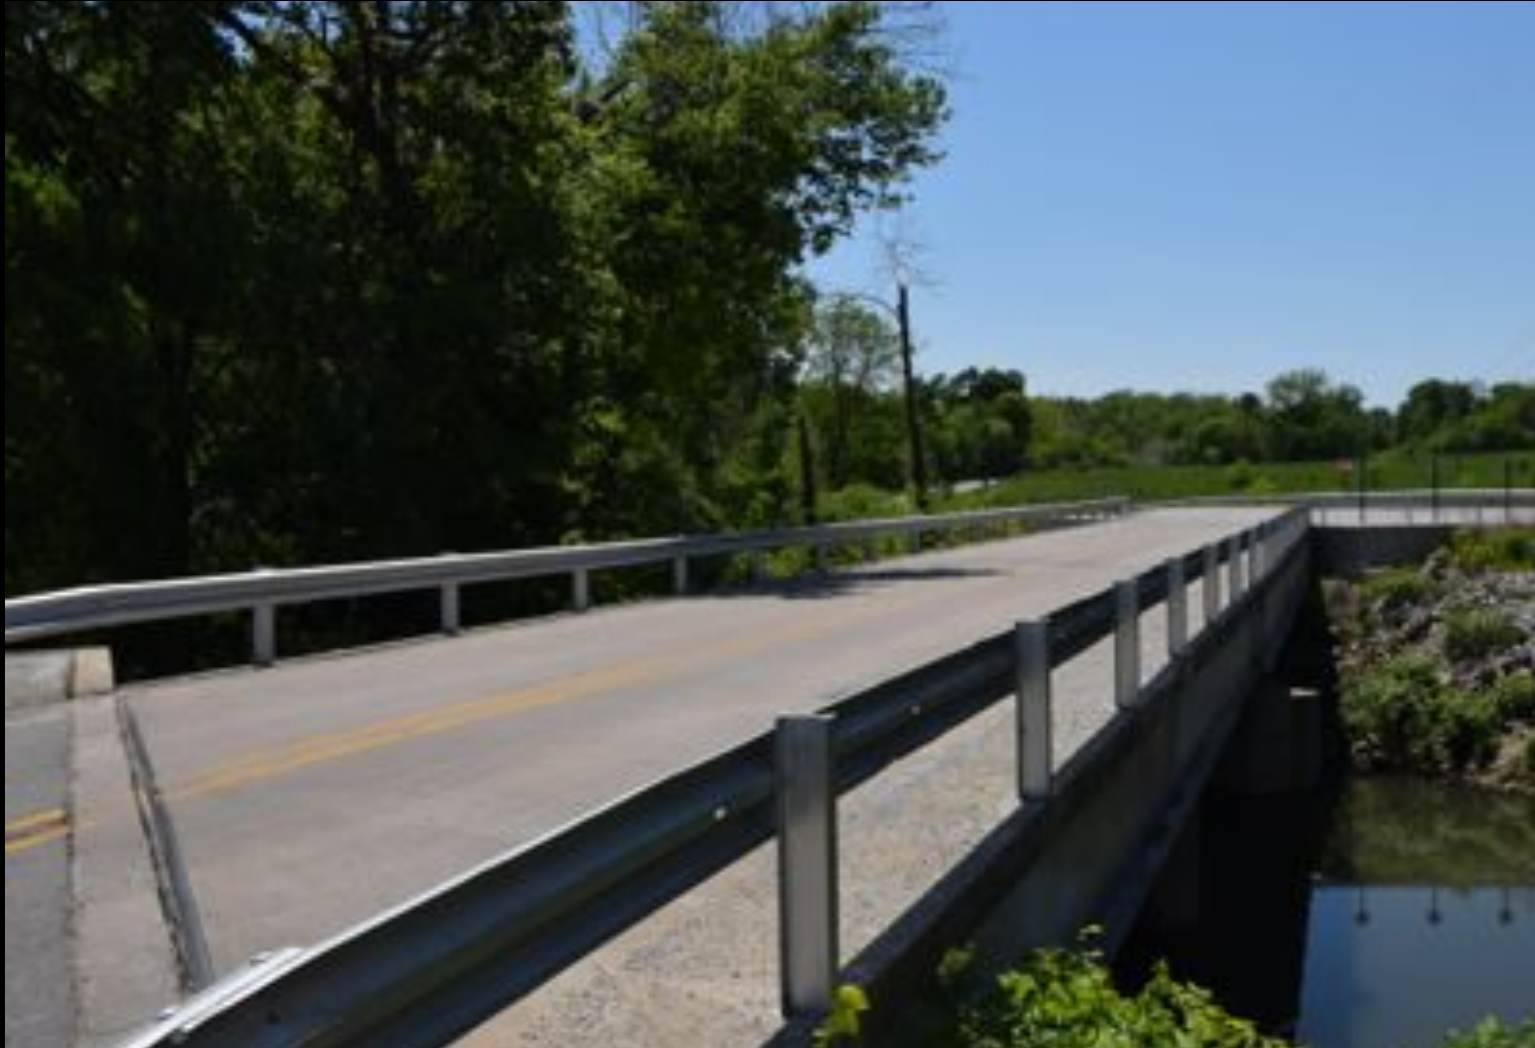
“Per Plan” Curb/Guard Rail

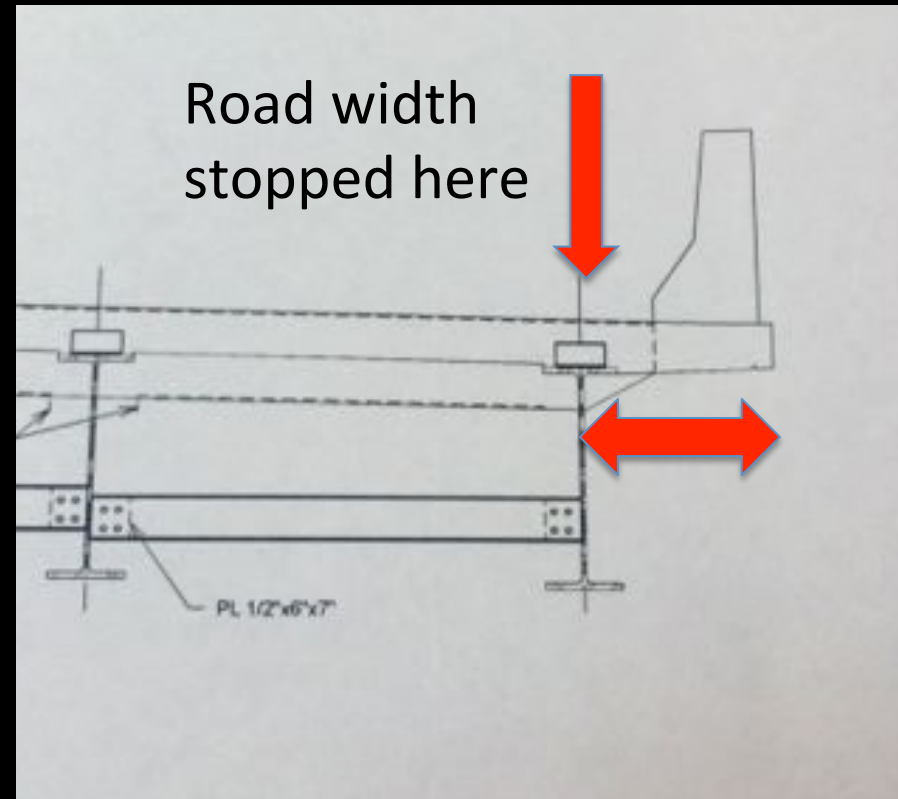
Harvey Dowell Road Width

- Road deck width not to plan
- Exclusion of concrete curb included exclusion of that width

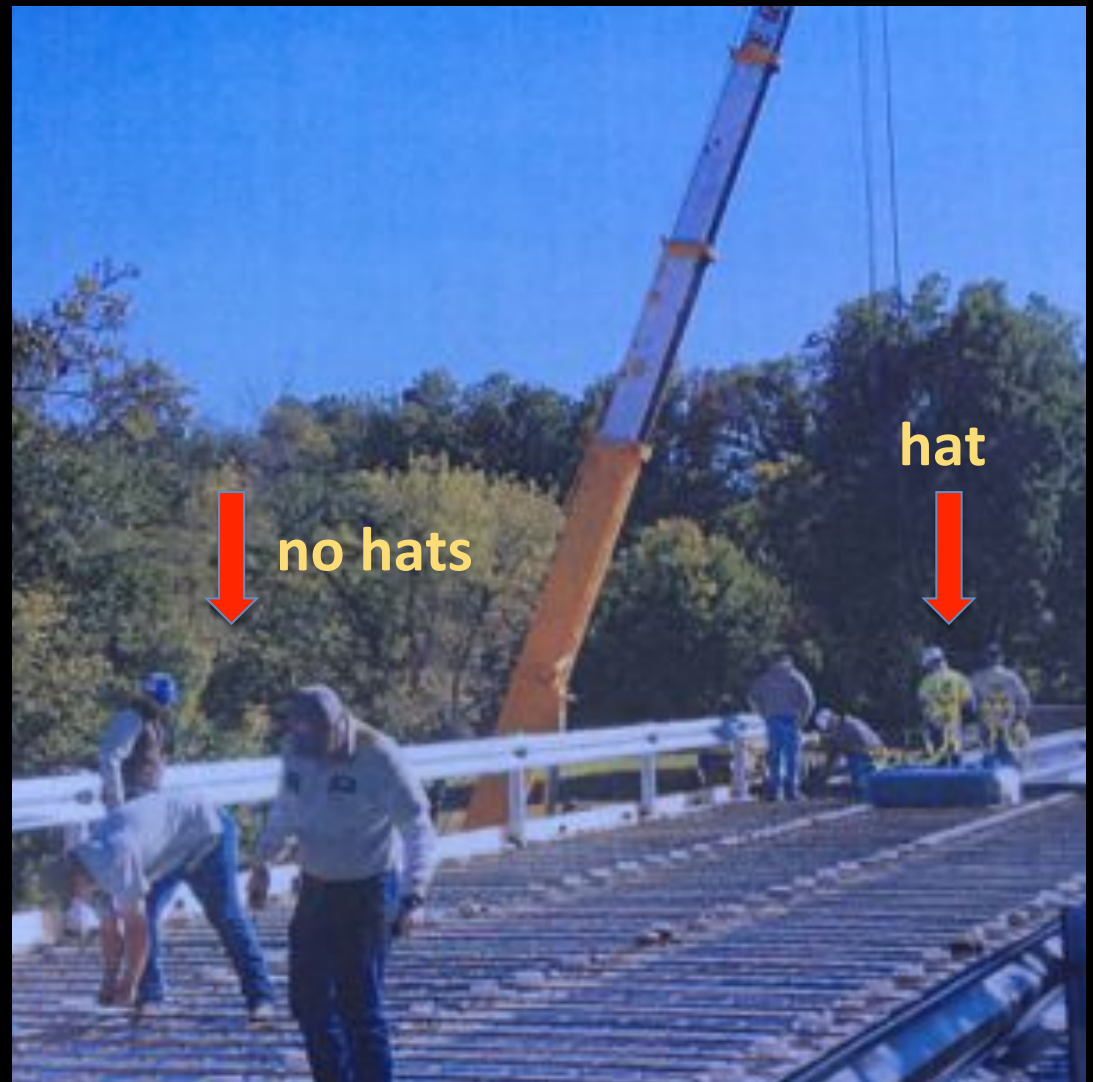
- Despite having regular safety meetings and being regarded as having a top safety program among area Road Departments, safety is not a priority.
- PPE (Personal Protective Equipment) is worn infrequently: hard hats occasionally, safety glasses rarely, steel-toed boots rarely, safety harnesses occasionally.

- Employees reported wearing hard hats only when a crane is being operated.
