Fracture Investigation Memphis, Tennessee

**FINAL REPORT** October 7, 2021 WJE No. 2021.3178.1

The 3.3-mile long I-40 Hernando deSoto Bridge crossing the Mississippi River was closed May 11, 2021 after inspectors performing a routine inspection identified a partial fracture in a tension member that supports one of two tied-arch truss spans. The fracture occurred at a welded plate transition in the upstream (north), box-shaped tension tie member (Figure 1). The six-lane bridge was subsequently closed to traffic.

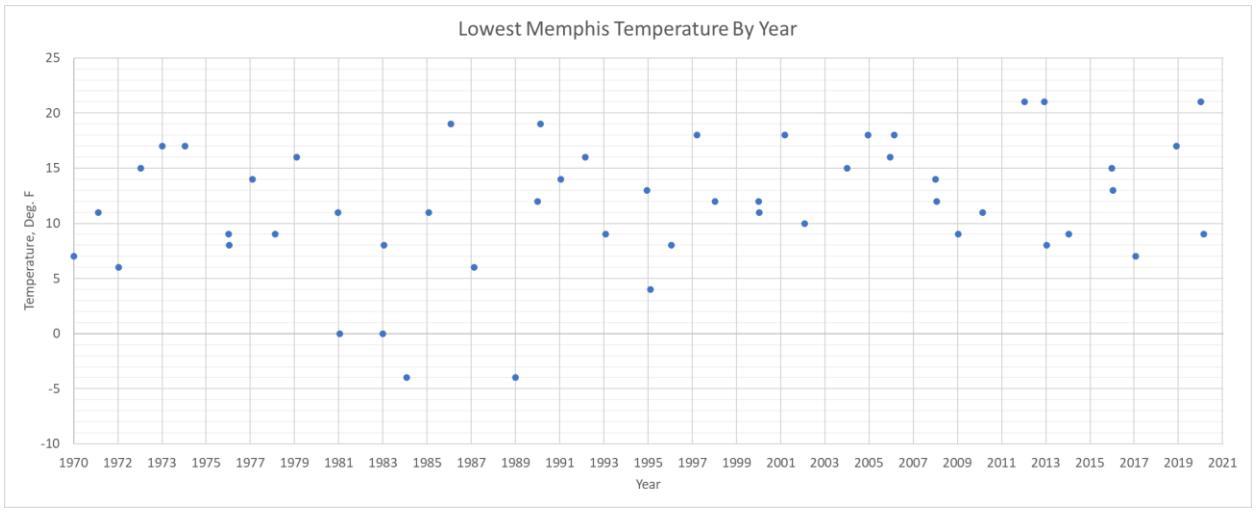
Temperature records for Memphis over the last fifty years were reviewed. Figure 13 provides a list of annual low temperature events over that time period. These data were collected at the Memphis International Airport. Since 2019, the lowest temperature has been 9 deg. F on February 15, 2021. Since the bridge was constructed there have been twenty minimum low temperatures of 10 deg. F or below with the coldest temperatures of -4 deg. F recorded in 1985 and 1989.

Figure 13. Annual lowest temperatures in Memphis.

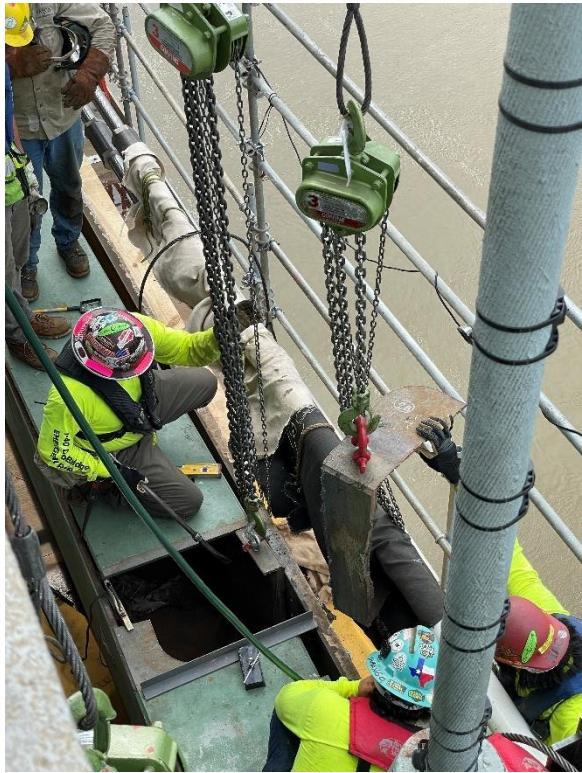
Following the installation of a jacking system to temporarily support a portion of the north tie girder load, the fractured portions of the top and bottom cover plates and outboard (north) side plate were removed from the bridge by Kiewit Infrastructure South Co. and transported to WJE's Northbrook, Illinois laboratory for examination and evaluation. A combination of plasma and oxygen-acetylene torch cutting were used to remove the pieces of plate from the bridge (Figure 14).

Figure 14. Removal of fractured pieces from tie.

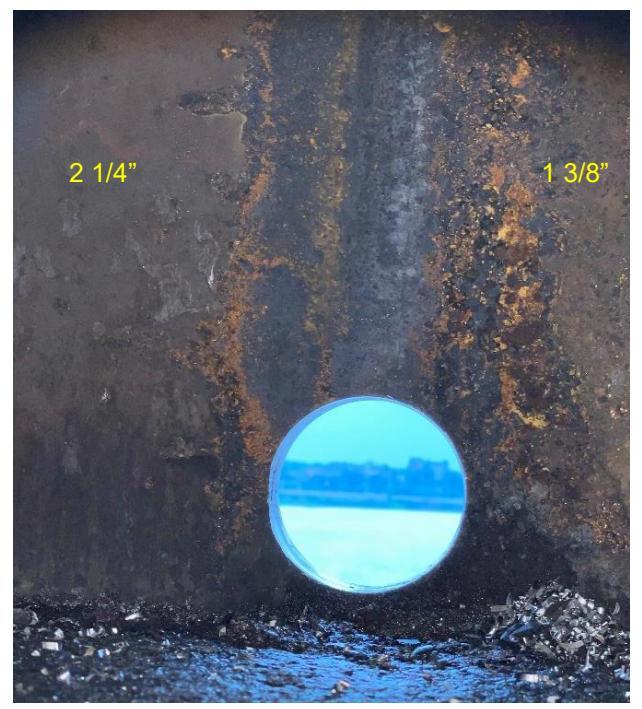
In addition to the fractured plates, ten 3-inch diameter core samples were removed by WJE at locations identified by PAUT has having possible defects. A core sample extracted from the weld at SA168W is shown in Figure 15. The ten core locations are shown in Figure 16.

Figure 15. View from inside tie showing core sample removed from groove weld.

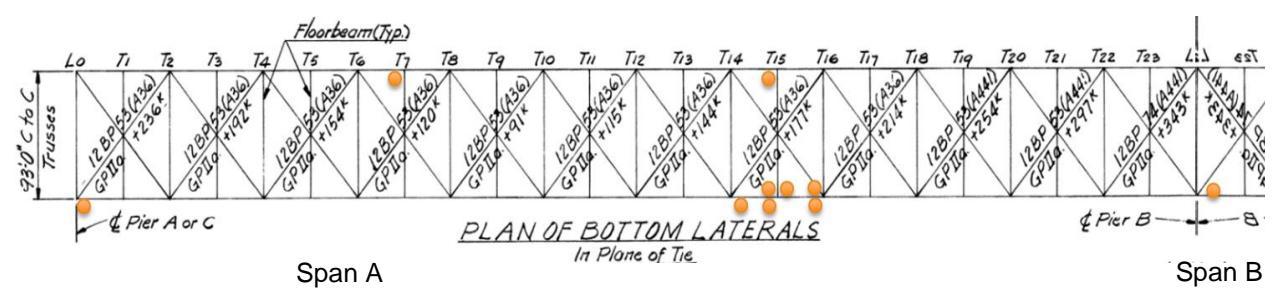
Figure 16. Locations in Span A of core samples removed from other tie girder groove welds with defect indications.

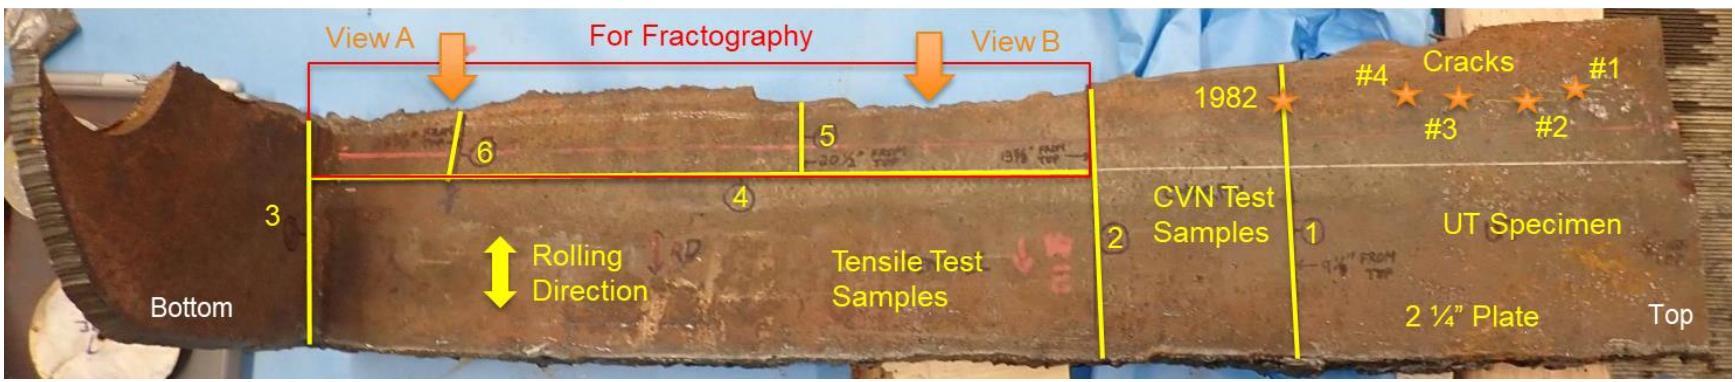
The east sample was used for mechanical testing, metallurgical analysis, and ultrasonic inspection while the west sample was used for mechanical testing with limited metallurgical analysis. Figure 18 denotes the cut lines where the material was sectioned for further analysis from the east sample. The west fracture was not utilized for the primary fractographic and metallographic analysis because portions of the fracture surface had been inadvertently sandblasted in preparation for removal of the fracture pieces. The discoloration along portions of the fracture surface indicative of sandblasting is shown in Figure 19.

Figure 18. Overall photograph of the east fracture surface depicting the samples used for mechanical testing and metallographic analysis prior to sectioning.

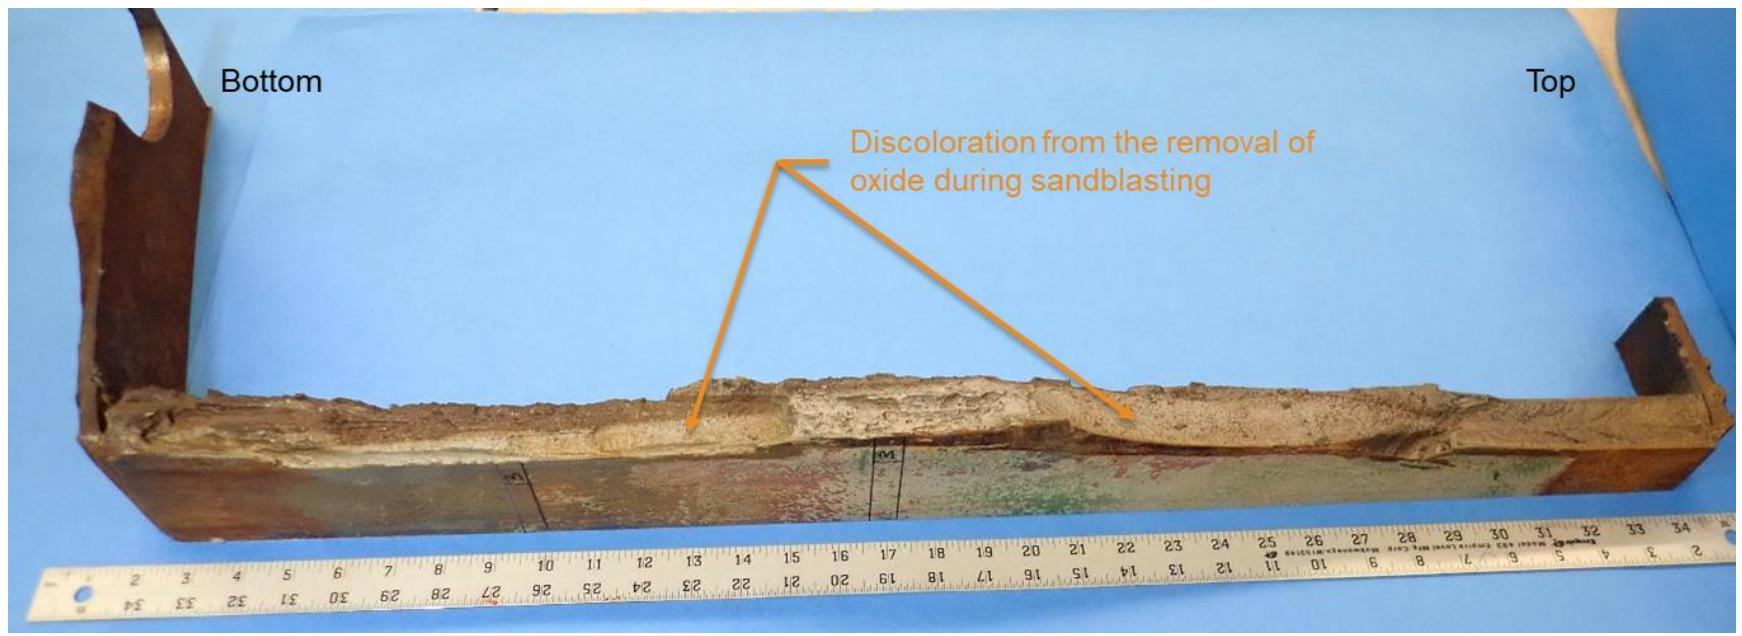
Figure 19. West fracture surface (left piece shown in Figure 17).

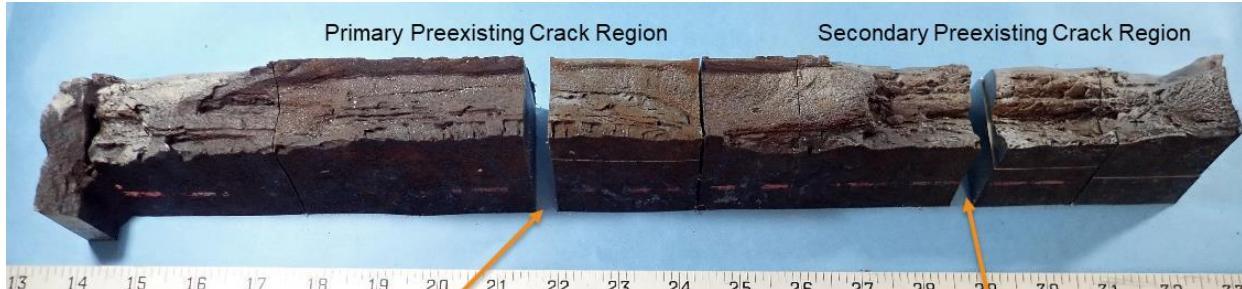
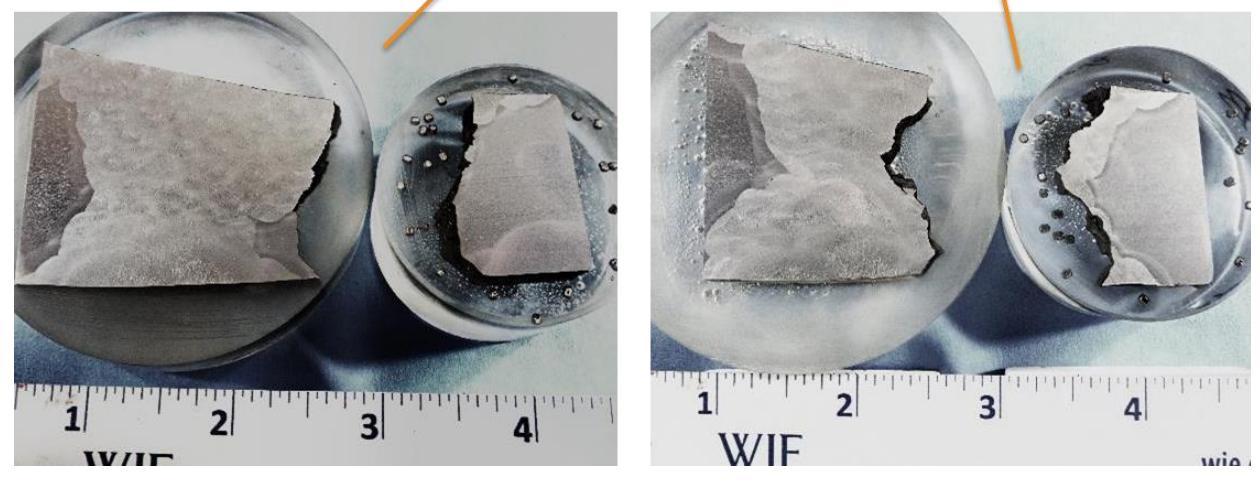
Four large-format cold mount samples were removed from the mating surfaces of the fracture at locations indicated by the orange arrows shown in Figure 35. A low magnification montage was assembled as Figure 36 to examine the full cross-section of the primary preexisting crack. The 2 1/4-inch plate is on the left side of the weld and the 1 3/8-inch plate is on the right. The crack was observed to pass through the weld metal, heat affected zones (HAZ), and base metal. Figure 37 displays a montage of the two mating surface samples prepared at the secondary (upper) preexisting crack region of the weld. In this section, most of the crack growth progressed through weld metal.

Figure 35. Overall primary and secondary preexisting crack regions along the fracture surface and associated mating fracture surface prepared for metallographic examination.

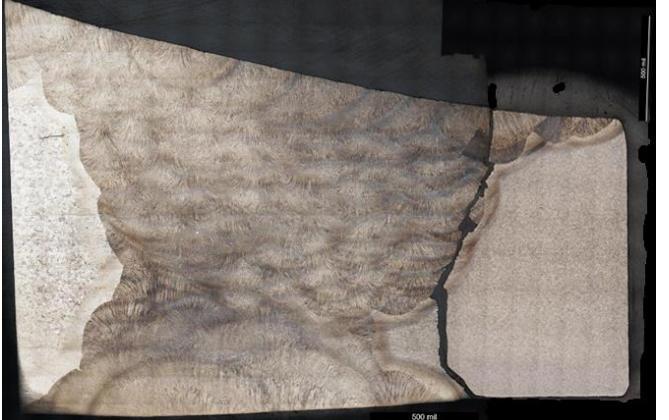
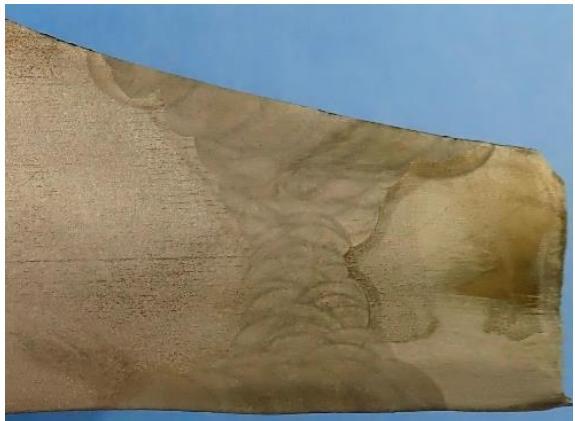
When the two montages of the weld profiles cut from the preexisting crack regions (Figure 36 and Figure 37) were viewed in comparison to the weld region near the top of the fractured side plate or with welds contained in the core samples, the weld profiles from the preexisting crack regions were significantly wider. Figure 39 and Figure 40 show these comparisons. Moreover, the placement of the weld beads differed in that welds shown in Figure 39b and Figure 40a and b indicated the inside bevel weld had been placed first with the two plates laid flat, as shown in the photo, followed by the second bevel weld after the plates were flipped over. In comparison, the welds in the preexisting crack regions showed the inside weld beads having been placed after the outside weld, and the weld bead stacking arrangement appeared to have been misaligned with the root of the weld. This suggested that the two preexisting crack regions were likely weld repairs.

a. Primary Preexisting Crack weld profile.Figure 39. Comparative weld profiles in fractured side plate.

b. Weld profile near top of fractured side plate.

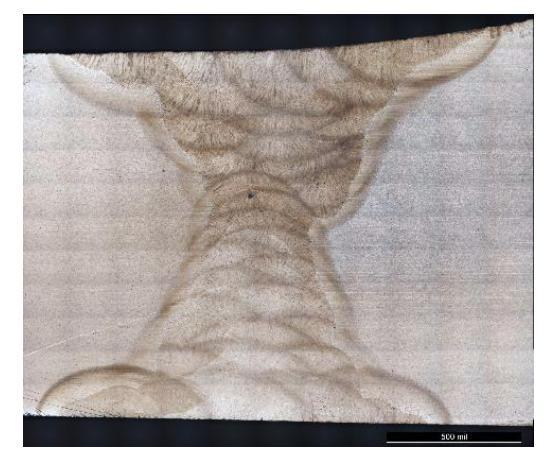
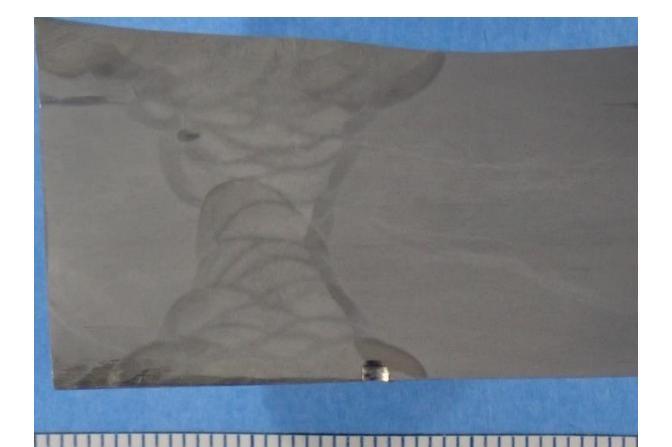
a. Core Sample SA008E weld profile.b. Core Sample NA154W weld profile.Figure 40. Comparative weld profiles from representative core samples.

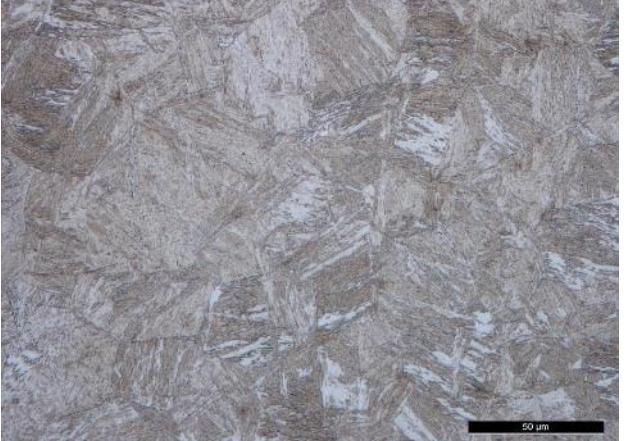
The intergranular path of the crack in Core Sample SA008E is clearly visible in Figure 49 and Figure 50. As in SA158W, it progressed through the GCHAZ and GRHAZ before arresting at the ICHAZ. The base metal fracture visible in Figure 48 was caused intentionally in order to separate the crack faces for examination. At 500X magnification, it was clear that the martensite in the GCHAZ had experienced significantly less tempering (Figure 51) than the base metal (Figure 52).

Figure 51. Core Sample SA008E GCHAZ – 500X magnification.

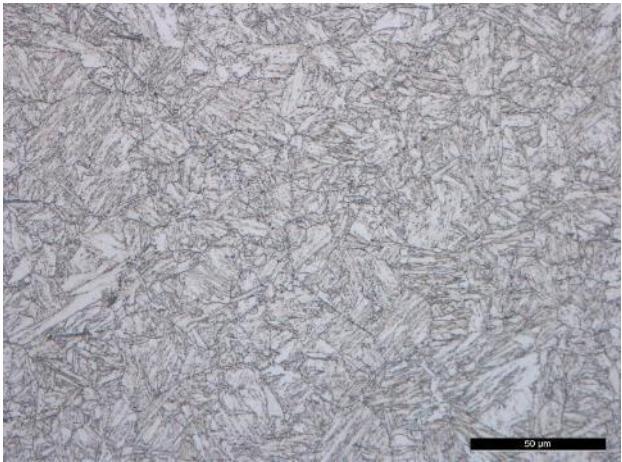
Figure 52. Core Sample SA008E base metal – 500X magnification.

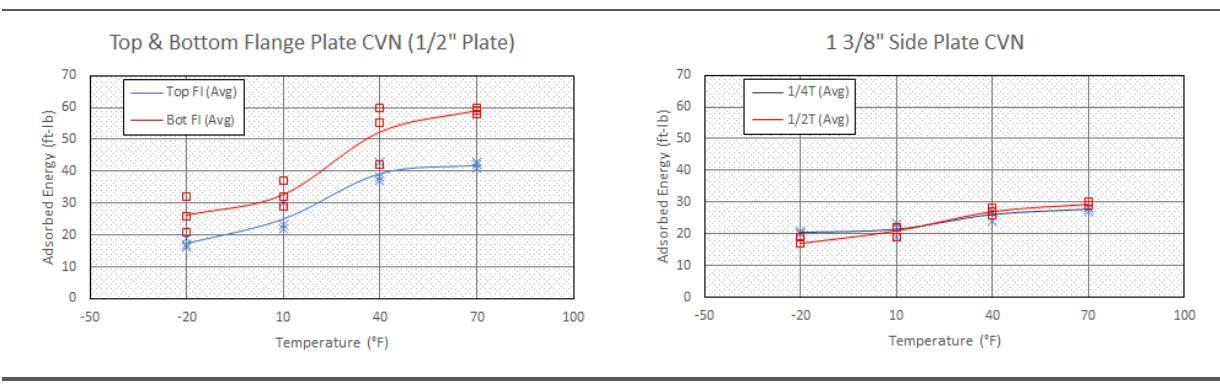
Plate samples were sent for Charpy V-Notch (CVN) impact testing. The tests were conducted in accordance with the ASTM A673-17 *Standard Specification for Sampling Procedure for Impact Testing of Structural Steel.* The test temperatures were set to –20 deg. F, 10 deg. F, 40 deg. F, and 70 deg. F to develop the upper and lower shelf toughness behavior of the material. The results of the base material tests for the cover plates and 1 3/8-inch side plate are shown in Table 5a and b. The initial test results were invalid for the 2 1/4-inch plate, thus additional 2 1/4-inch plate material was sent to another laboratory for testing. Those test results are presented in Table 5c. An upper temperature value of 100 deg. F was used for these tests. The CVN results for the base materials are plotted in Figure 56 through Figure 58. The average for each test was greater than 15 ft-lbs.

Figure 56. CVN test results for the top and bottom cover plate material.

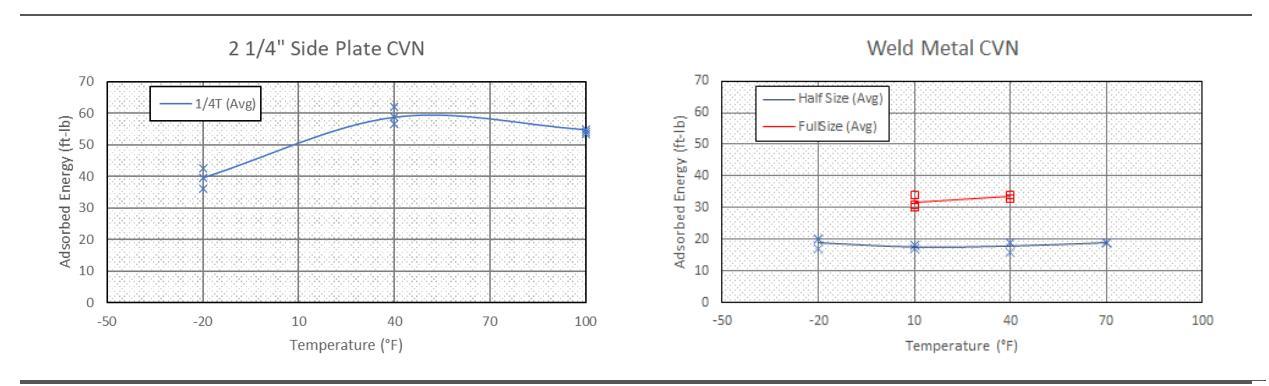
Figure 58. CVN test results for the 2 1/4-inch side plate Figure 59. CVN test results for the weld metal material.

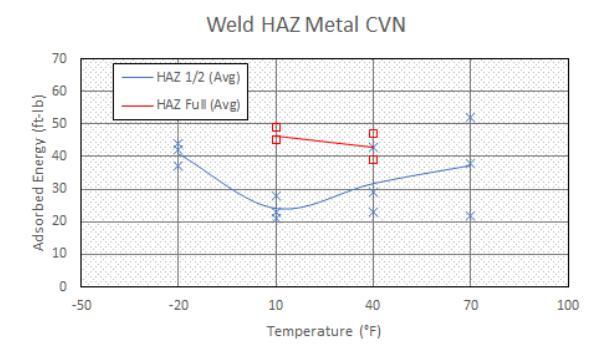
The weld and HAZ CVN samples were obtained from the 2 1/4-inch plate side of the weld. There was insufficient material available to obtain CVNs from the 1 3/8-inch side of the weld. To maximize the number of tests from the available weld and HAZ materials, a combination of full-size and half-size CVNs were machined. The half-size CVN test results have not been adjusted to represent full-size specimens. Results for the weld and HAZ CVN tests are presented in Table 5d and e. Figure 59 and Figure 60 are plots of these results. The variability in the test results for the HAZ specimens shown in Figure 60 suggests notch placement inconsistencies within the HAZ.

Figure 60. CVN test results for the material in the weld HAZ.
