**UNITED STATES  
NUCLEAR REGULATORY COMMISSION**

**SUBJECT: ARKANSAS NUCLEAR ONE – NRC AUGMENTED INSPECTION TEAM  
FOLLOW-UP INSPECTION REPORT 05000313/2013012 AND  
05000368/2013012; PRELIMINARY RED AND YELLOW FINDINGS**

**Unit 1**  
**Outage Detailed Risk Evaluation**  
(Phase 3 Risk Assessment Loss of Offsite Power)

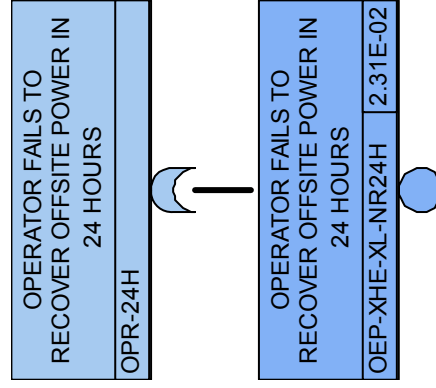
**Figure A-3: Offsite Power Recovery Fault Tree**

Note that the non-recovery probability was set to one in a change set

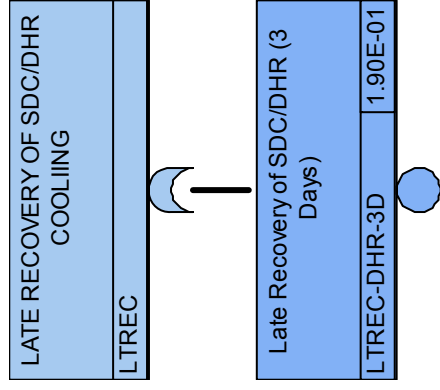
Figure A-11: SDC/DHR Late Recovery Fault Tree

Note the value of the late recovery basic event varies with the time available
